# Interim Reclamation and Stormwater Inspection

May 19, 2021

Operator: GREAT WESTERN OPERATING COMPANY LLC- #10110

Location Name: Kodak South FD Pad /28-222HN

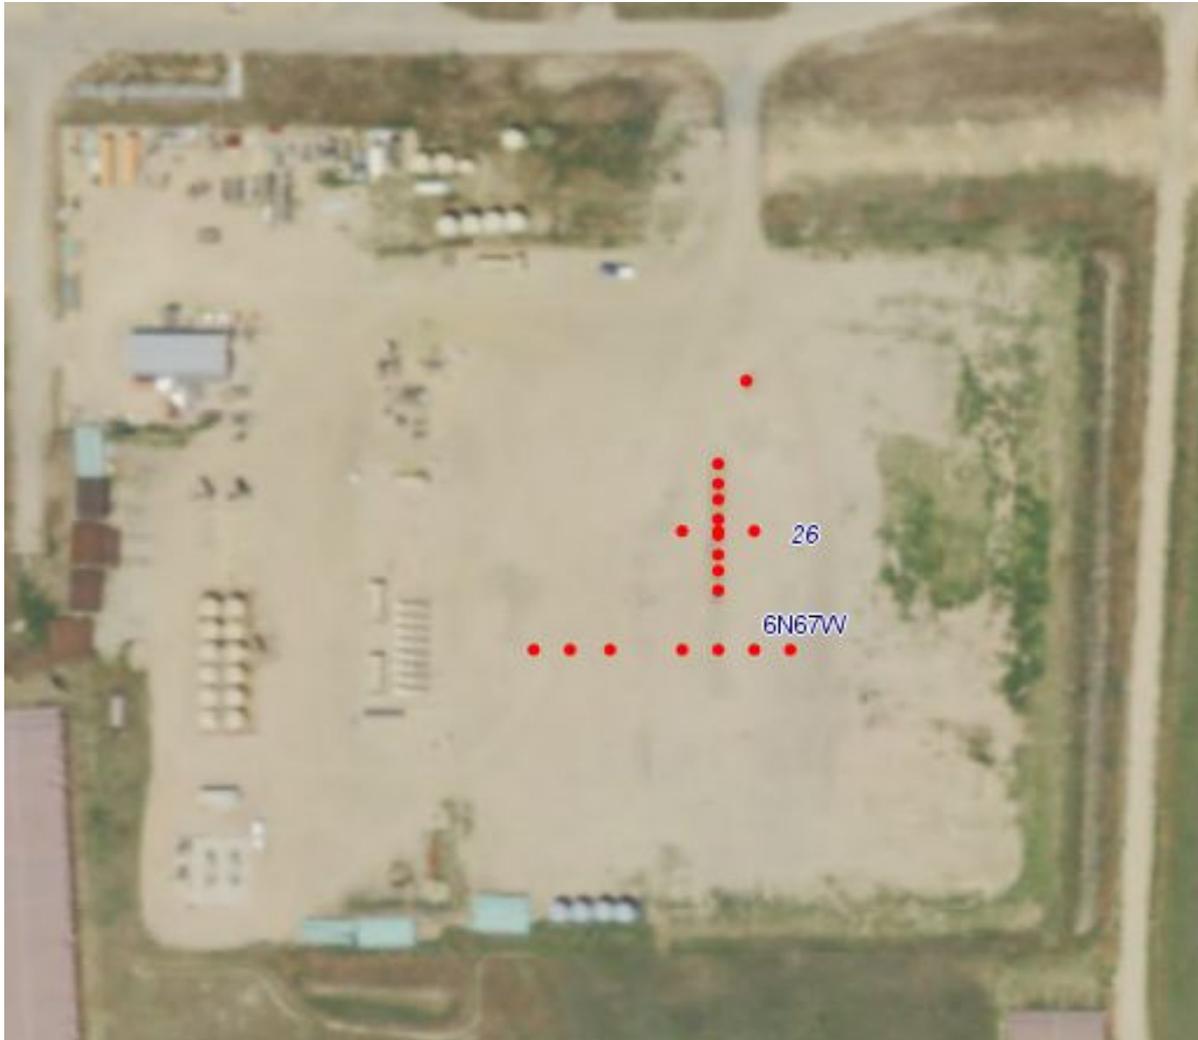
**Photo 1.** 2019 aerial imagery illustrates the total disturbance area. Operator has not performed interim reclamation activities- refer to the following photos.

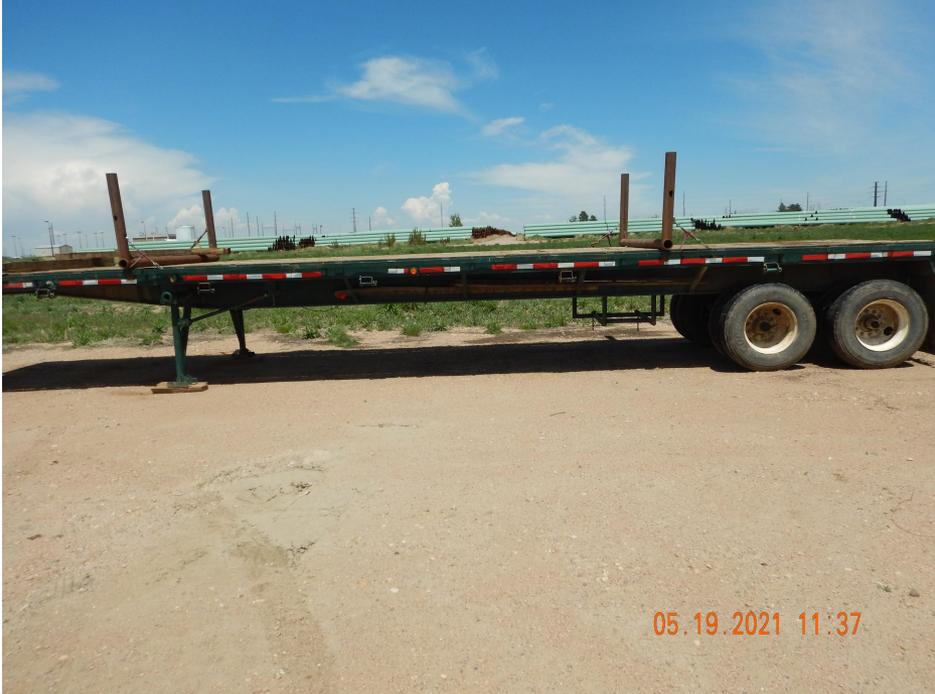
**Photo 2.** Photo taken from the northern location, facing North. Photo illustrates the storage of a trailer on location.

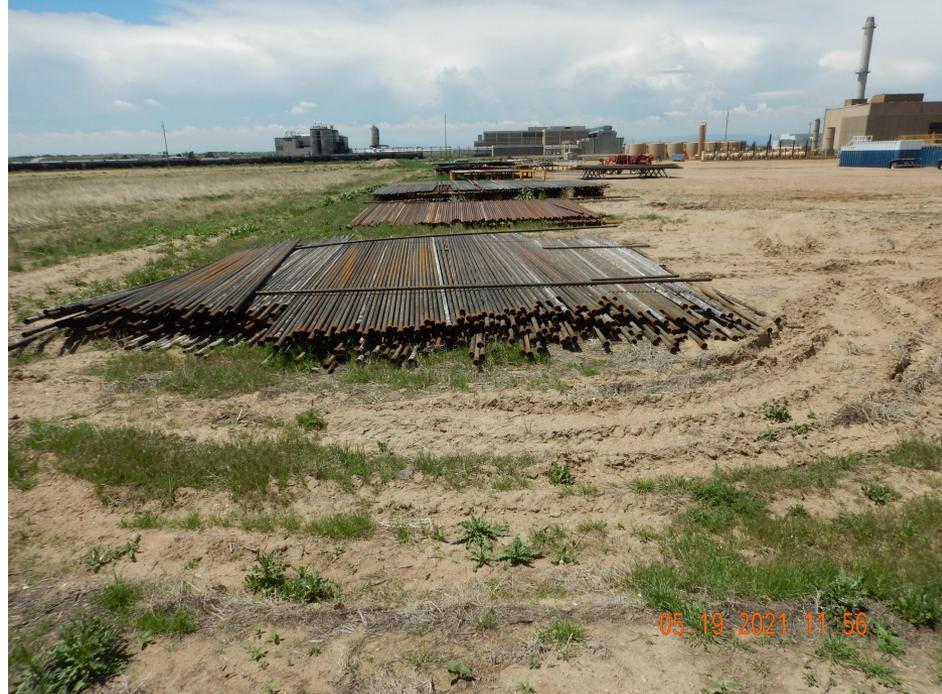
**Photo 3.** Photo taken from the southeastern location, facing West. Photo illustrates the storage of supplies.

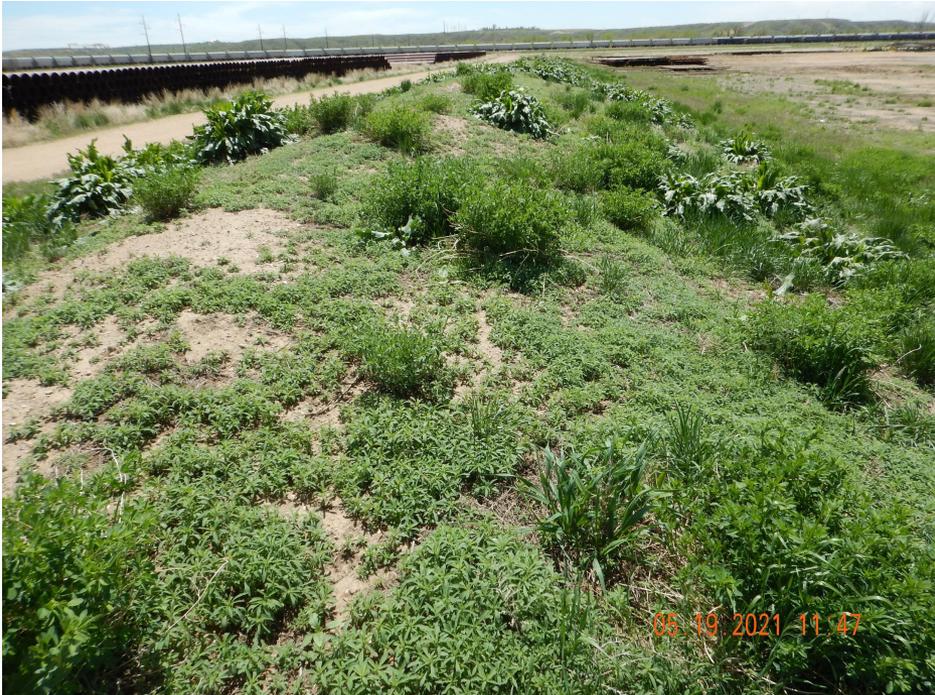
**Photo 4.** Photo taken from the eastern location, facing South. Photo illustrates weed establishment on the topsoil stockpile.

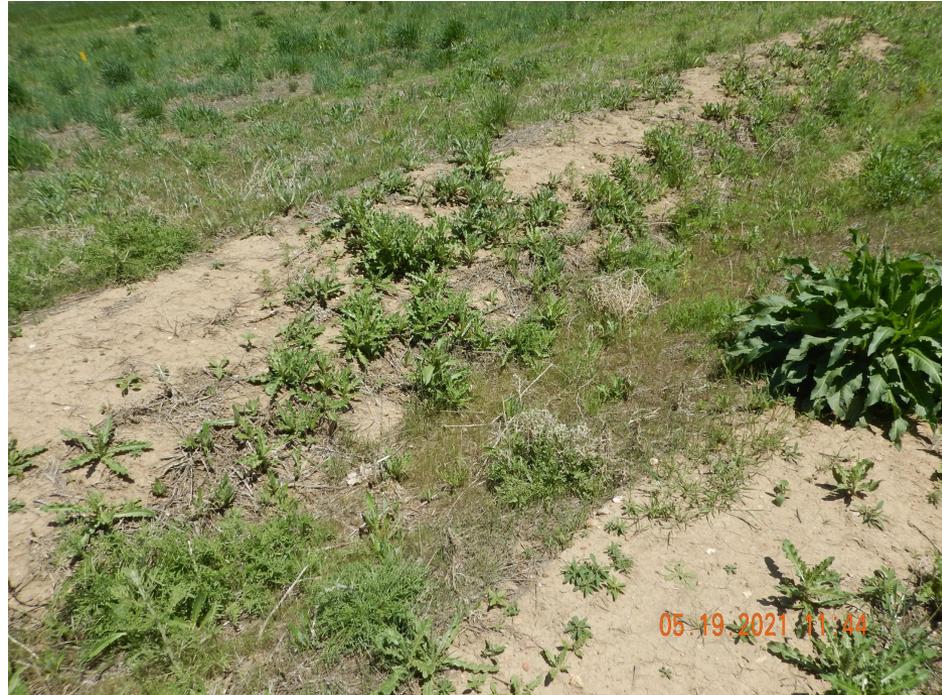
**Photo 5.** Photo taken from the northeastern location. Photo illustrates a List B Colorado noxious weed, Canada thistle. This was observed throughout the location, including the topsoil stockpile.

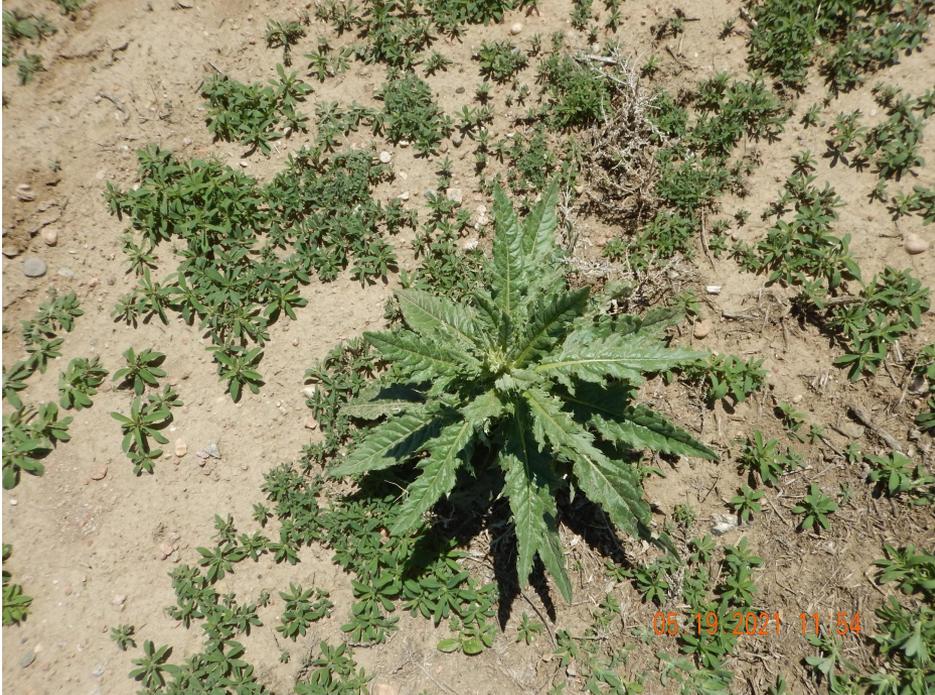
**Photo 6.** Photo taken from the topsoil stockpile. Photo illustrates a List B Colorado noxious weed, Scotch thistle.

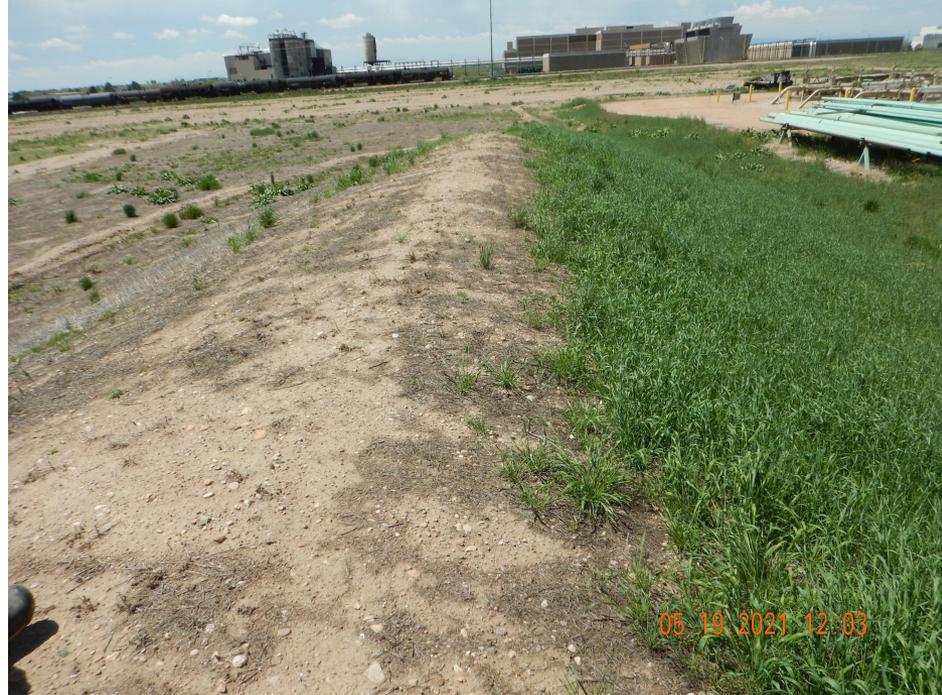
**Photo 7.** Photo taken from the southern location, facing South. Photo illustrates the north-facing topsoil stockpile is vegetated with cereal rye but not the remainder.
