Interim Reclamation and Stormwater Inspection

May 20, 2021

Operator: GREAT WESTERN OPERATING COMPANY LLC- #10110

Location Name: Baseline LE Pad

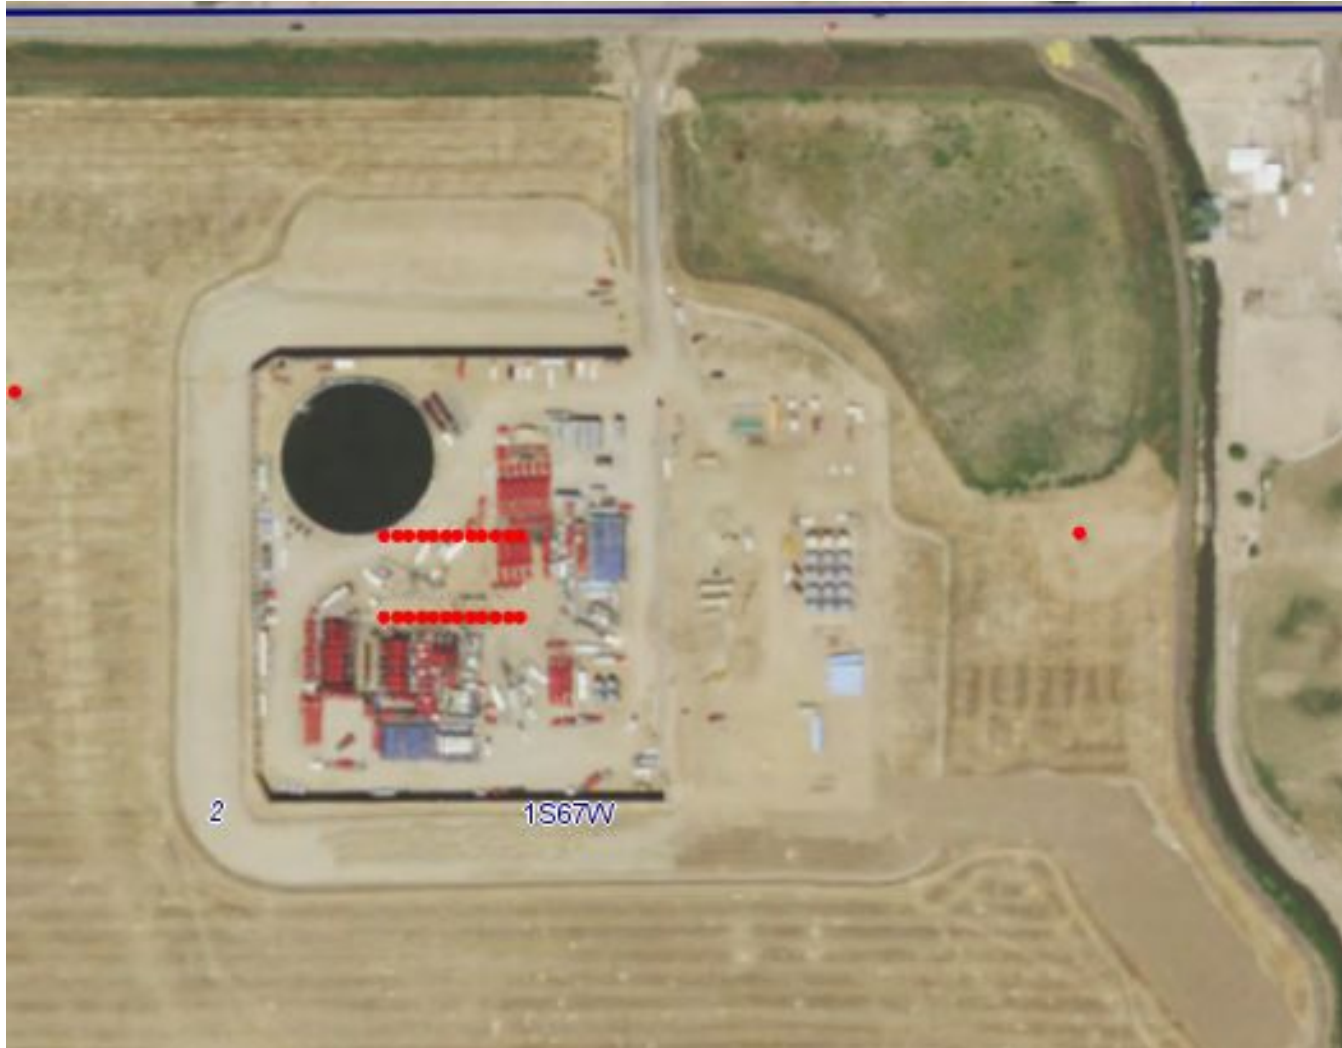
Photo 1. 2019 aerial imagery illustrates the total disturbance area. Operator has not performed interim reclamation activities- refer to the following photos. Note: Operator indicated they are coordinating with Butterfly Pavilion on a project.

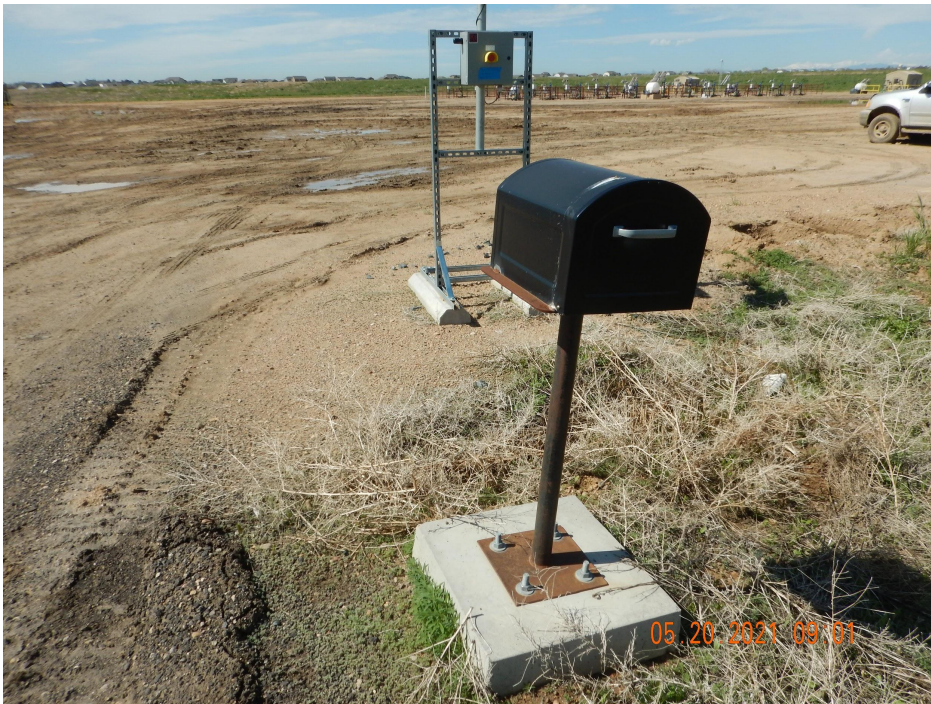
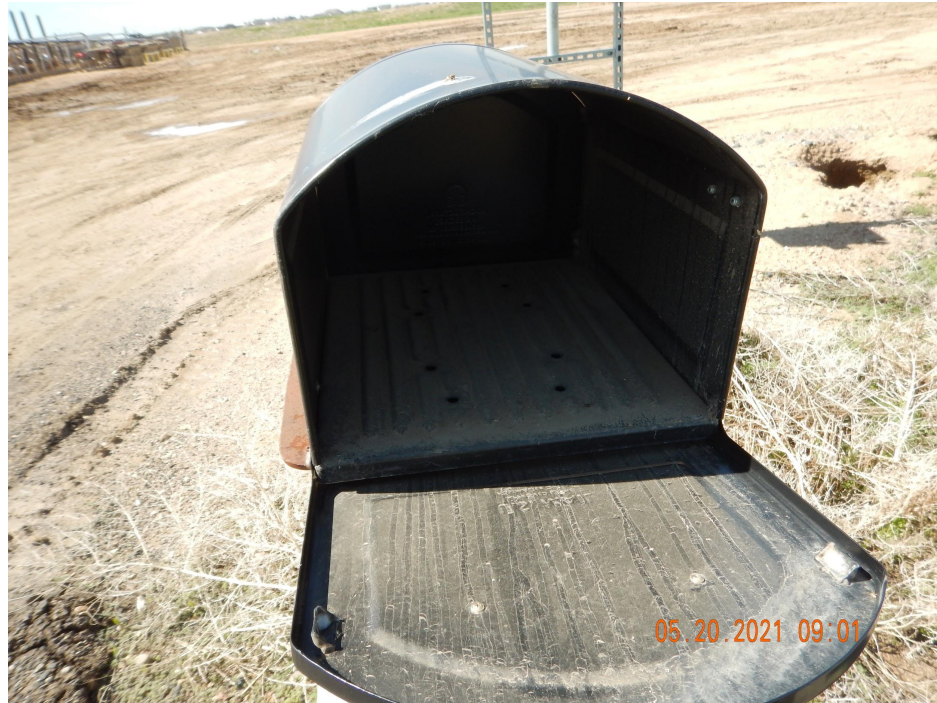
Photo 3. See comments under Photo 2.

Photo 2. Photo taken from the entrance of location, facing South. Photo illustrates a mailbox for the purposes of storing permits; however, no permits were present.

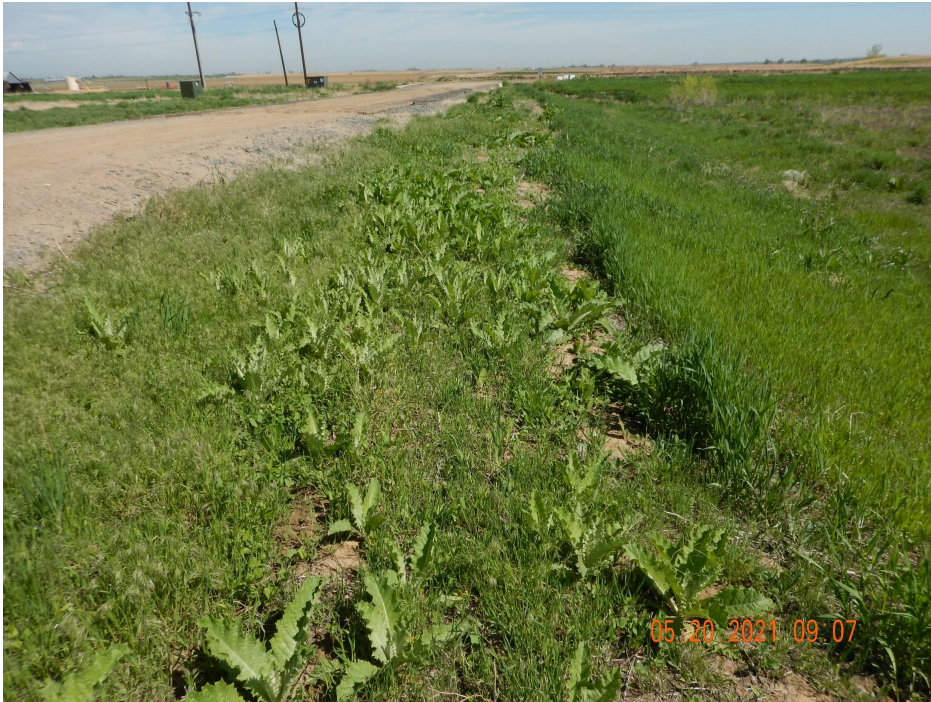
Photo 4. Photo taken from the eastern access road, facing North. Photo illustrates a List B Colorado noxious weed, Scotch thistle, establishment throughout the entire access road.

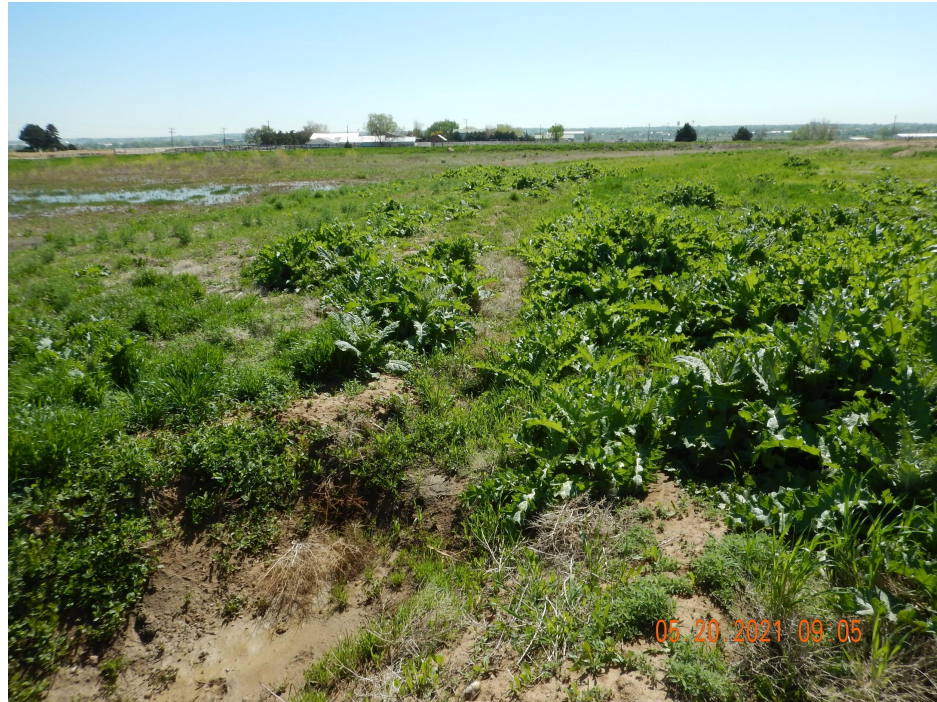
Photo 5. Photo taken from the northern location, facing East. Photo illustrates a List B Colorado noxious weed, Scotch thistle, which appears to be spreading off location. Operator shall control and manage what has spread off location, in addition to what is on location.

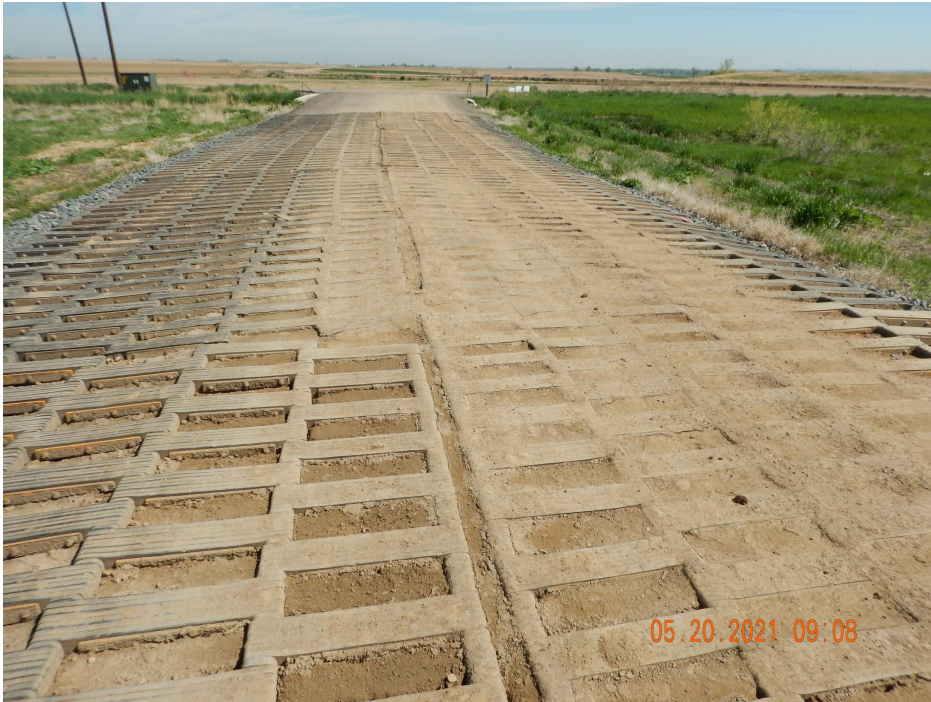
Photo 6. Photo taken from the entrance of location, facing North. Photo illustrates the vehicle tracking device BMP is in need of maintenance.

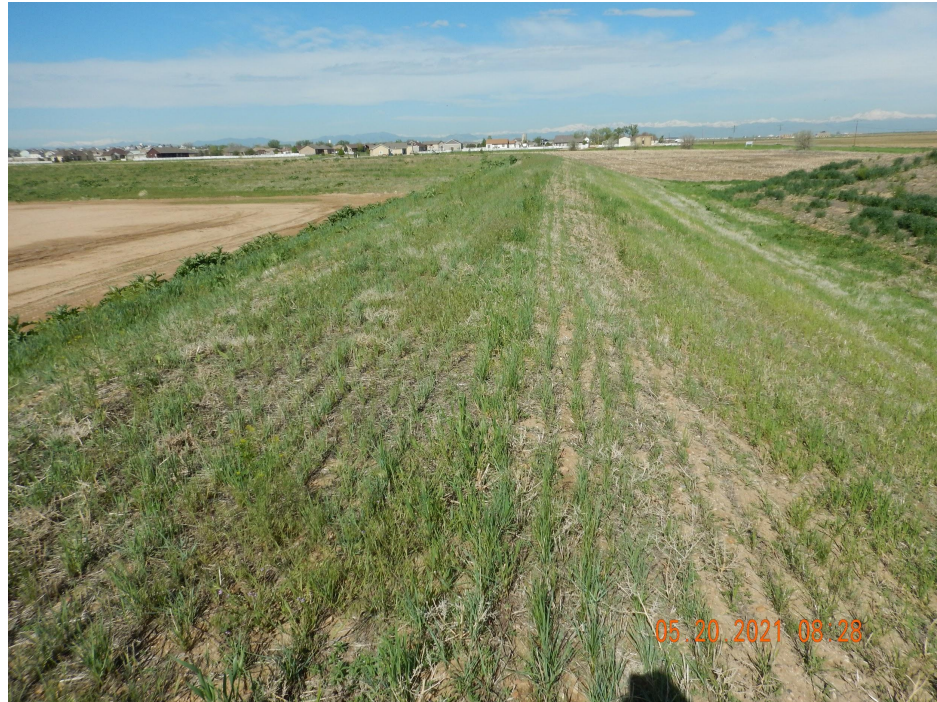
Photo 7. Photo taken from the northern berm, facing West. Photo illustrates the desirable vegetation is establishing; however, noxious weeds were observed throughout the entire berm.

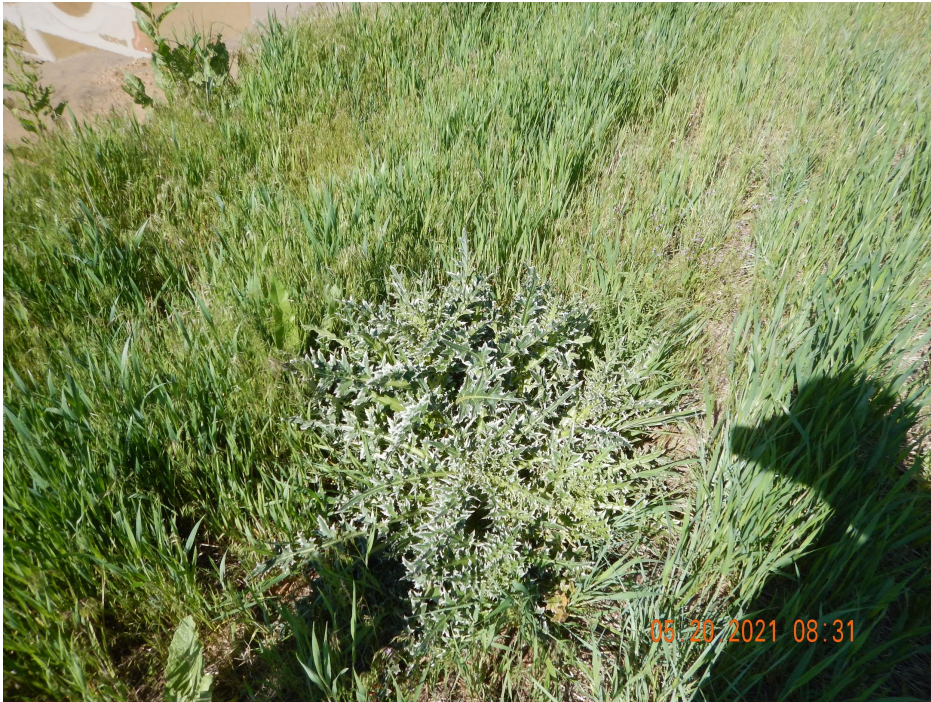
Photo 8. Photo taken from the northern berm. Photo illustrates a List B Colorado noxious weed, Musk thistle.

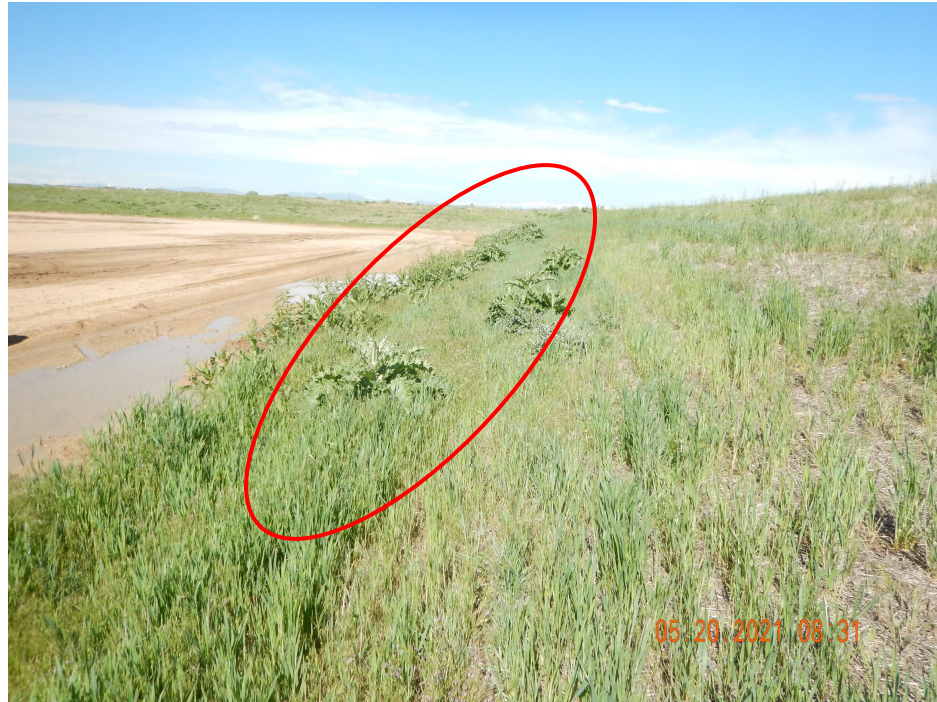
Photo 9. Photo taken from the northern berm, facing West. Photo illustrates a List B Colorado noxious weed, Scotch thistle.

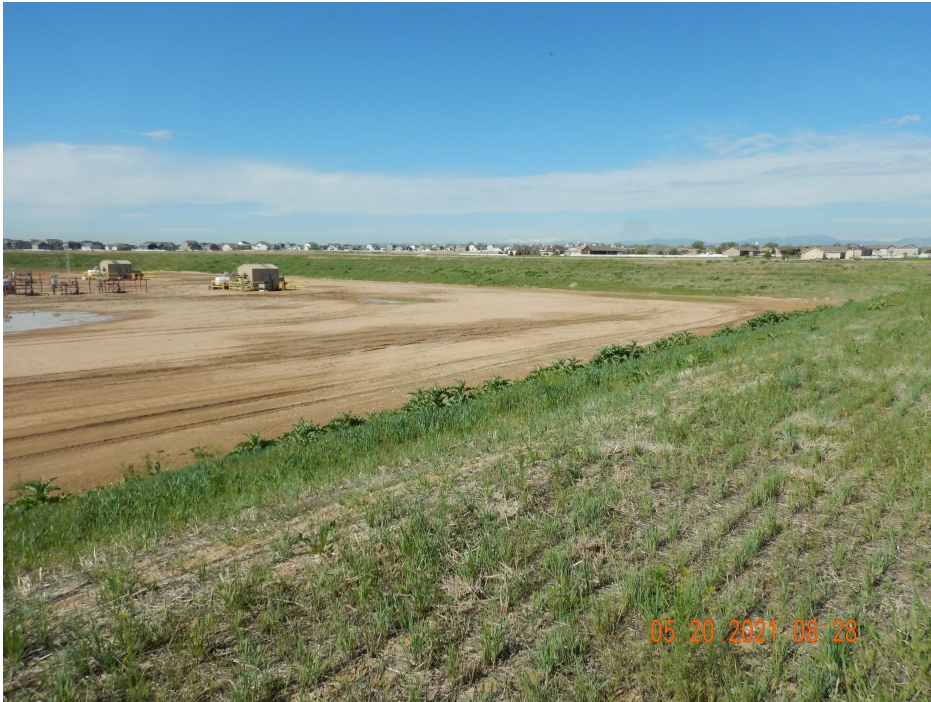
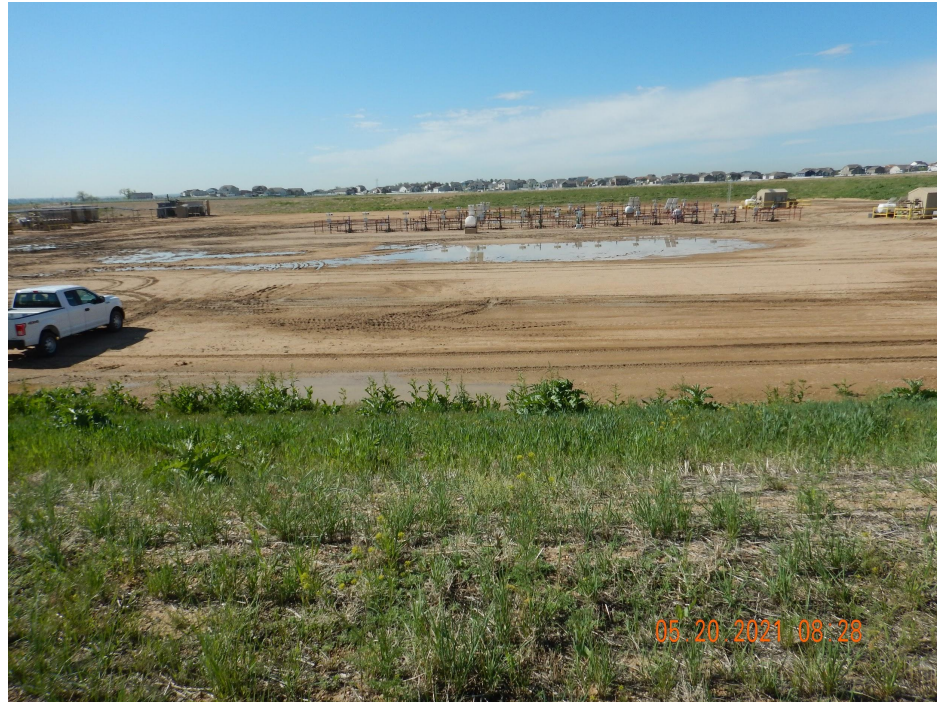
Photo 11. Photo taken from the northern berm, facing South. See comments under Photo 10.

Photo 10. Photo taken from the northern berm, facing Southwest. Photo illustrates Operator has not yet performed interim reclamation and claims the ~12.5' perimeter berm is permanent.
