# Interim Reclamation and Stormwater Inspection

May 20, 2021

Operator: GREAT WESTERN OPERATING COMPANY LLC- #10110

Location ID: 459907

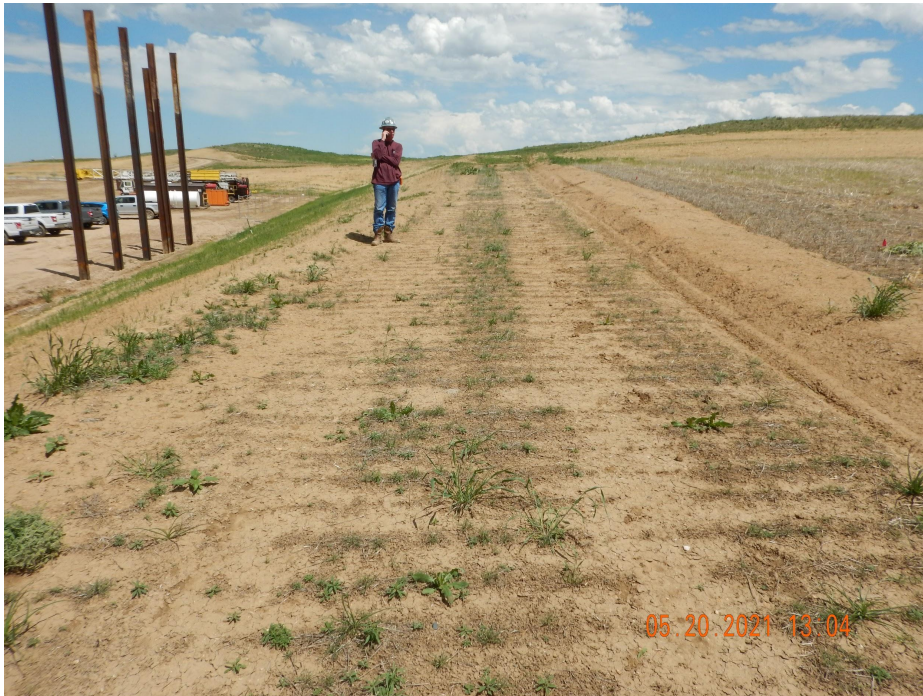
**Photo 1.** Photo taken from the southern location, facing East. Photo illustrates a ditch BMP along the perimeter with the cut slope to the interior.

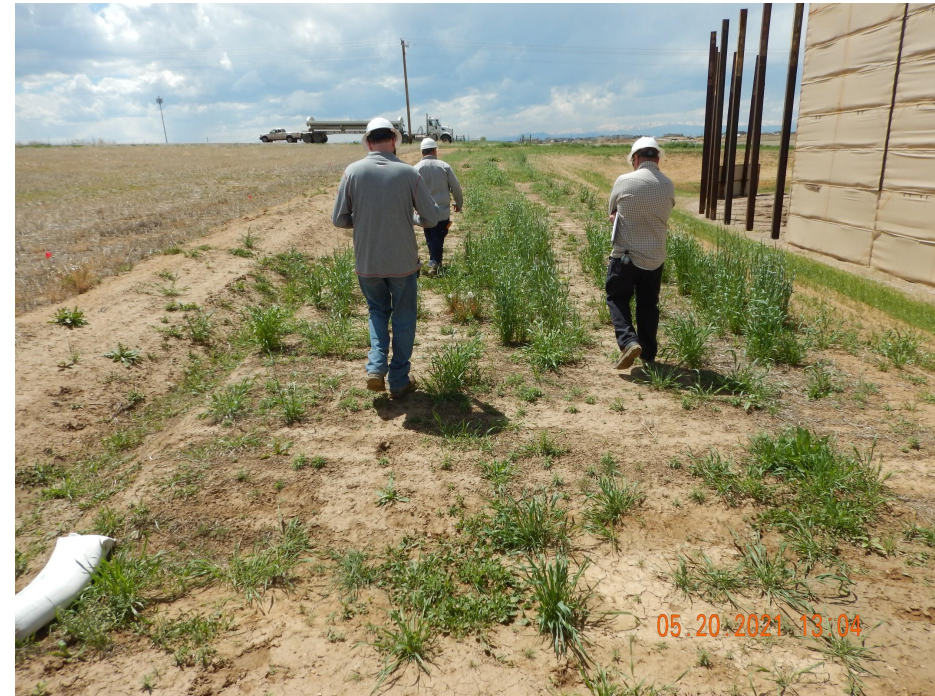
**Photo 2.** Photo taken from the southern location, facing West. See comments under Photo 1.

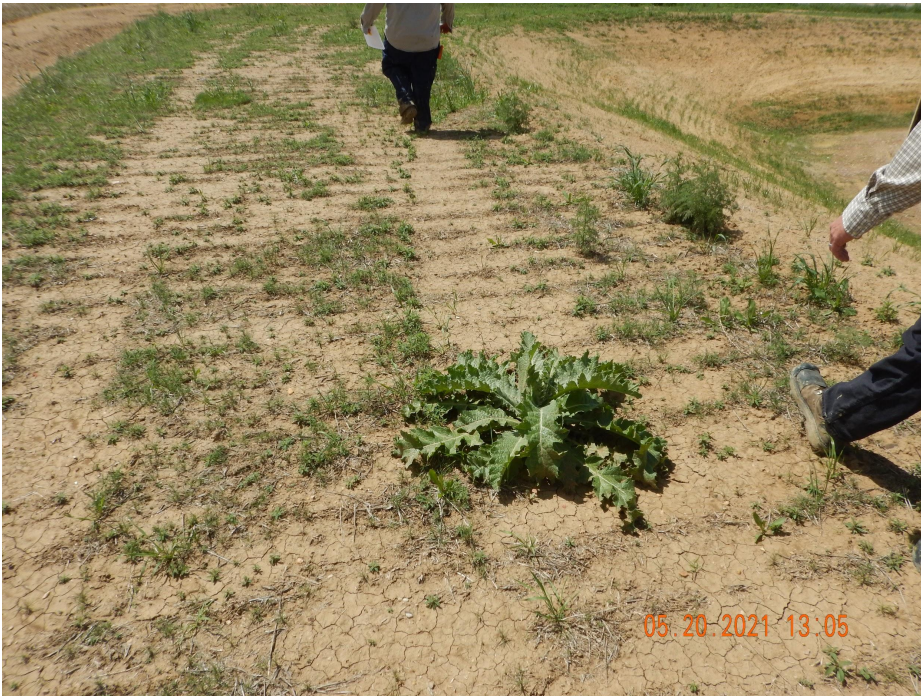
**Photo 3.** Photo taken from the southern location. Photo illustrates a List B Colorado noxious weed, Scotch thistle.

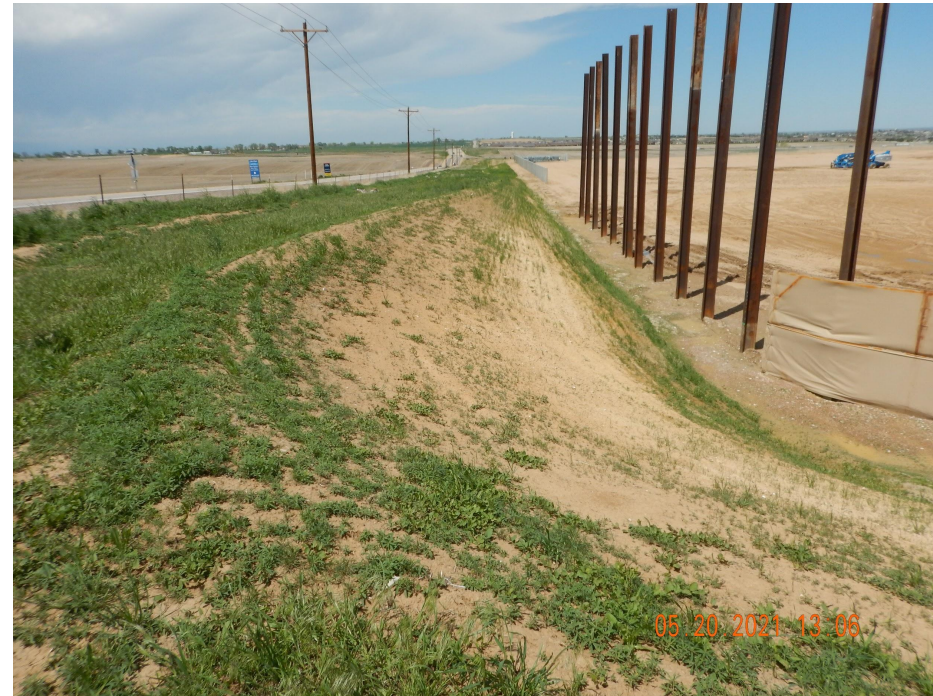
**Photo 4.** Photo taken from the southwestern location, facing North. See comments under Photo 1.

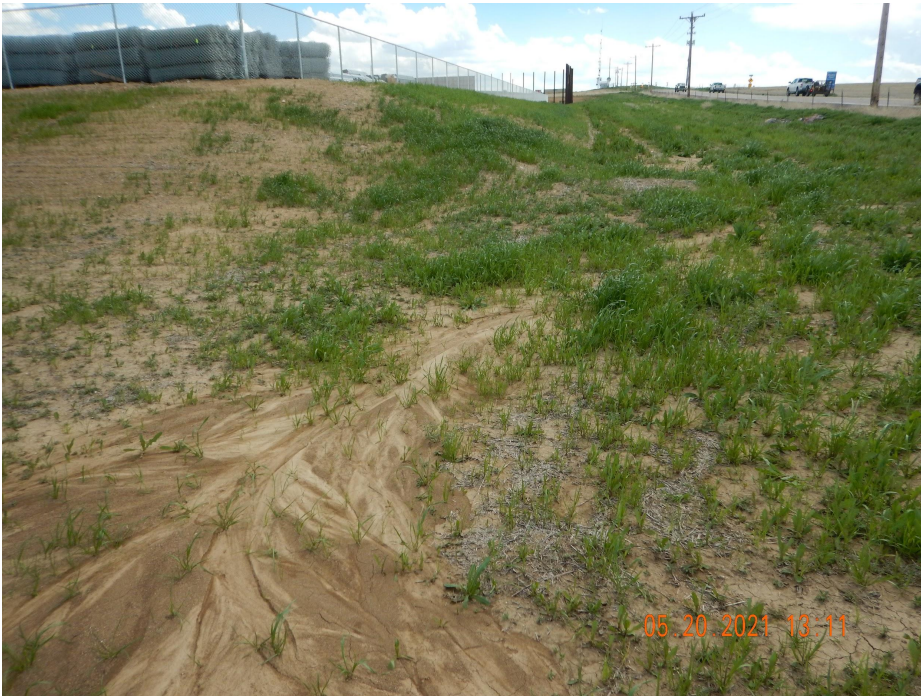
**Photo 5.** Photo taken from the northwestern location, facing South. Photo illustrates a path of erosion.

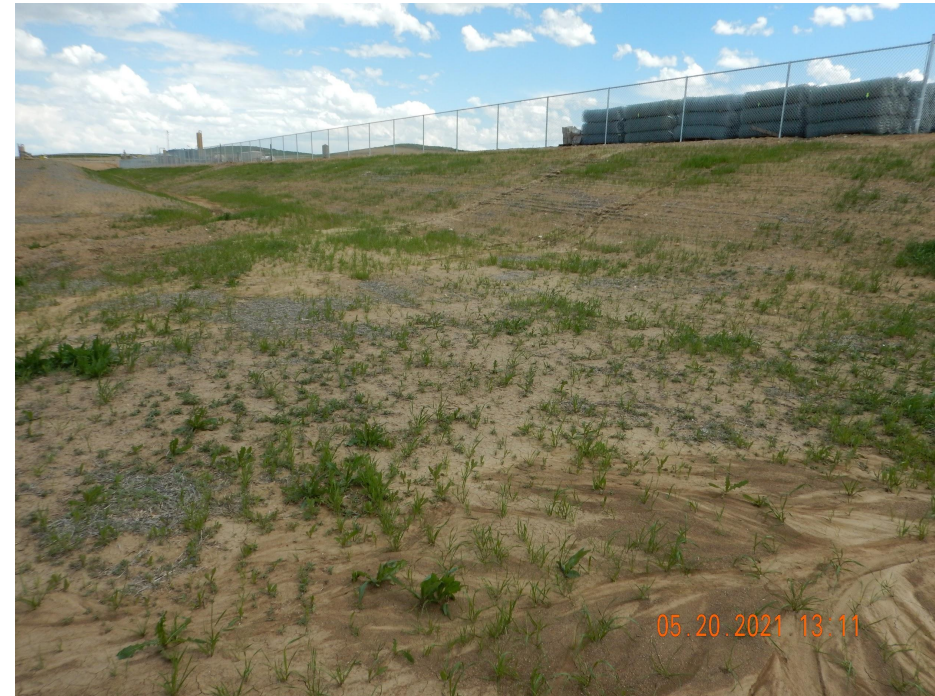
**Photo 6.** Photo taken from the northwestern location, facing East. See comments under Photo 5.

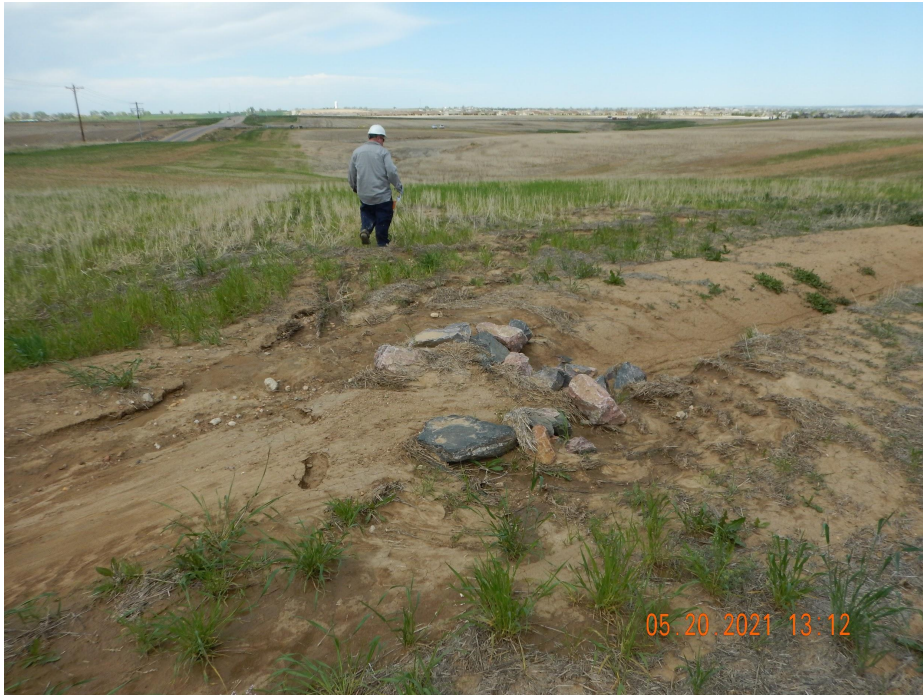
**Photo 7.** Photo taken from the northwestern location, facing North. Photo illustrates sediment has filled up the check dam and is discharging sediment offsite.

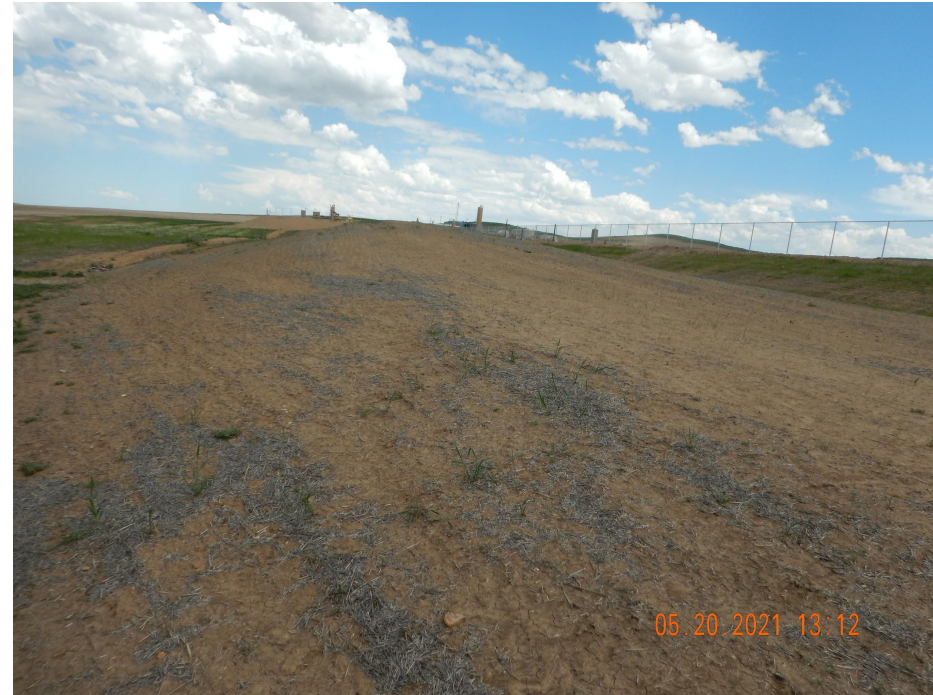
**Photo 8.** Photo taken from the topsoil stockpile, facing East. There was some evidence of germination but Operator plans to reseed.

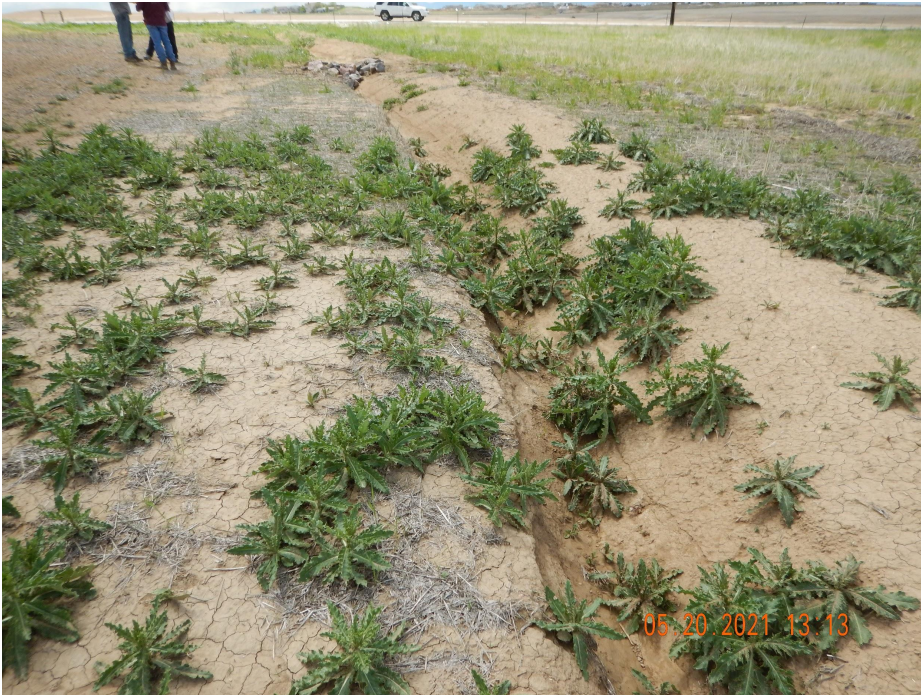
**Photo 9.** Photo taken from the northwestern location, facing West. Photo illustrates a patch of List B Colorado noxious weeds.

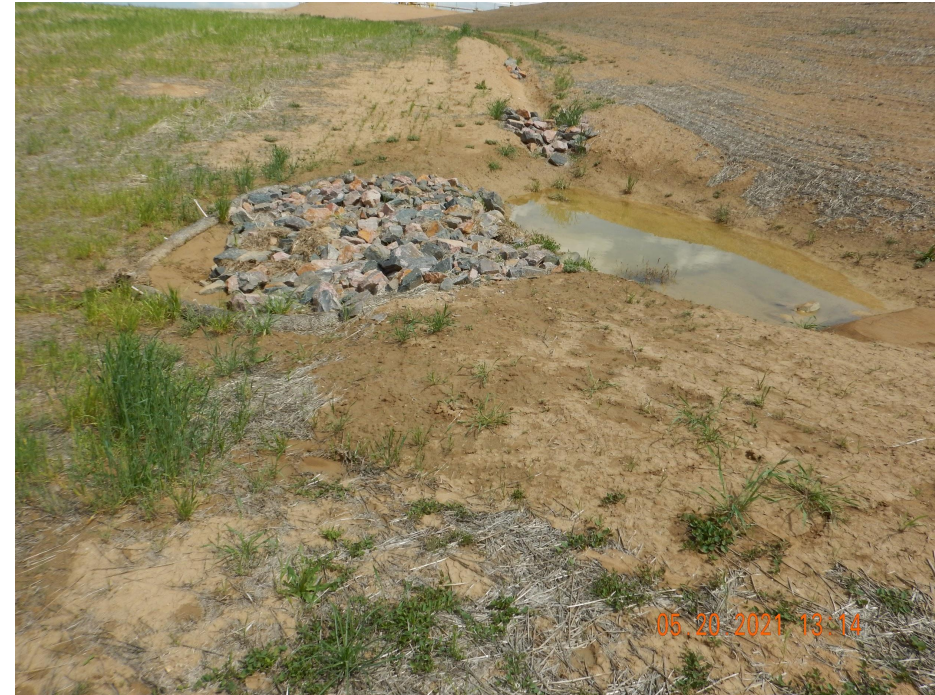
**Photo 10.** Photo taken from the northern location, facing East. Photo illustrates a sediment trap in need of maintenance.

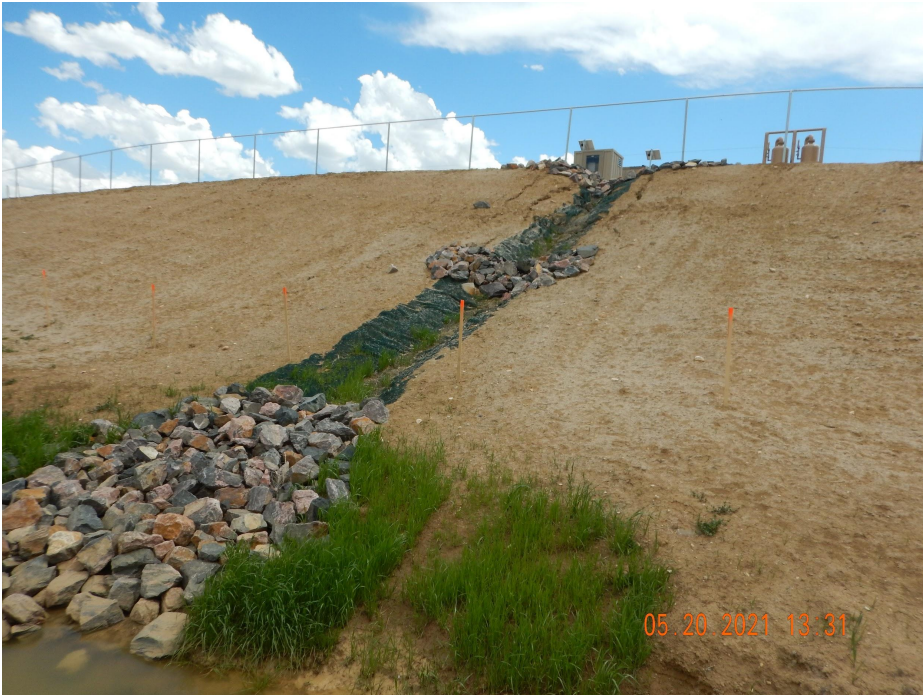
**Photo 11.** Photo taken from the northeastern location, facing South. Photo illustrates a stabilized channel with check dams and appears maintenance is required along the upslope portion.

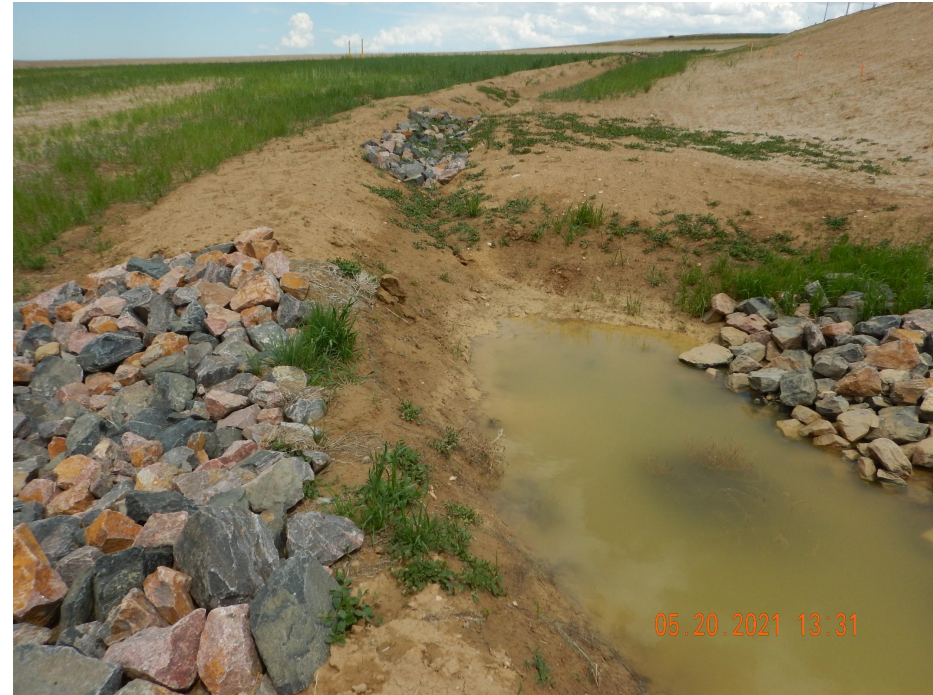
**Photo 12.** Photo taken from the northeastern location, facing East. Photo illustrates a sediment trap in need of maintenance.
