Final Reclamation Inspection

Operator: CONFLUENCE DJ LLC - #10518

Location ID: 320347

Inspection Photos
Location Name: KALLSEN #A-1
Location ID: 320347

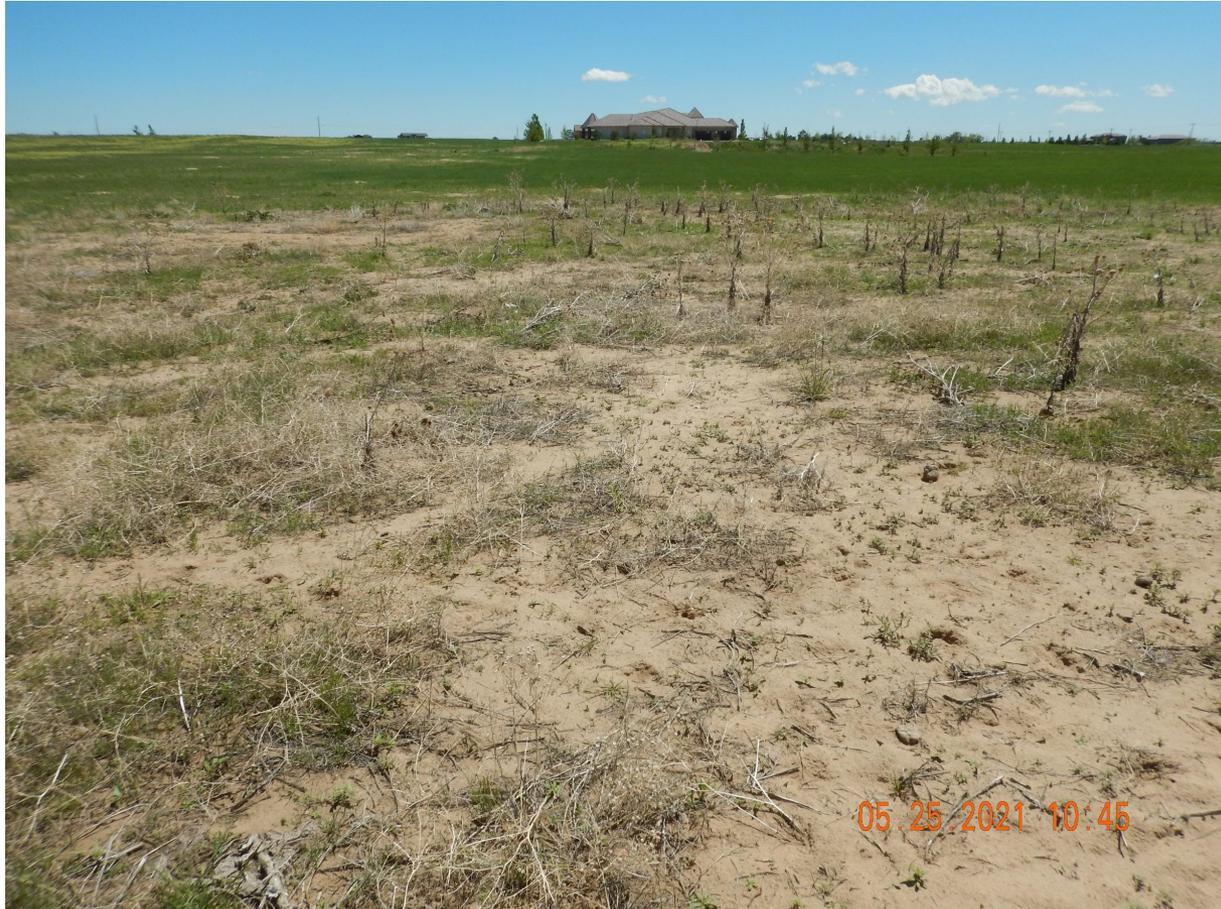
Photo 1. Photo taken from the well location, facing East. Photo illustrates the well location is not reflective of reference areas and a List B Colorado noxious weed, Scotch thistle, is spreading off location, in addition to other undesirable plant species. Also, the well location has not been properly recontoured to the surrounding area.

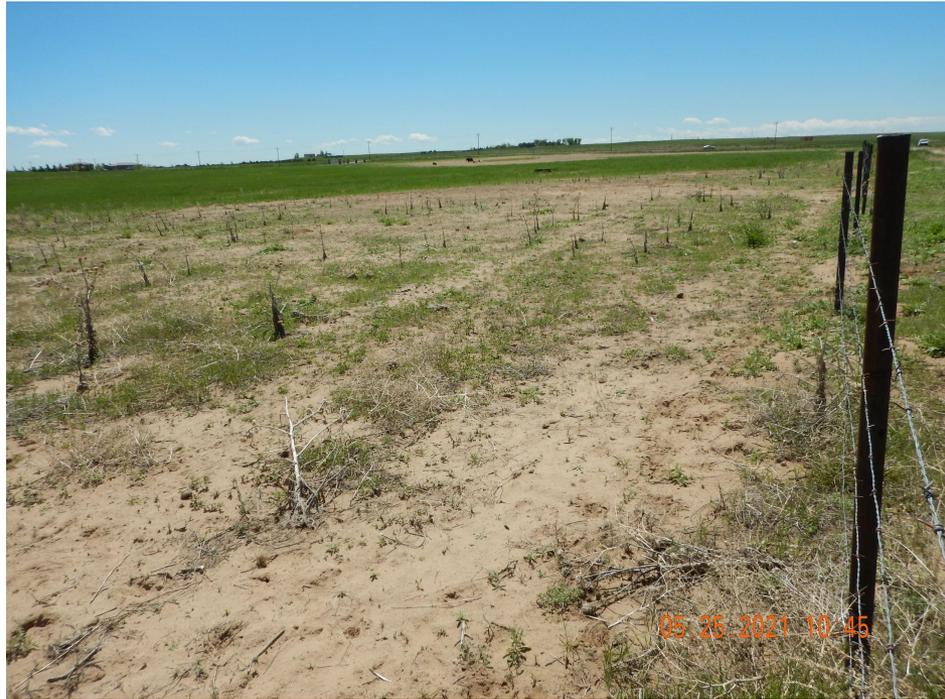
Photo 2. Photo taken from the well location, facing Southeast.
See comments under Photo 1.

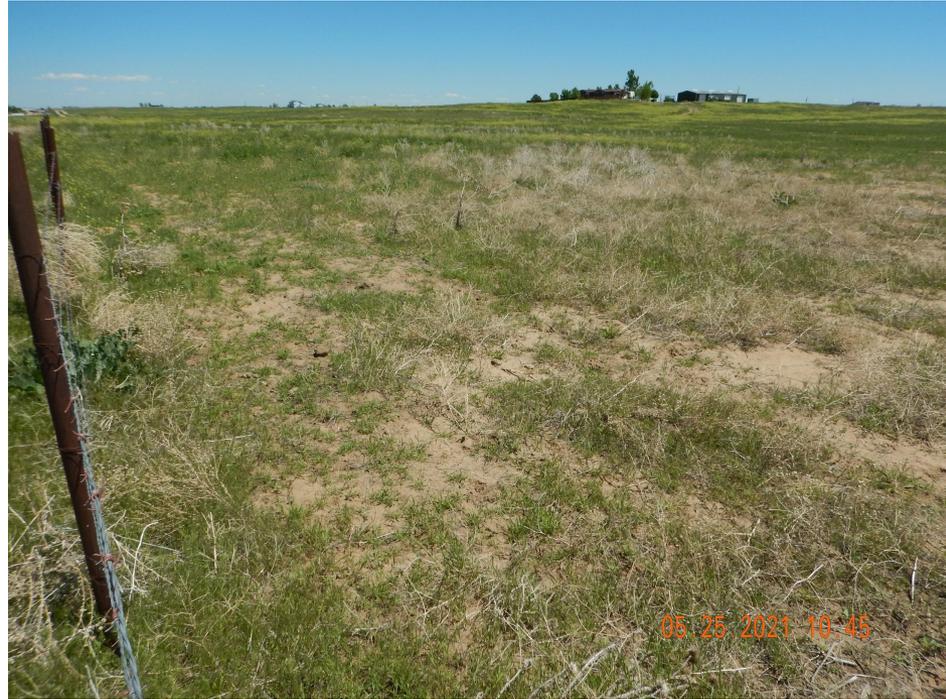
Photo 3. Photo taken from the well location, facing Northeast.
See comments under Photo 1.

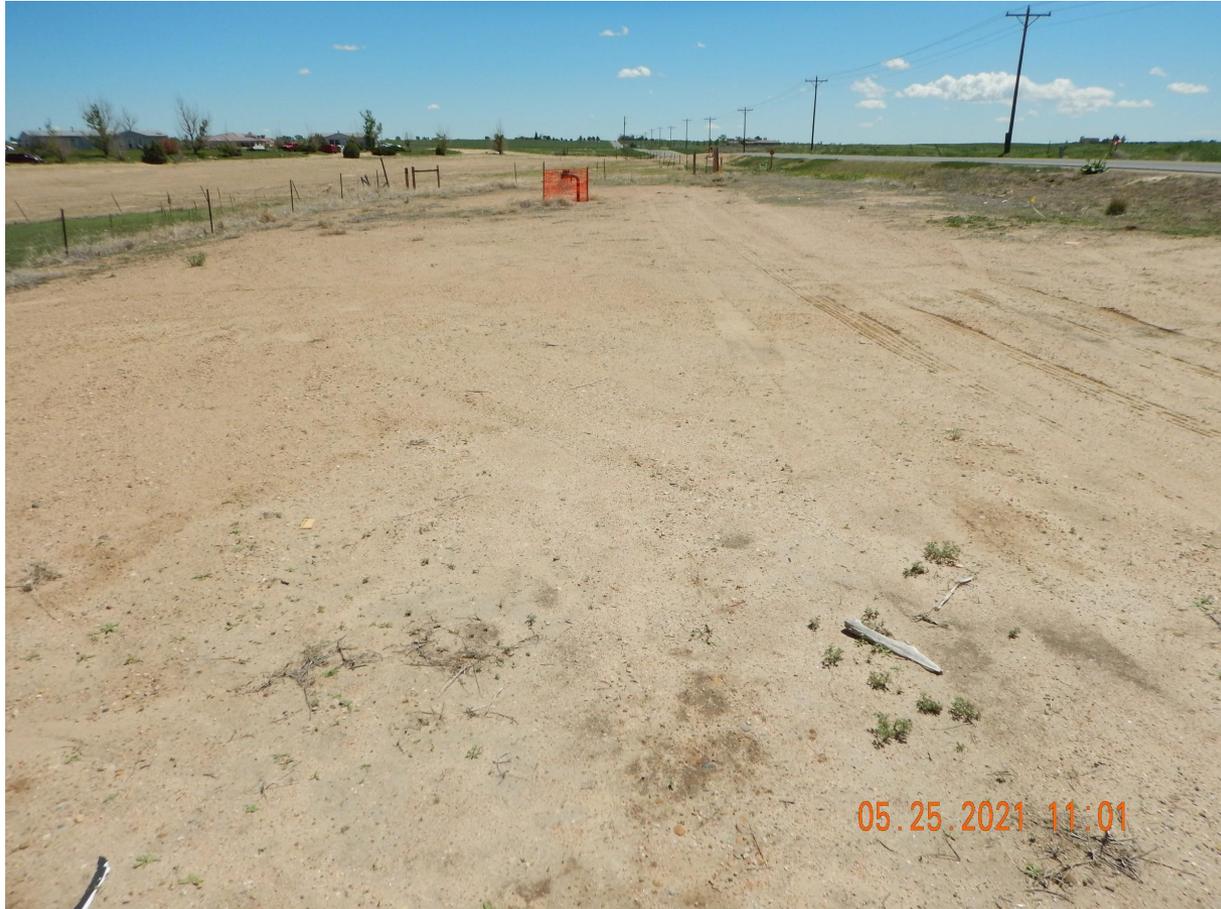
Photo 4. Photo taken from the associated offsite tank battery location, facing East. Photo illustrates not all equipment has been removed and final reclamation activities have not been performed.

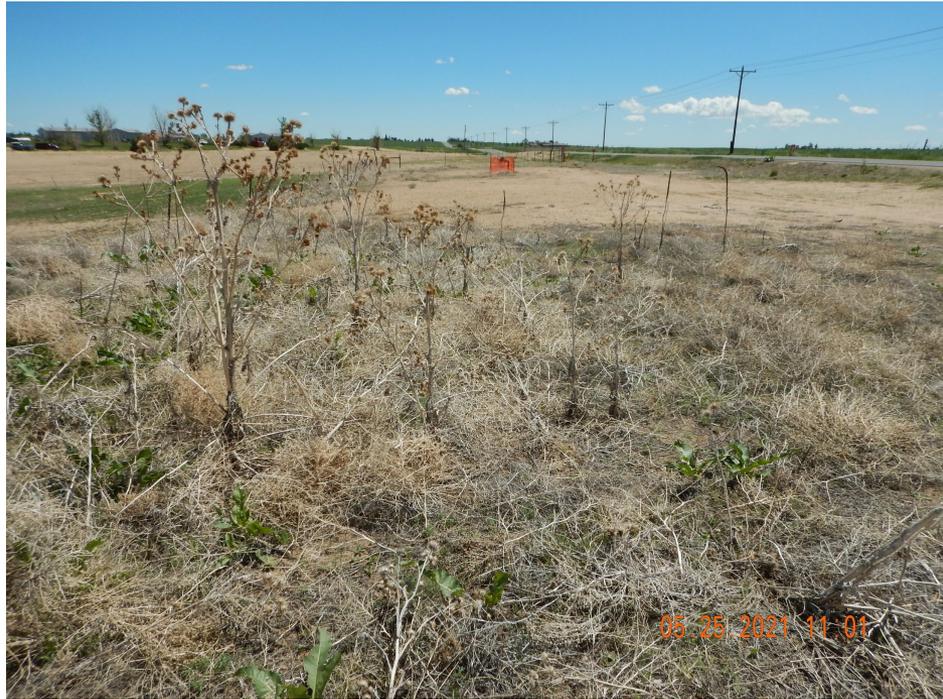
Photo 5. Photo taken from the associated offsite tank battery location, facing East. Photo illustrates a List B Colorado noxious weed, Scotch thistle.

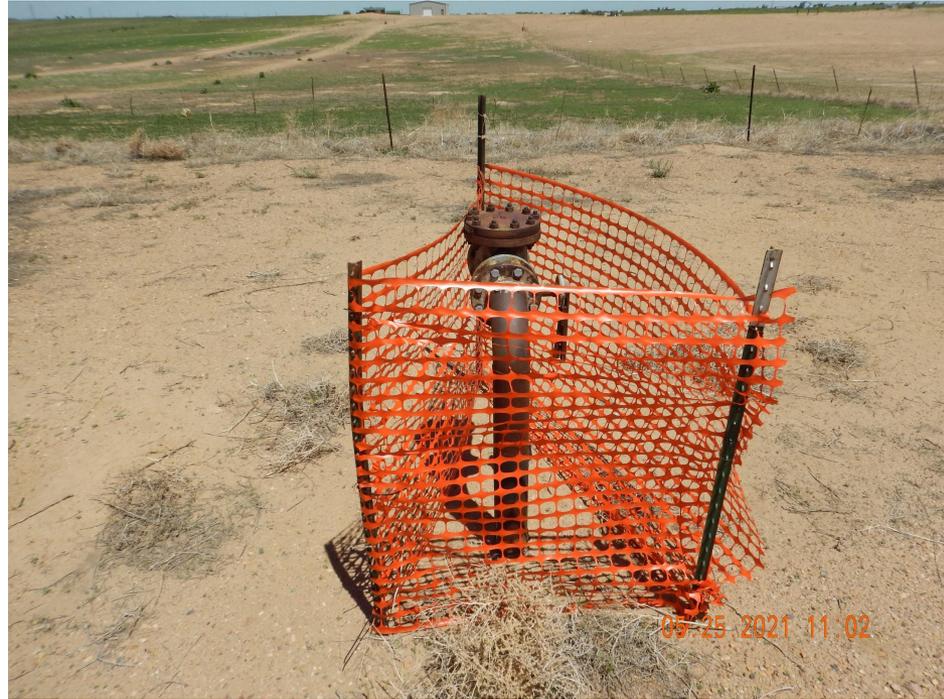
Photo 6. Close up photo taken of the remaining equipment.
