Inspection Photos
Operator: Catamount
API: 067-08990
Date: 6/3/2021

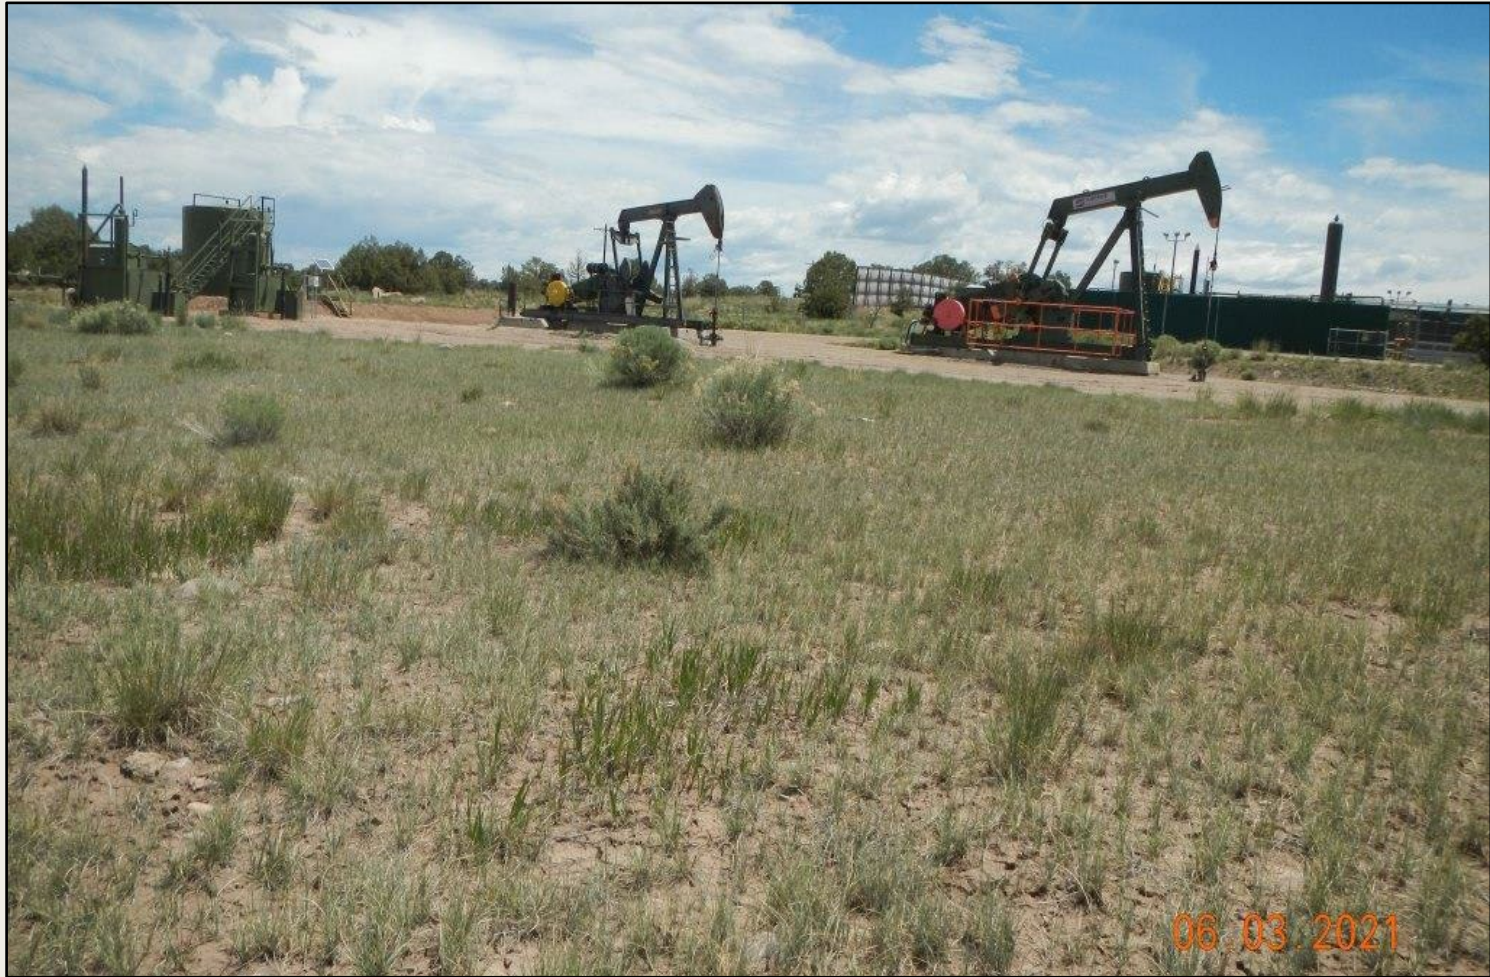
Photo 1. View of project area from the southwestern corner facing center.

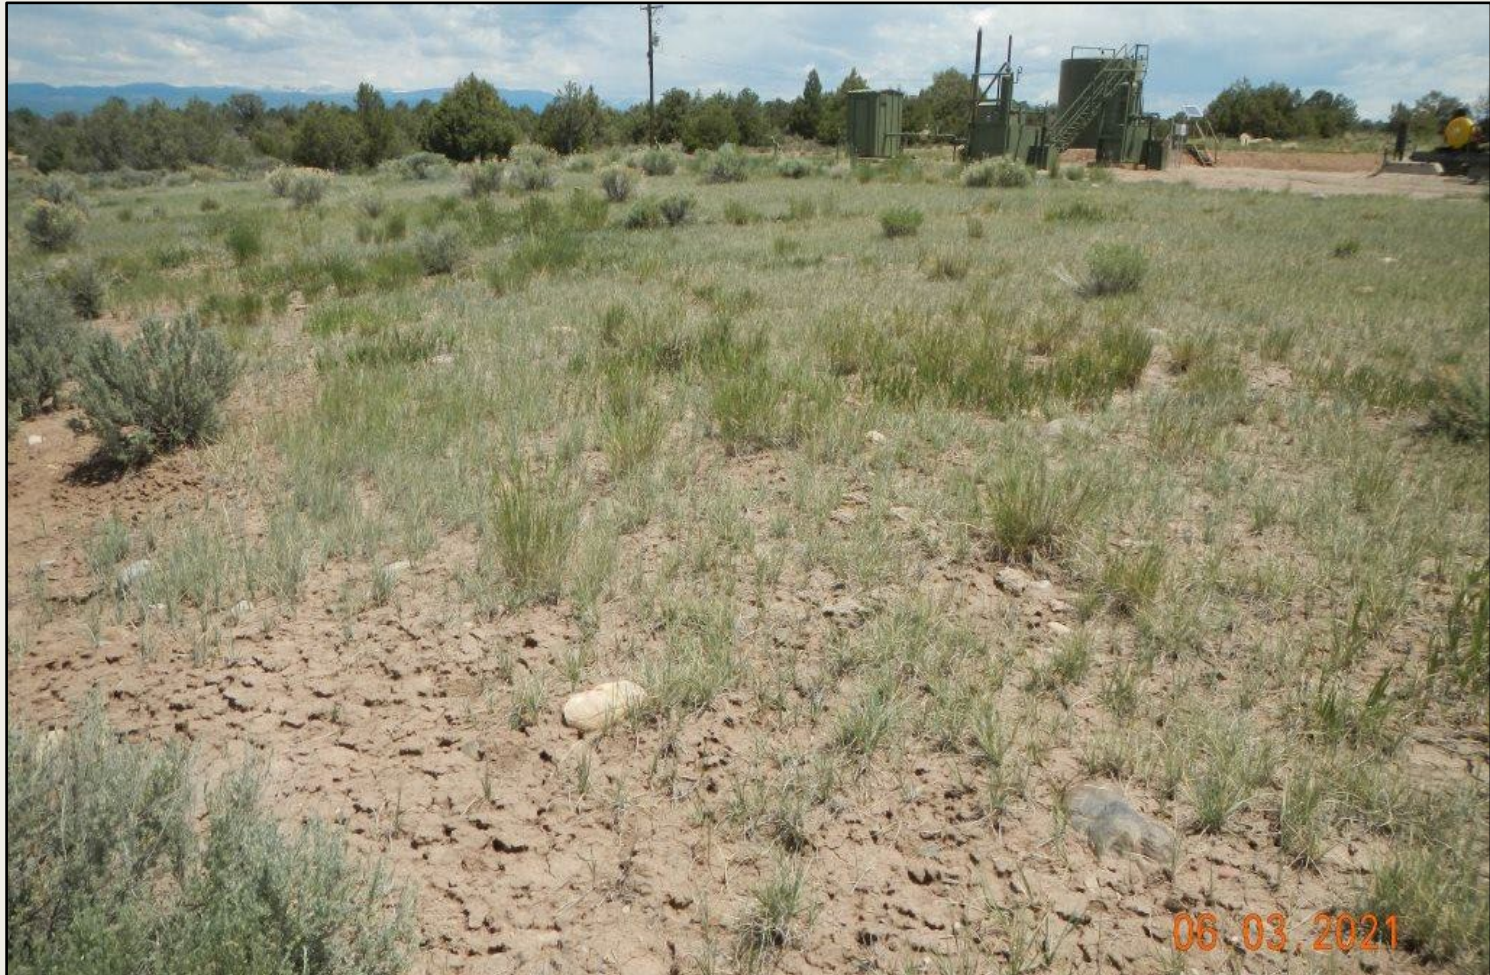
Photo 2. View of the western project area from the southwestern corner facing northward. Revegetation is progressing with western wheatgrass, smooth brome, and crested wheatgrass. Revegetation at final reclamation will need to use a native seed mix representative of the reference area.

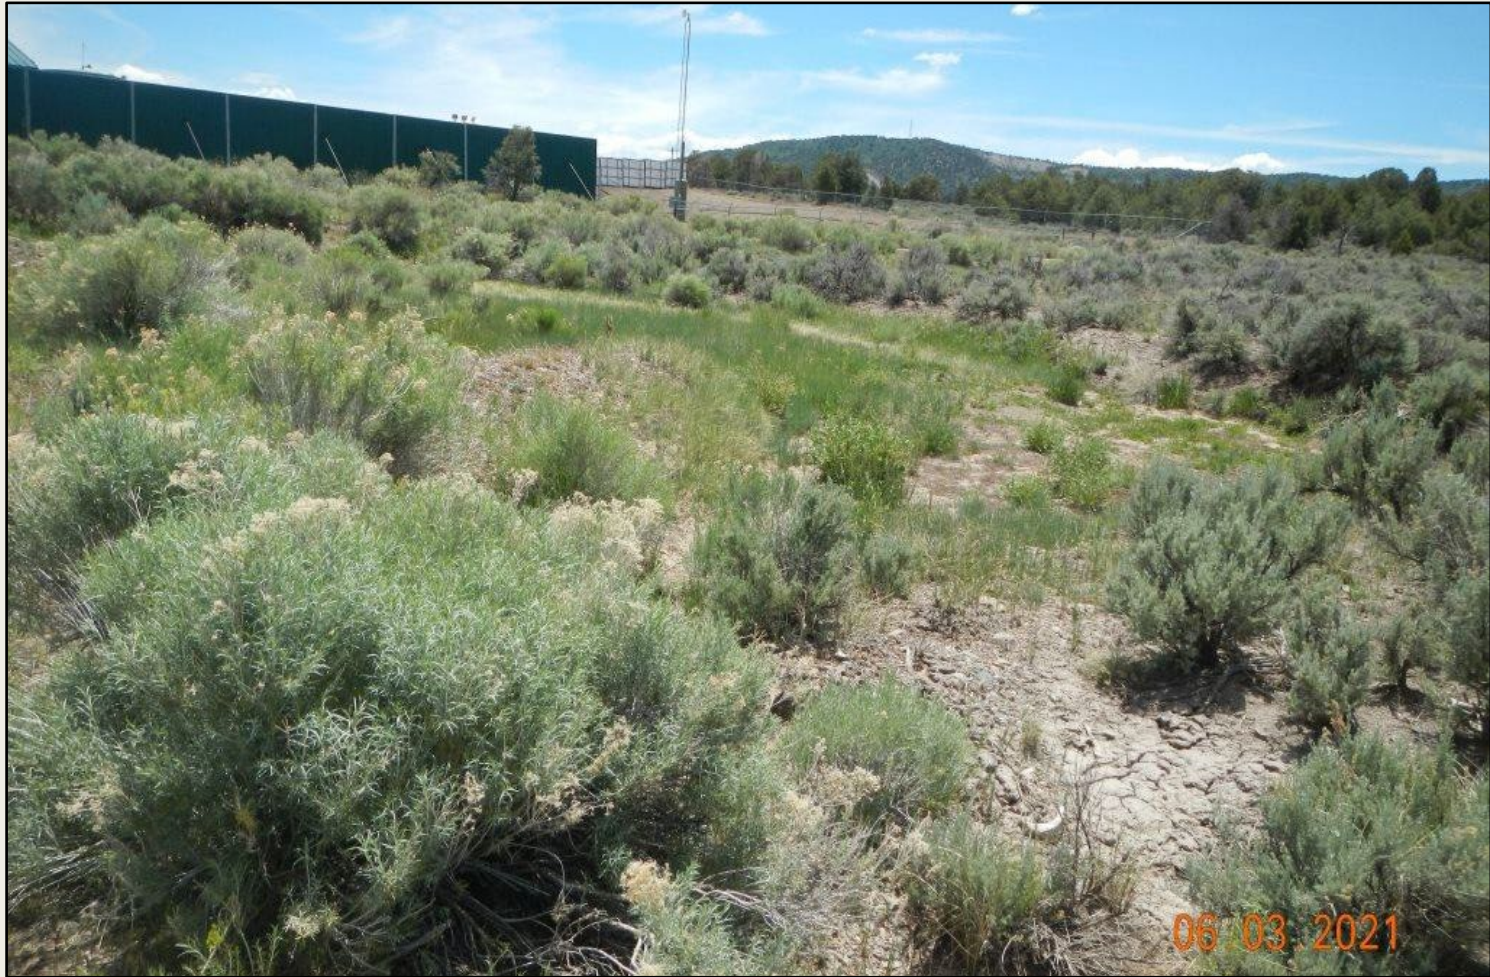
Photos 3. View of the southern project area from the southwestern corner facing eastward.

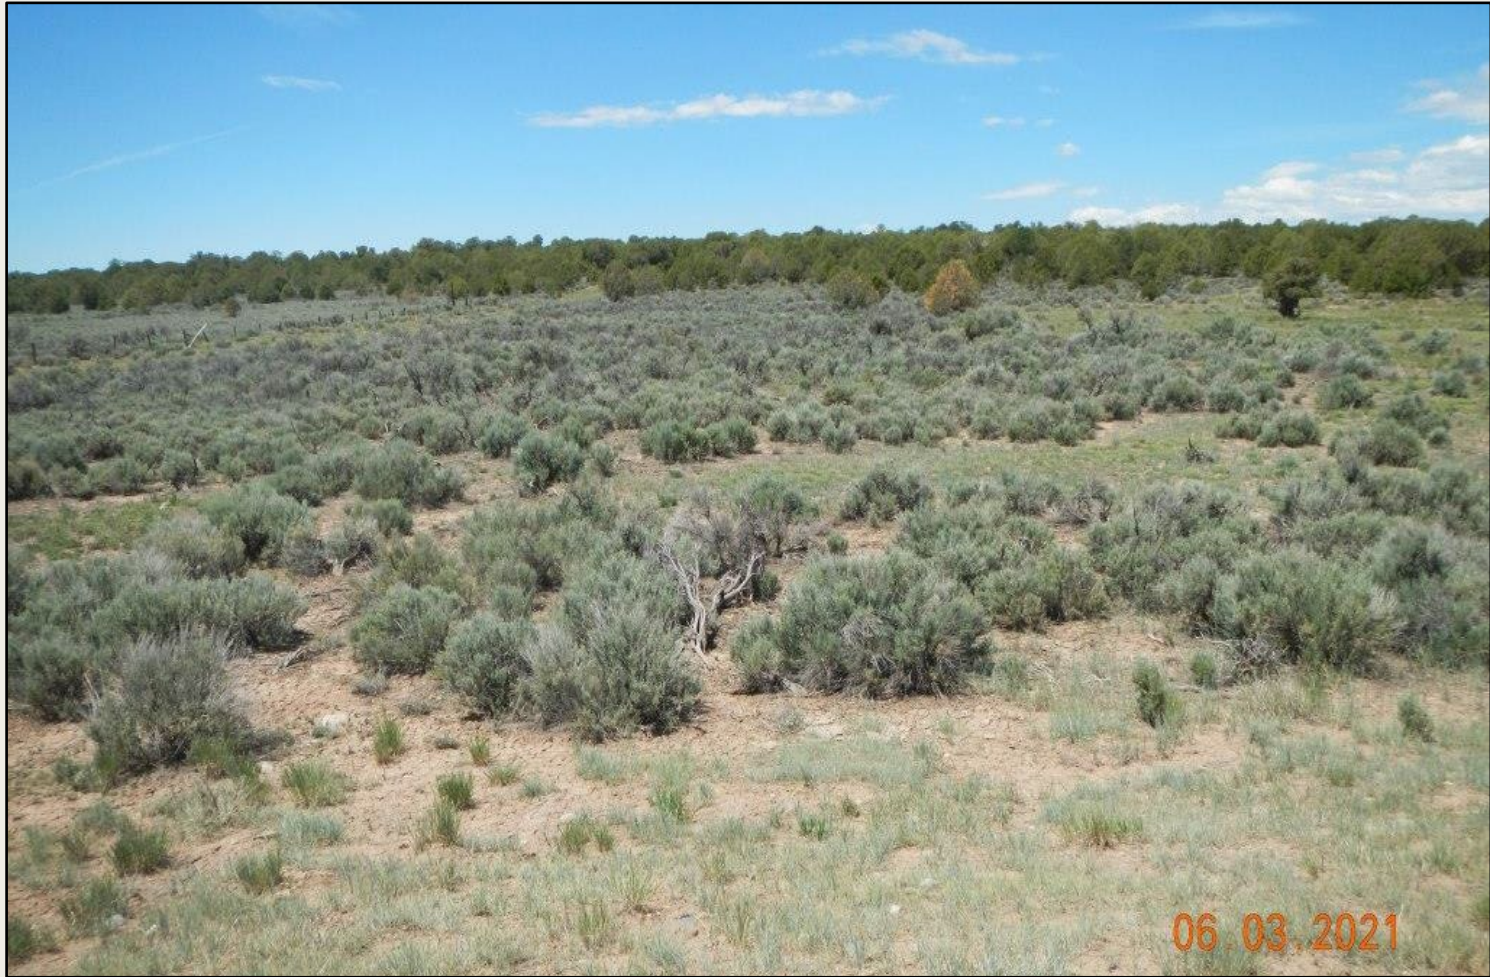
Photos 5. View of reference area comprised of big sagebrush and black sagebrush shrubland with scattered pinyon and juniper trees, and squirreltail, western wheatgrass, mat penstemon in the understory.
