Inspection Photos

Operator: Paradox Upstream
API: 113-06096
Date: 6/8/2021

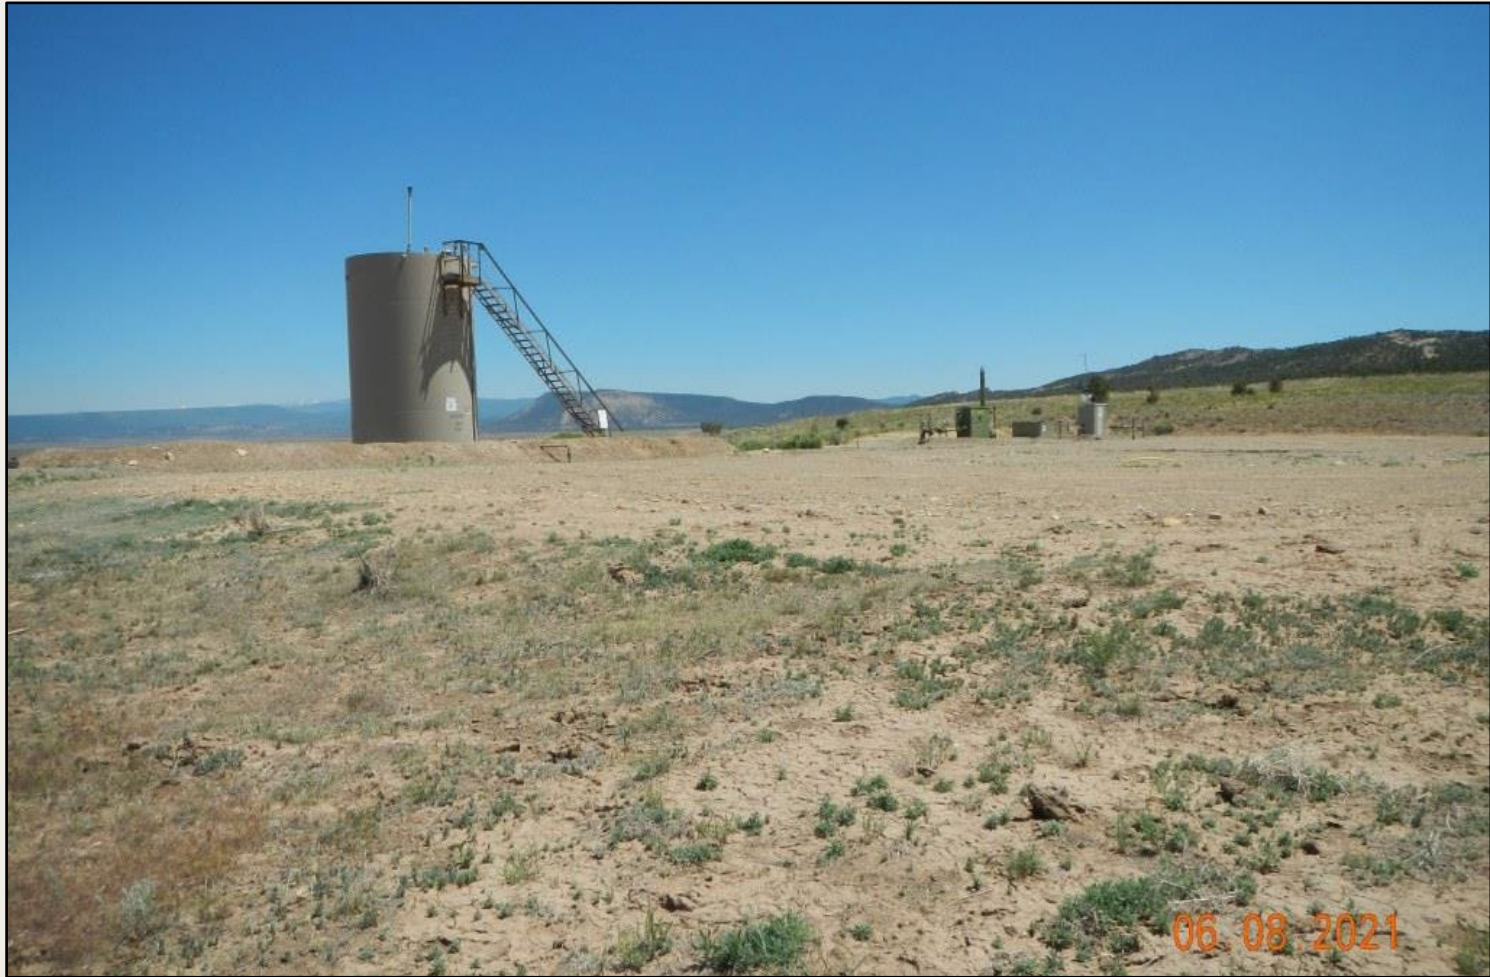
Photo 1. View the project area from the northwestern corner facing center.

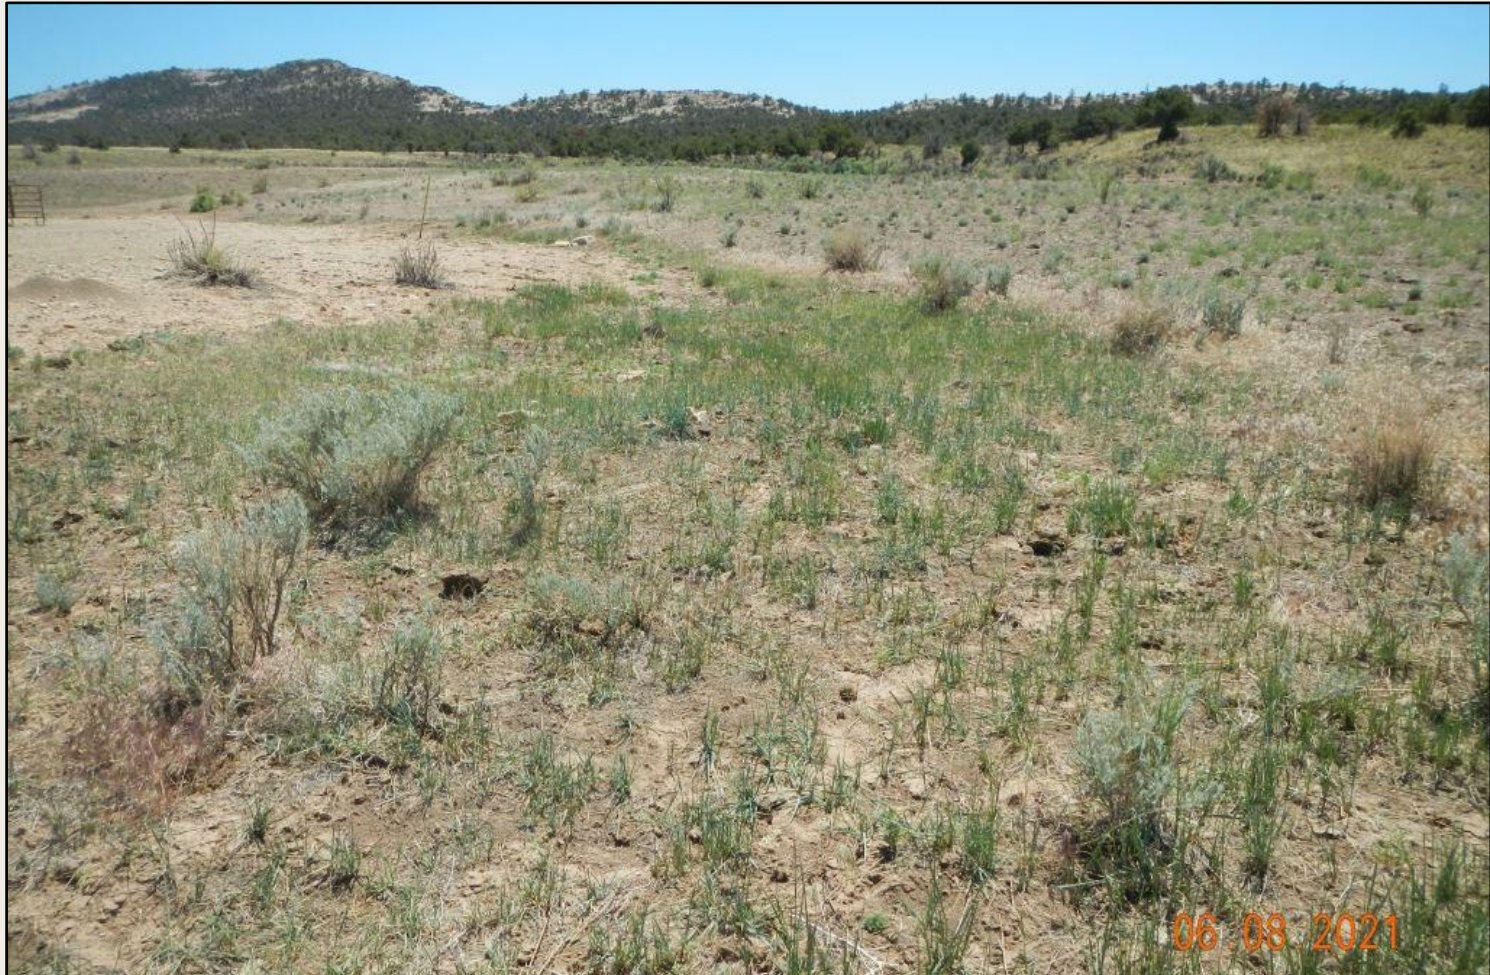
Photo 2. View of the western project area from the northwestern corner facing southward. Revegetation is progressing with western wheatgrass, winterfat, and needleandthread grass.

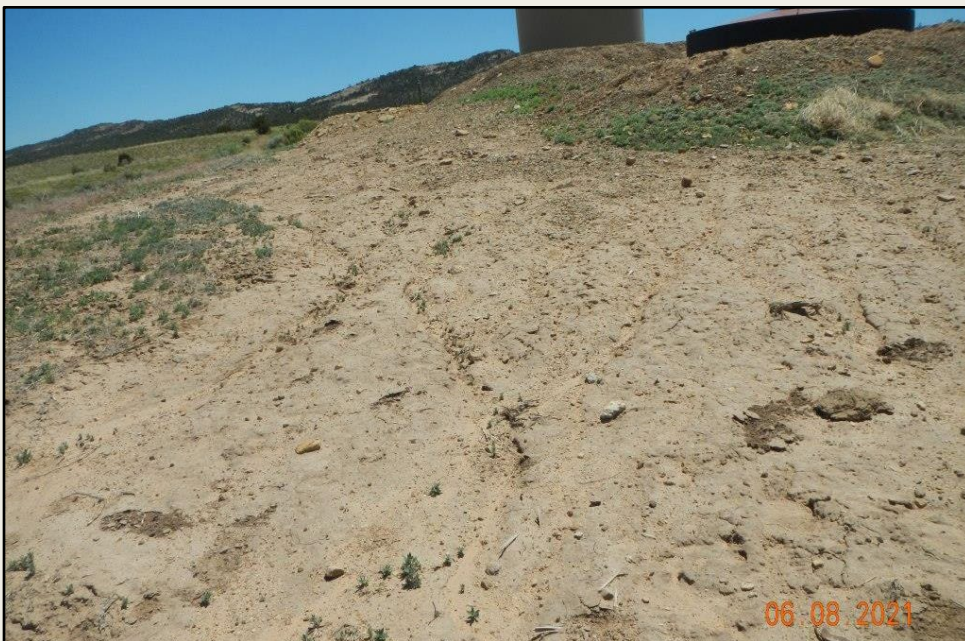
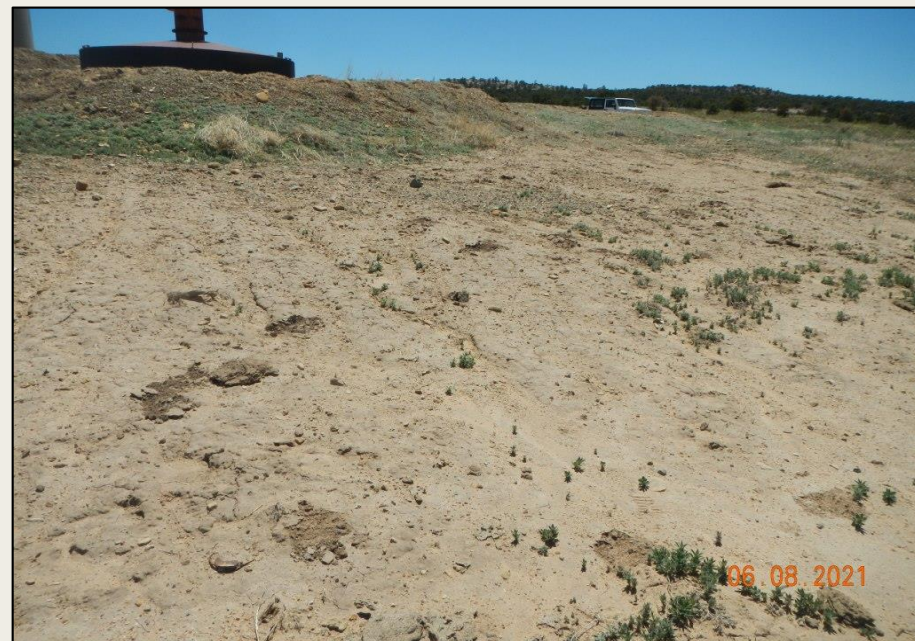
Photos 3/4. View of bare and eroding soils in the northeastern corner of the project area. Stormwater and erosion controls need to be installed to stabilize erosion here.

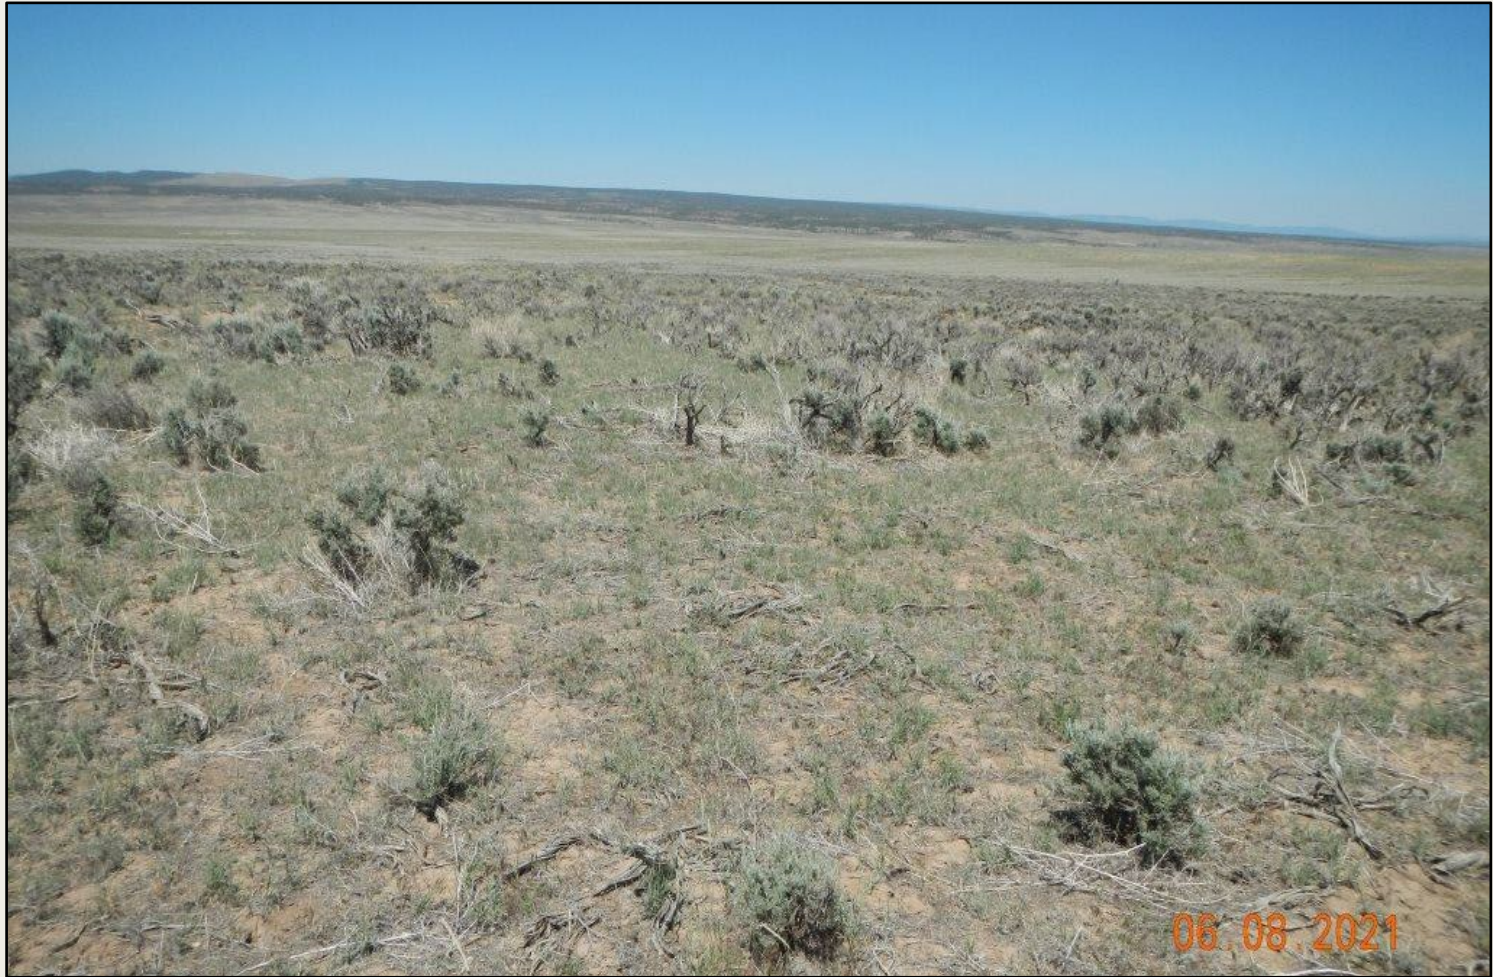
Photos 5. View of reference area comprised of sagebrush shrubland with an understory of James galleta, needleandthread grass, and sego lily.
