Inspection Photos

Operator: Paradox Upstream
API: 113-06123
Date: 6/9/2021

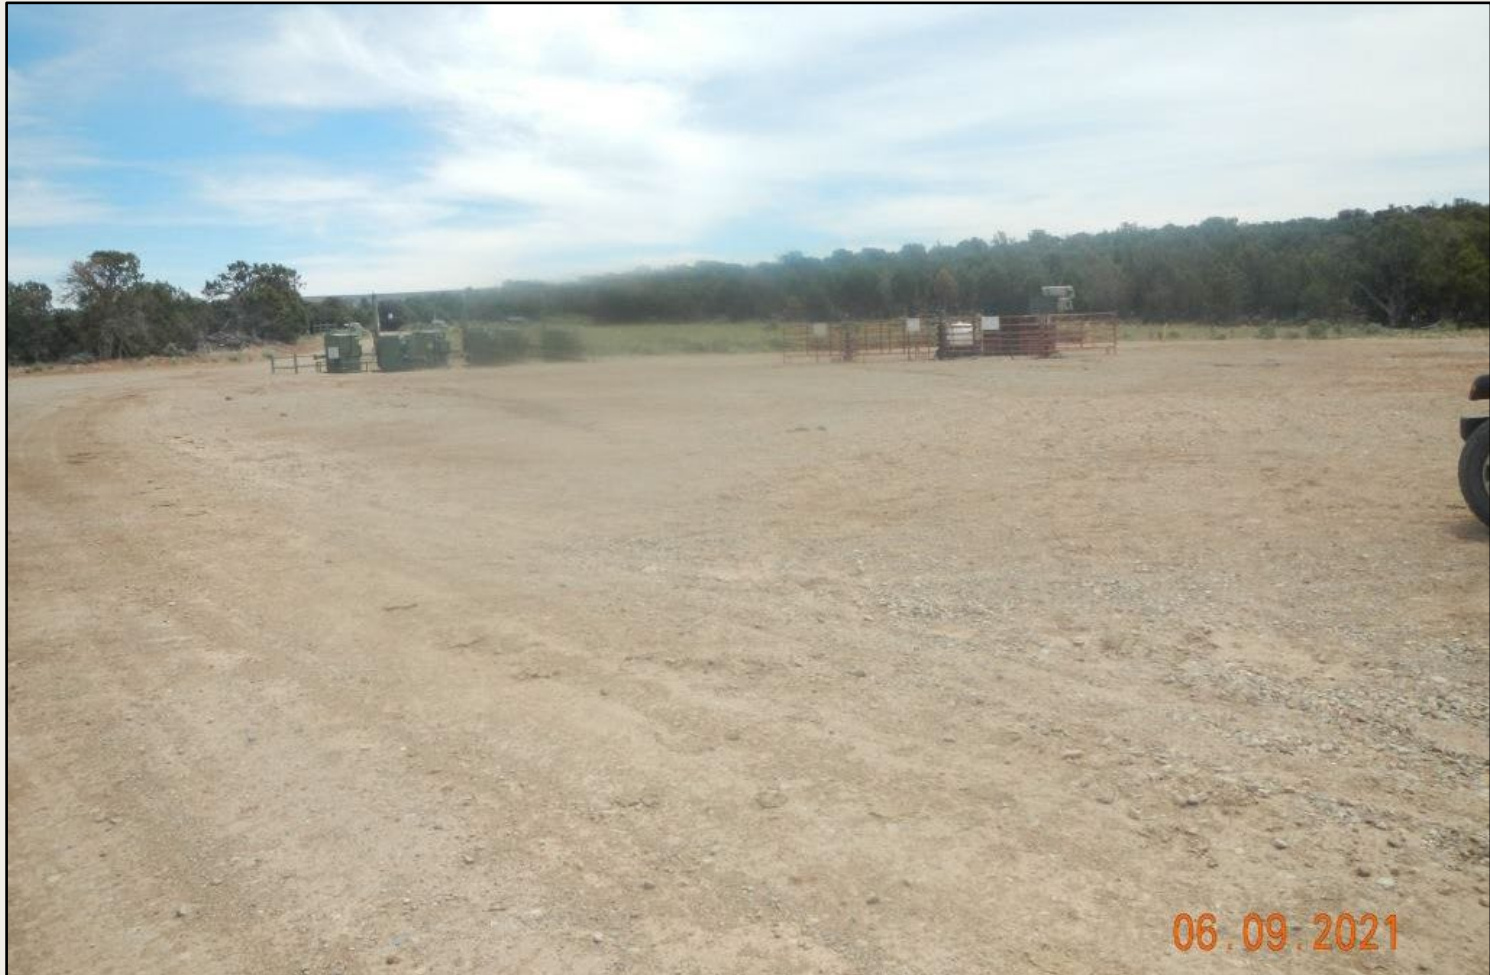
Photo 1. View the project area from the western corner facing center.

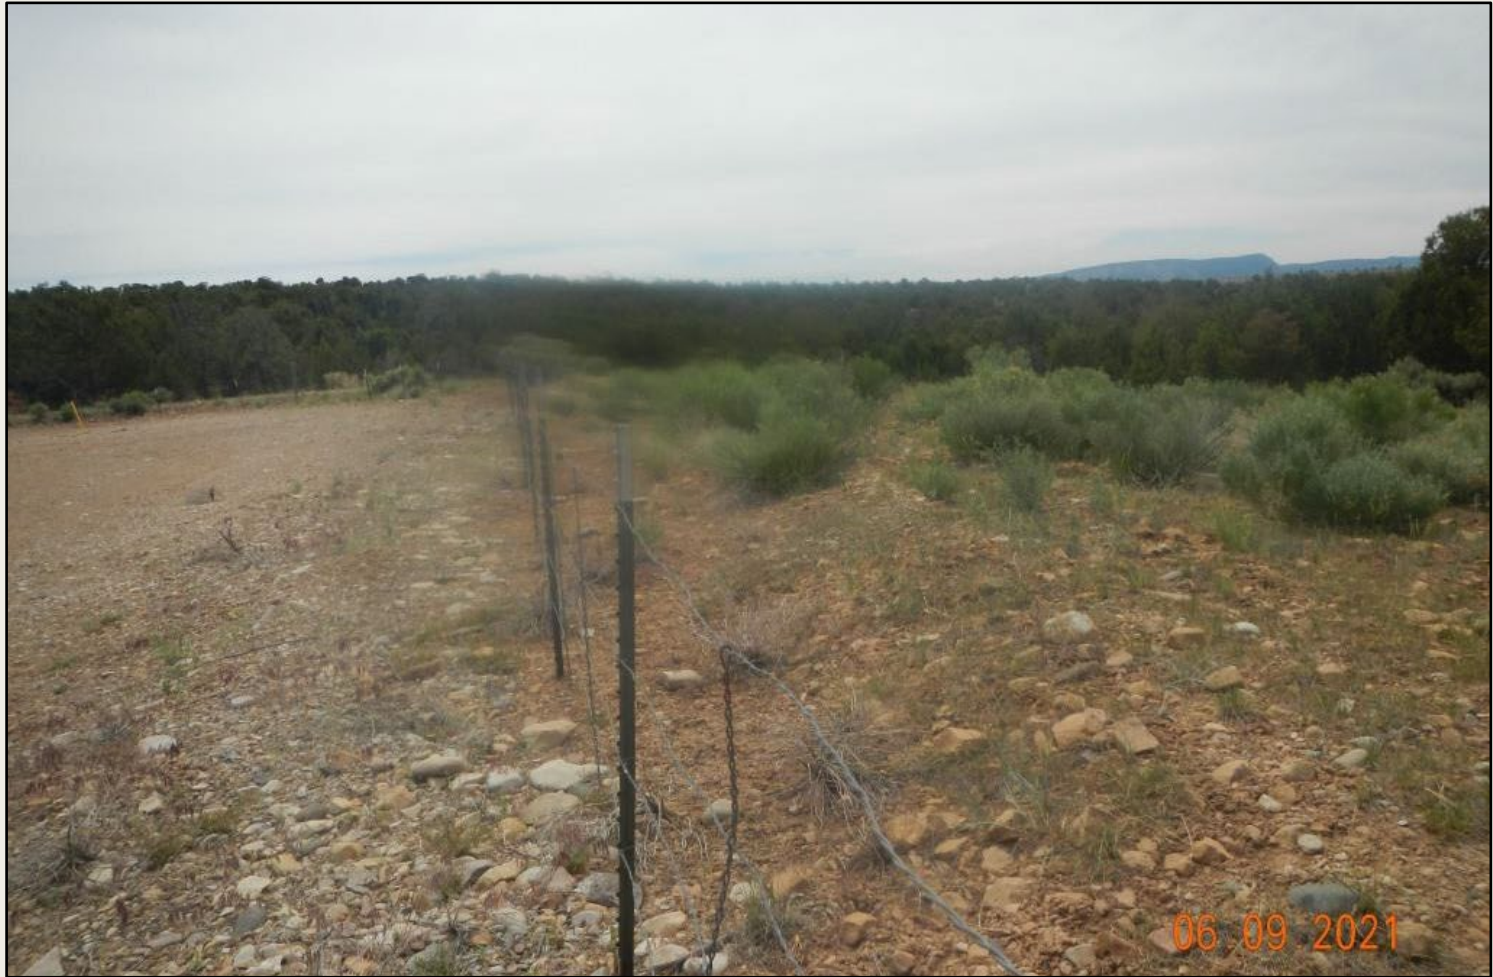
Photo 2. View of the western project area from the northwestern corner facing southward. Revegetation is progressing with western wheatgrass, crested wheatgrass, and rubber rabbitbrush.

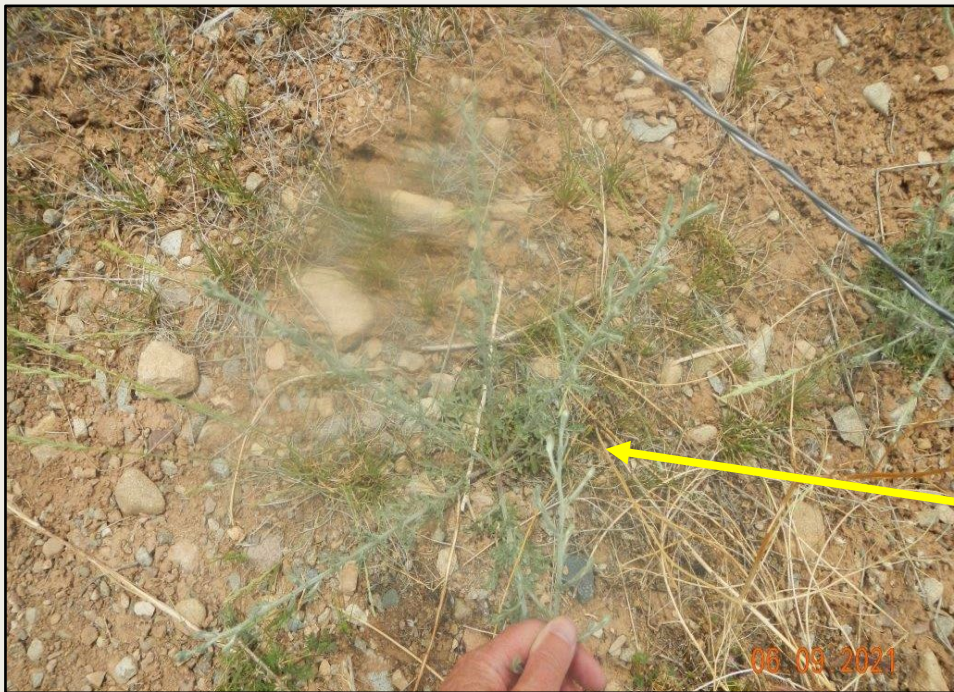
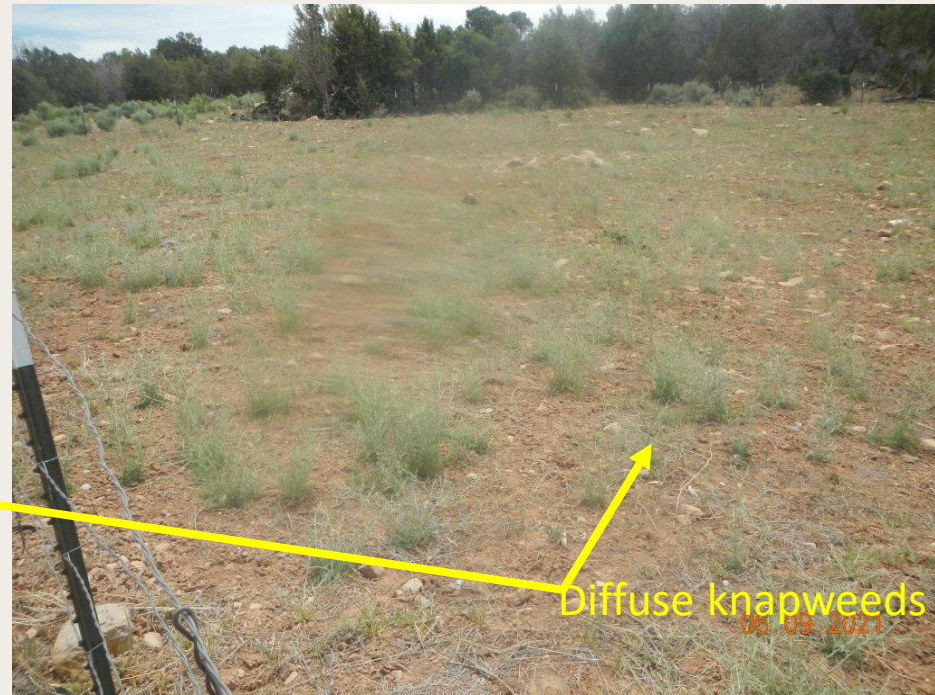
Photos 3/4. View of diffuse knapweeds within the project area. Approximately 5000 individuals observed. Infestation is not controlled and is expanding.
