Inspection Photos

Operator: Paradox Upstream
API: 113-06054
Date: 6/9/2021

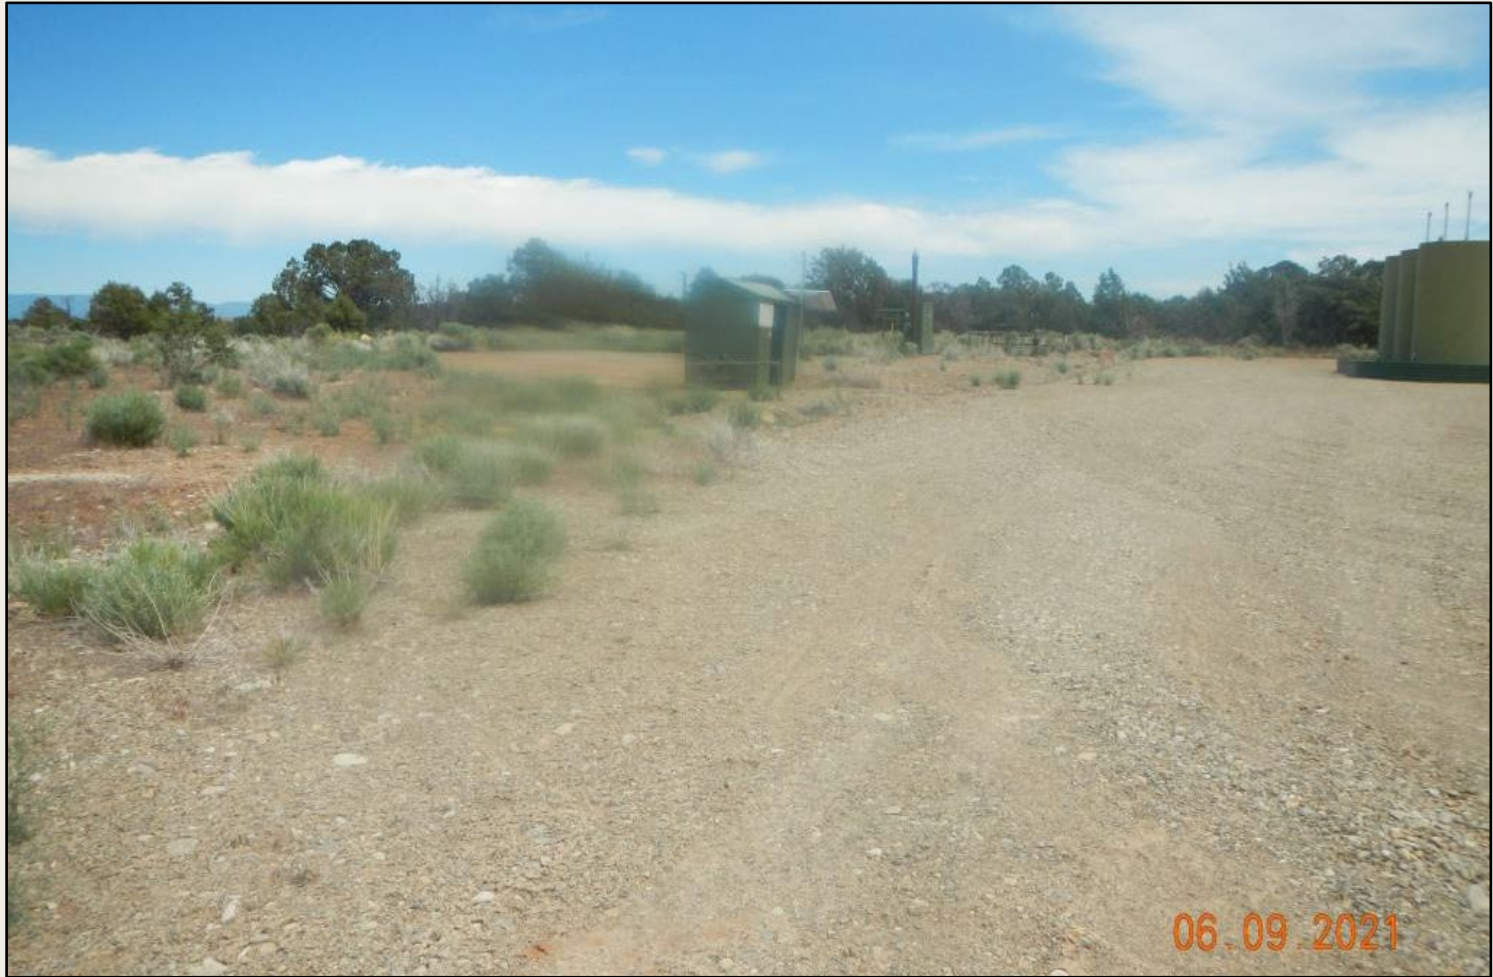
Photo 1. View the project area from the western corner facing center.

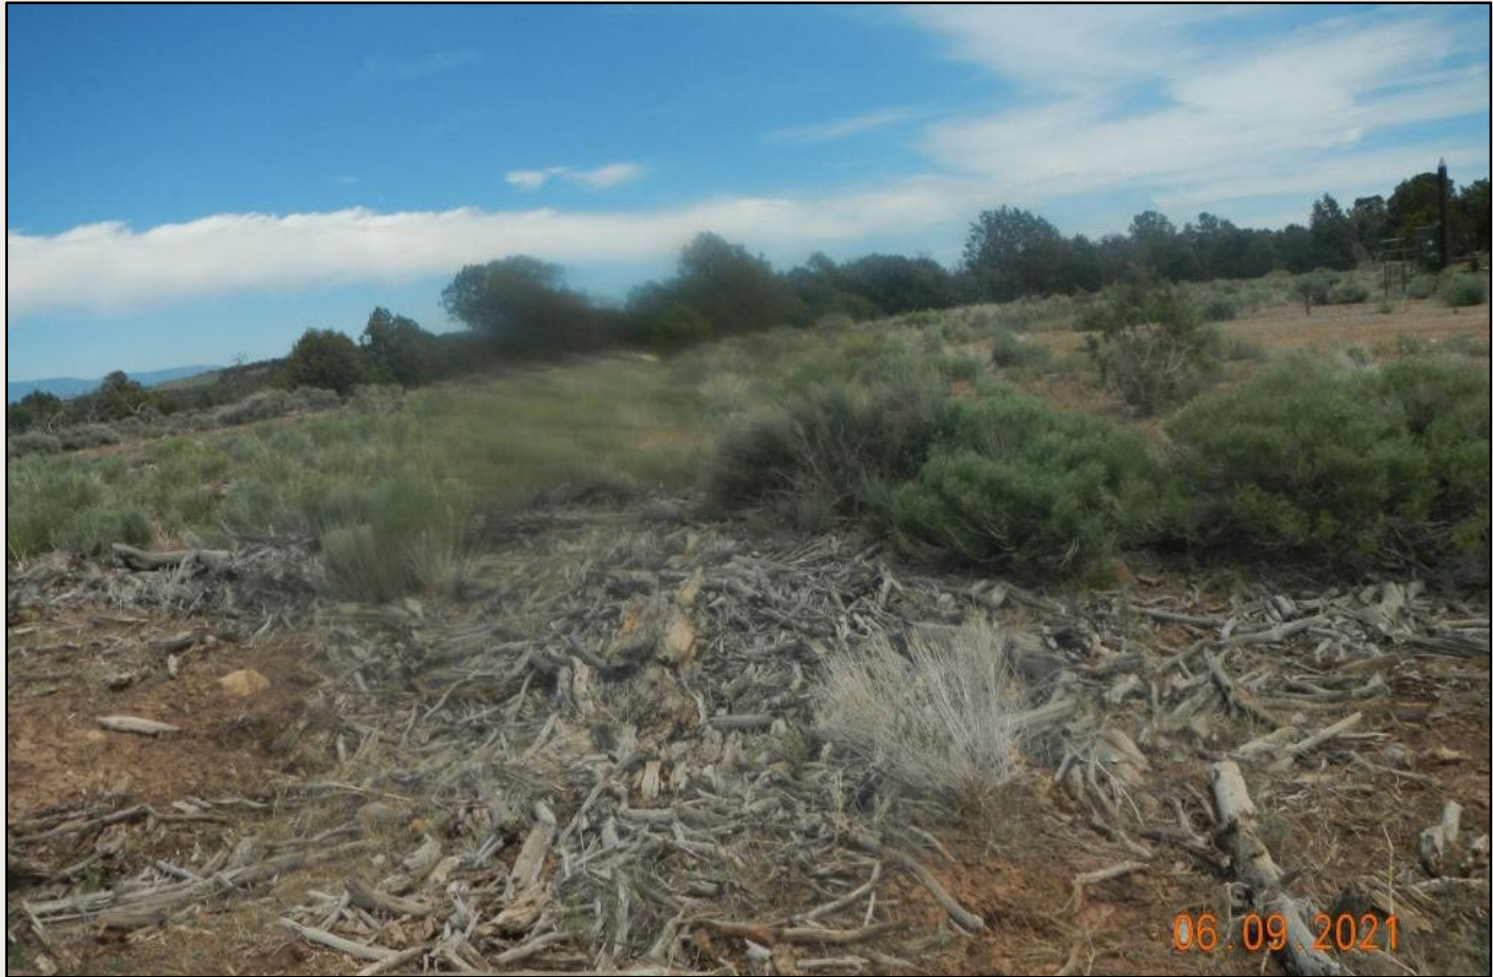
Photo 2. View of the northern project area from the northwestern corner facing eastward. Revegetation is progressing with western wheatgrass, crested wheatgrass, and rubber rabbitbrush.

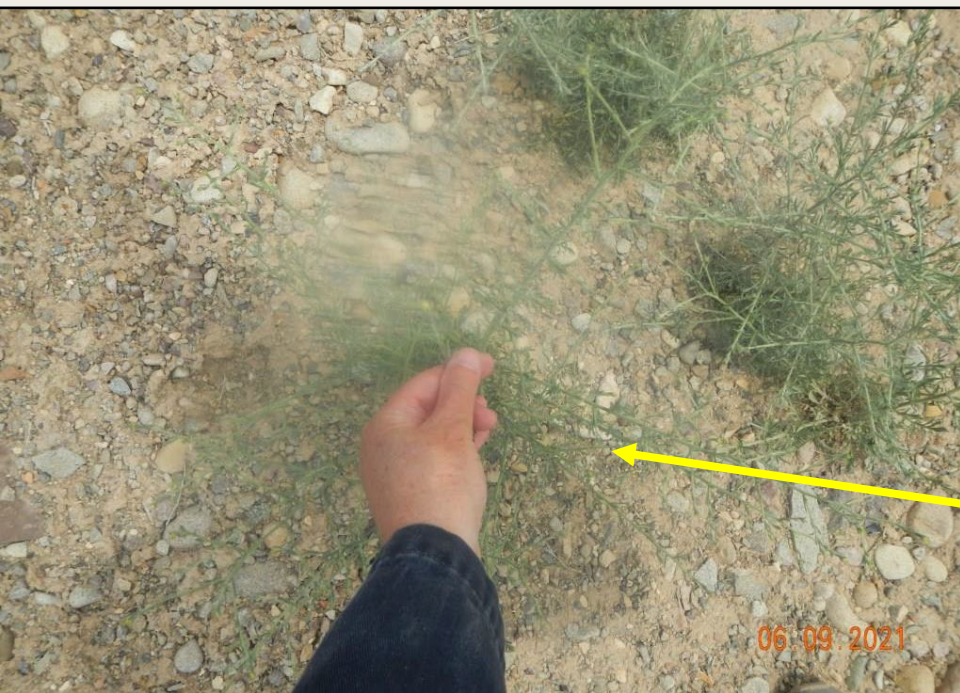
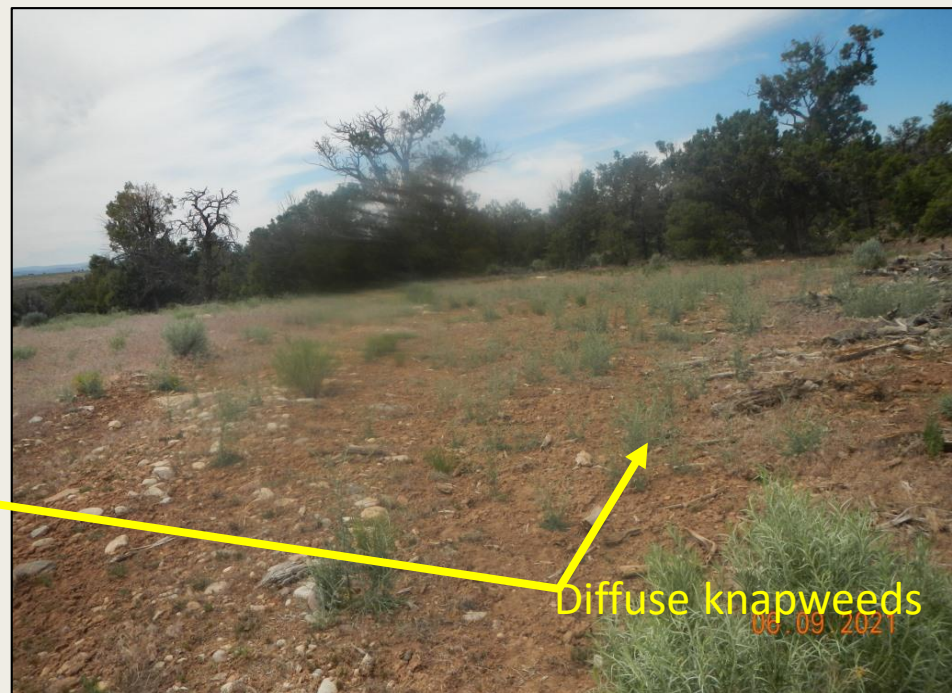
Diffuse knapweeds

Photos 3/4. View of diffuse knapweeds within the project area. Approximately 5000 individuals observed. Infestation is not controlled and is expanding.

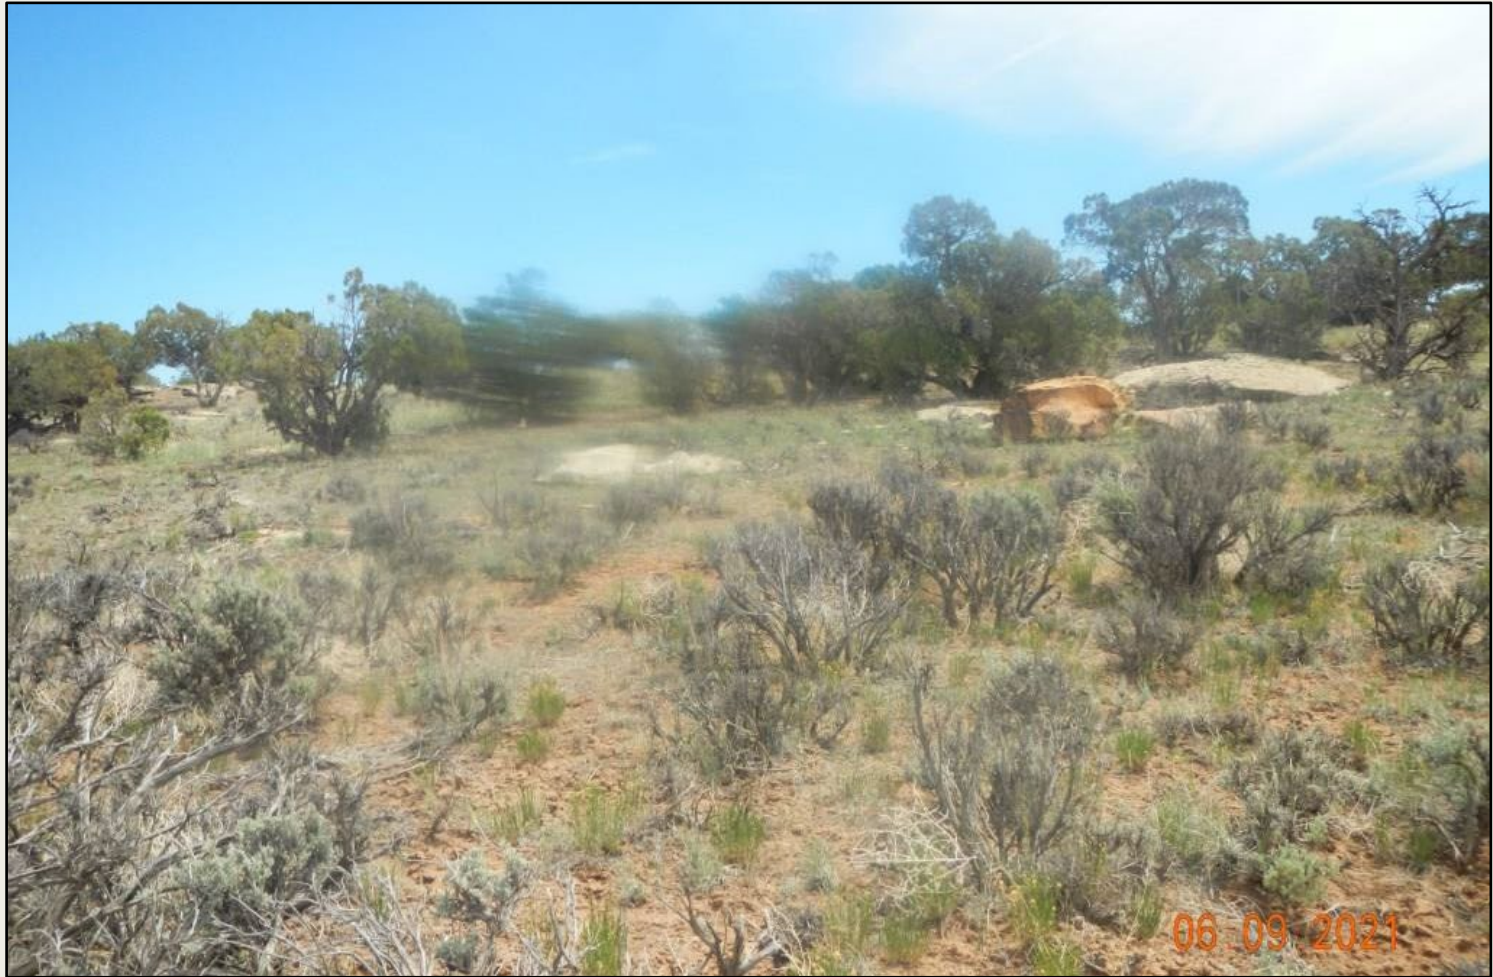
Photo 5. View of reference area comprised of pinyon and juniper woodland mixed with sagebrush, James galleta, snakeweed, and goldenasters.
