Inspection Photos
Operator: Paradox Upstream
API: 113-06235
Date: 6/9/2021

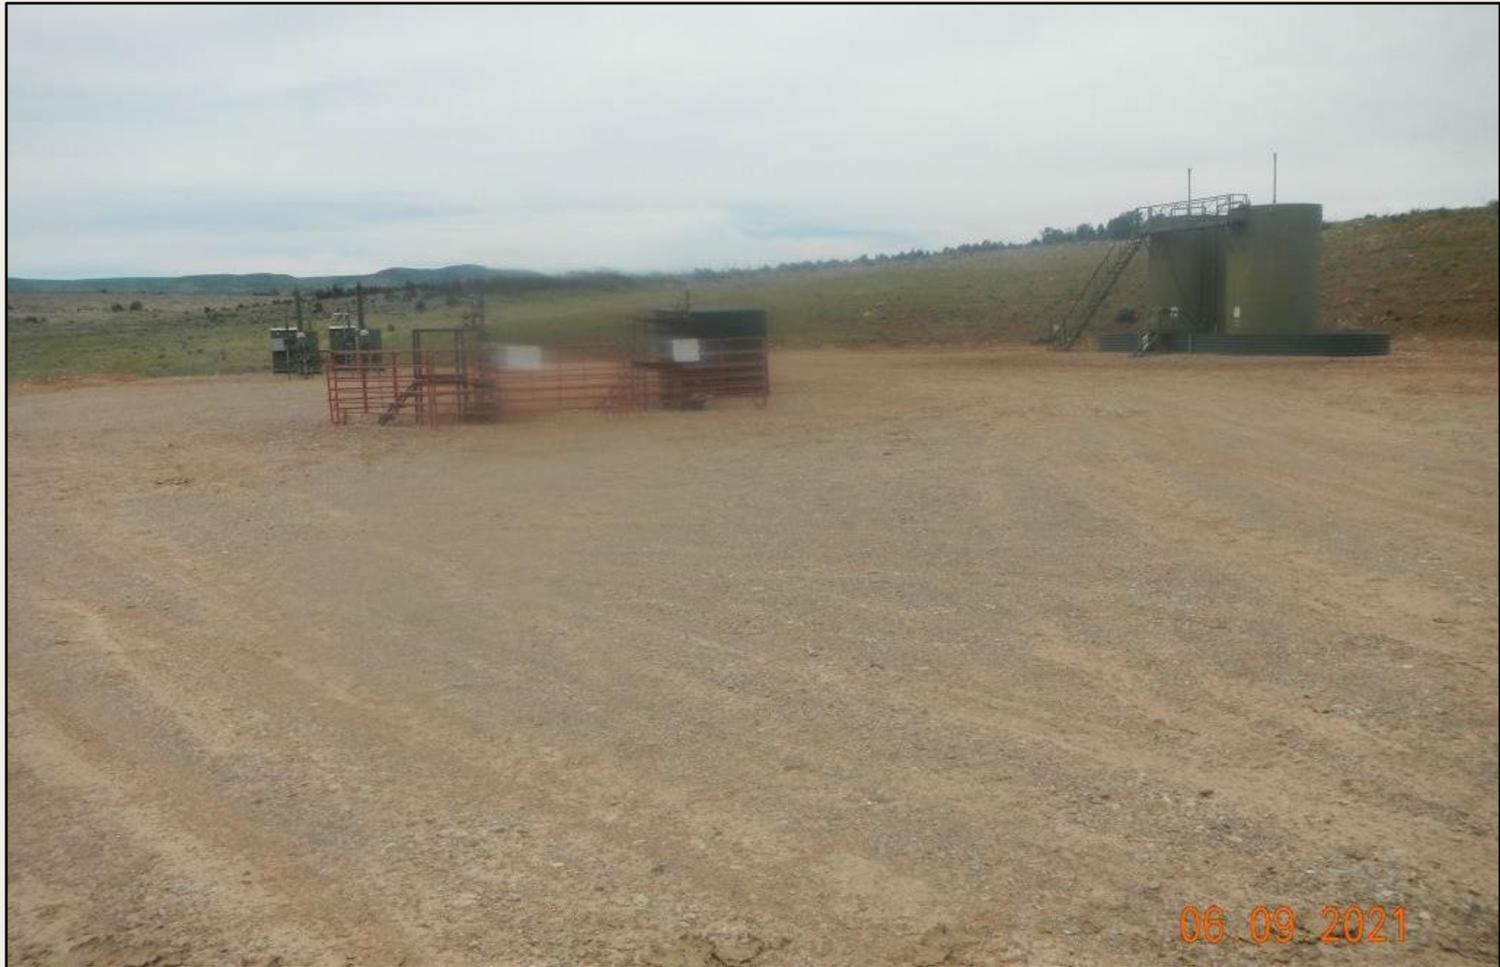
Photo 1. View the project area from the northeastern corner facing center.

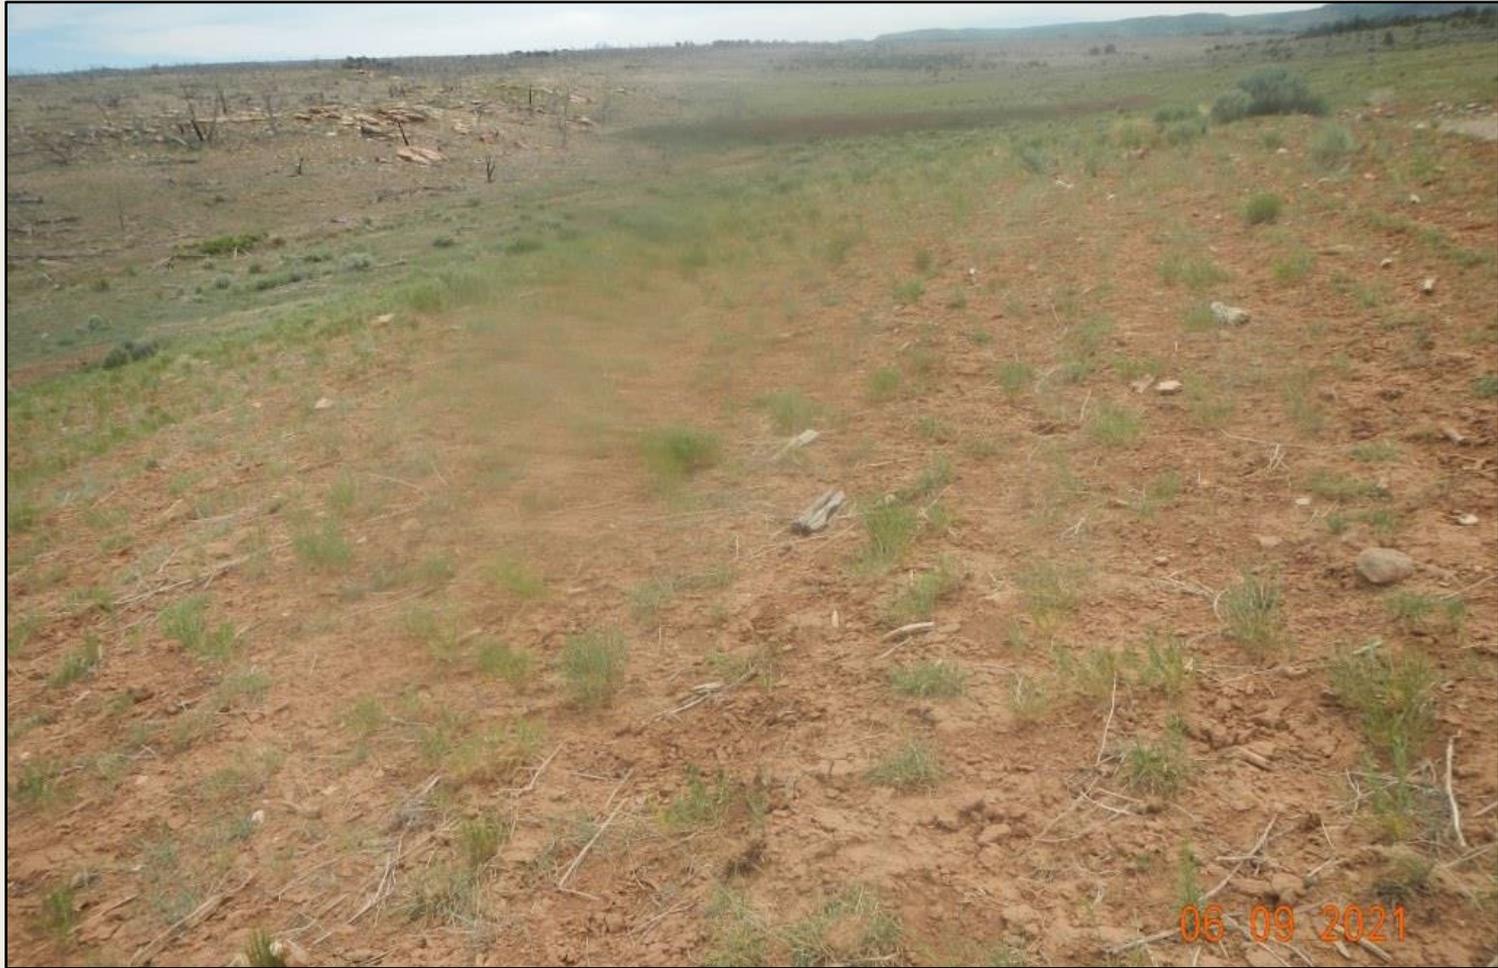
Photo 2. View of the eastern fill slope from the northeastern corner facing southward. Revegetation is progressing with western wheatgrass, crested wheatgrass, and goldenaster.

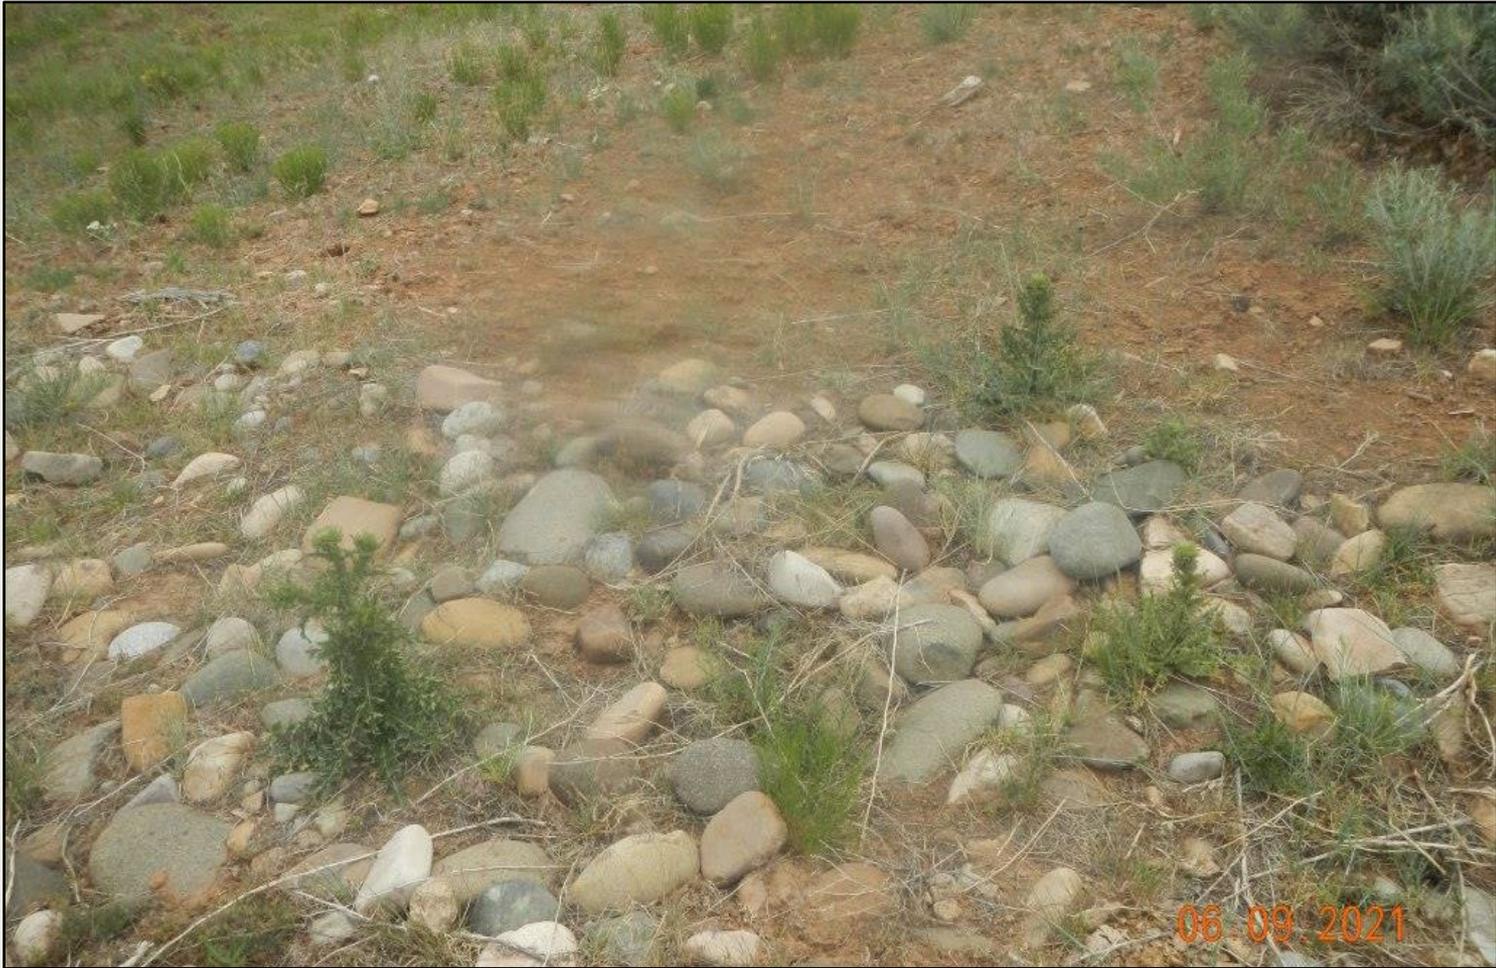
Photo 3. View of musk thistles within the southern project area. Approximately 50 individuals observed.

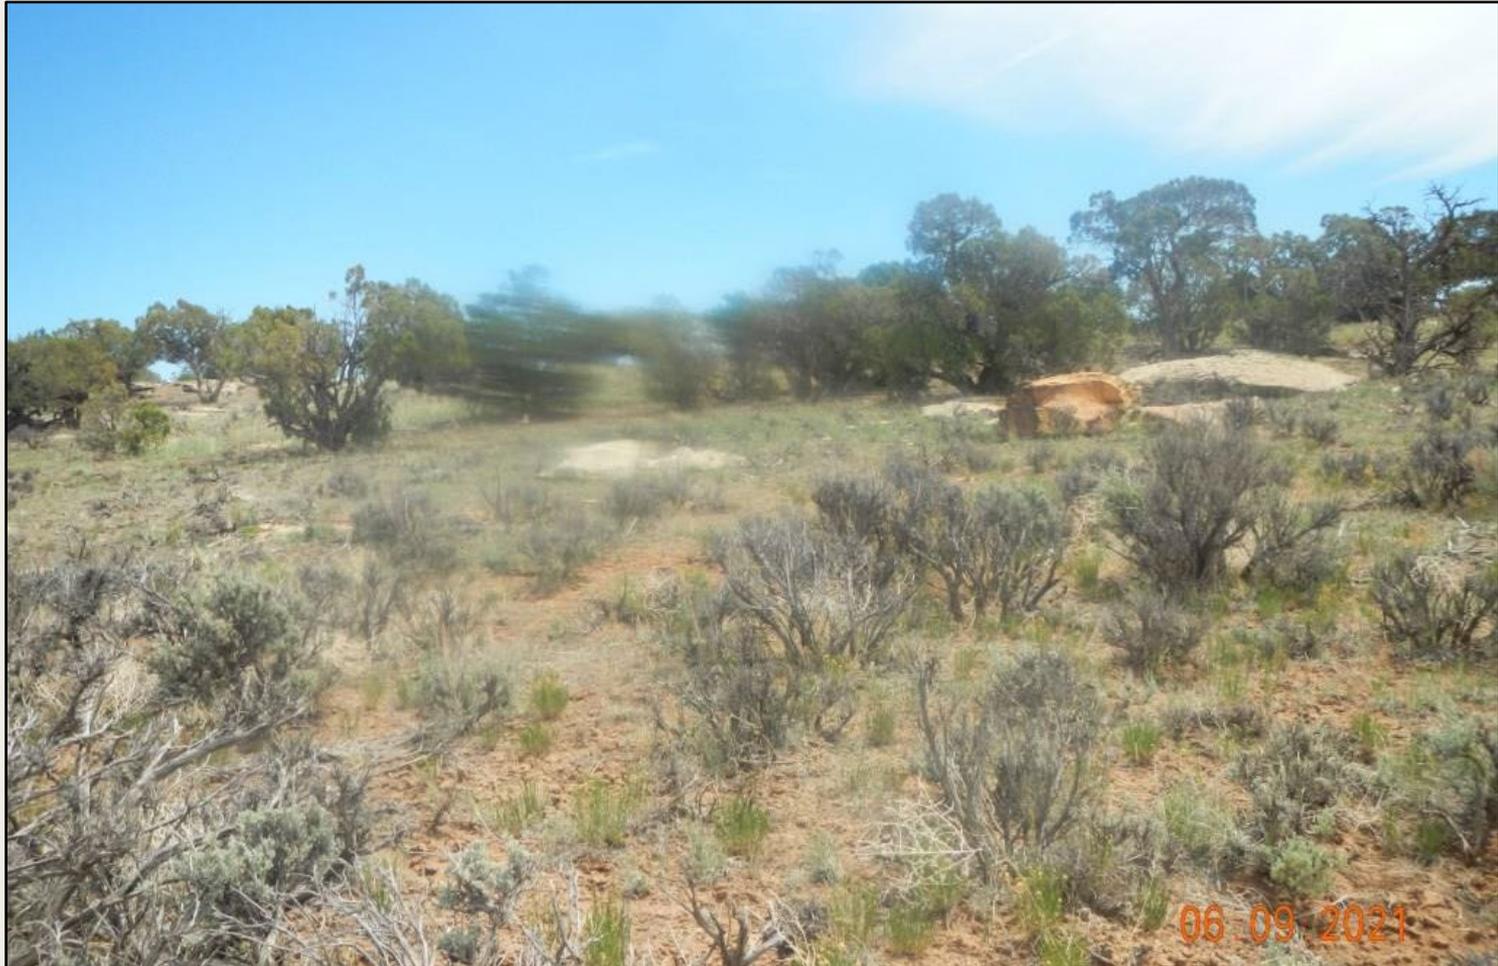
Photo 4. View of reference area comprised of pinyon and juniper woodland mixed with sagebrush, James galleta, snakeweed, and goldenasters.
