Attachment B

TANK BATTERY DECOMMISSIONING FORM

SITE NAME: Kreps 21-7 Tank Battery							DATE: 3/23/2021	REM. PROJECT #: 16748	WEATHER: 30s, windy, cloudy		
SITE DIRECTIONS: CR 49/72 turn S into site							CLIENT: PDC				
LEGALS AND LAT/LONG: NENW 7 6N 64W 6, 40.507268, -104.595676							TASMAN PERSONNEL: Cody Miller				
SOIL TYPES: Silty Sand - SM							SURFACE GRADIENT: Southeast				
SOIL SAMPLING							FACILITY INFRASTRUCTURE				
Date/Time	Soil Sample ID	PID (ppm)	Visual	Olfactory	Photo?	Grab or Lab Sample?	EQUIPMENT		Quantity		
							Above Ground Storage Tank (AST)		1		
3/23/2021 10:33	AST01@0-6"	1.9	No Staining	No Odor	Yes	Lab	Buried or Partially Buried Vessel		1		
3/23/2021 10:50	SEP01-FL@4'	0.1	No Staining	No Odor	Yes	Lab	Separator		1		
3/23/2021 10:51	SEP01-DL@4'	0.1	No Staining	No Odor	Yes	Lab	Emission Control Device (ECD)				
3/23/2021 11:04	MH01@0-6"	0.0	No Staining	No Odor	Yes	Grab	Dump Line		1		
3/23/2021 11:09	BKG01@2.5'	0.0	No Staining	No Odor	Yes	Lab	Wellhead

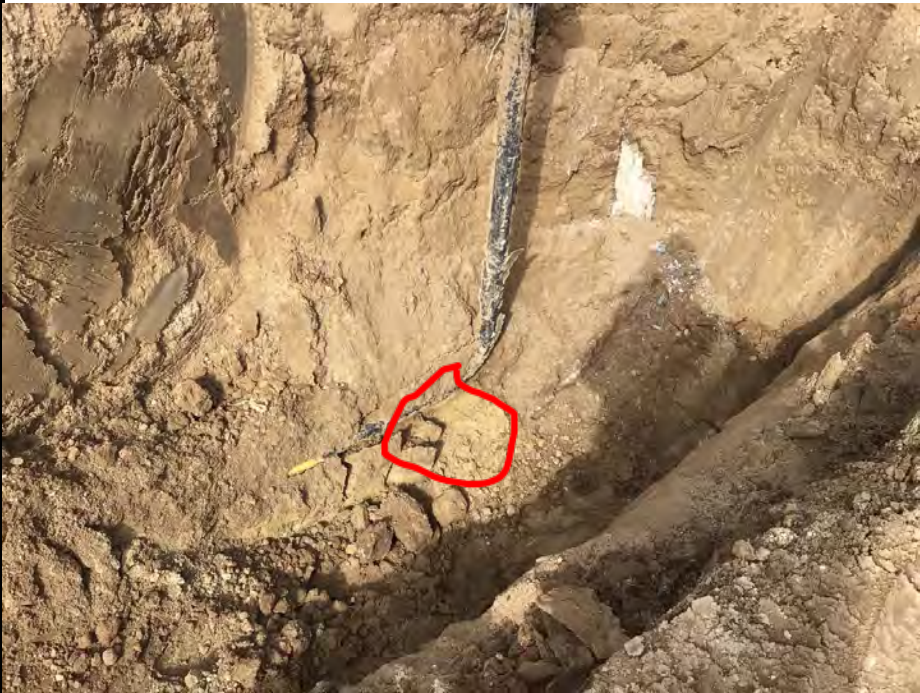
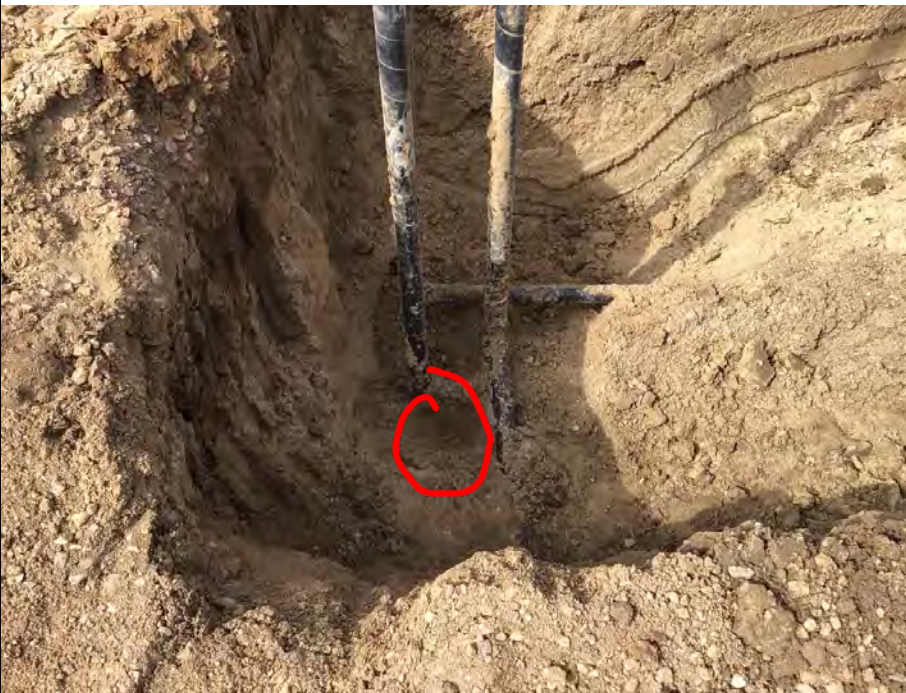
Equipment ID: SEP01-FL		Equipment Type:		Equipment ID: SEP01-DL		Equipment Type:	
Material:	Volume:	Contents:		Material:	Volume:	Contents:	
Notes/Conditions: SEP01-FL@5'				Notes/Conditions: SEP01-DL@4'

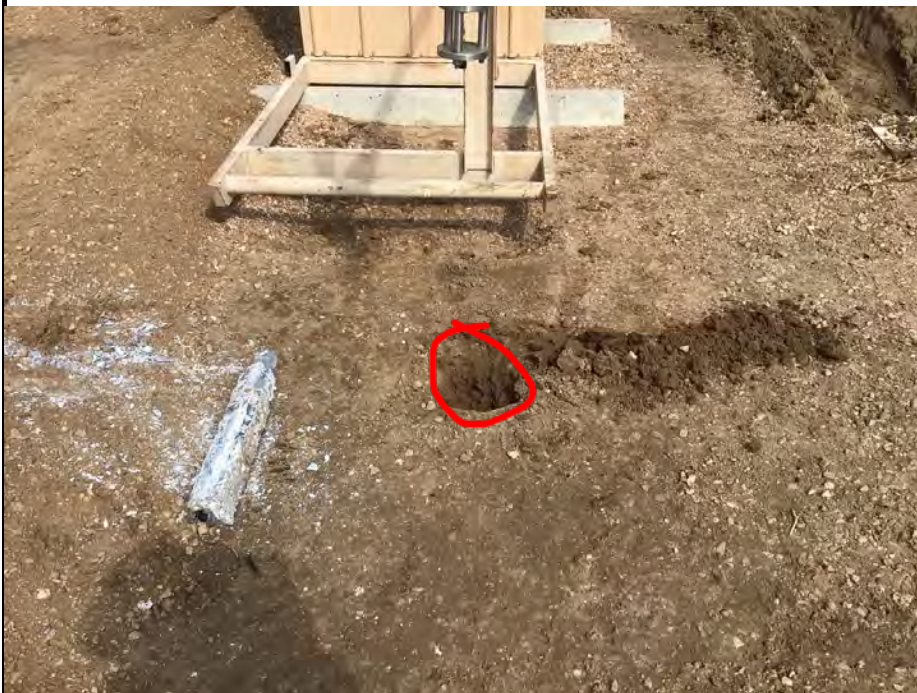
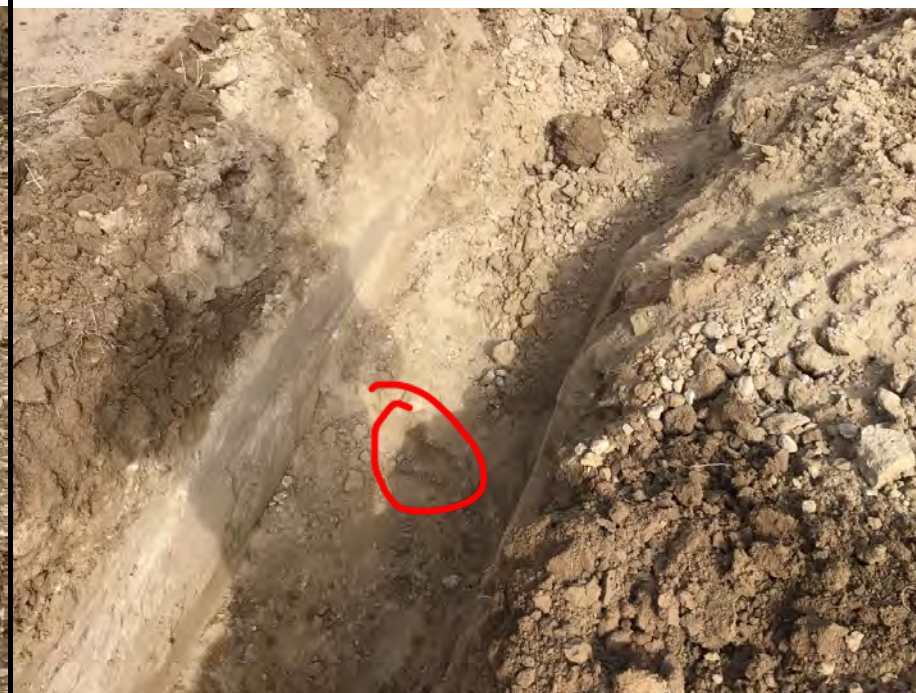
Equipment ID: MH01		Equipment Type:		Equipment ID: BKG01		Equipment Type:	
Material:	Volume:	Contents:		Material:	Volume:	Contents:	
Notes/Conditions: MH01 @ 0-6"				Notes/Conditions: BKG01 @ 2.5'

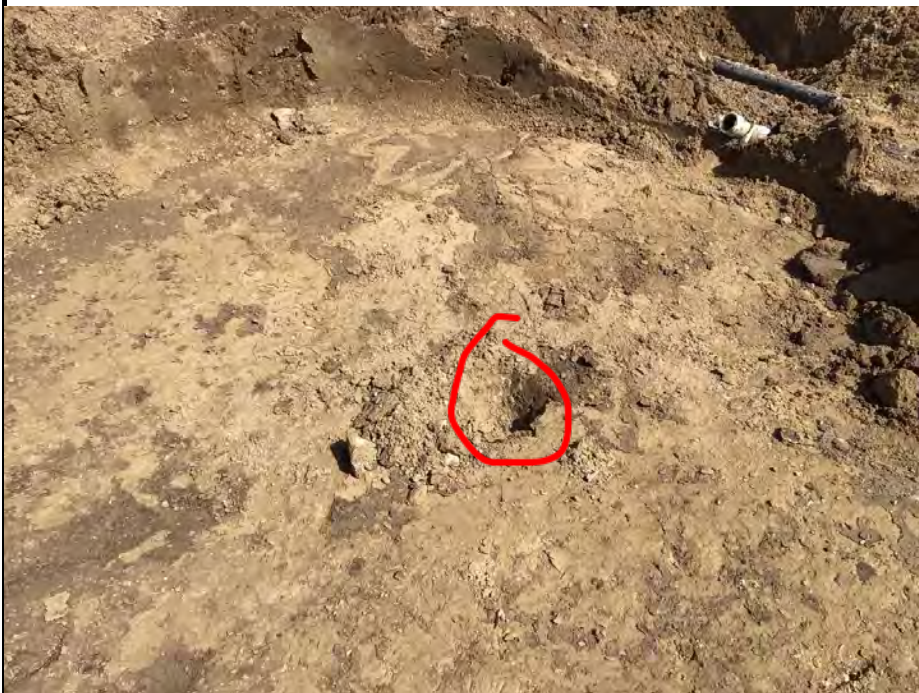
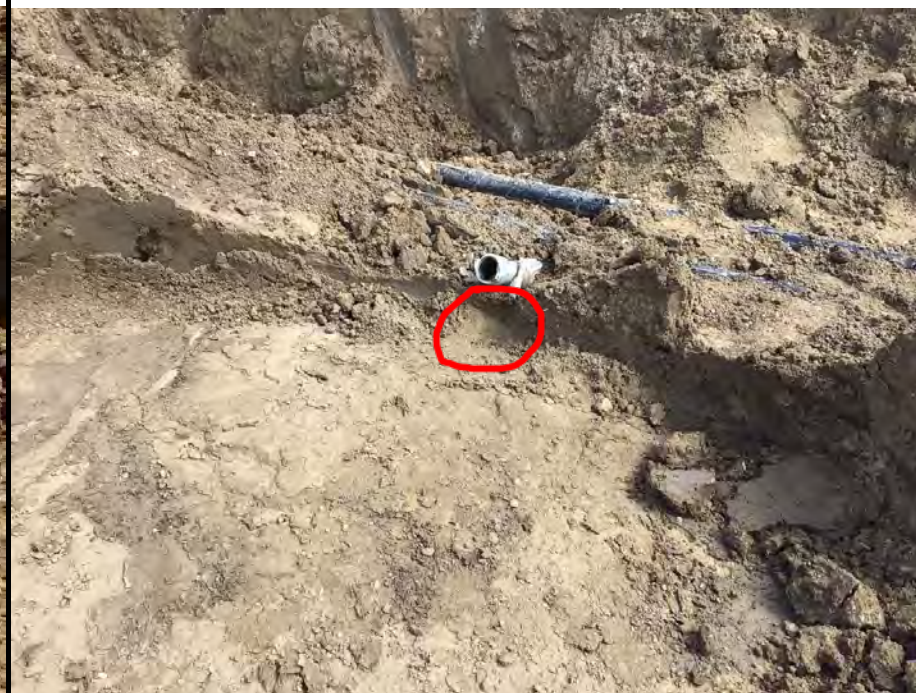
Equipment ID: PWV01-B		Equipment Type:		Equipment ID: WDL01		Equipment Type:	
Material:	Volume:	Contents:		Material:	Volume:	Contents:	
Notes/Conditions: PWV01-B @ 4'				Notes/Conditions: WDL01 @ 4'

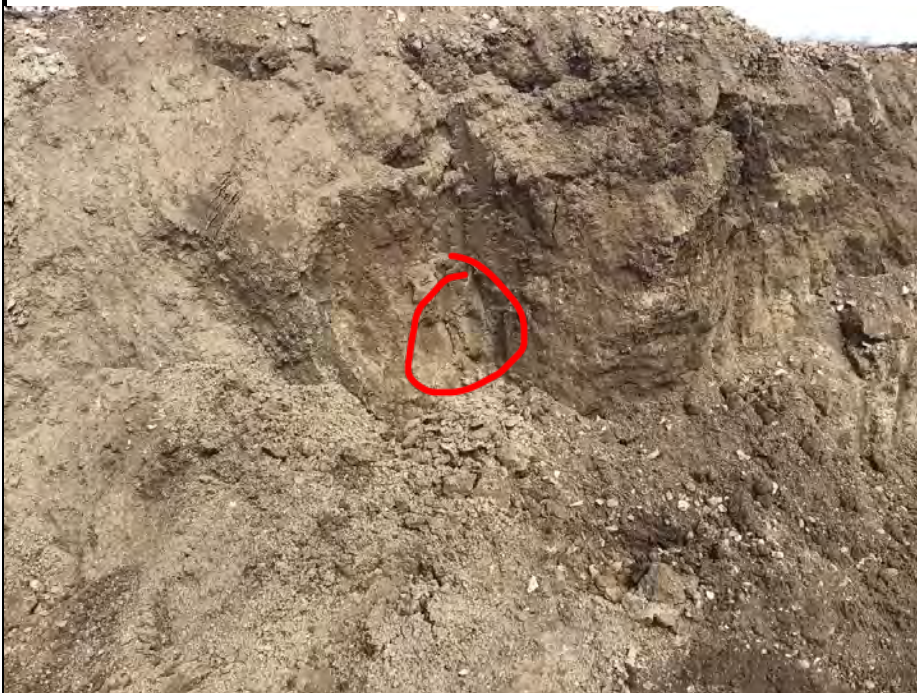
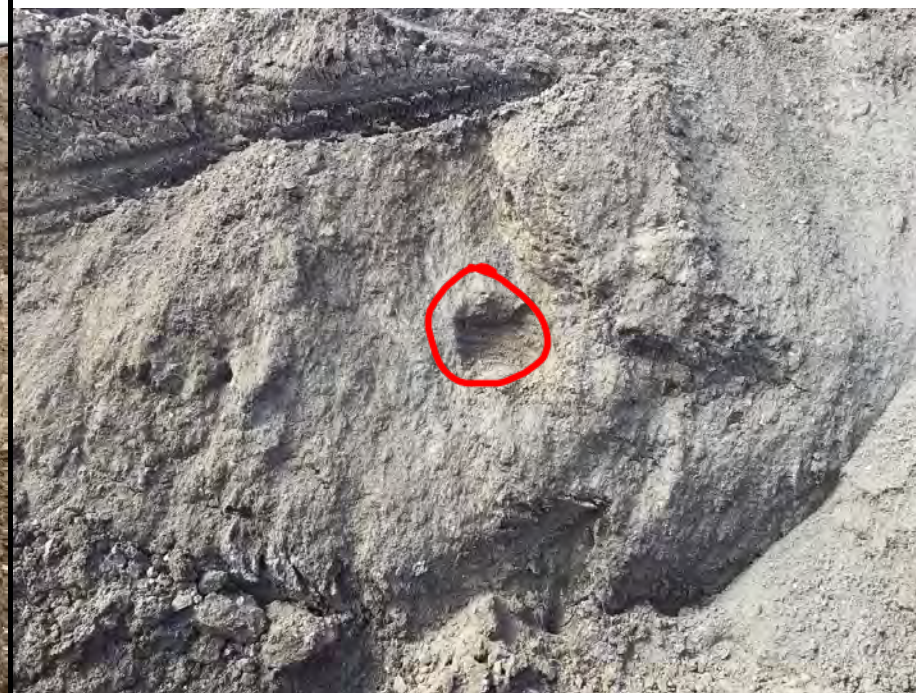
Equipment ID: PWV01-N		Equipment Type:		Equipment ID: PWV01-W		Equipment Type:	
Material:	Volume:	Contents:		Material:	Volume:	Contents:	
Notes/Conditions: PWV01-N@2.5'				Notes/Conditions: PWV01-W@2.5'

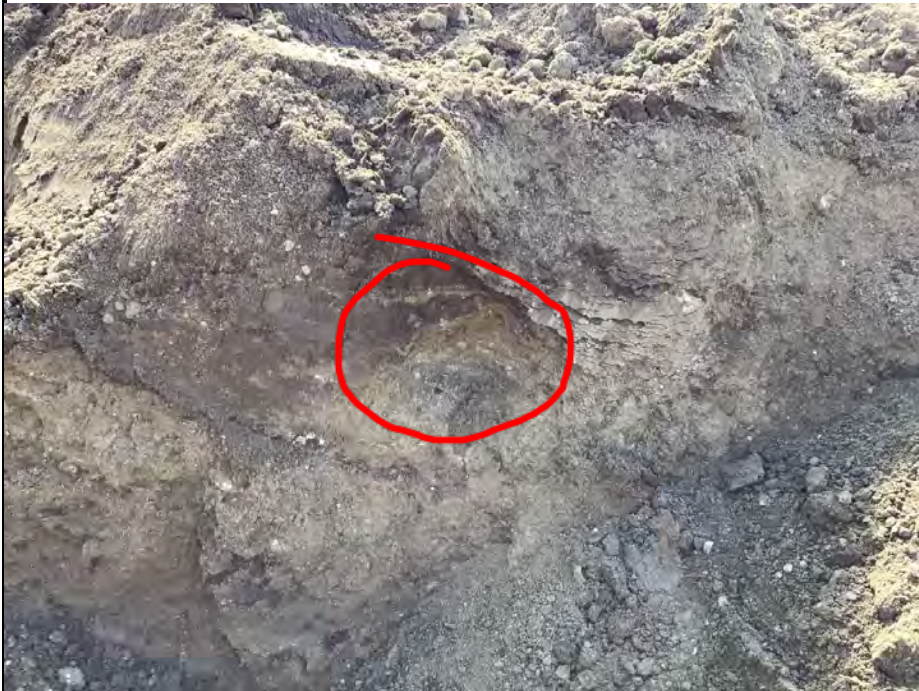
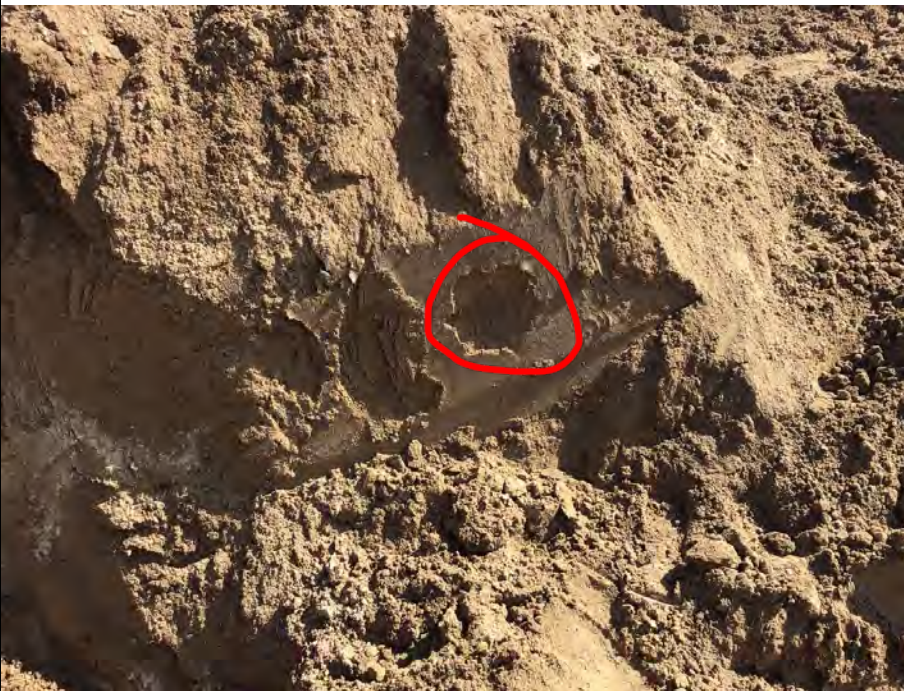
Equipment ID: PWV01-S		Equipment Type:		Equipment ID: PWV01-E		Equipment Type:	
Material:	Volume:	Contents:		Material:	Volume:	Contents:	
Notes/Conditions: PWV01-S@2.5'				Notes/Conditions: PWV01-E@2.5'

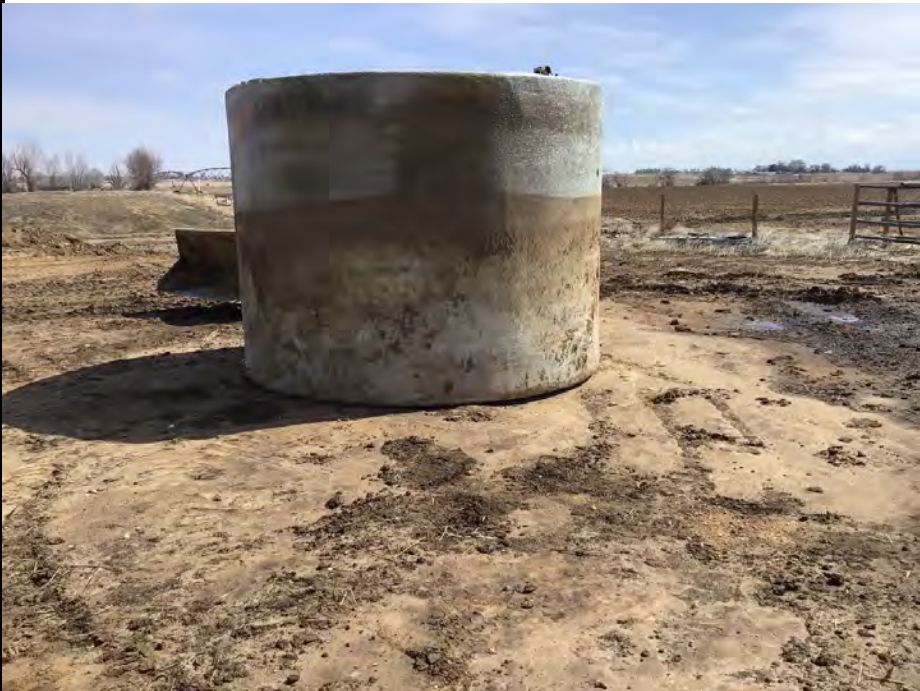
Equipment ID:		Equipment Type:		Equipment ID:		Equipment Type:					
Material:		Volume:		Contents:		Material:		Volume:		Contents:	
Notes/Conditions: Removed PWV						Notes/Conditions:
