Inspection Photos

Operator: FOUNDATION ENERGY
MANAGEMENT LLC - 10112

Location ID: 322320
Garfield County, CO

Aaron Trujillo
NW Reclamation Specialist
COGCC

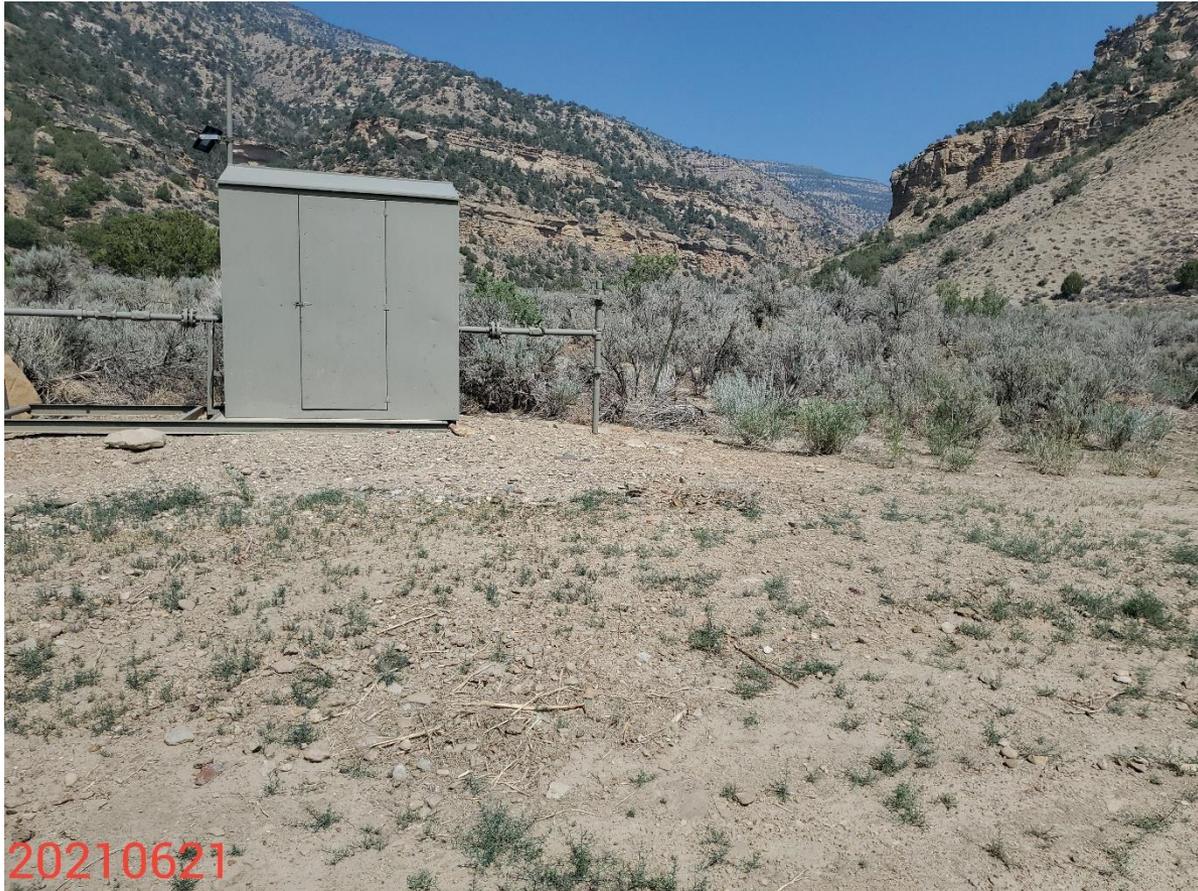
Photo 1: Photo taken from the south end of the Location, facing west. Photo shows meter shed.

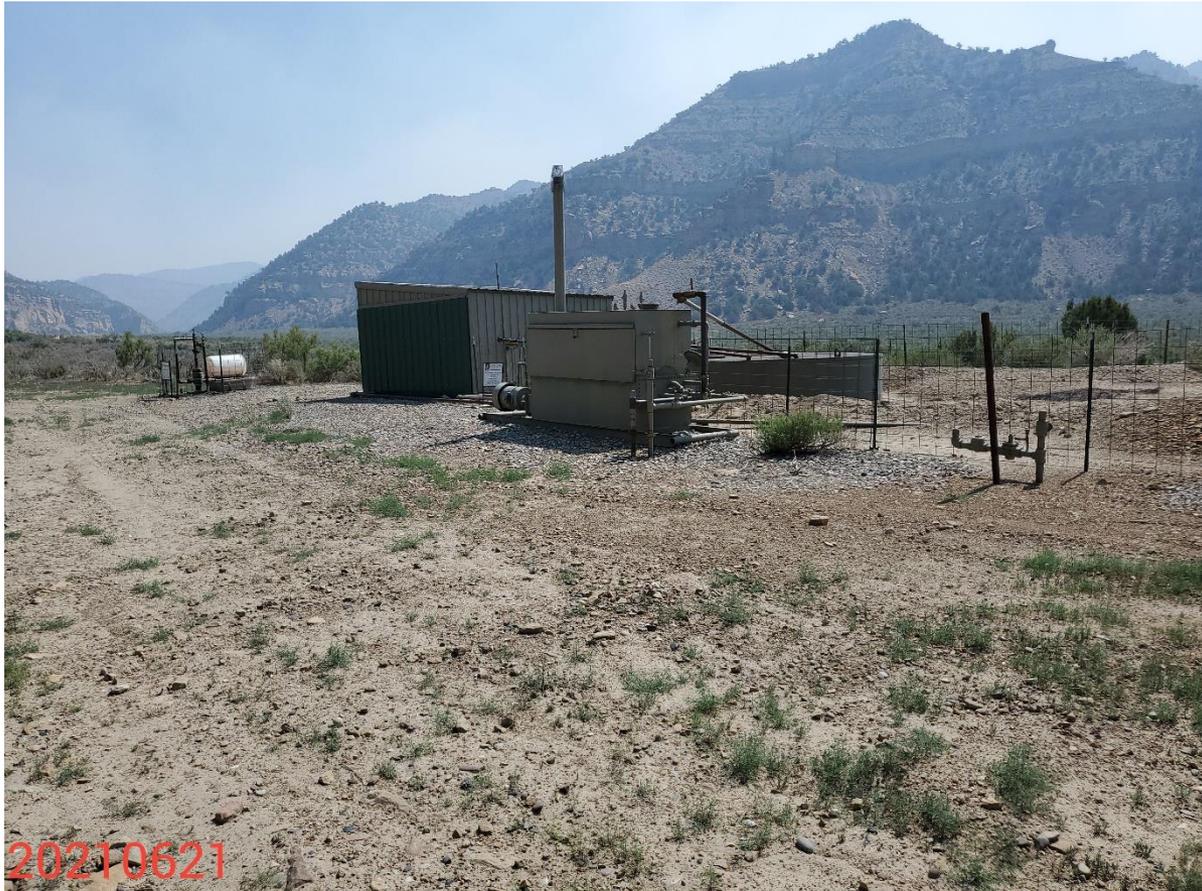
Photo 2: Photo taken from the south end of the Location, facing west. Photo shows compressor/separator/produced water tank equipment.

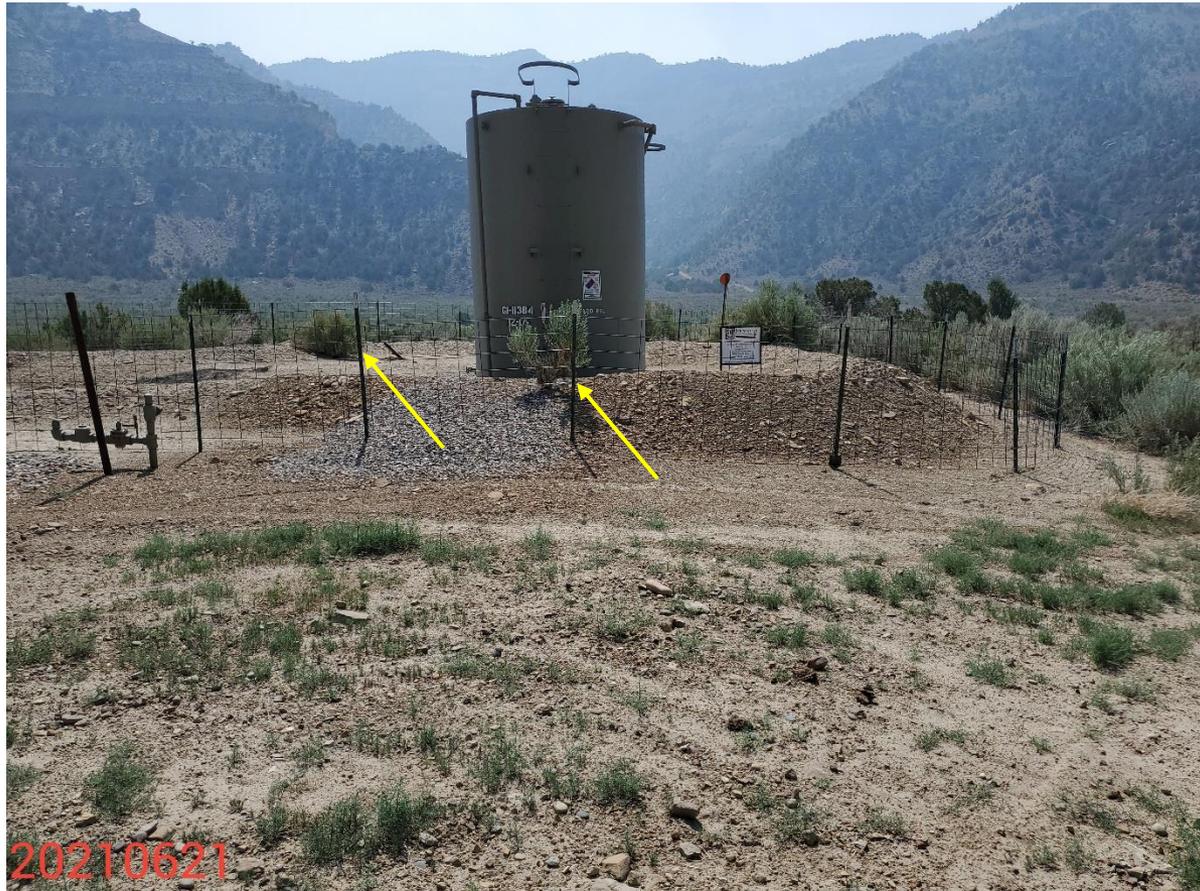
Photo 3: Photo taken from the south end of the Location, facing east. Photo shows example of vegetation observed established on, and within the secondary containment BMP; vegetation establishment compromises the integrity and permeability of the containment BMP.

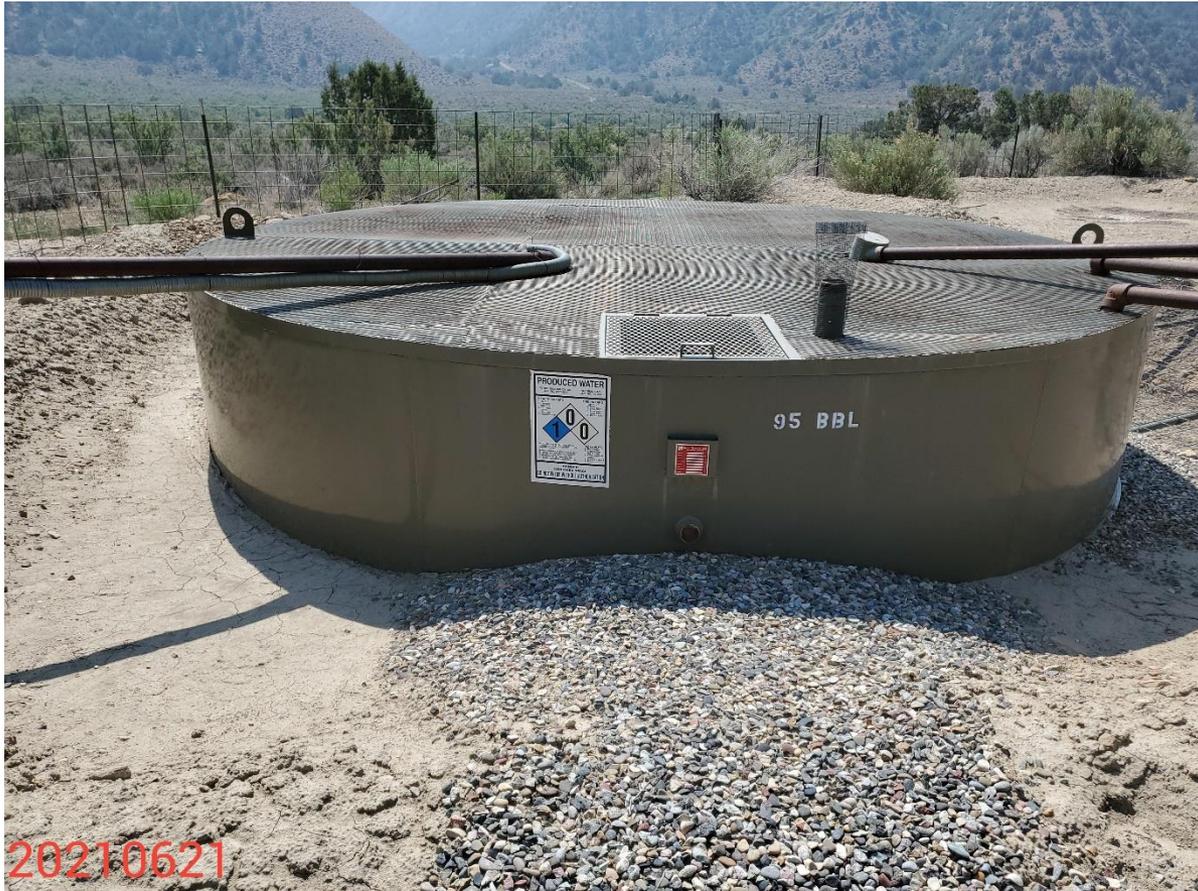
Photo 4: Produced water tank.

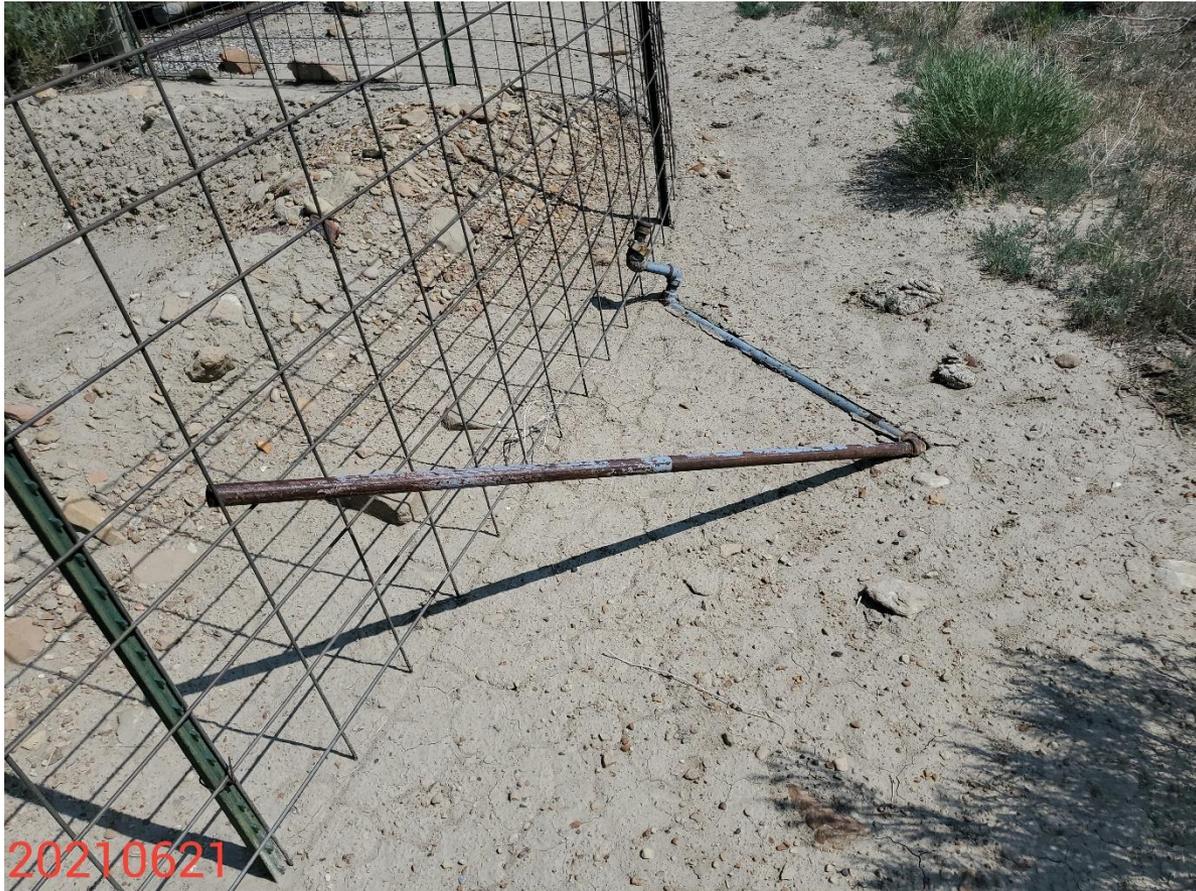
Photo 5: Photo shows unused pipe equipment/trash debris remaining on Location. Inspection #693802957 required compliance with Rule 606 and good housekeeping requirements; corrective action has not been addressed.

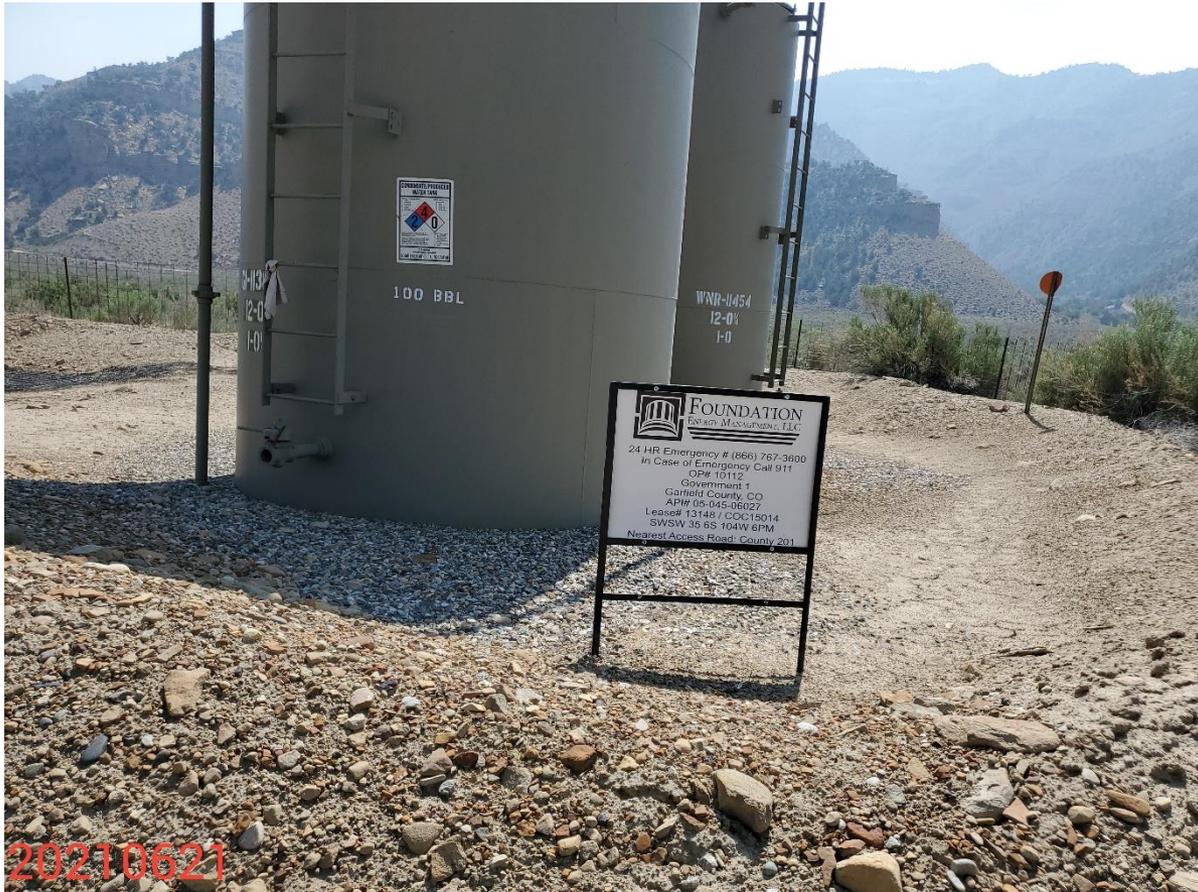
Photo 6: Photo of signage at tank battery

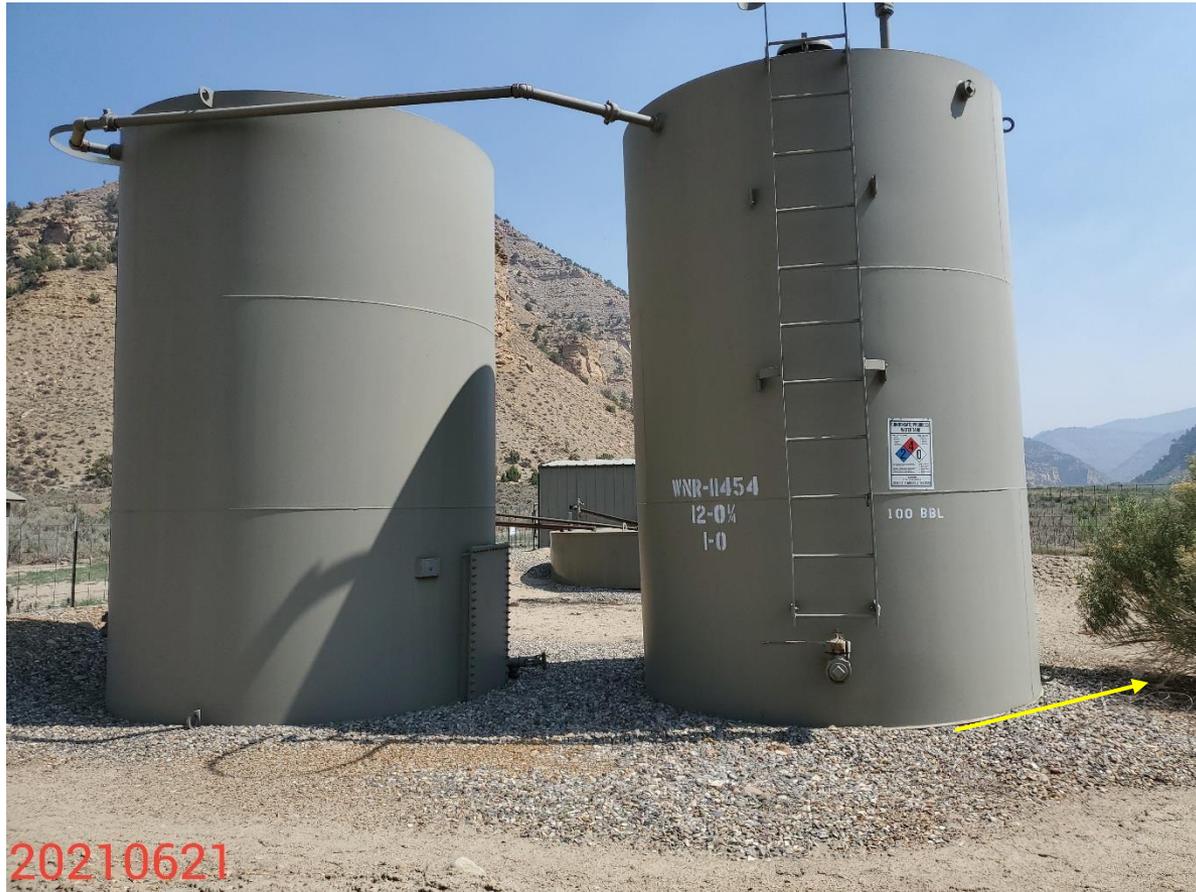
Photo 7: Photo of the tank battery on the southeast end of the Location. Photo also shows example of vegetation observed established on, and within the secondary containment BMP; vegetation establishment compromises the integrity and permeability of the containment BMP.

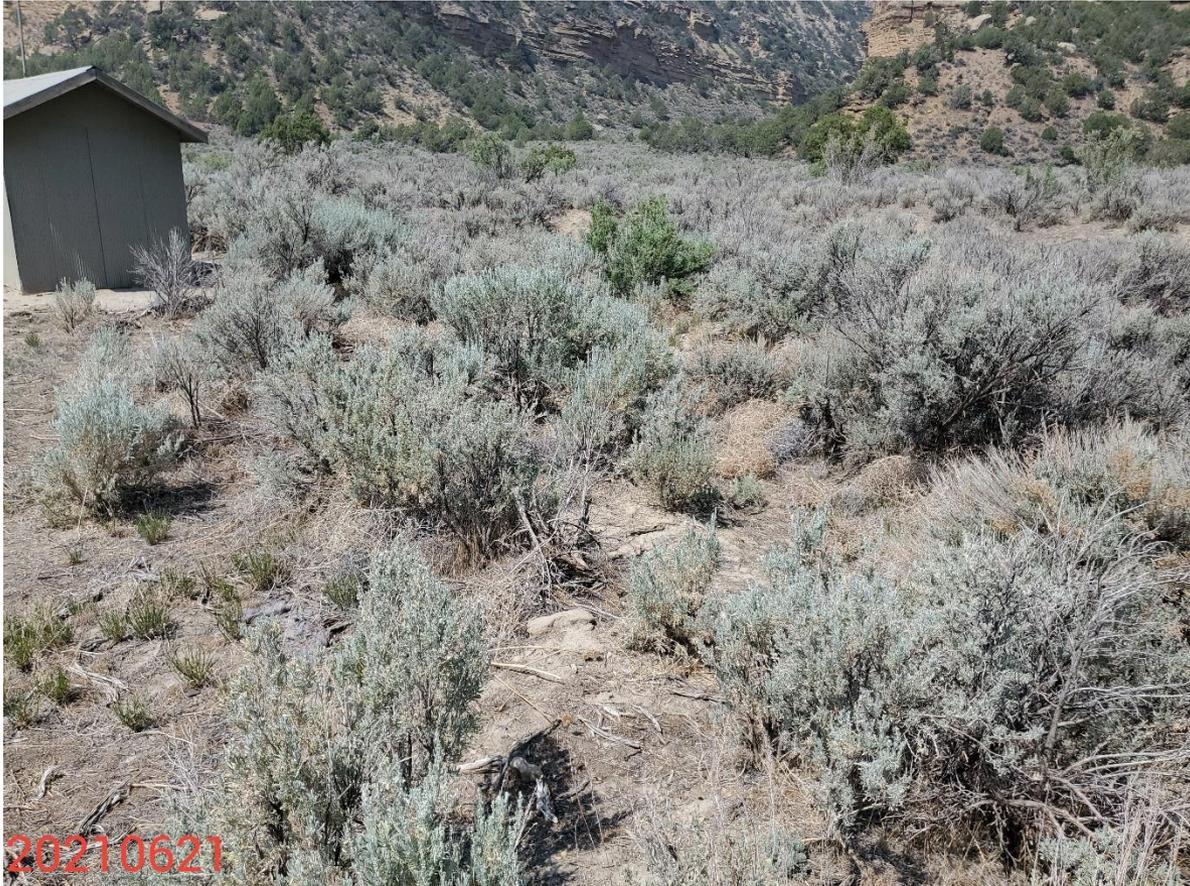
Photo 8: Photo taken from the interim areas on the west end of the Location.

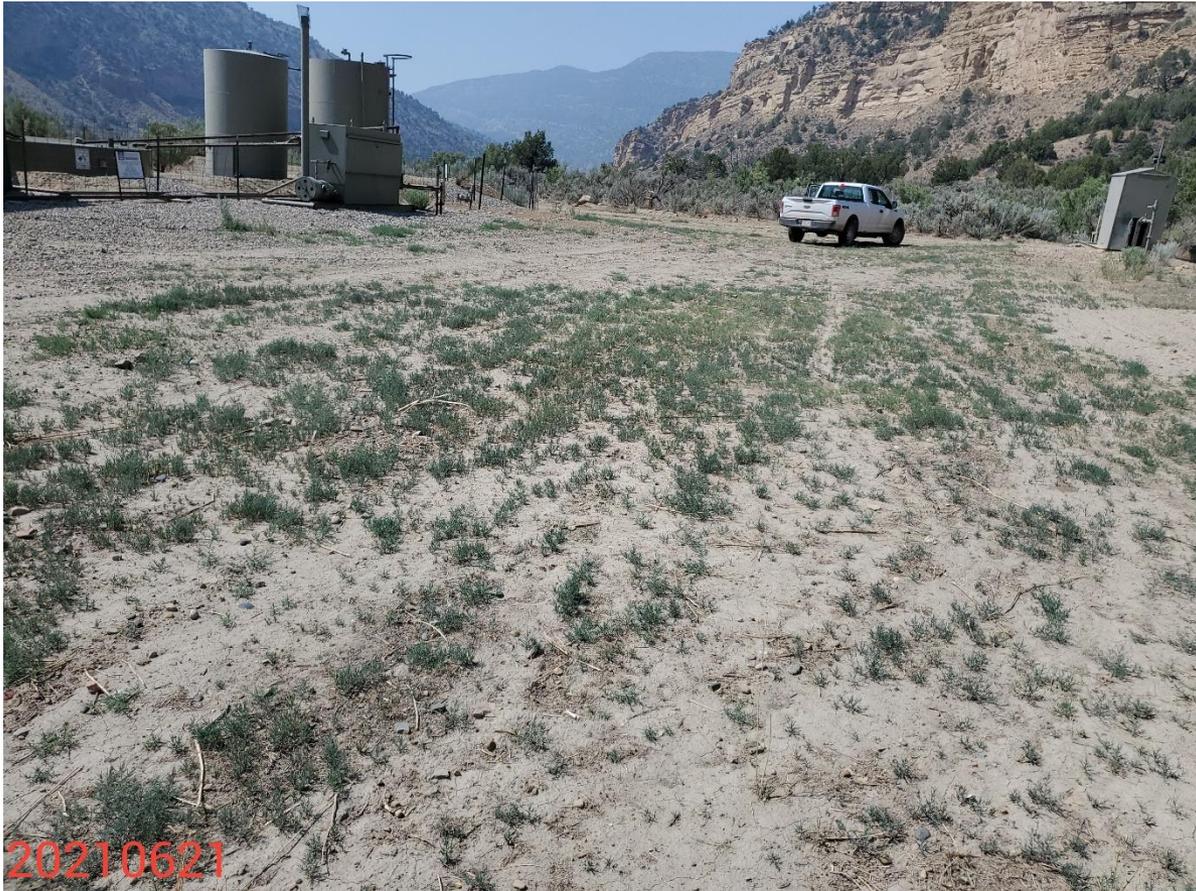
Photo 10: Photo taken from the north end of the Location, facing South. Photo shows undesirable weedy plant establishment on the Location.
