TEP  
KP 33-18  
Location # 417271

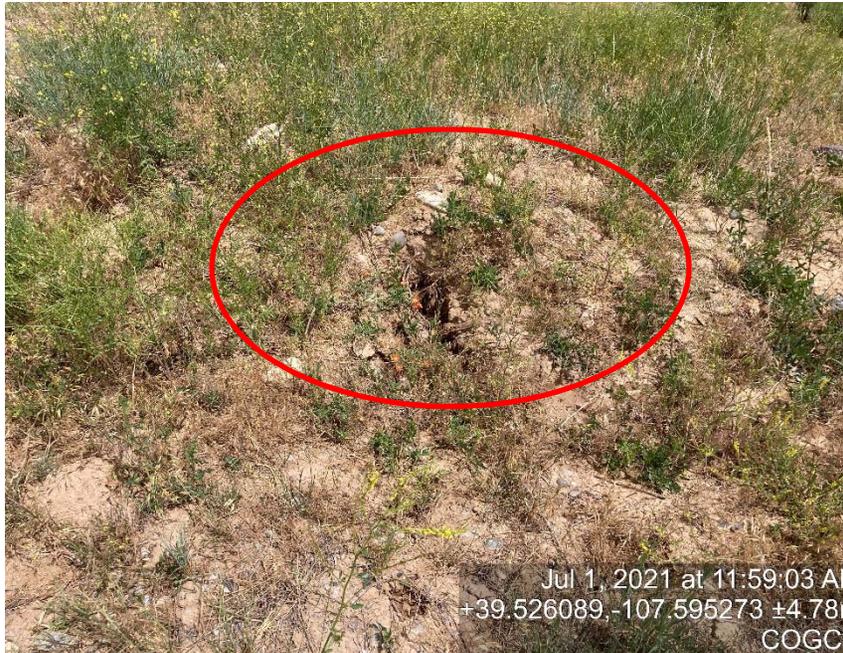
**Perimeter ditch is full of sediment and over running causing some riling and undermining**

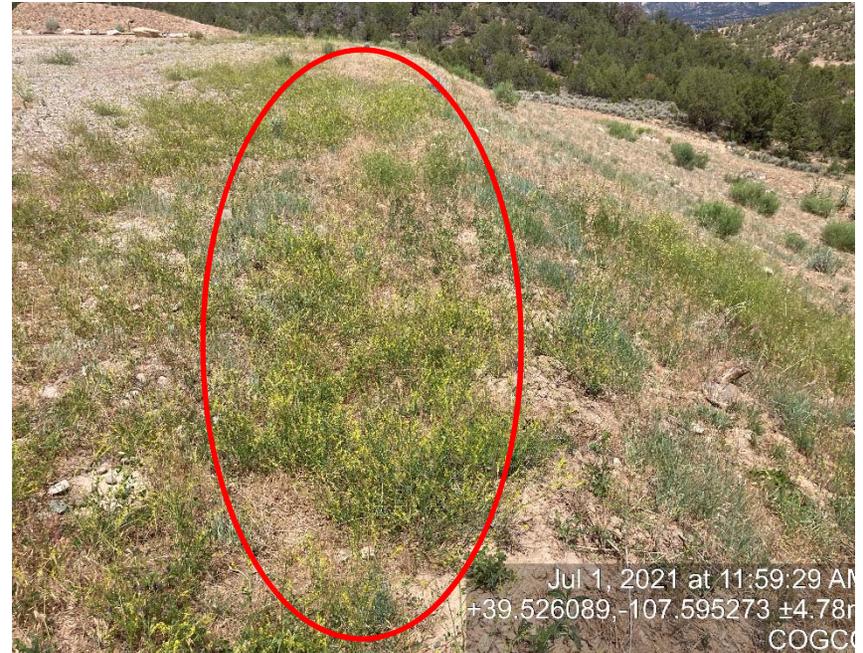
**Perimeter ditch is full of sediment and over running causing some riling and undermining**

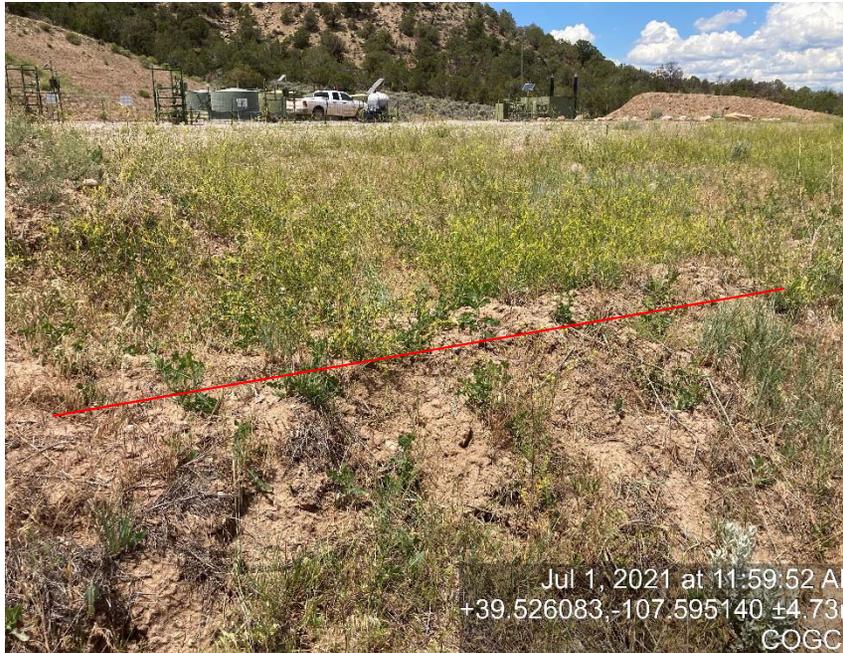
Jul 1, 2021 at 11:59:52 AM  
+39.526083, -107.595140 ±4.73r  
COGCC

**Perimeter ditch is full of sediment and over running causing some riling and undermining. Red line is downhill side of ditch.**

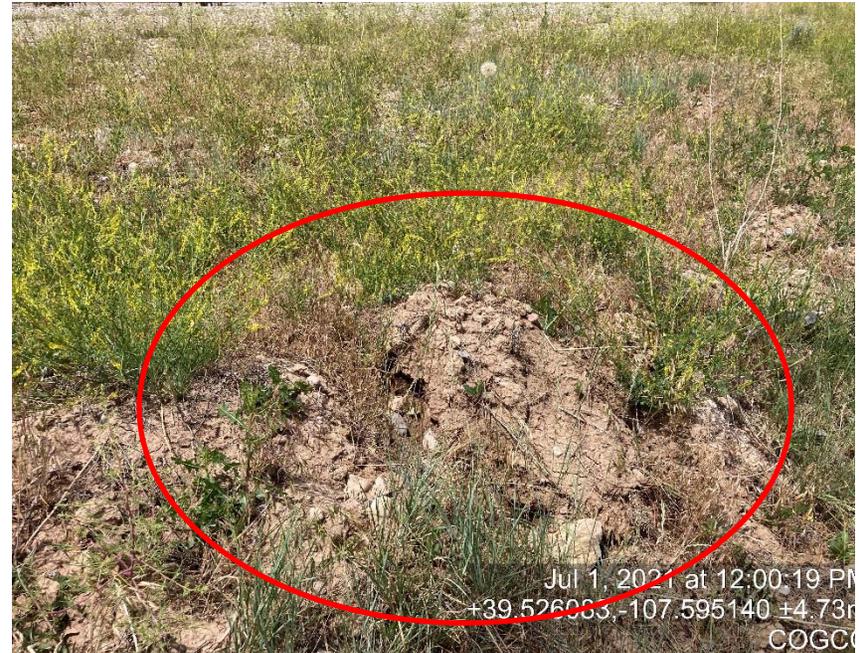
Jul 1, 2021 at 12:00:19 PM  
+39.526083, -107.595140 ±4.73r  
COGCC

**Perimeter ditch is full of sediment and over running causing some riling and undermining**
