# Inspection Photos

API: 055-06195

Operator: EVERGREEN NATURAL RESOURCES

Inspection Date: 7/2/2021

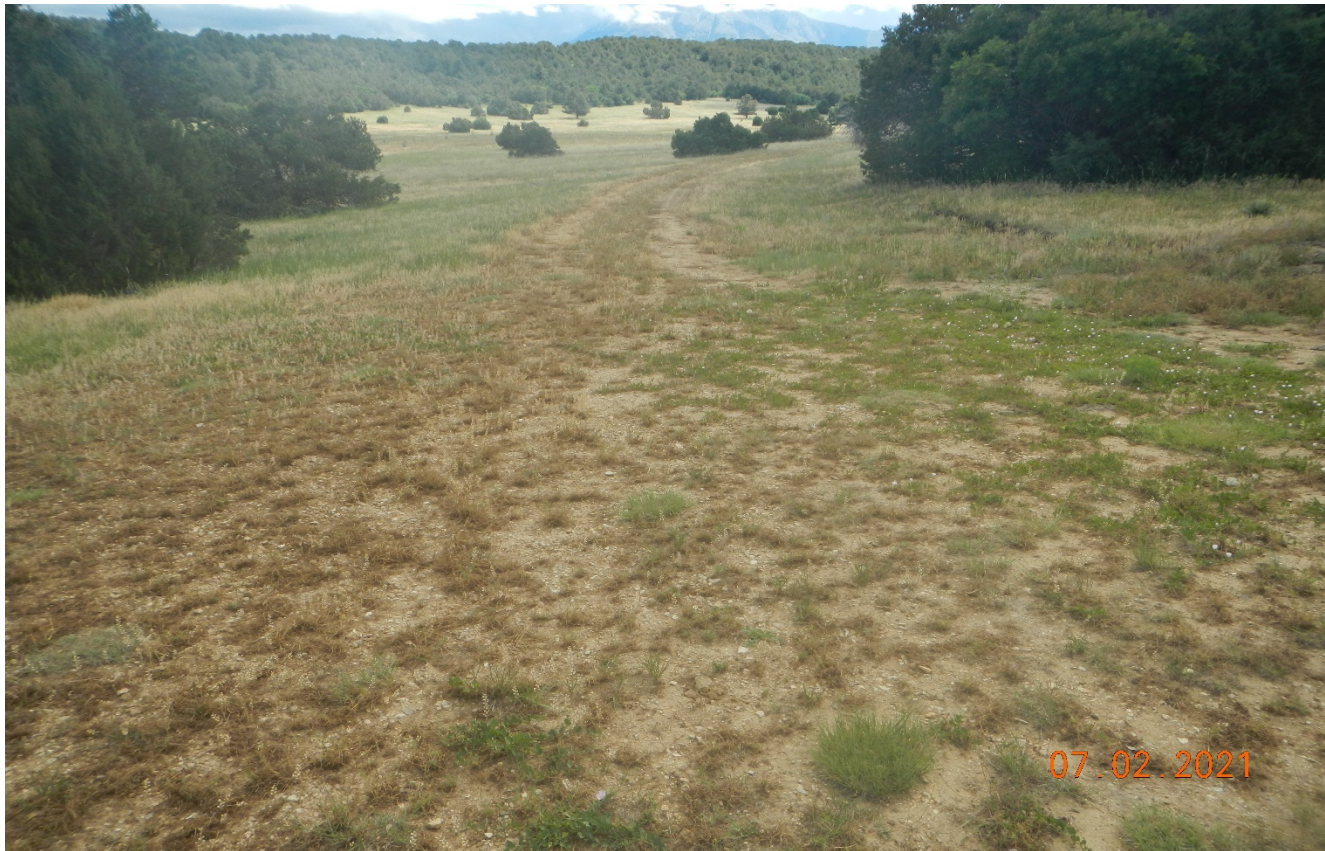
**Photo 1.** Facing southwest along the former access road. The road was not recontoured and reclaimed.

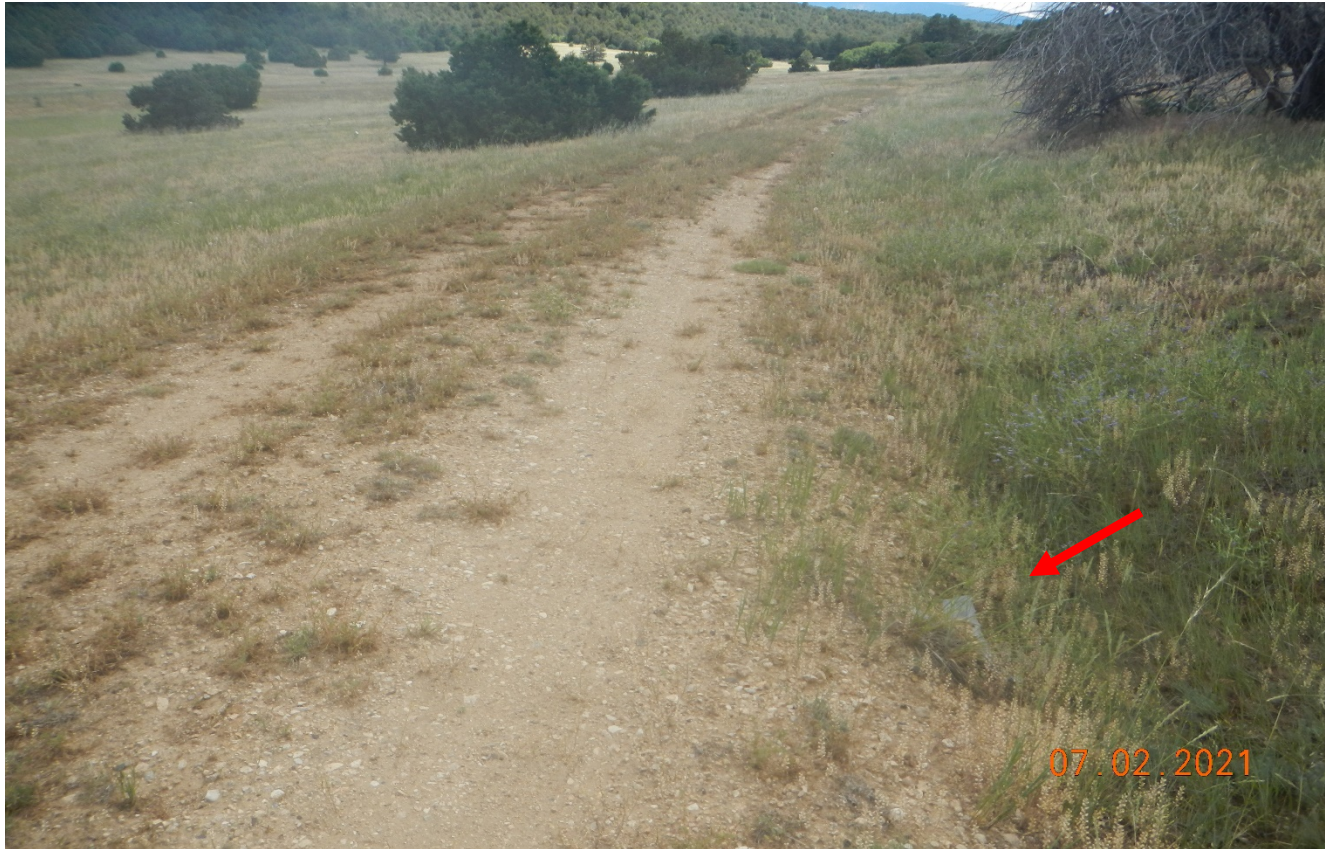
**Photo 2.** There is gravel and culverts that remain along the road . Arrow points to the culvert that remains.

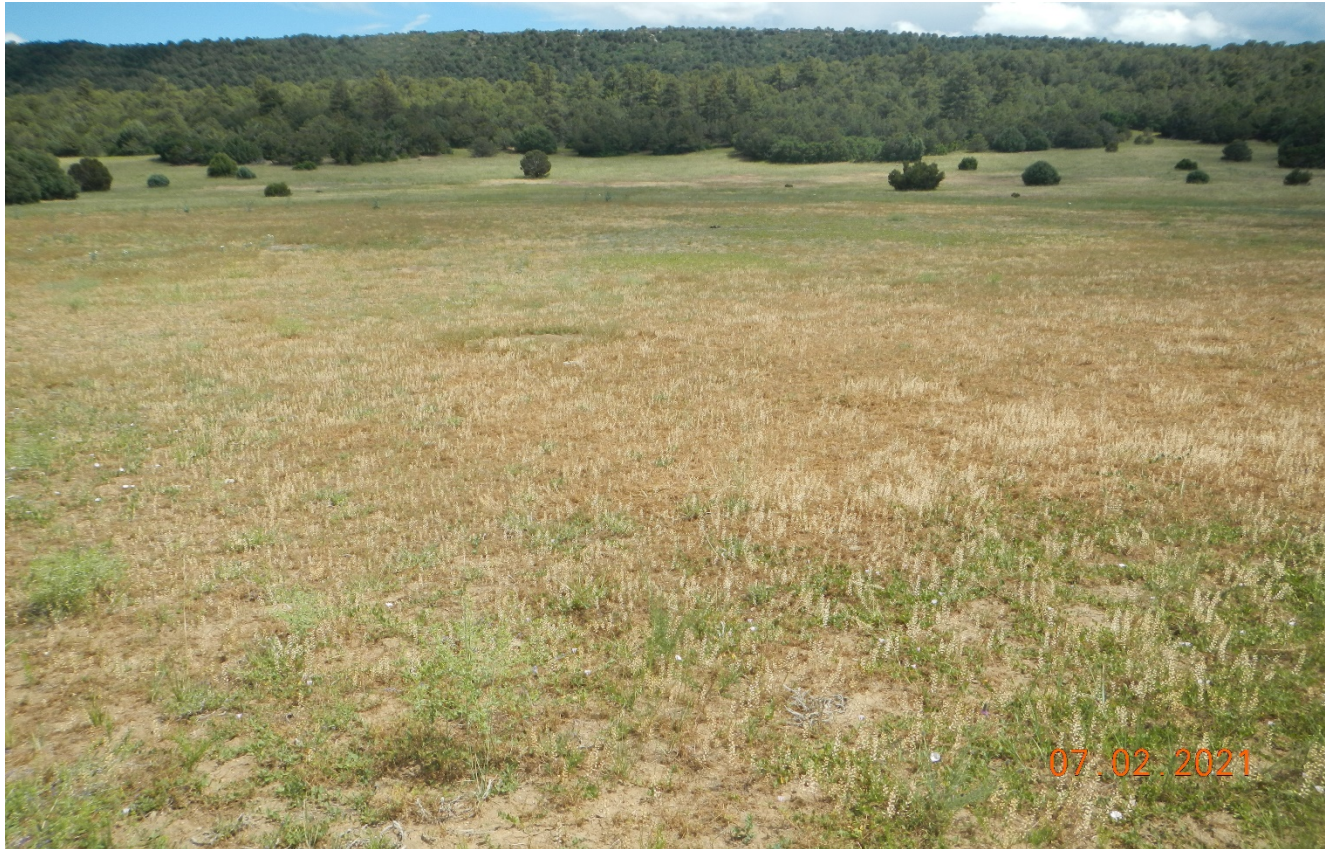
**Photo 3.** Facing south toward the location. The desirable vegetation has not re-established at the location and there are noxious weeds throughout the disturbed location.

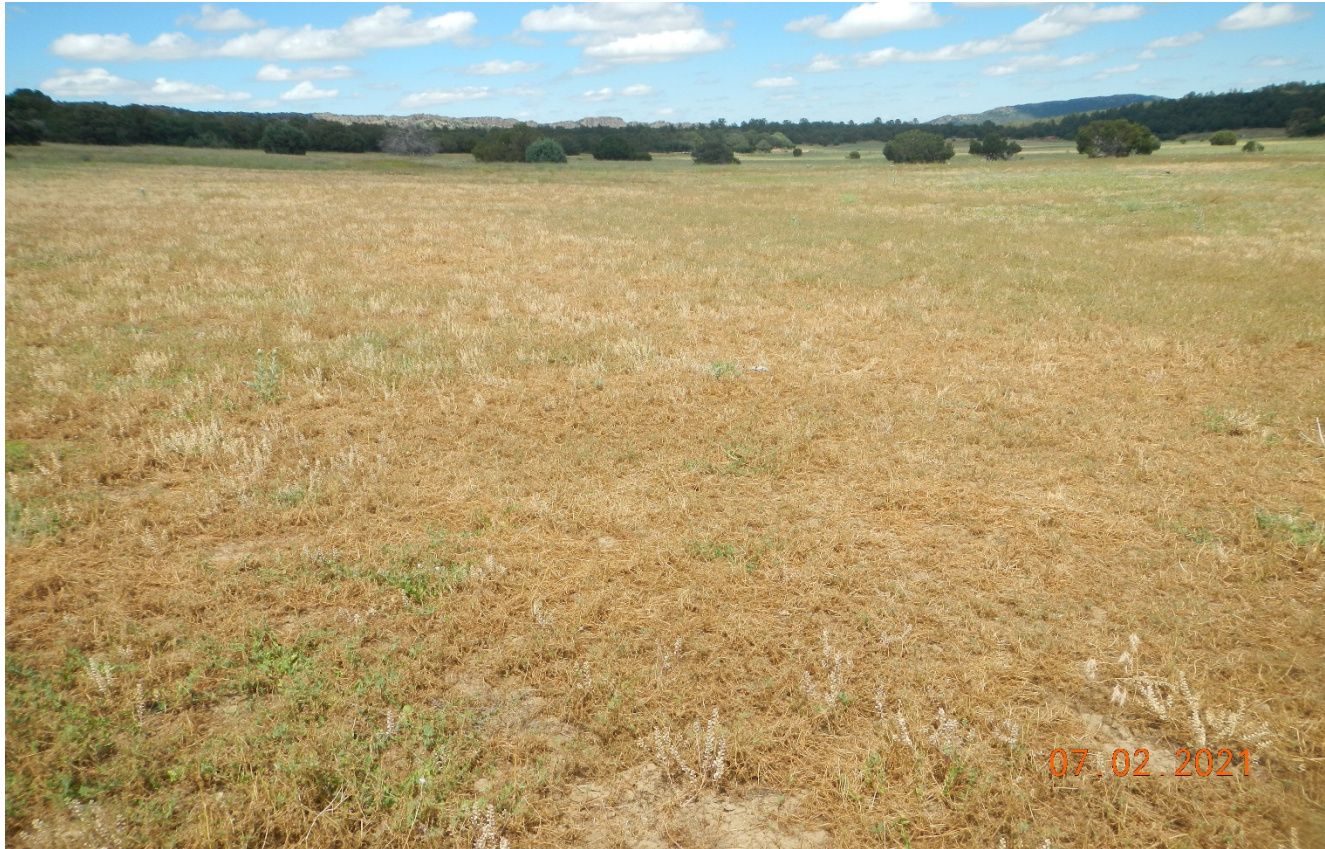
**Photo 4.** Facing east toward the location. The desirable vegetation has not re-established at the location and there are noxious weeds throughout the disturbed location.

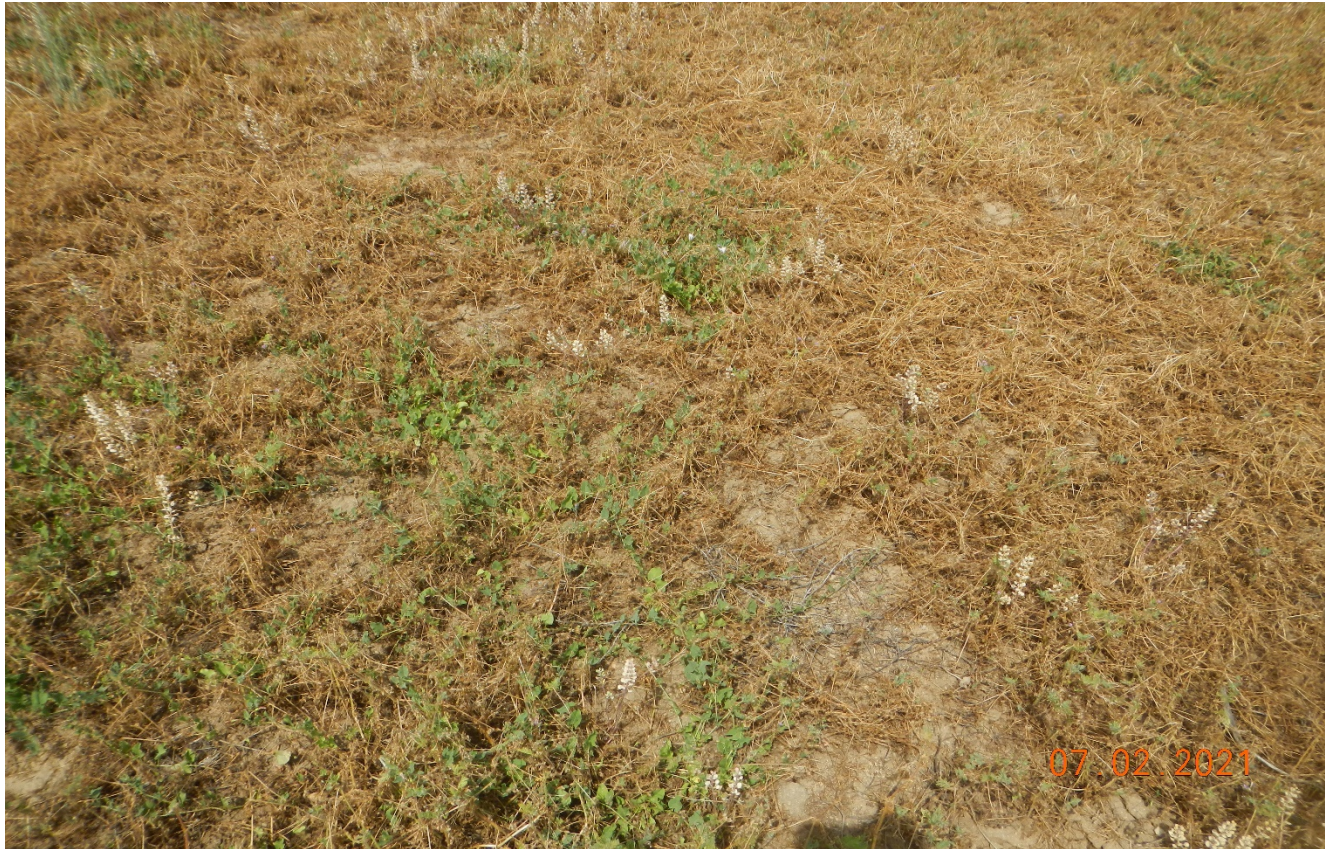
**Photo 5.** View of ground cover shows noxious weeds Redstem filaree and Field bindweed.

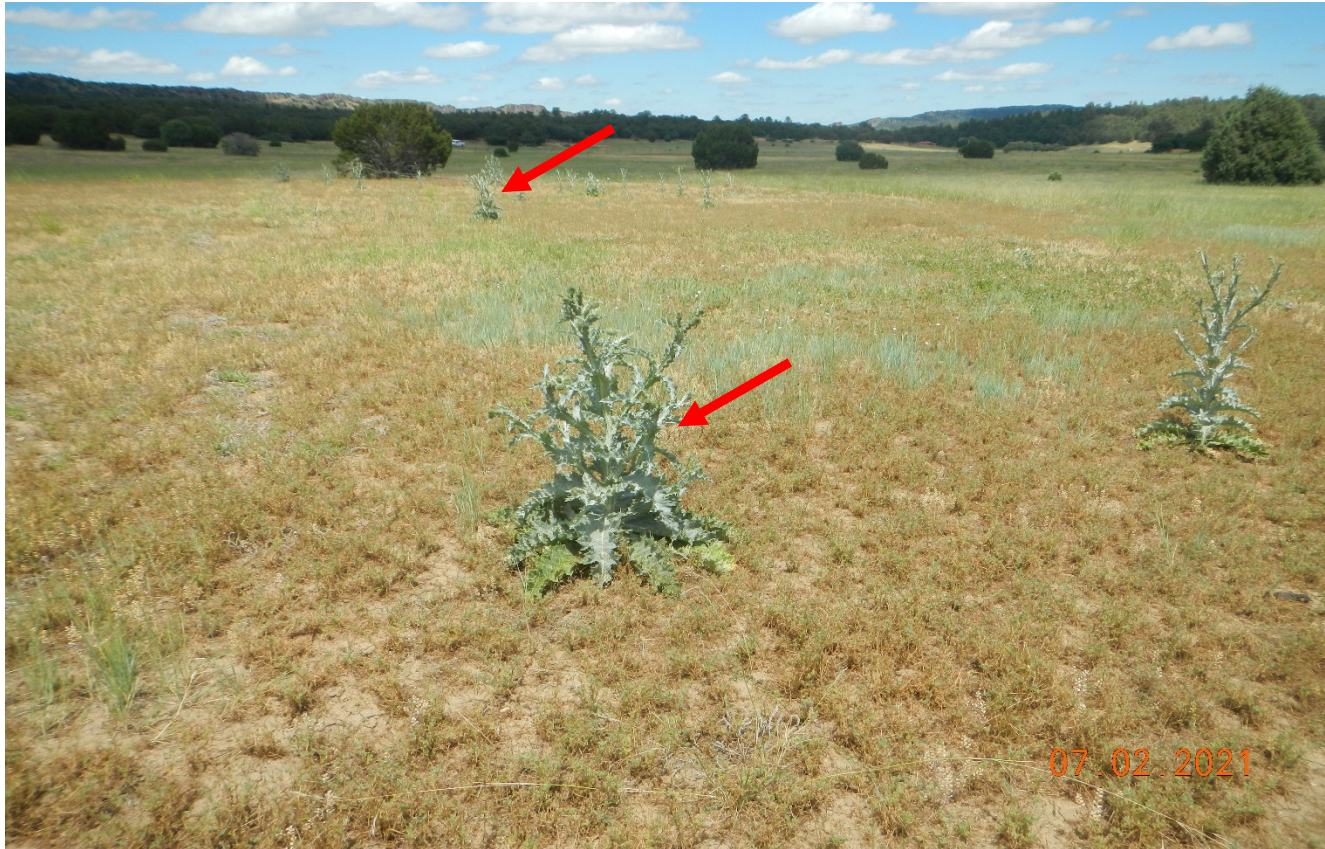
**Photo 6.** Facing east at the south side of the location. There is scotch thistle which is a List B noxious weed growing along this area shown at red arrow

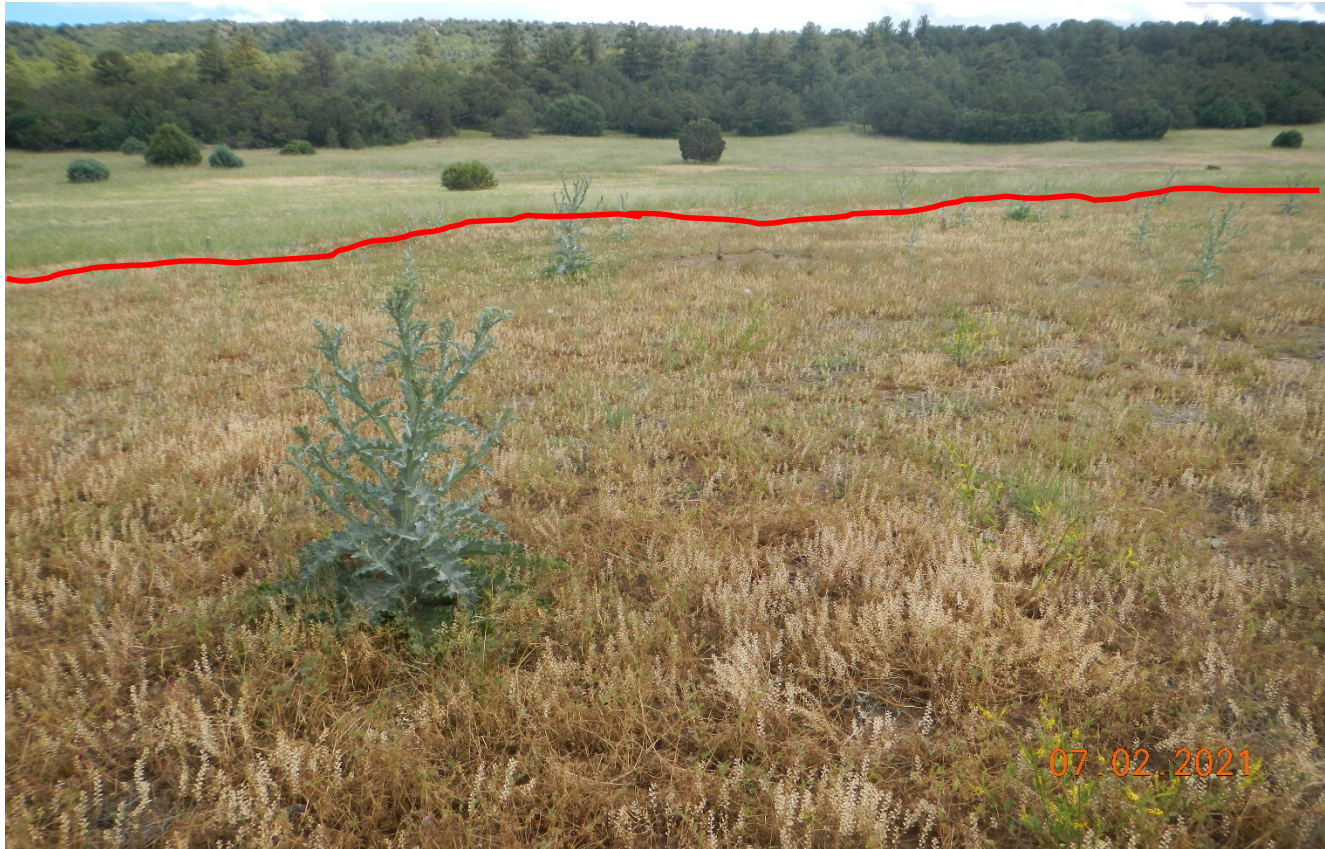
**Photo 7.** Facing south at the southern side of the location. Red outline shows the edge of disturbance with a change in vegetation off the location.

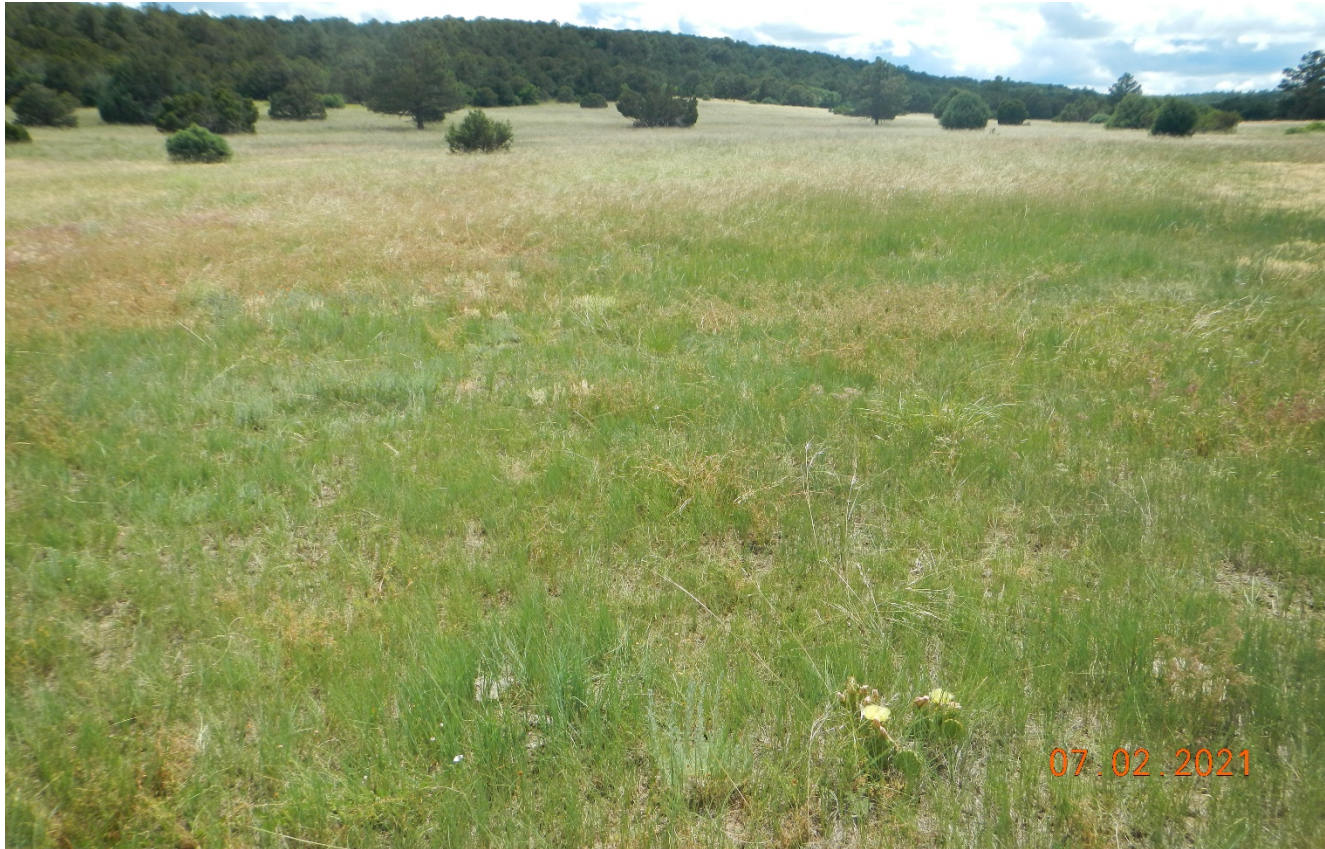
**Photo 8.** Facing southwest at the surrounding undisturbed vegetation which consists of Western wheat, Needle and thread grass, Sand drop seed, among other native species.
