Inspection Photos
Operator: Simcoe
API: 067-06505
Date: 7/2/2021

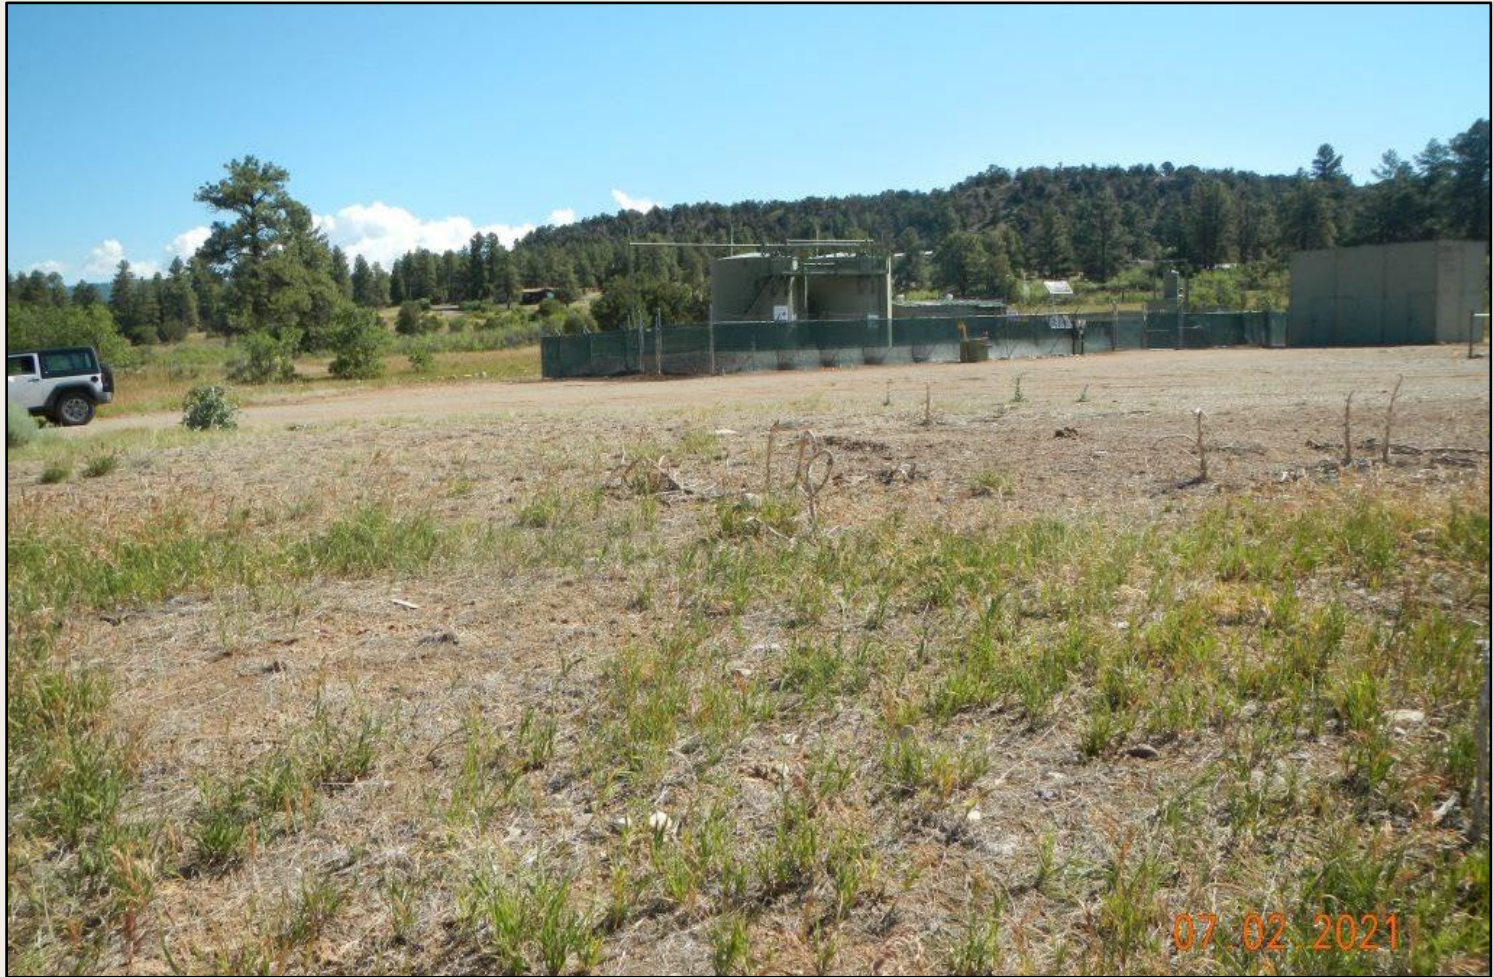
Photo 1. View the project area from the southwestern corner facing center.

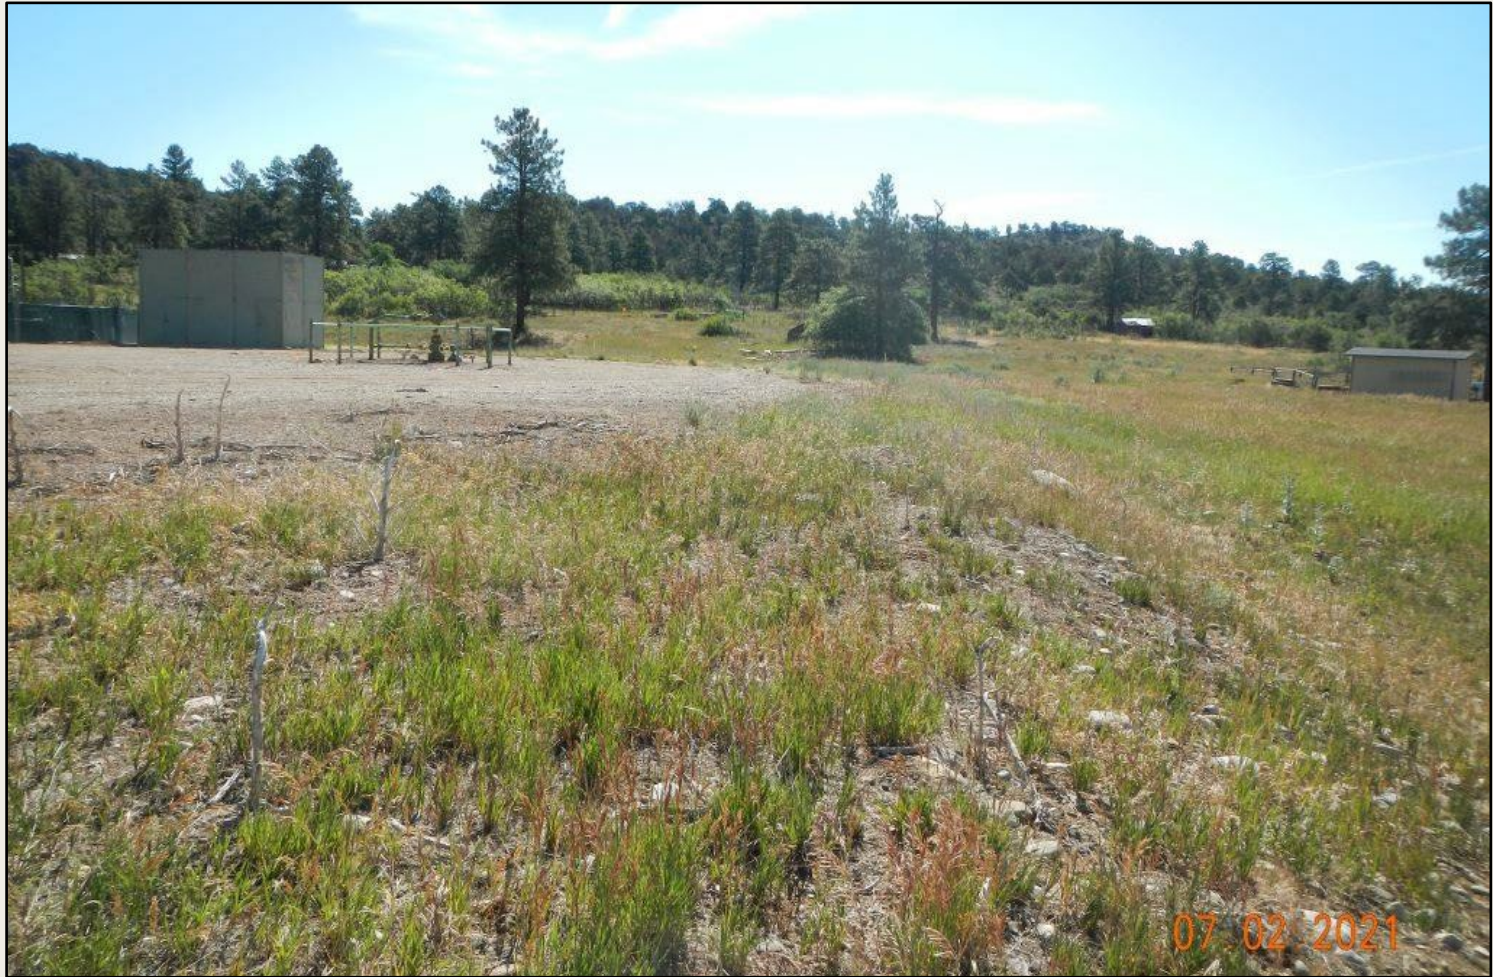
Photo 2. View of the southern project area from the southwestern corner facing eastward. Revegetation is progressing with smooth brome.

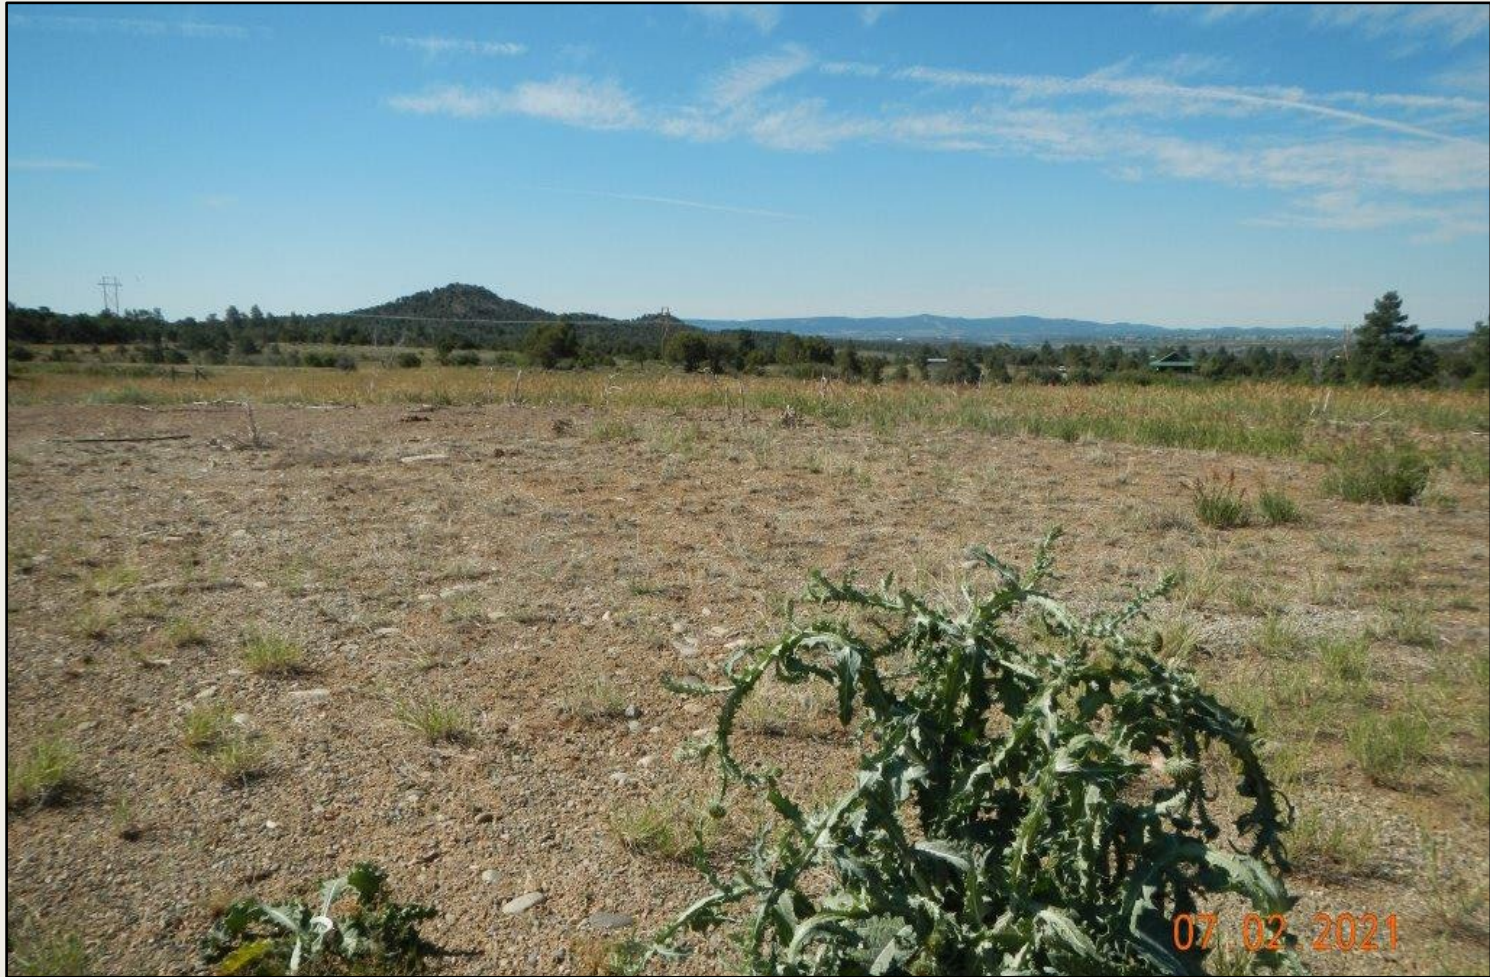
Photo 3. View of scattered Scotch thistles within the southwestern project area. Scotch thistles are largely treated, but approximately 20 individuals remain partially treated or untreated.

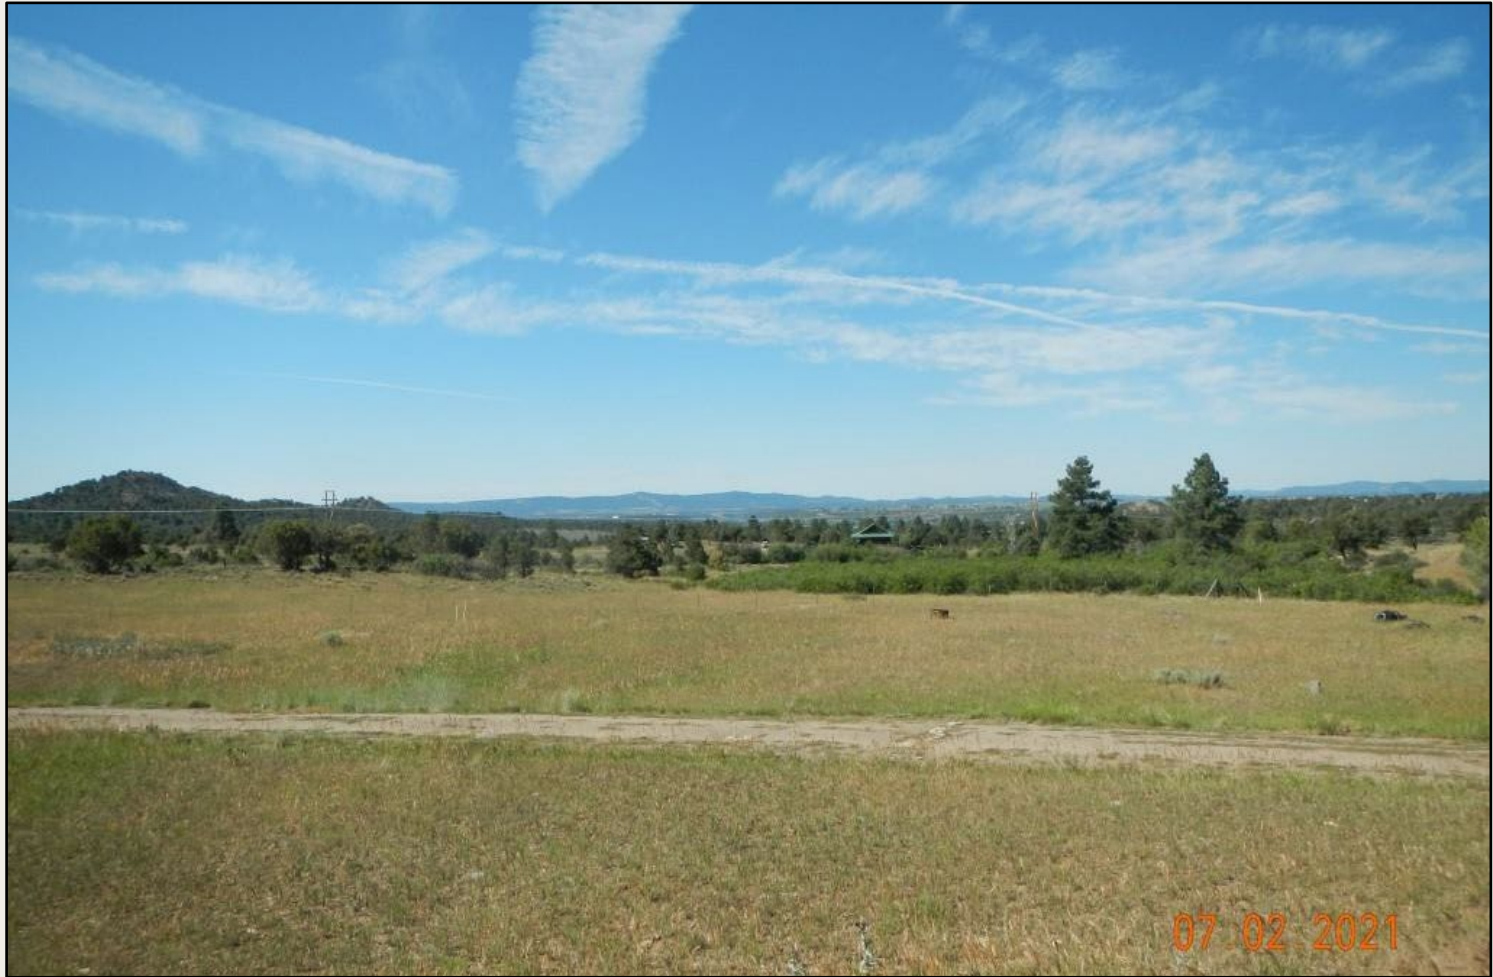
Photo 4. View the reference area comprised of smooth brome grass field mosaic with sagebrush shrubland with gambel oak, pinyon and juniper, Indian ricegrass, squirreltail, western wheatgrass, and prickly pear.
