# Inspection Photos

API: 071-06191

Operator: OGRIS OPERATING LLC

Inspection Date: 7/7/2021

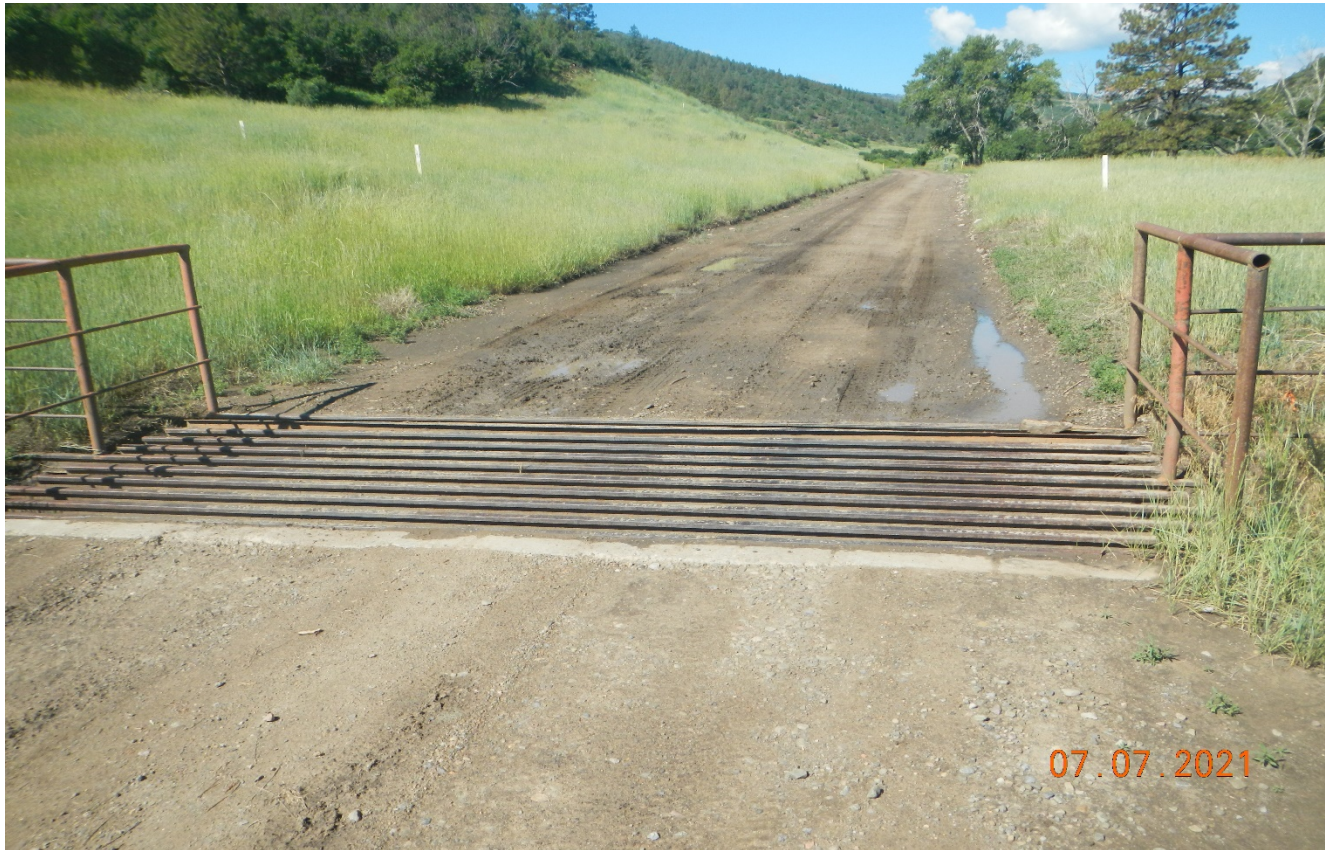
**Photo 1.** The cattle guard along the main road near the Bingham campground has been maintained.

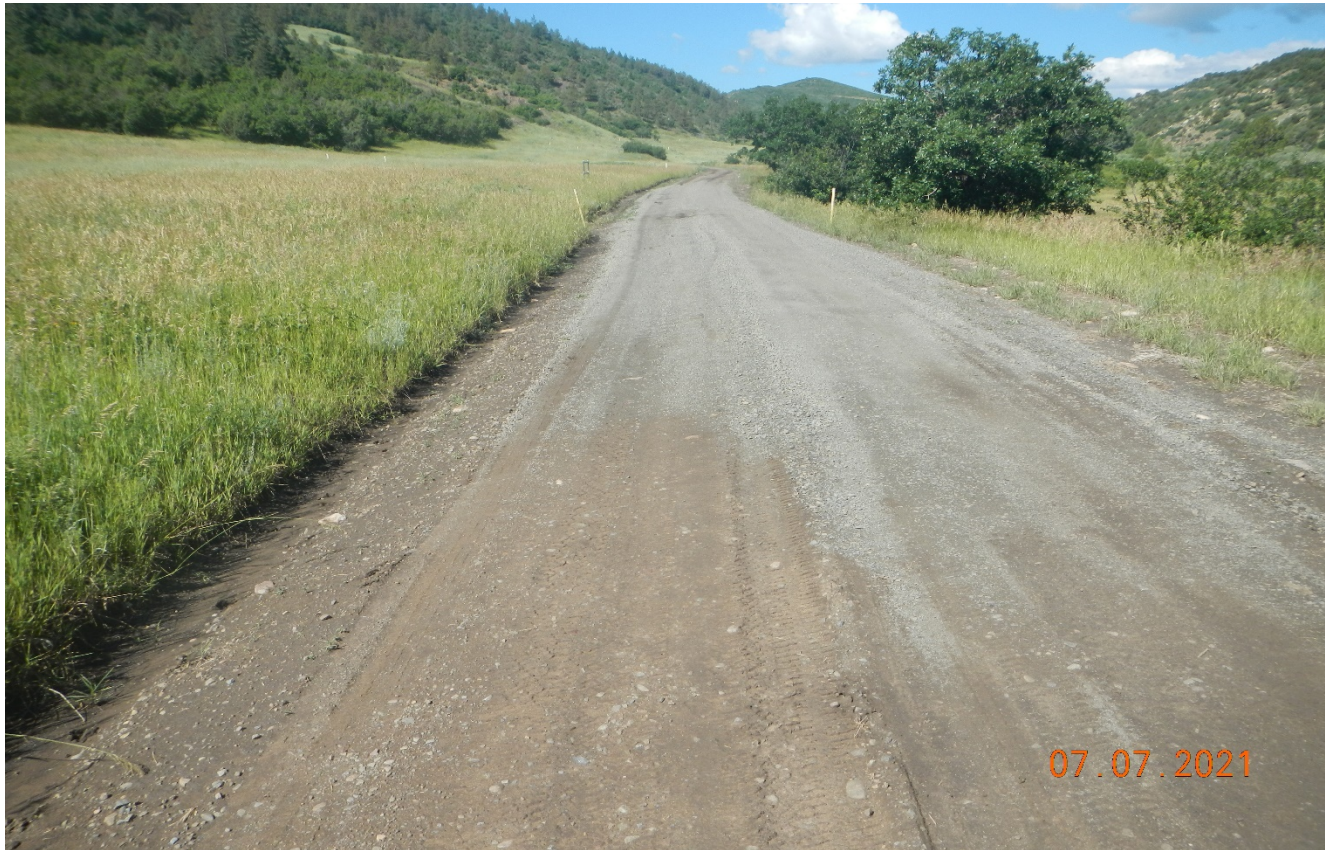
**Photo 2.** The road was regraded and gravel was applied to area of the road.

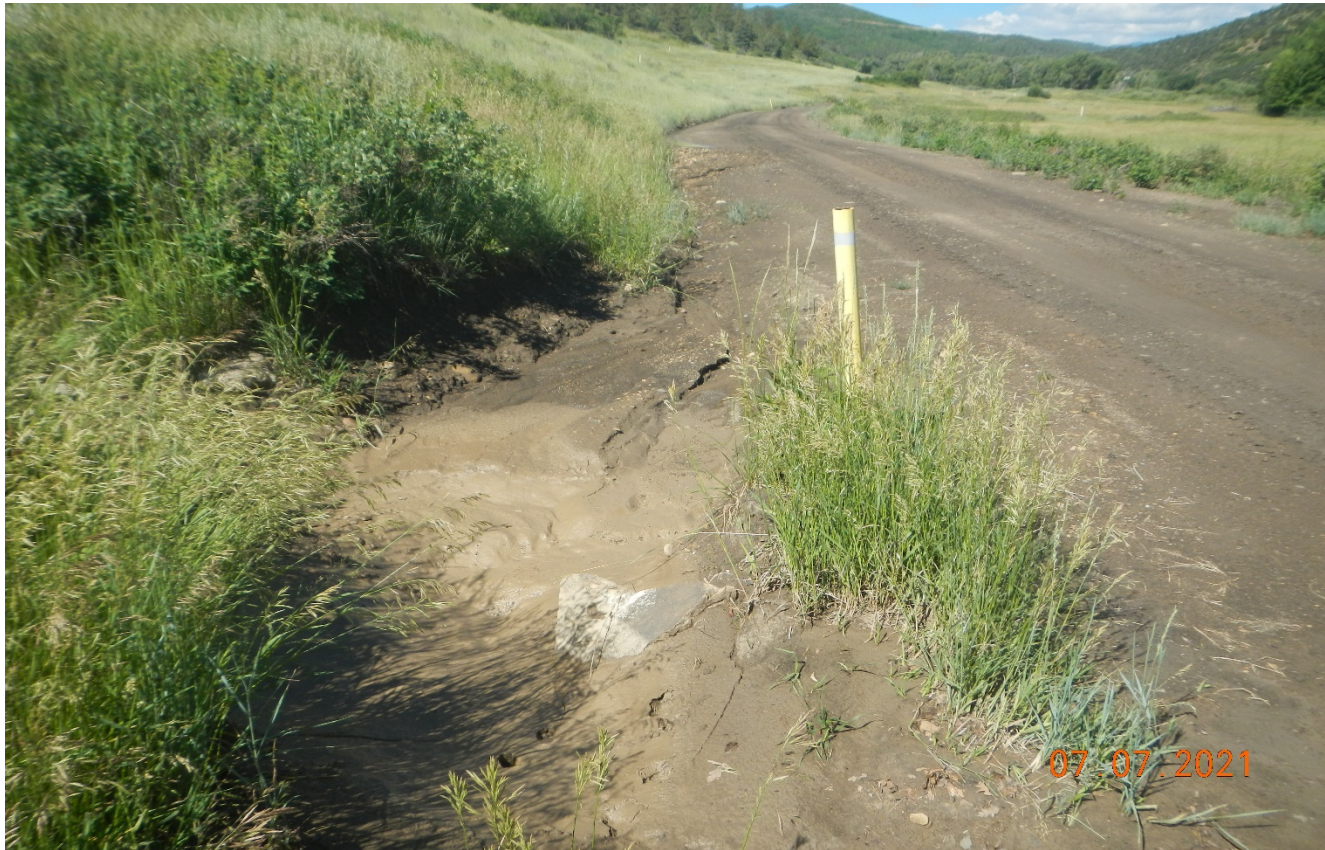
**Photo 3.** It appears recent rain events have deposited sediment into the culverts. Ongoing maintenance needs to be performed.

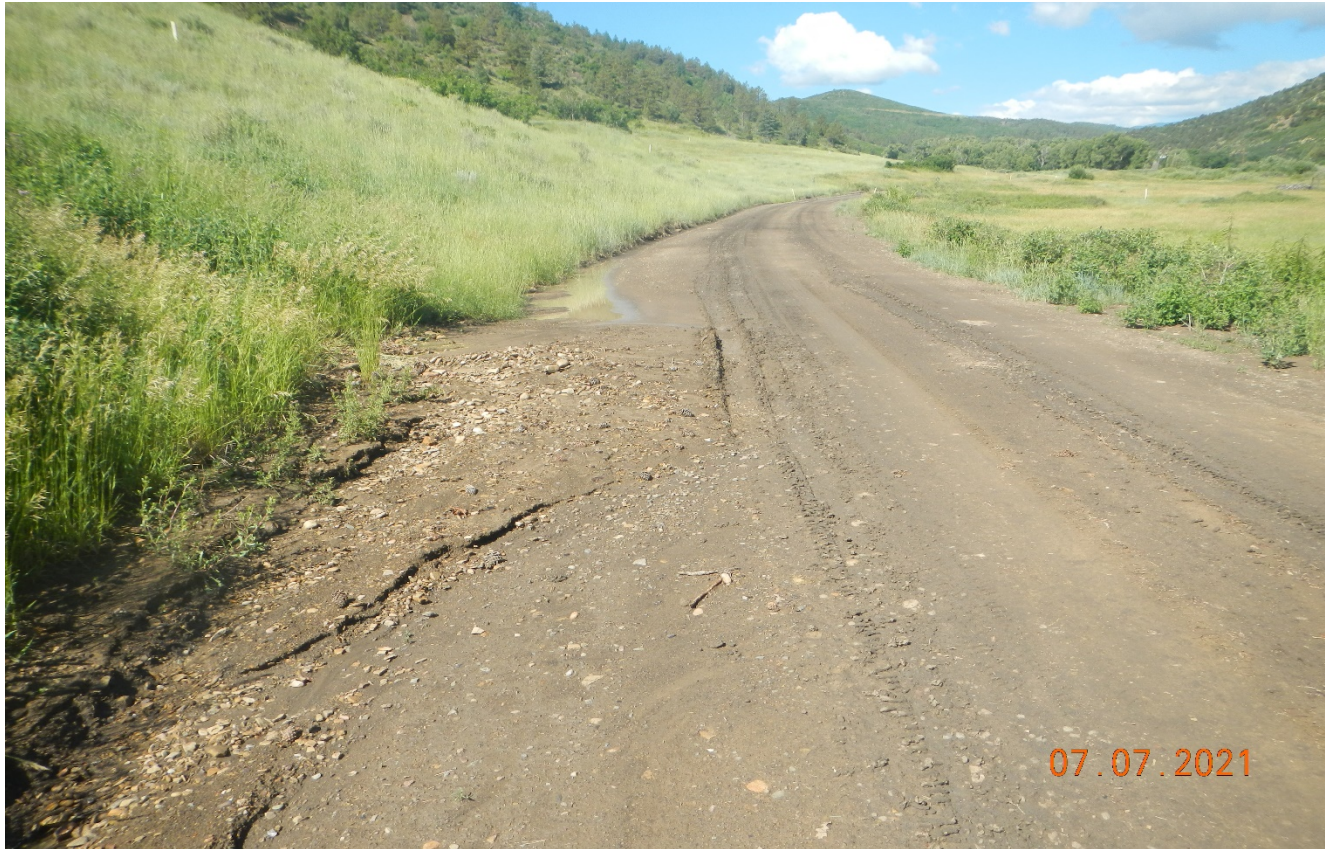
**Photo 4.** Sediment has washed into the road from recent rain event. The sediment needs to be removed to establish drainage toward the culvert.

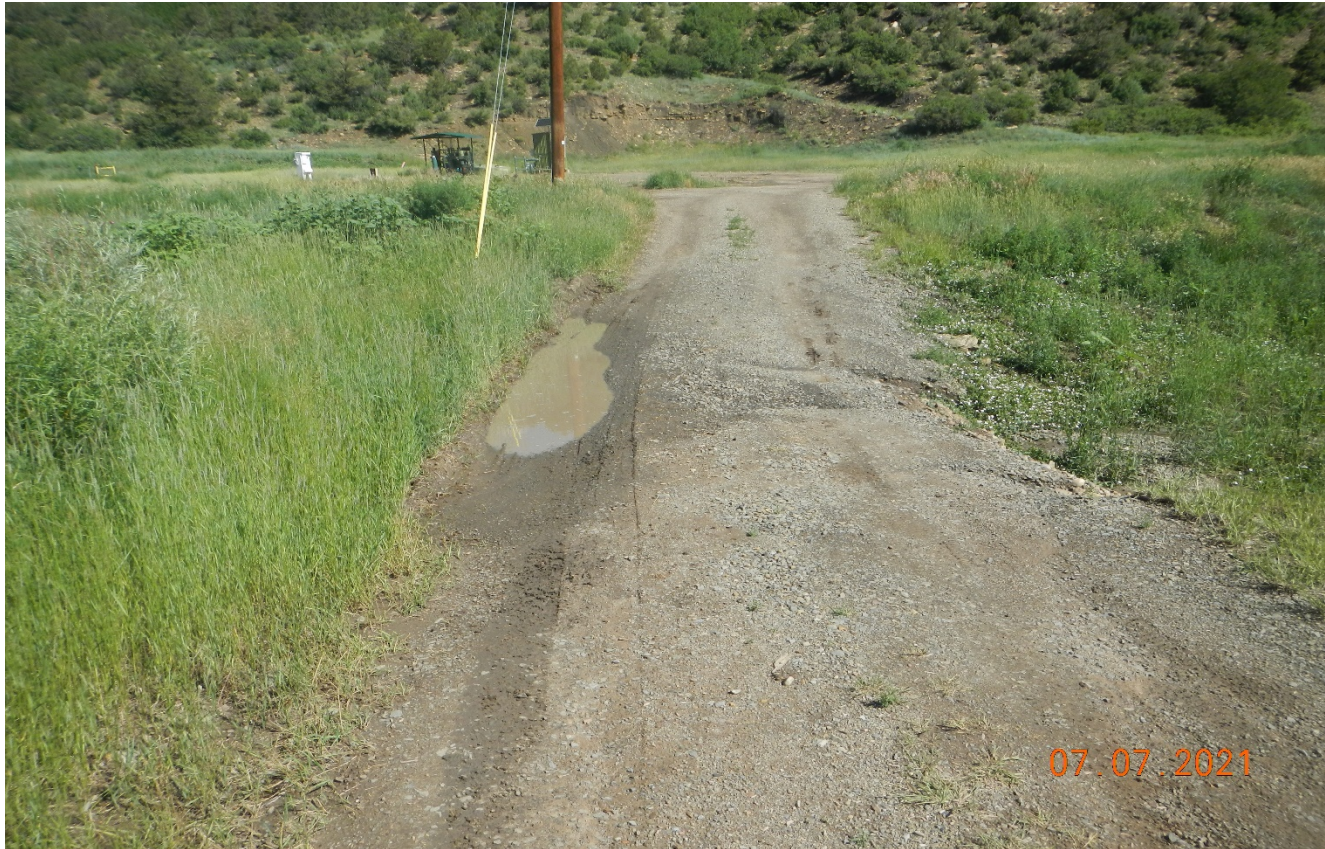
**Photo 5.** Facing northwest along the access road. This area of the road was not repaired. Stormwater is accumulating and has eroded across the road.

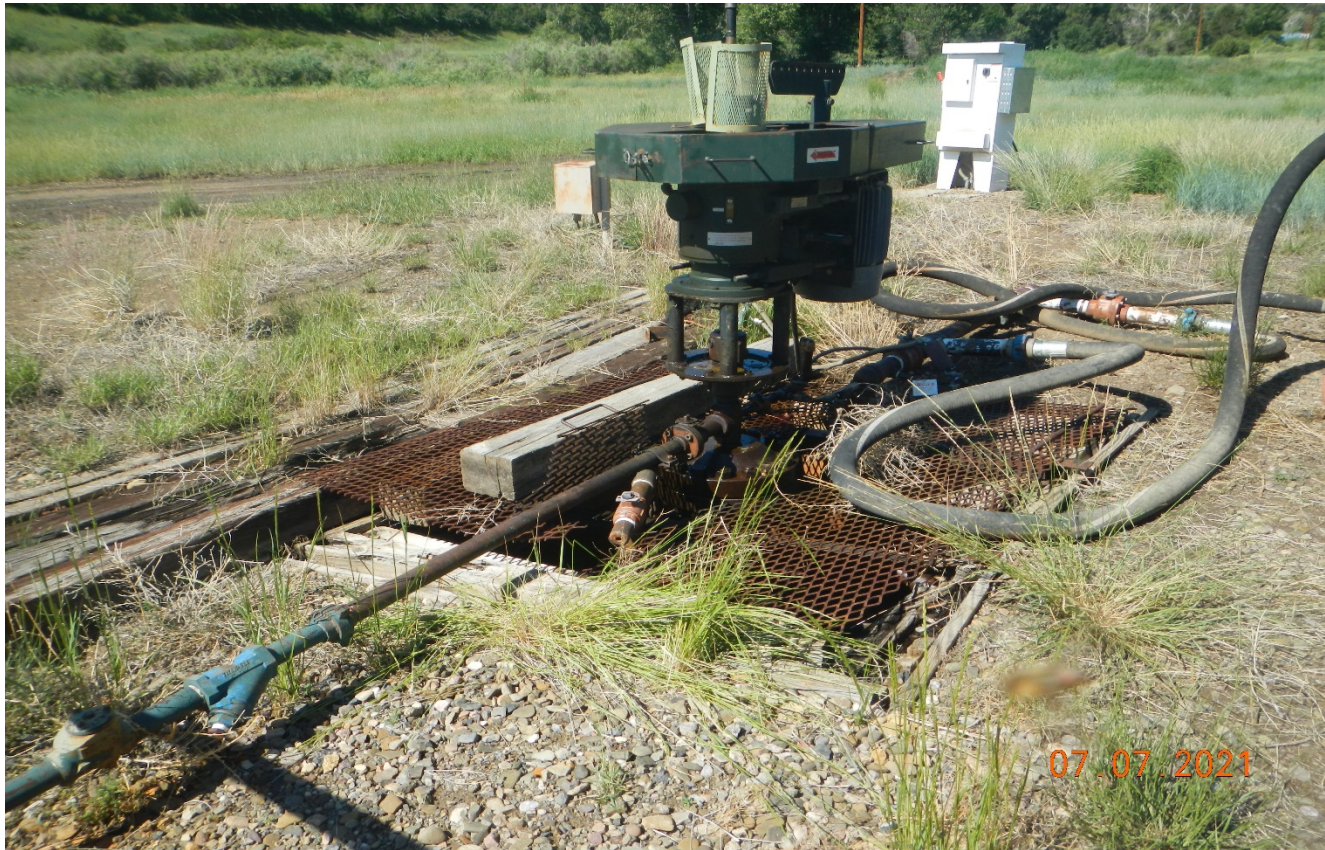
**Photo 7.** There is an opening where the steel grate is around the wellhead. This area needs to be covered to prevent wildlife entry. Previous corrective action was not performed.

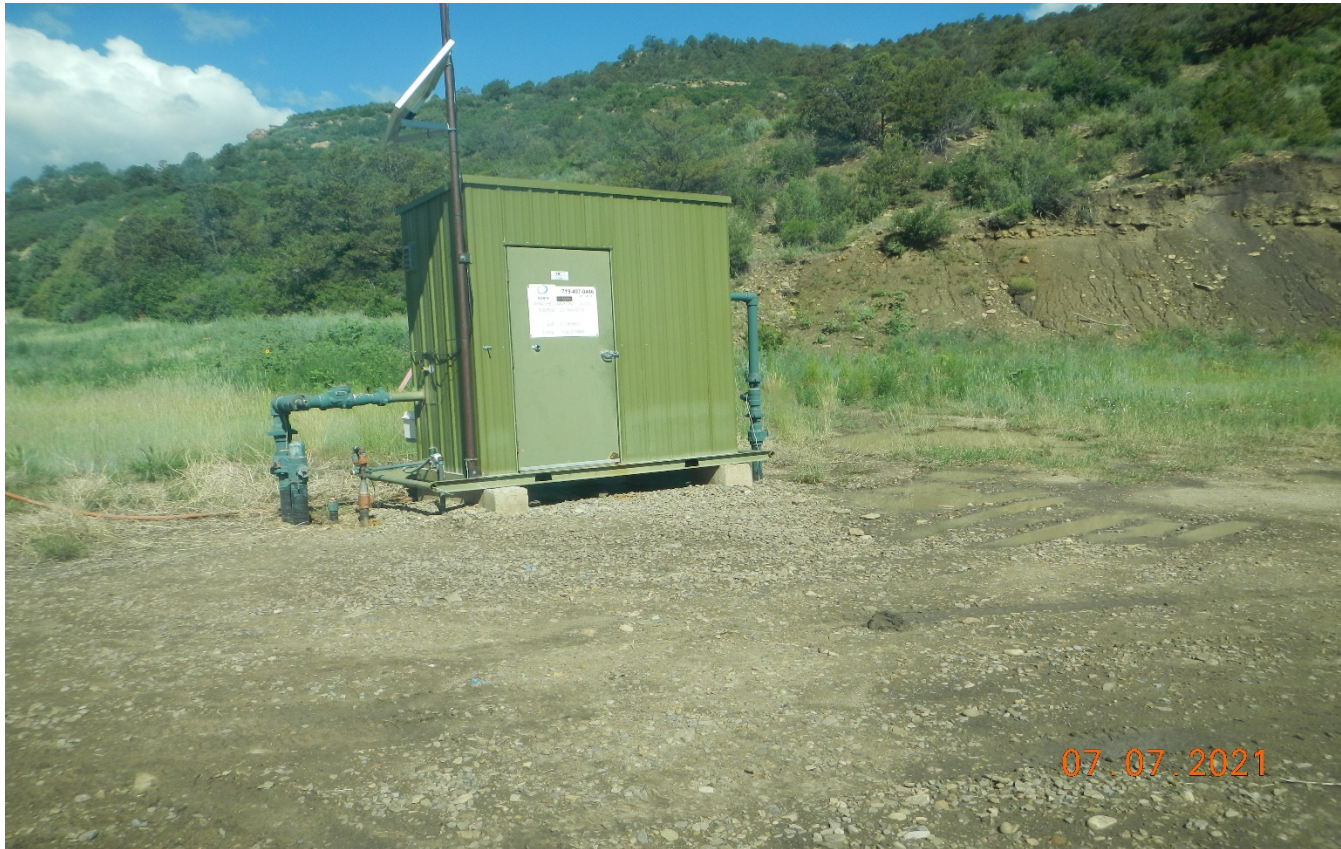
**Photo 8.** Sign posted on meter shed.

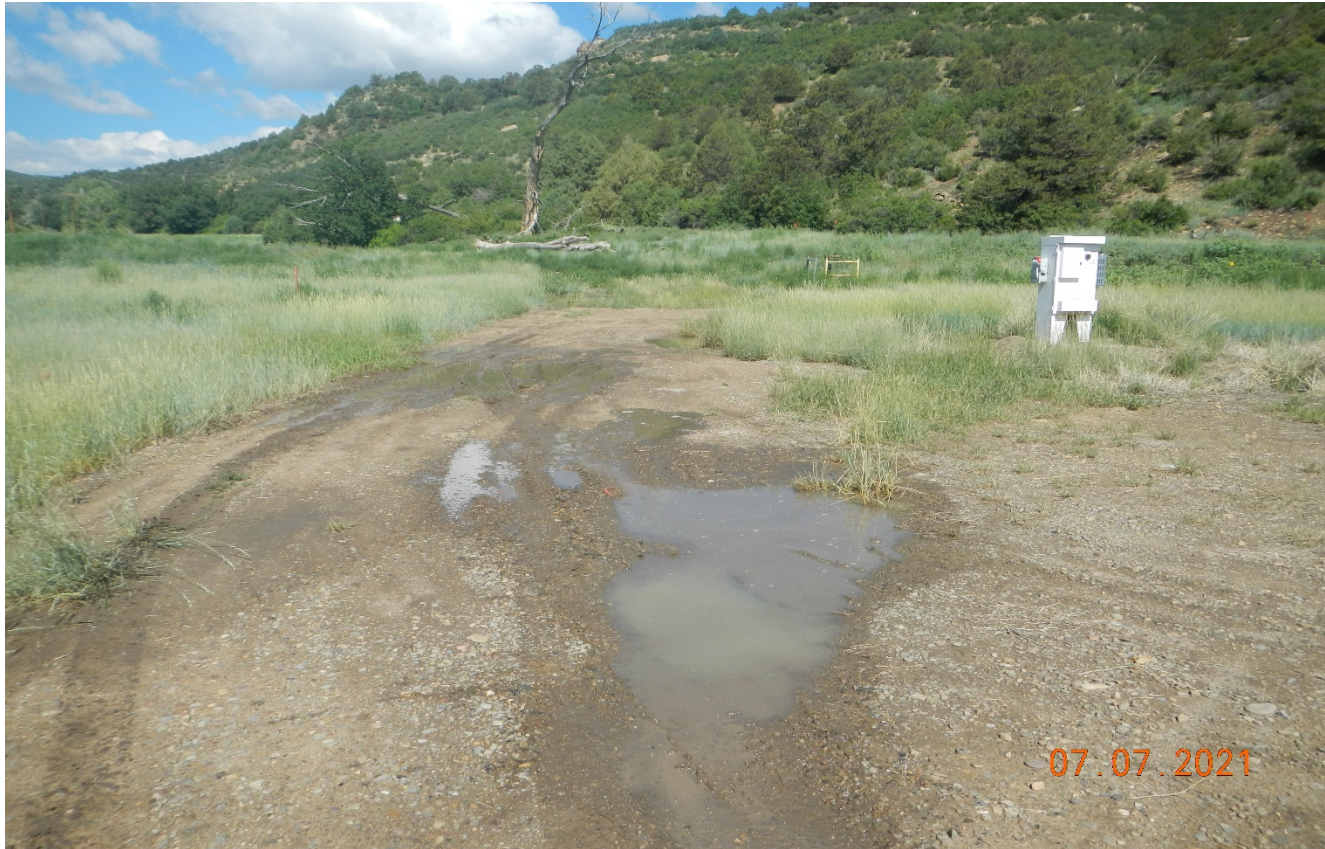
**Photo 10.** There does appear to be gravel toward the drip line. Additional gravel may be needed toward the drip line to prevent rutting.
