Inspection Photos
Operator: Arkoma
API: 067-05439
Date: 7/7/2021

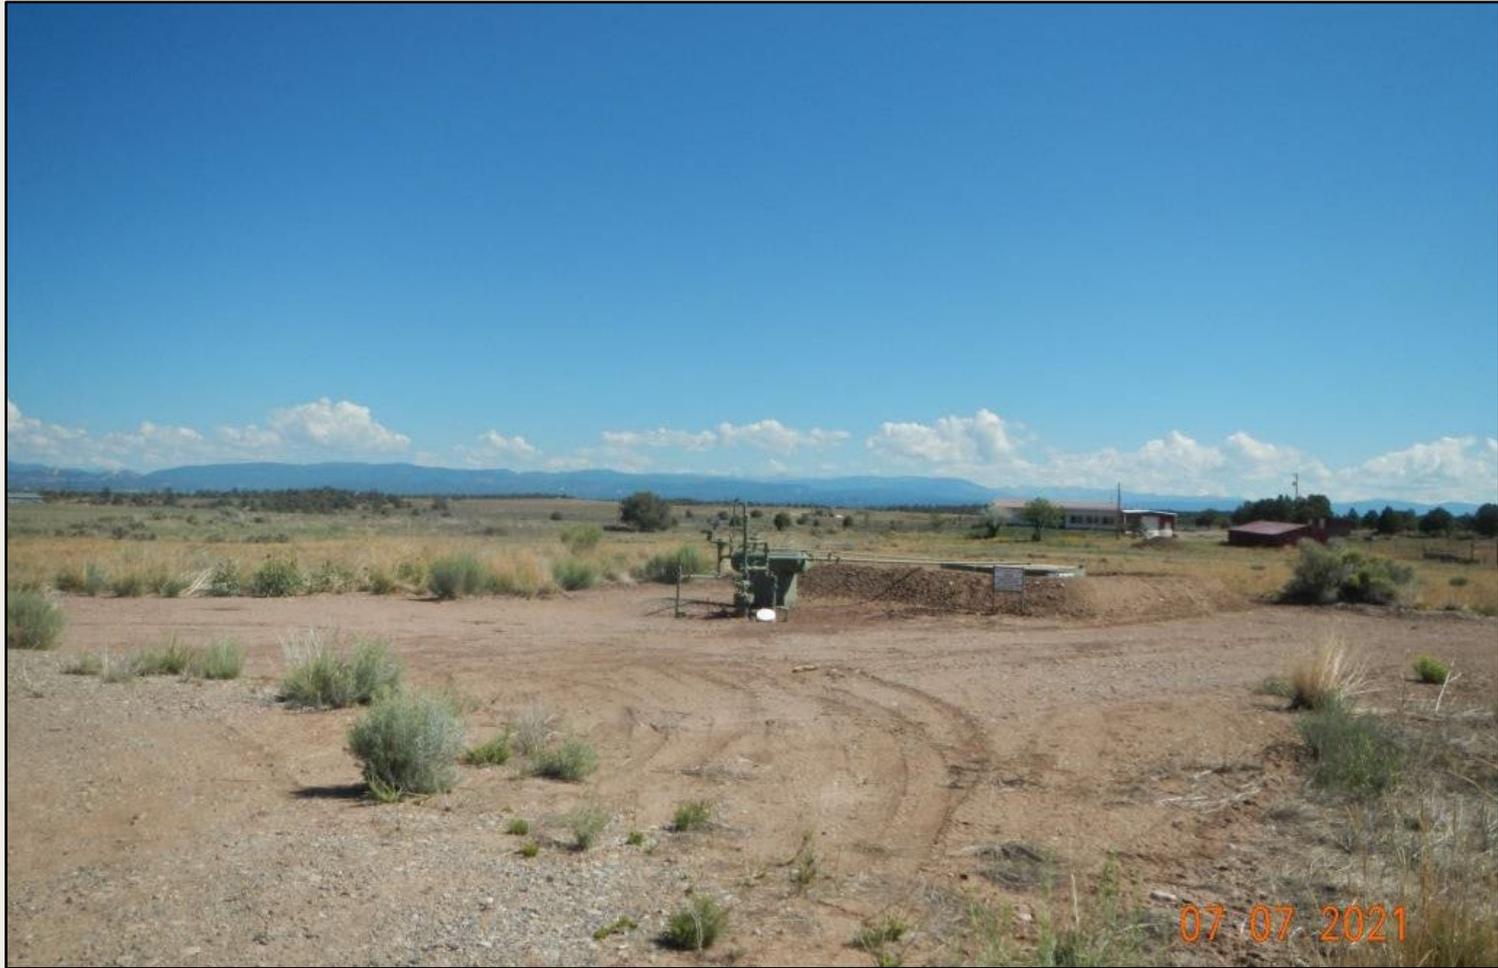
Photo 1. View the project area from the southern entrance facing center.

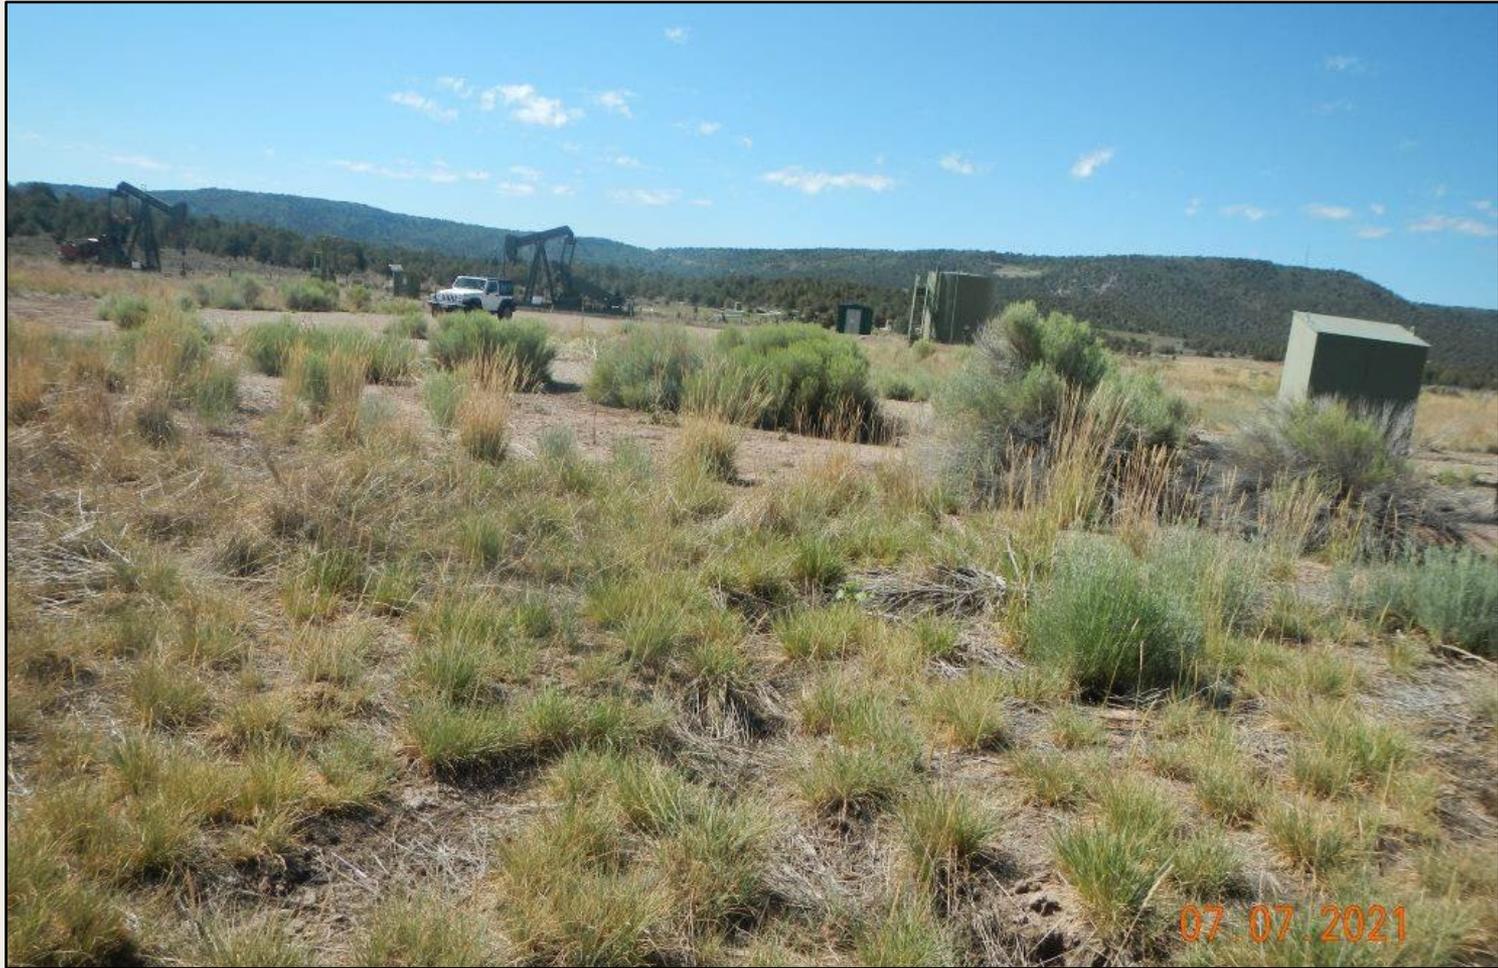
Photo 2. View of the northwestern project area from the northern corner facing southwestward. Revegetation is progressing with crested wheatgrass, western wheatgrass, and rubber rabbitbrush.

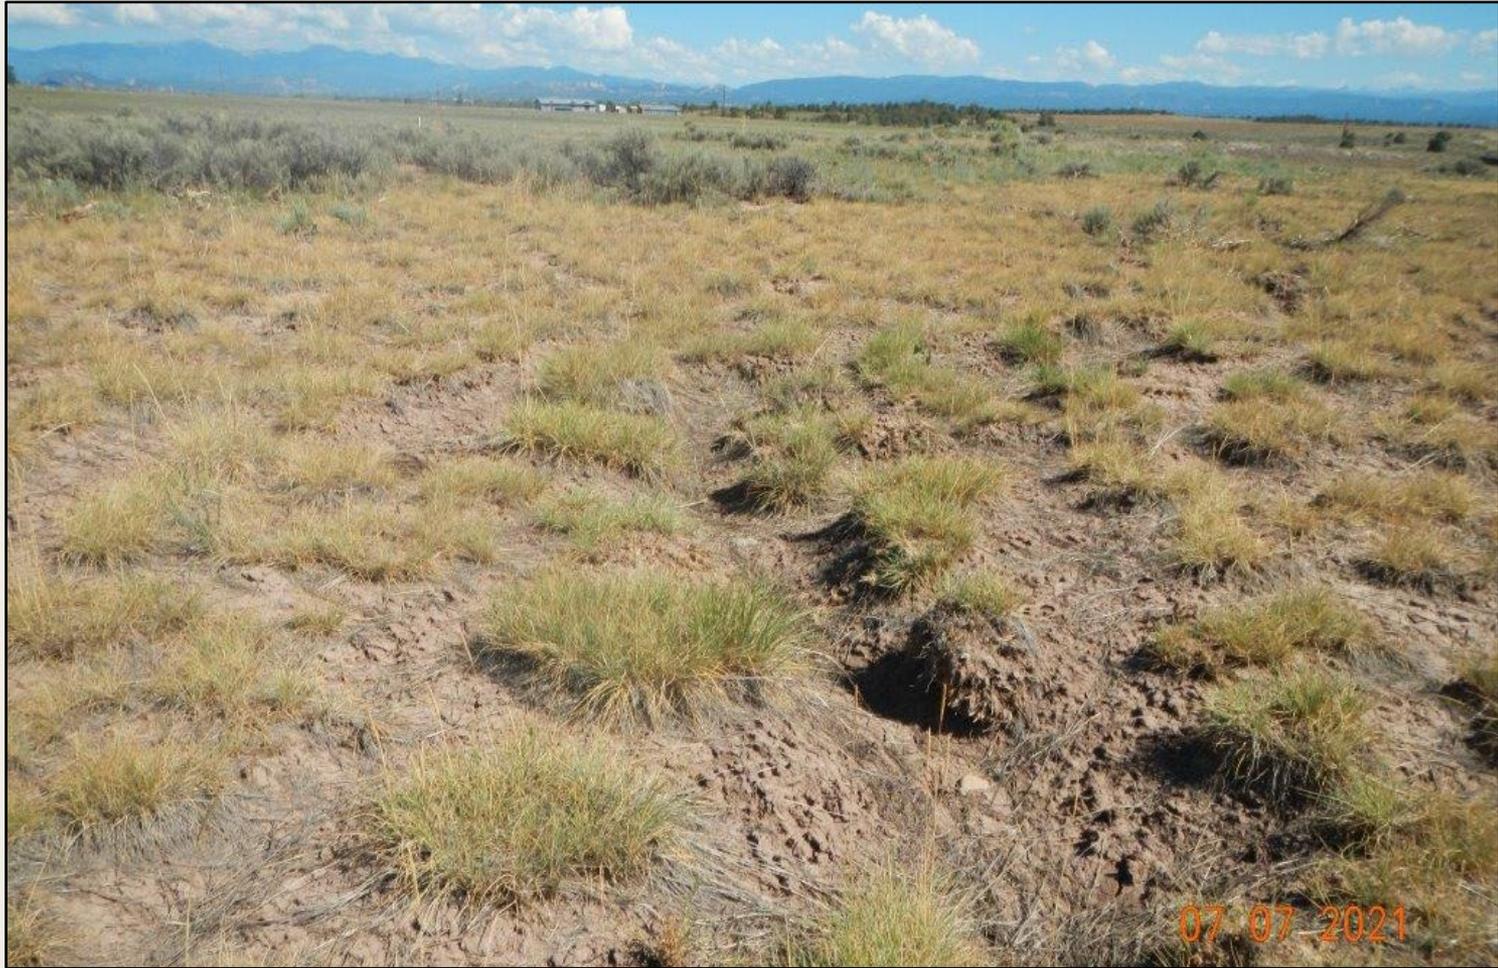
Photo 3. View of erosional channel forming (approximately 12 inches deep and 12 inches wide) within the northern project area.

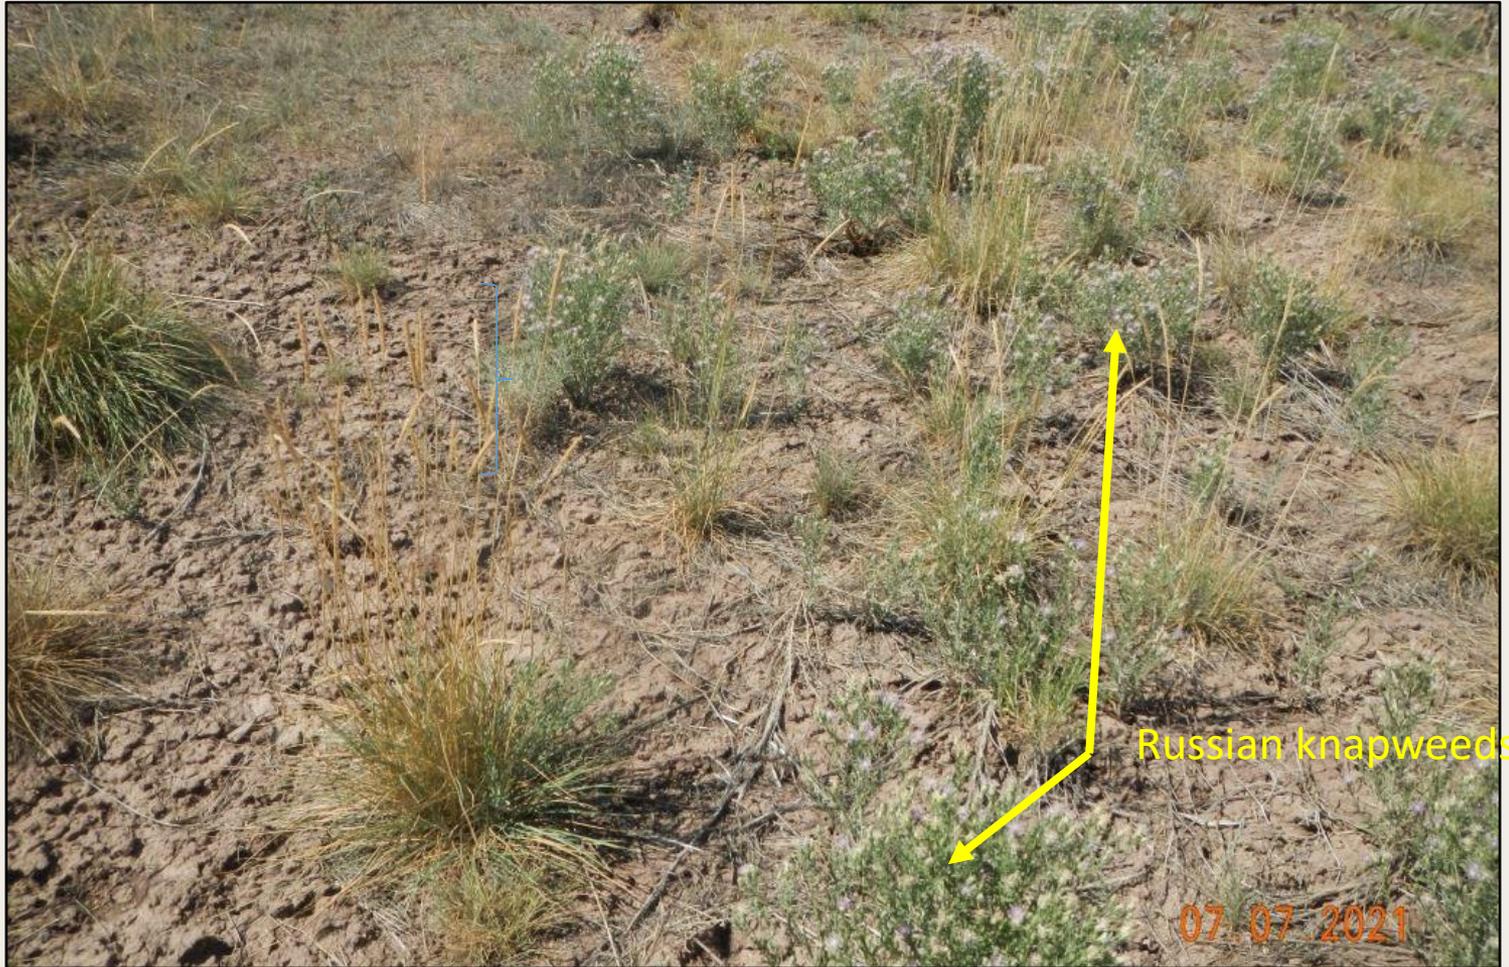
Photo 4. View of Russian knapweeds observed within the project are, need to be controlled. Approx. 200 individuals observed.

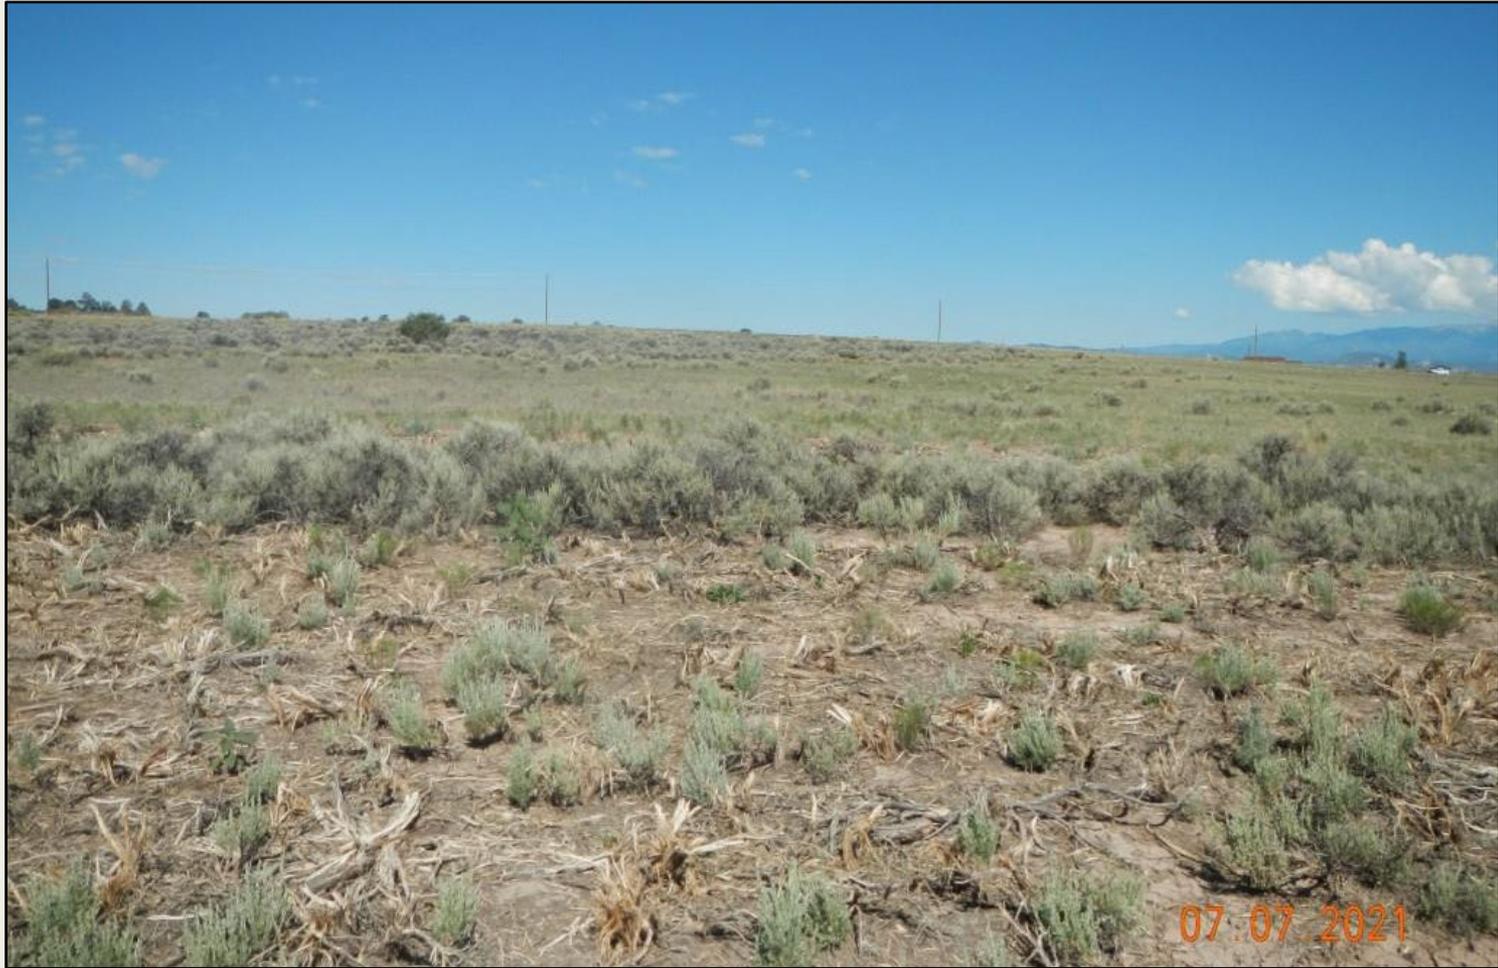
Photo 5. View the reference area comprised of sagebrush shrubland with understory of western whatgrass, squirreltail, and sunflowers.
