Inspection Photos  
Operator: Arkoma  
API: 067-08175  
Date: 7/7/2021

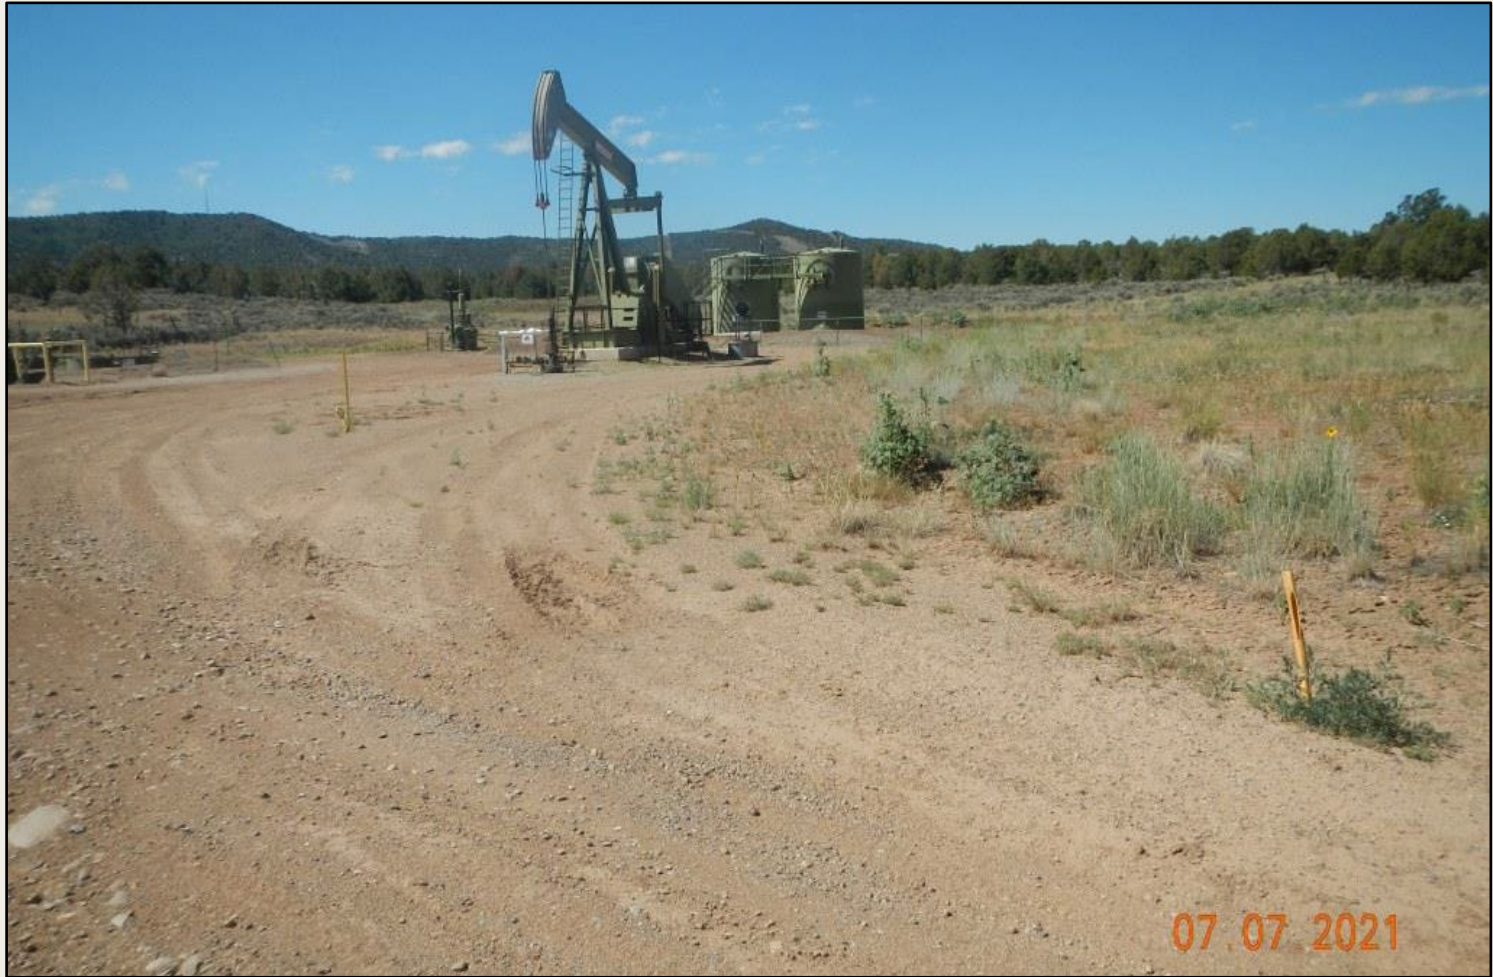
Photo 1. View the project area from the well pad entrance facing center.

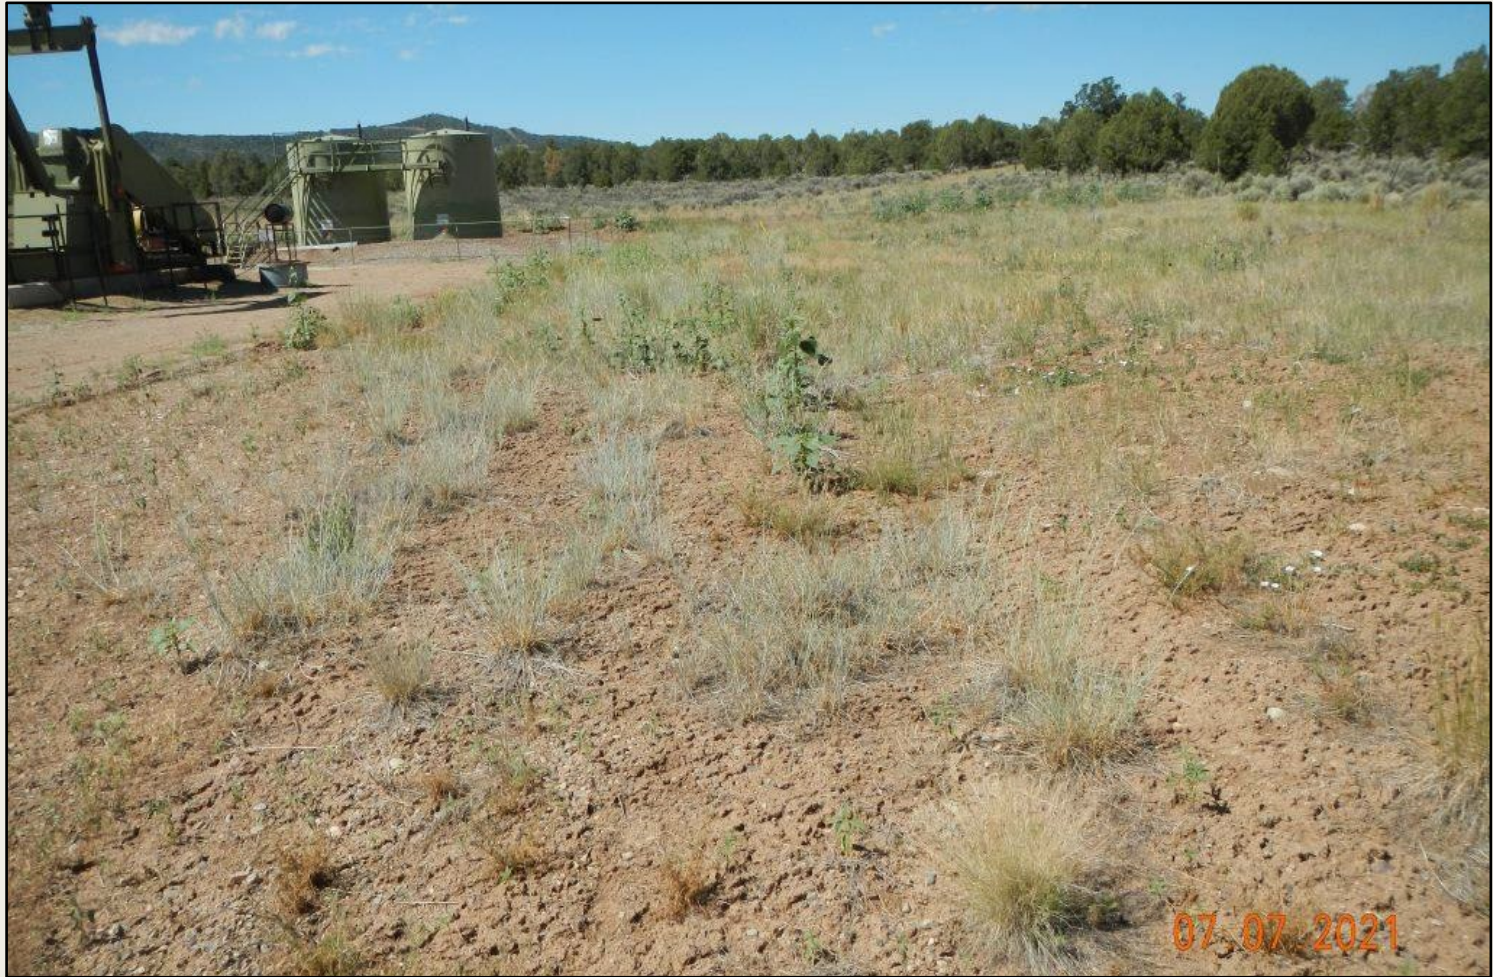
Photo 2. View of the western project area from the northwestern corner facing southward. Revegetation is progressing with crested wheatgrass, western wheatgrass, and sunflowers.

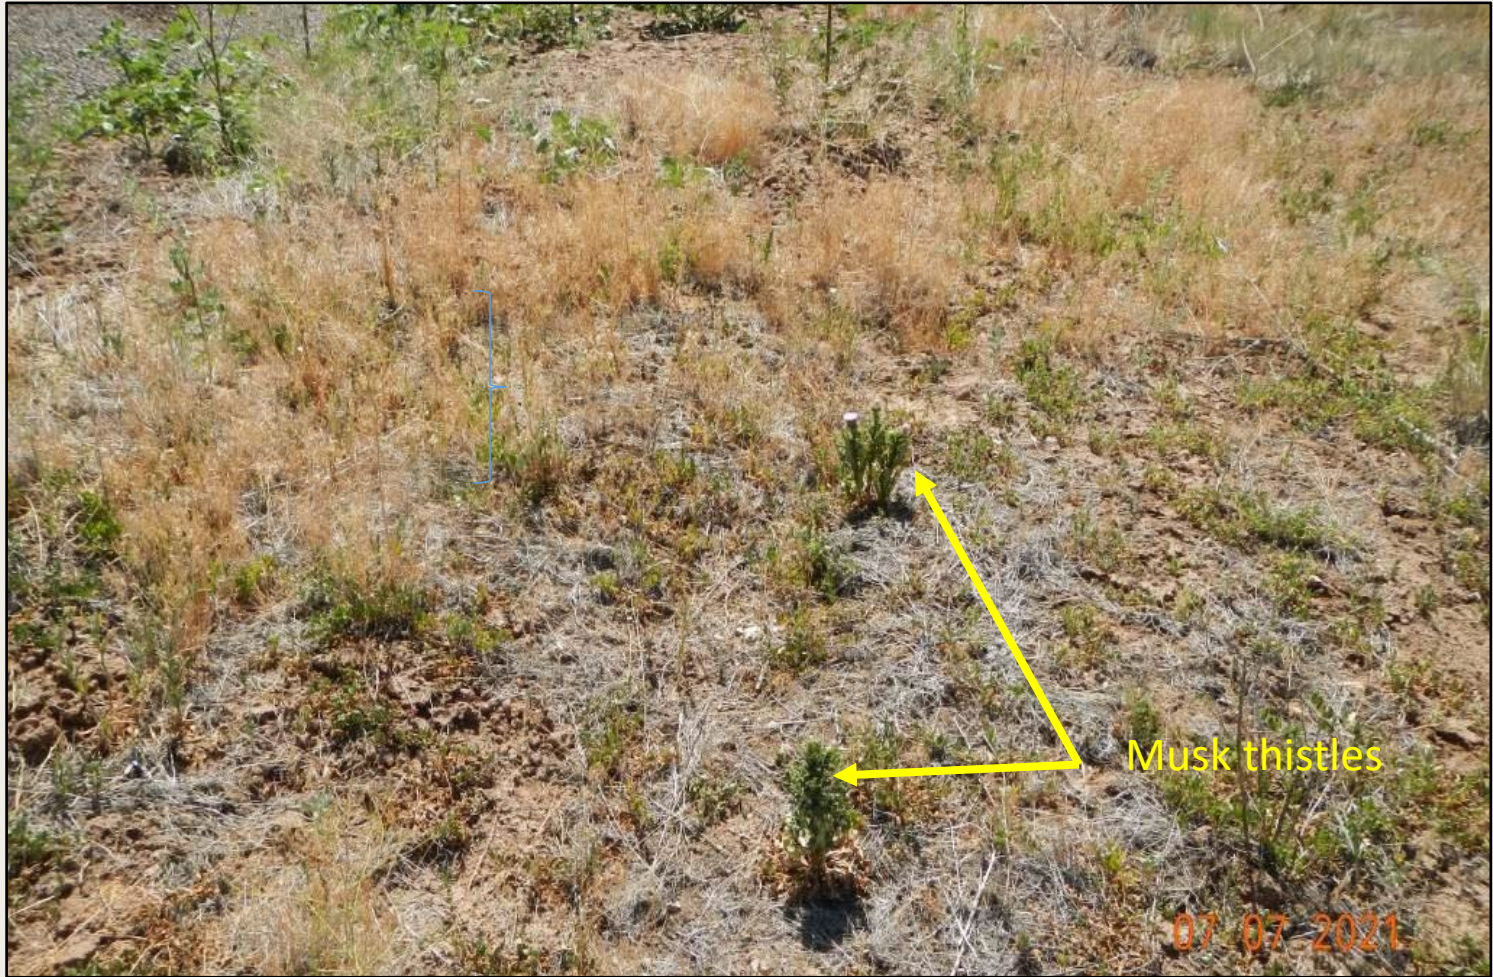
Photo 3. View of flowering musk thistles within the eastern project area. Approximately 200 individuals observed throughout the project area.

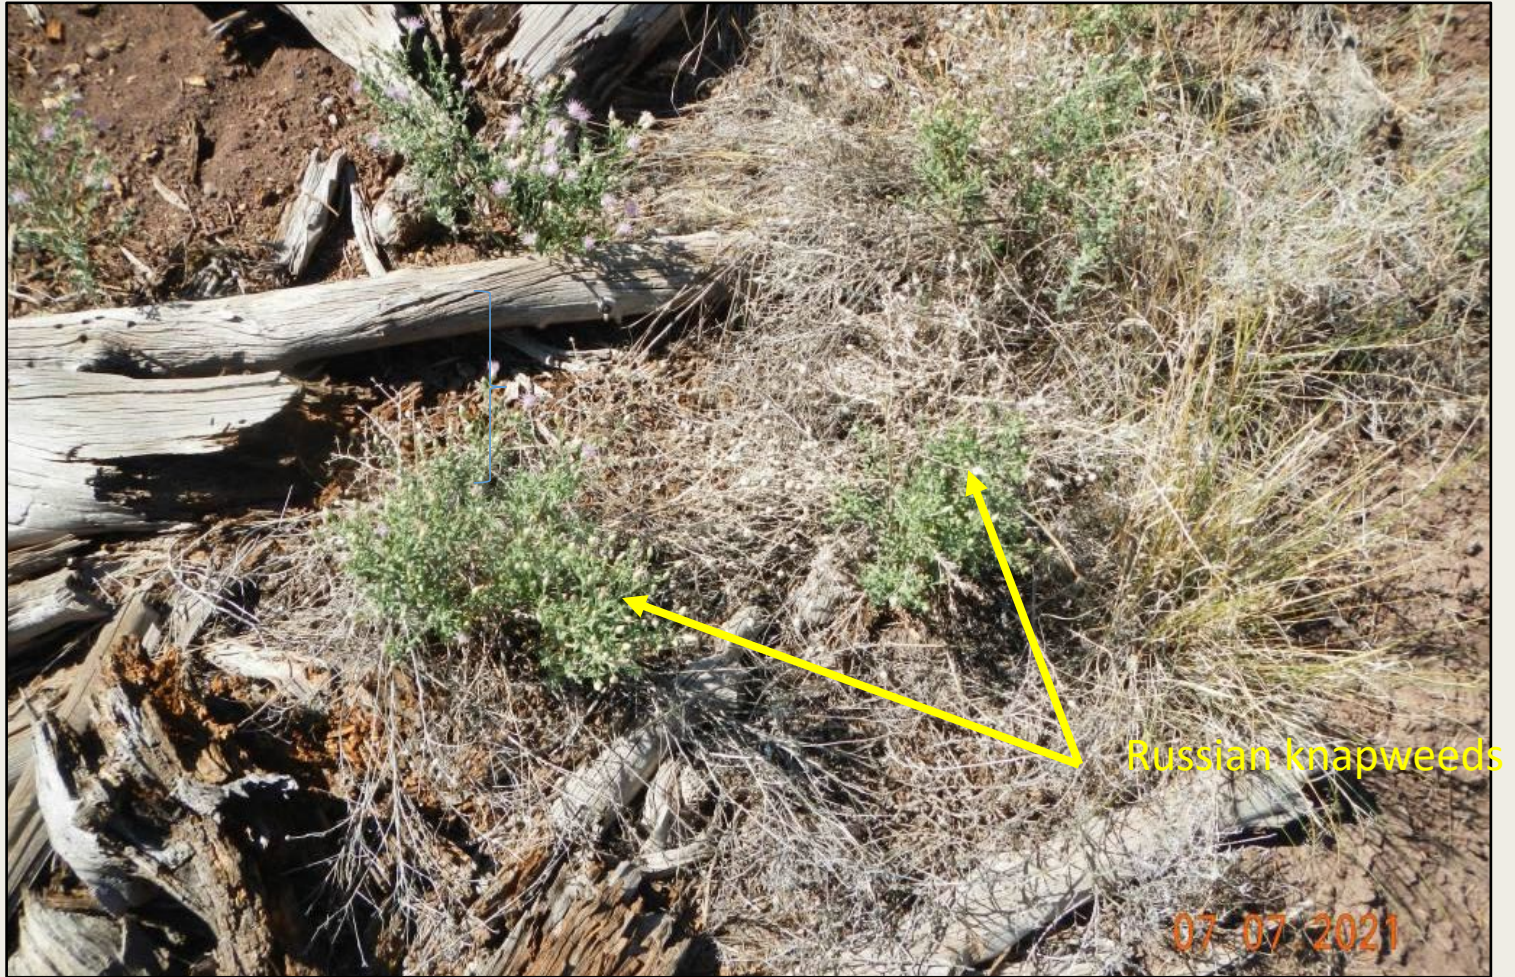
Photo 4. View of Russian knapweeds observed within the project area, need to be controlled. Approx. 200 individuals observed within the interim reclamation areas.

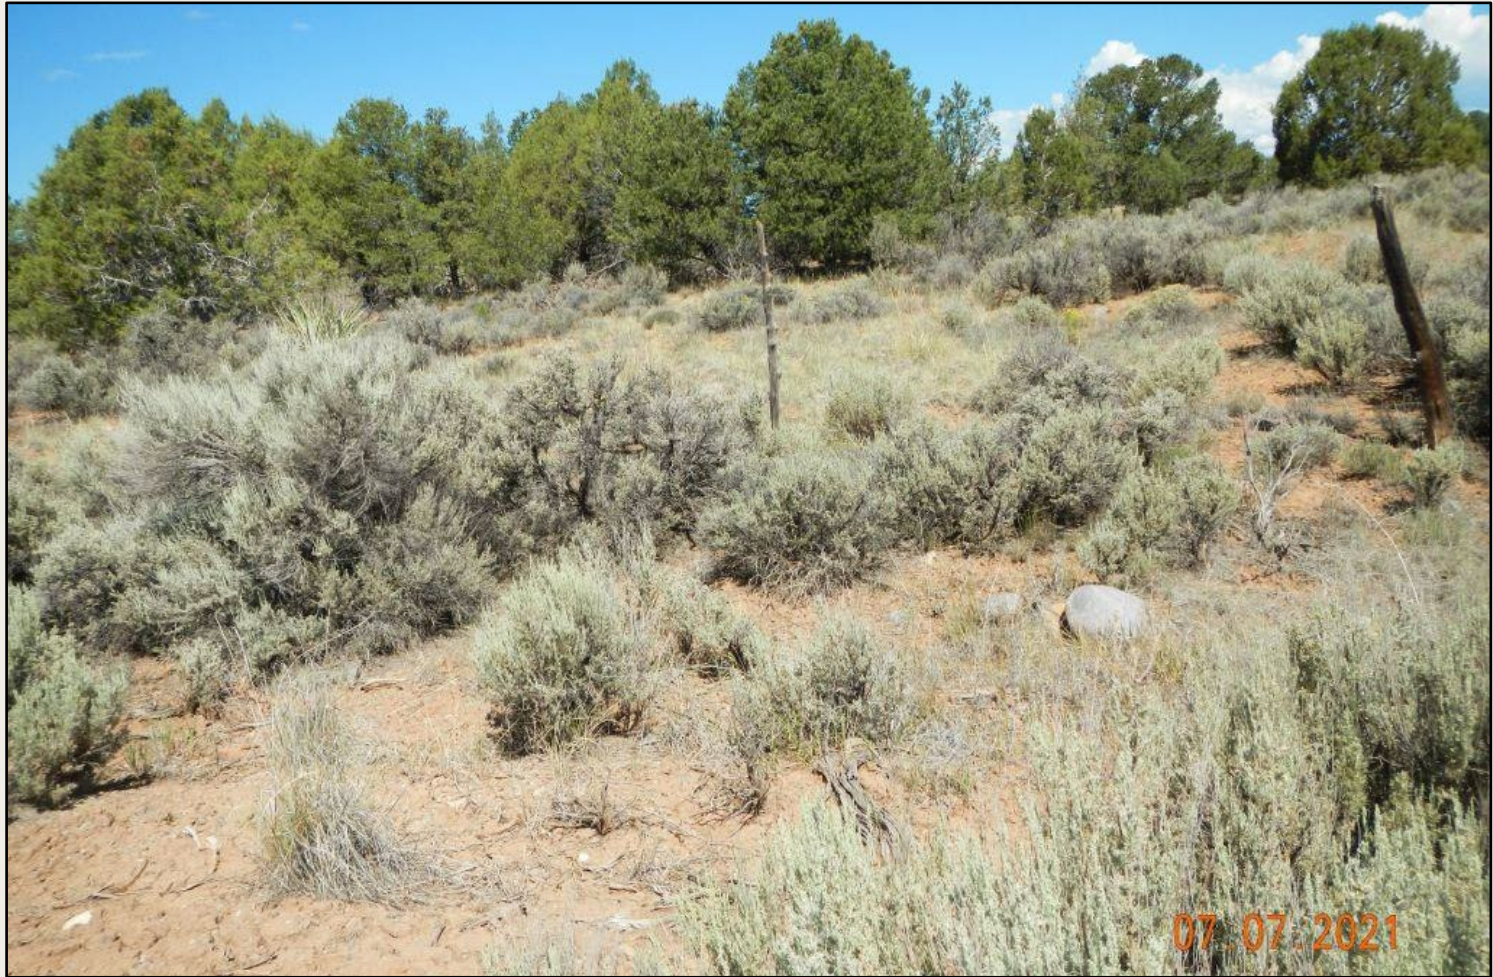
Photo 5. View the reference area comprised of sagebrush shrubland and pinyon/juniper woodland with understory of western whatgrass, squirreltail, buckwheat, and sunflowers.
