Inspection Photos

Operator: Advanced Wireless
API: 067-09317
Date: 7/7/2021

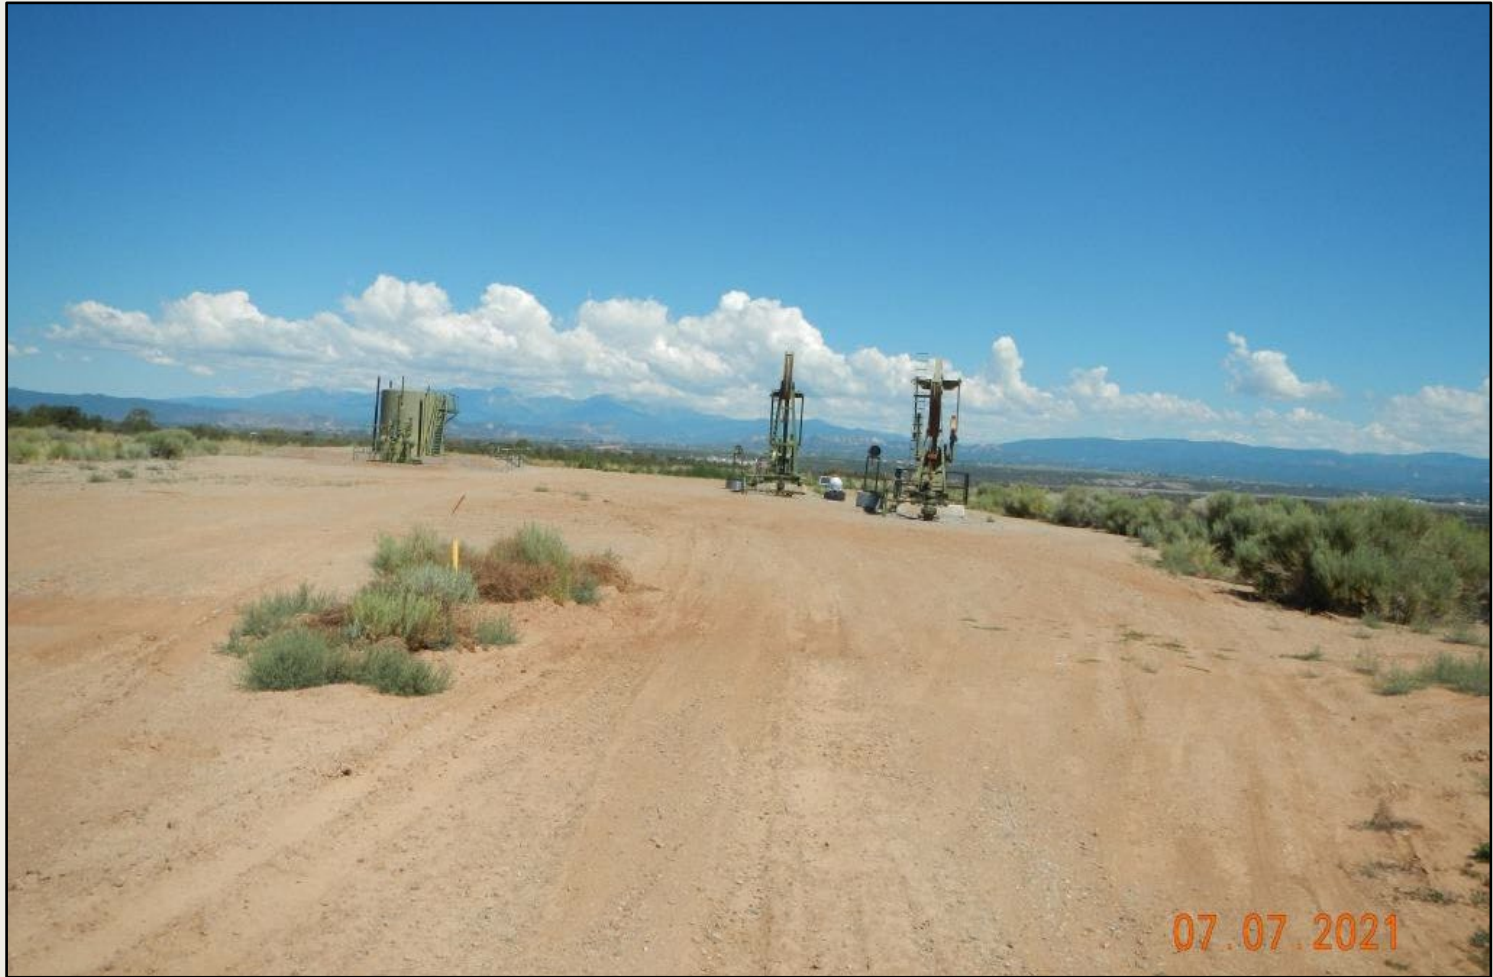
Photo 1. View the project area from the well pad entrance facing center.

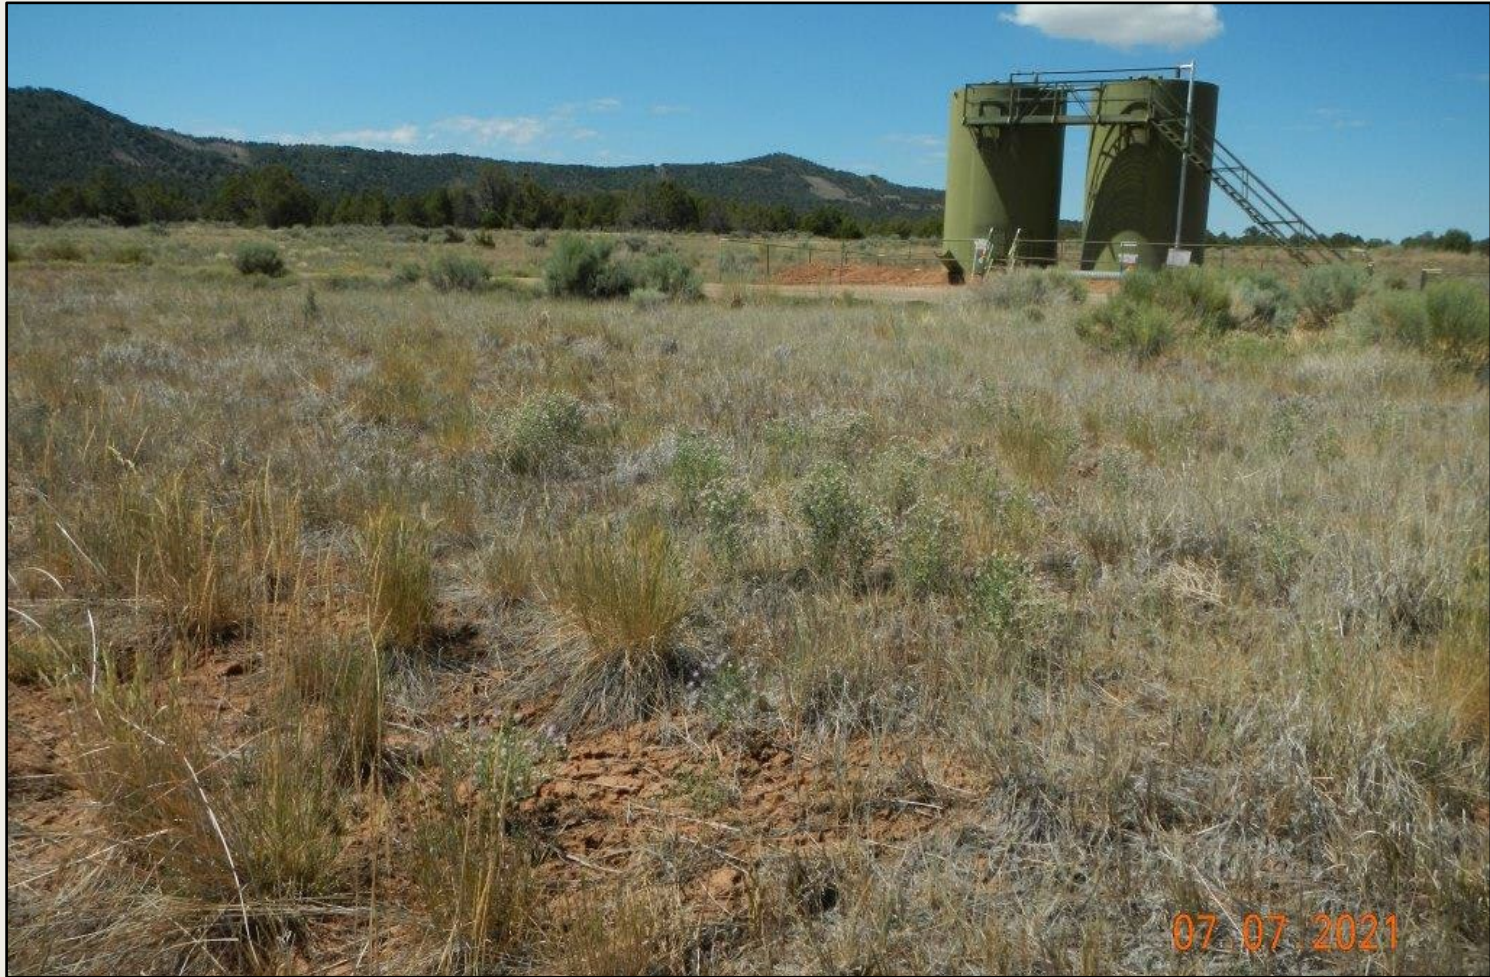
Photo 2. View of the eastern project area from the northeastern corner facing southward. Revegetation is progressing with crested wheatgrass, western wheatgrass, and smooth brome.

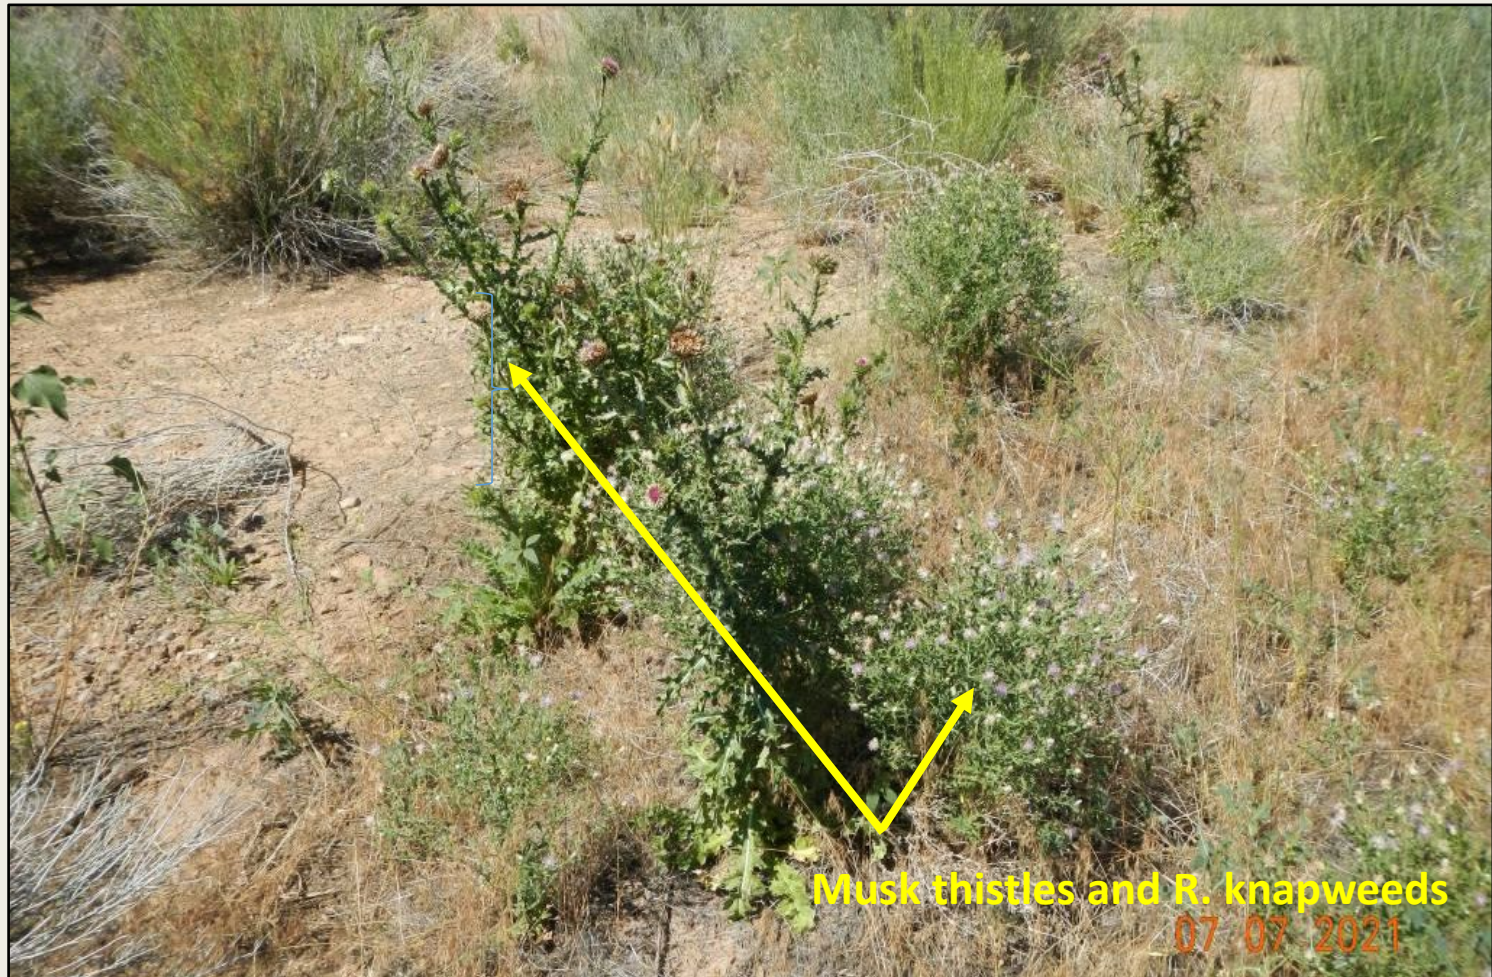
Photo 3. View of flowering musk thistles and Russian knapweeds within the project area. Approximately 300 individuals observed throughout the project area.

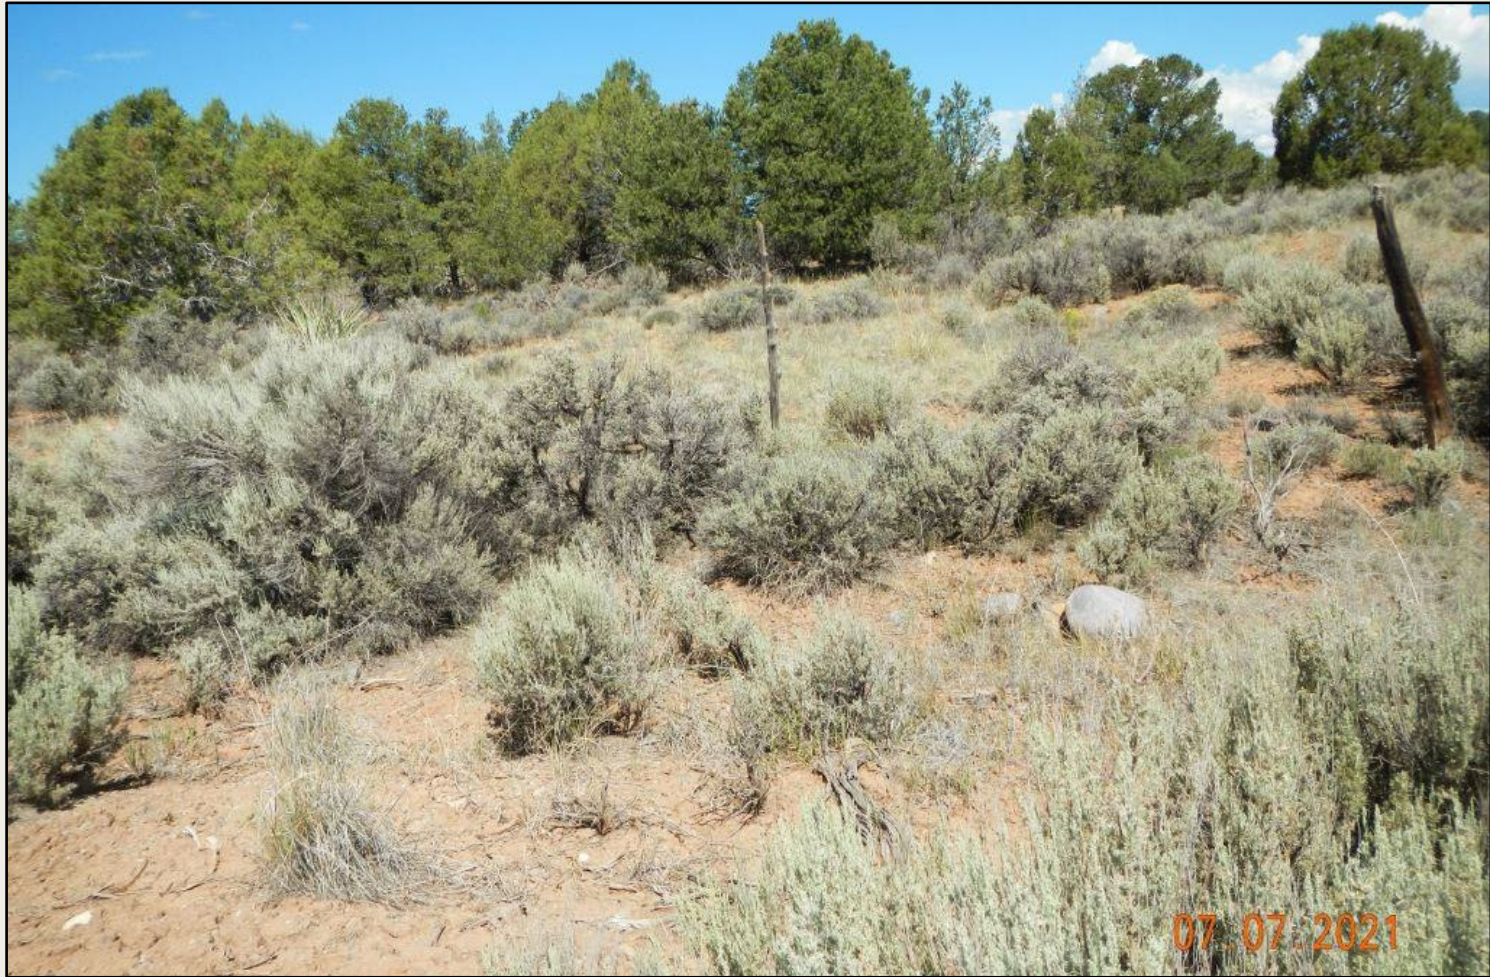
Photo 4. View the reference area comprised of sagebrush shrubland and pinyon/juniper woodland with understory of western whatgrass, squirreltail, buckwheat, and sunflowers.
