## Attachment B

<b>SITE NAME:</b> Booth 10 and 20-26							<b>DATE:</b> 6/30/2021	<b>REM. PROJECT #:</b> 18262	<b>WEATHER:</b> Sunny, 80s.		
<b>SITE DIRECTIONS:</b> .3 miles west on CR 76 from CR 47. Site is on directly south of CR 76.							<b>CLIENT:</b> PDC/Delbert Pace				
<b>LEGALS AND LAT/LONG:</b> 40.537532 -104.628950							<b>TASMAN PERSONNEL:</b> Tyler Murrel				
<b>SOIL TYPES:</b> Silty Sand - SM							<b>SURFACE GRADIENT:</b> Southeast				
<b>SOIL SAMPLING</b>							<b>FACILITY INFRASTRUCTURE</b>				
Date/Time	Soil Sample ID	PID (ppm)	Visual	Olfactory	Photo?	Grab or Lab Sample?	EQUIPMENT		Quantity		
							Above Ground Storage Tank (AST)		0		
6/30/2021 09:49	FLR01 @ 2.5'	0.4	No Staining	No Odor	Yes	Lab	Buried or Partially Buried Vessel		0		
6/30/2021 09:50	FLR02 @ 2.5'	0.2	No Staining	No Odor	Yes	Lab	Separator		0		
6/30/2021 09:51	WH02 @ 6'	0.0	No Staining	No Odor	Yes	Lab	Emission Control Device (ECD)		0

<b>SITE NAME:</b> Booth 10-26 Excavation							<b>DATE:</b> 7/1/2021	<b>REM. PROJECT #:</b> 18262	<b>WEATHER:</b> 80's Sunny
<b>SITE DIRECTIONS:</b> CR47/76, 0.1 m W, S into							<b>CLIENT:</b> PDC - Delbert Pace		
<b>LEGALS AND LAT/LONG:</b> 40.409690, -104.627047

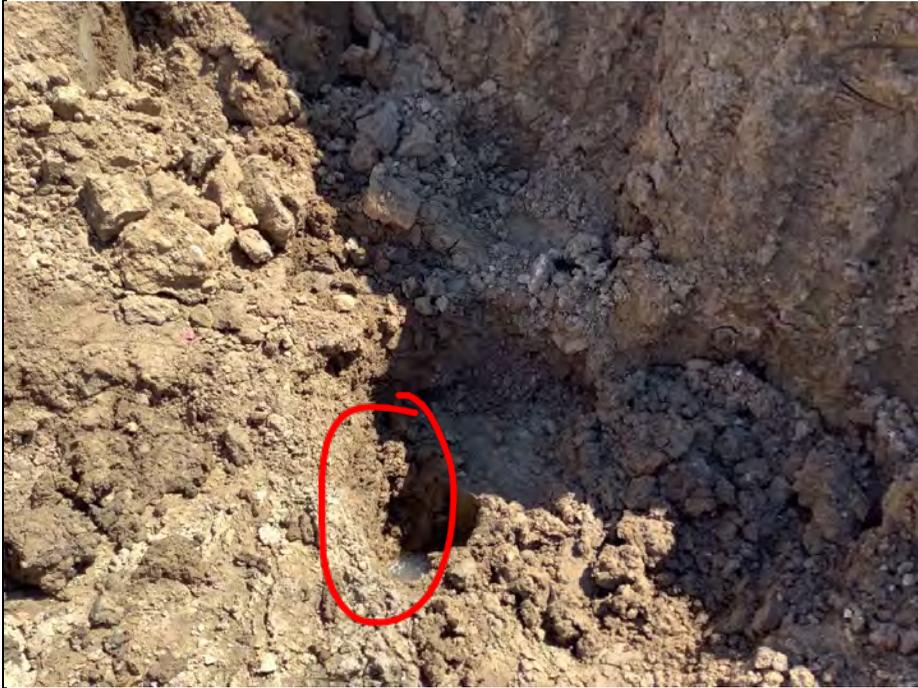
Material:	Volume:	Contents:	Material:	Volume:	Contents:
Notes/Conditions: WH01 @ 6'			Notes/Conditions: FLR01 @ 2.5' FLR01 @ 4' Water is from flushing of flow line. No ground water coming up in any other parts of excavation.

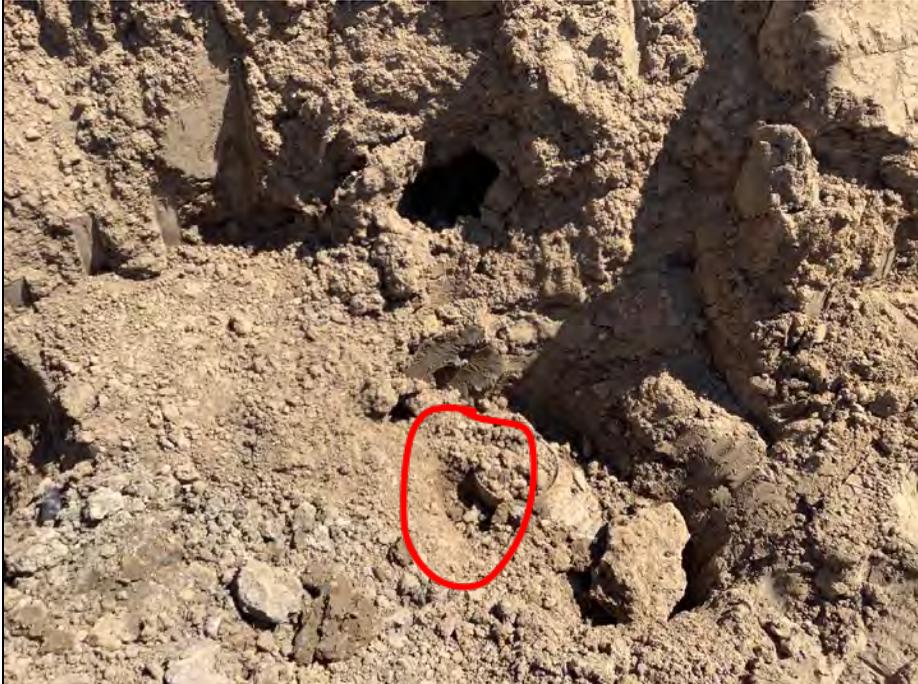
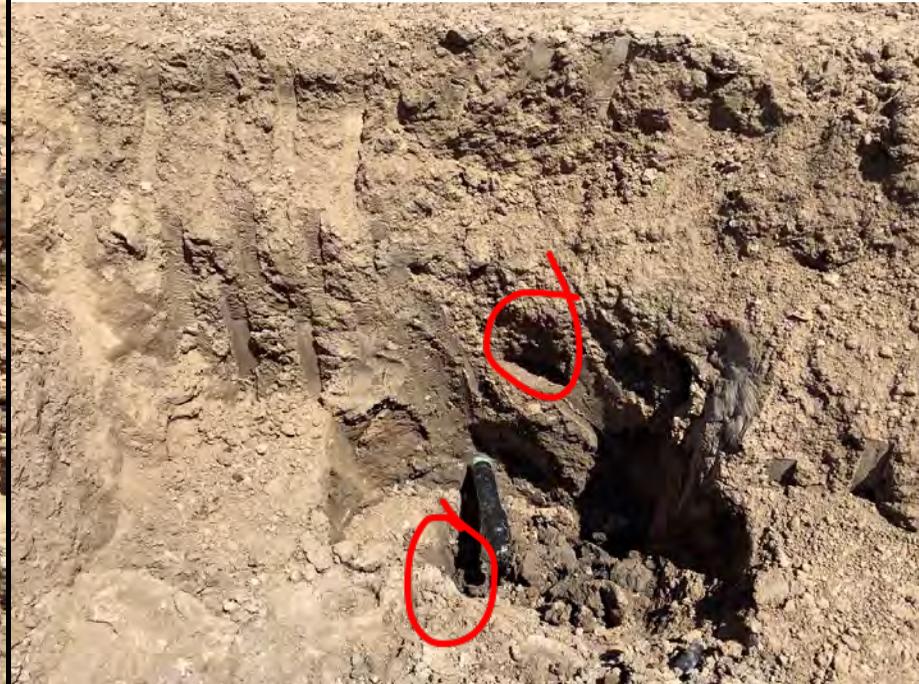
<b>Equipment ID:</b>		<b>Equipment Type:</b>		<b>Equipment ID:</b>		<b>Equipment Type:</b>	
<b>Material:</b>	<b>Volume:</b>	<b>Contents:</b>		<b>Material:</b>	<b>Volume:</b>	<b>Contents:</b>	
<b>Notes/Conditions:</b> WH02 @ 6'				<b>Notes/Conditions:</b> FLR02 @ 2.5' FLR02 @ 4'

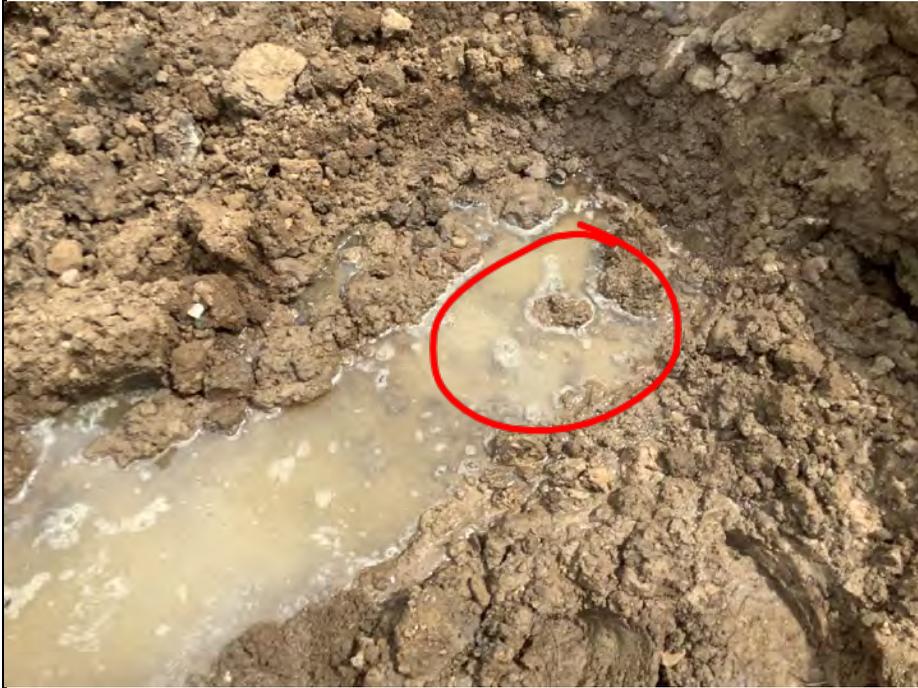
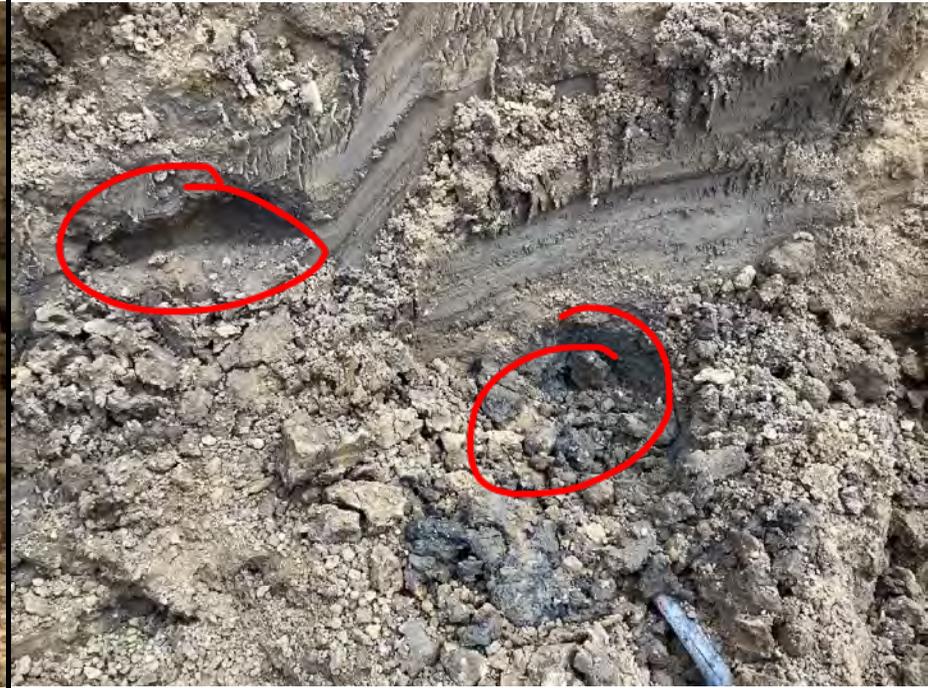
<b>Material:</b>	<b>Volume:</b>	<b>Contents:</b>	<b>Material:</b>	<b>Volume:</b>	<b>Contents:</b>
<b>Notes/Conditions:</b> SS01@6.5'			<b>Notes/Conditions:</b> SS02@4', SS03@6.5'

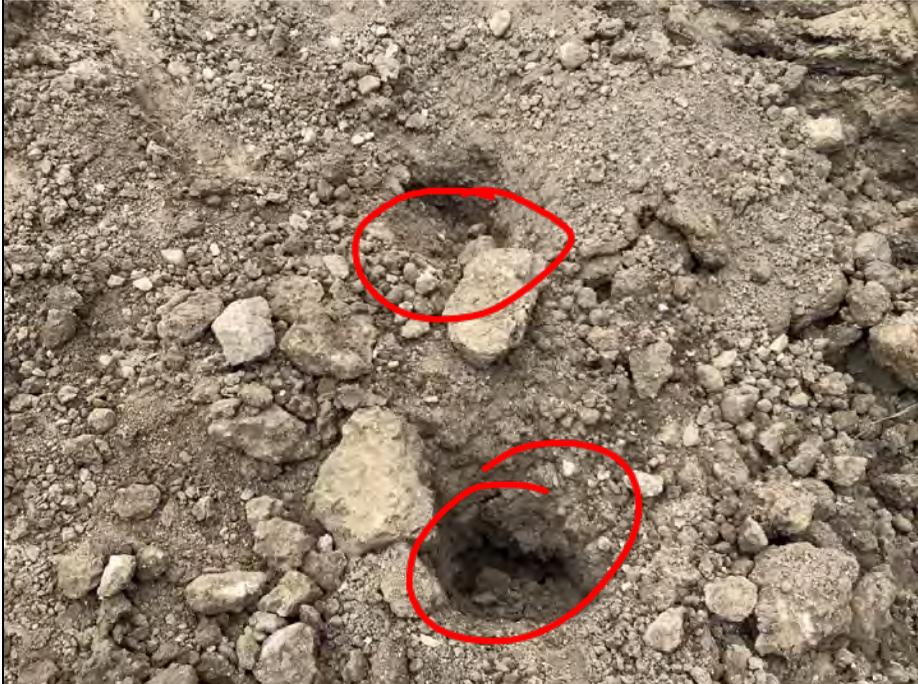
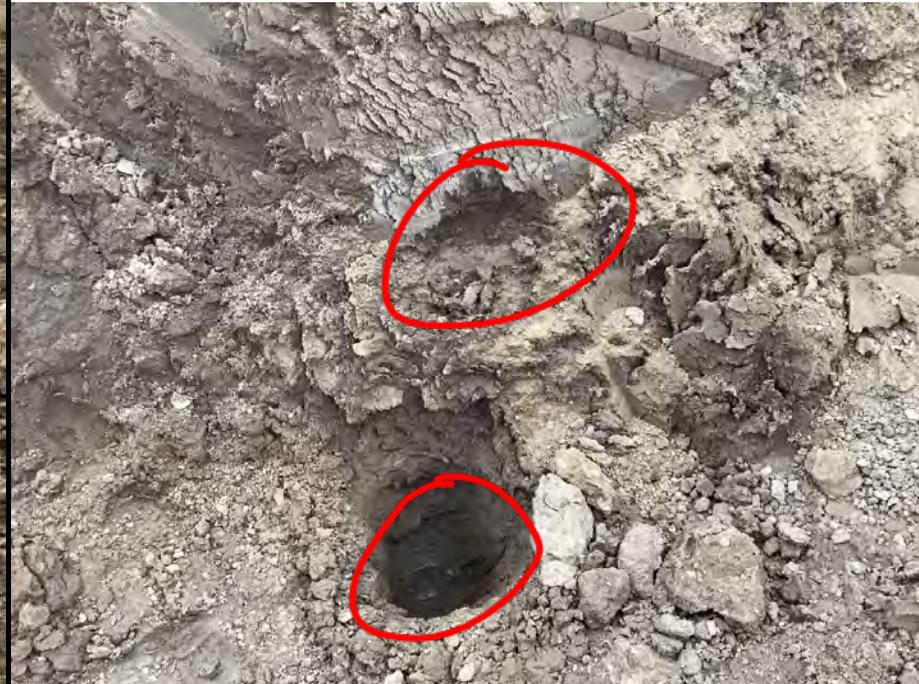
Material:	Volume:	Contents:	Material:	Volume:	Contents:
Notes/Conditions: SS04@4', SS05@6.5'			Notes/Conditions: SS06@4', SS07@6.5'

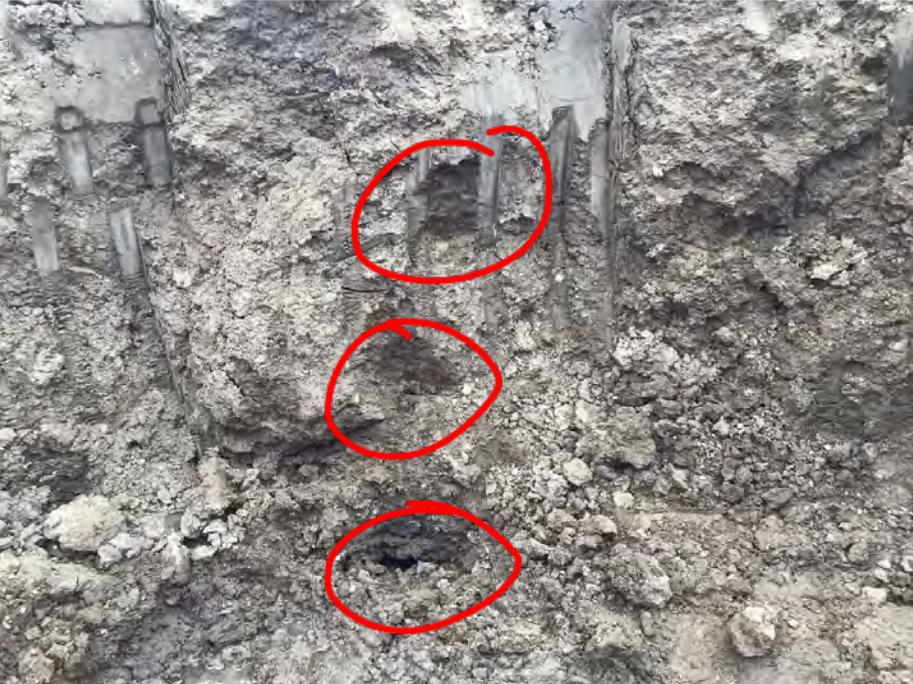
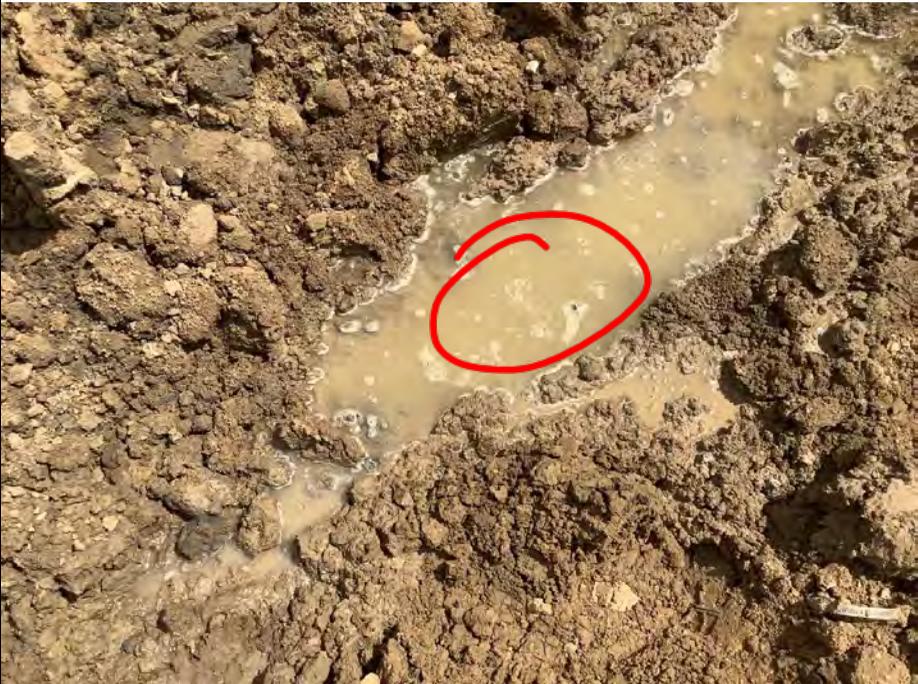
9.5		
							Disposal Facility: WM - Ault		
							Groundwater Recovery		
							DATE GW ENCOUNTERED: 7/1/2021	DEPTH: 6'	
							GROUNDWATER IN CONTACT WITH IMPACTED SOIL? Groundwater in contact with soil impacts.		
							LNAPL OR SHEEN OBSERVED ON GW? None Observed on GW.		
GROUNDWATER SAMPLING							Date	BBLs	
Date/Time	Groundwater Sample ID	Depth Collected	Turbid?	Sheen?	Odor?	Photo?			
7/1/2021 11:05	GW01	6	Clear	None	None	Yes			
							Total Removed		
							0		
							Disposal Facility:

Material:	Volume:	Contents:	Material:	Volume:	Contents:
Notes/Conditions: SS10@2.5', SS08@4', SS09@6.5'			Notes/Conditions: GW01
