Inspection Photos  
Operator: Simcoe  
API: 067-06651  
Date: 7/9/2021

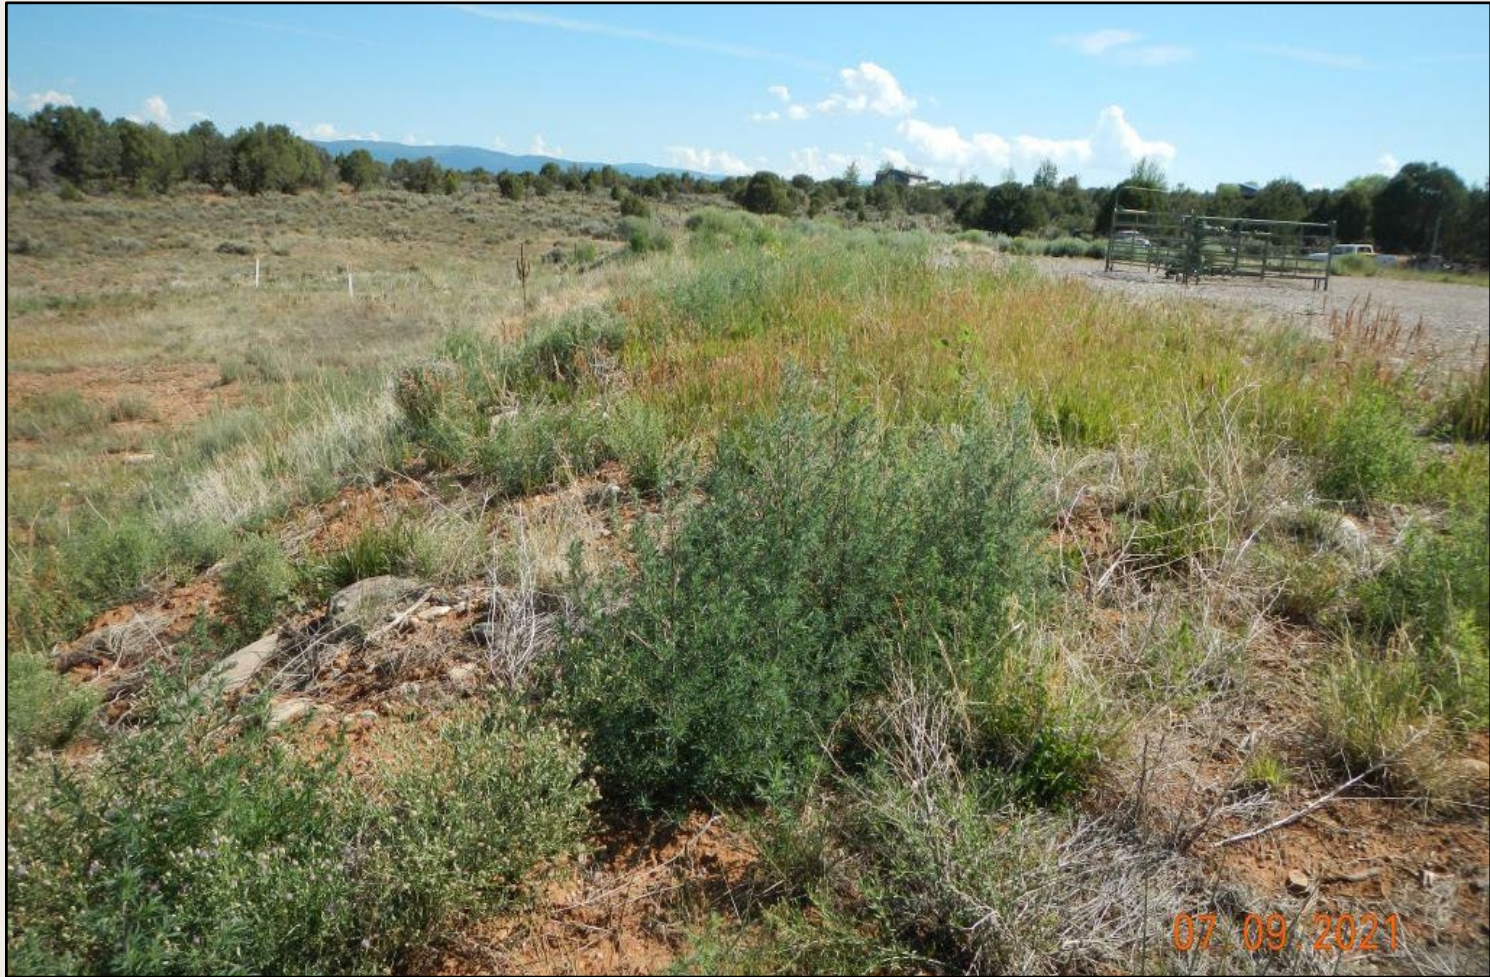
Photo 2. View of the western project area from the southwestern corner facing westward. Revegetation remains weedy and weeds continue to need management. Desirable species include sand dropseed, western wheatgrass, and smooth brome.

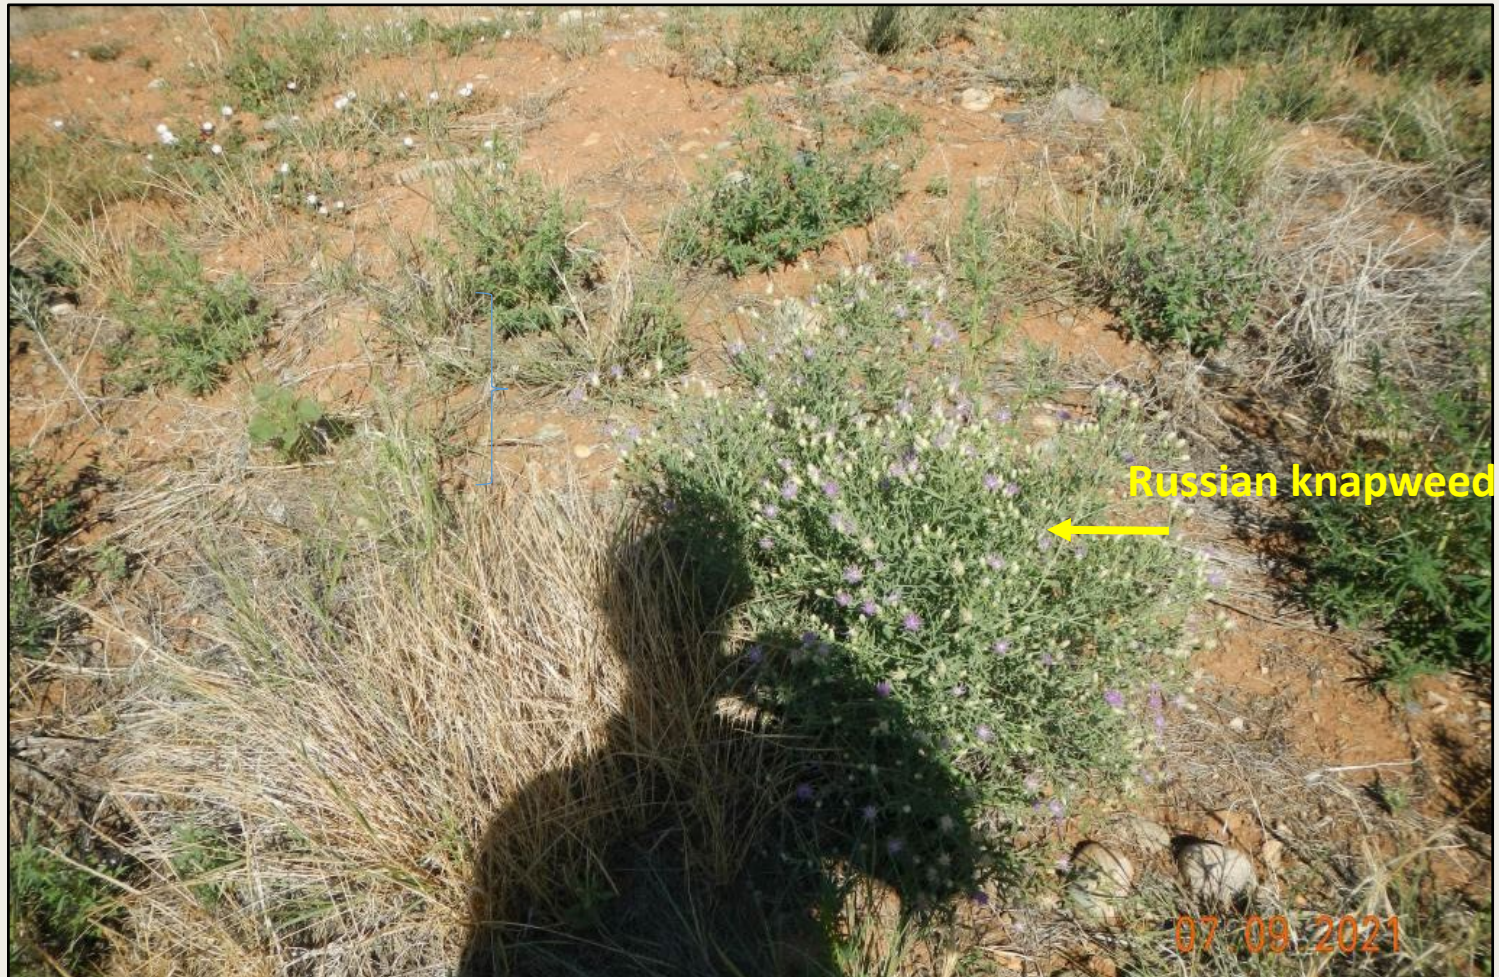
Photo 3. View the reference area comprised of open grass field with western wheatgrass, crested wheatgrass, and smooth brome.

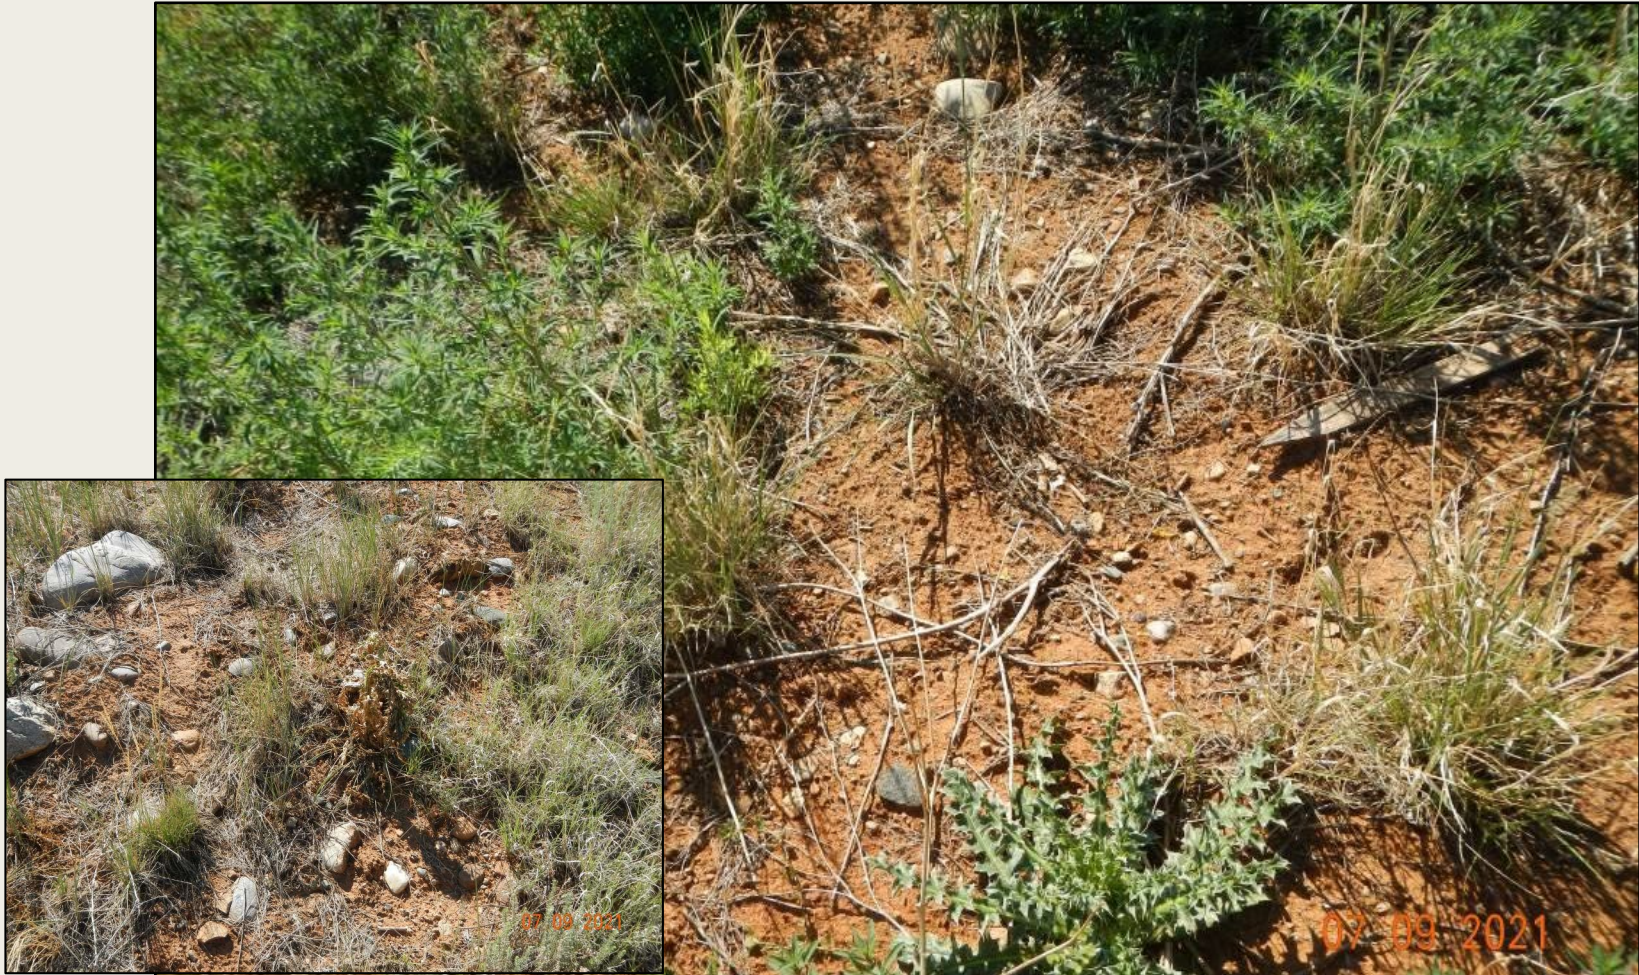
Photo 4. View of musk thistles within the project area, largely treated (inset) however untreated individuals remain.

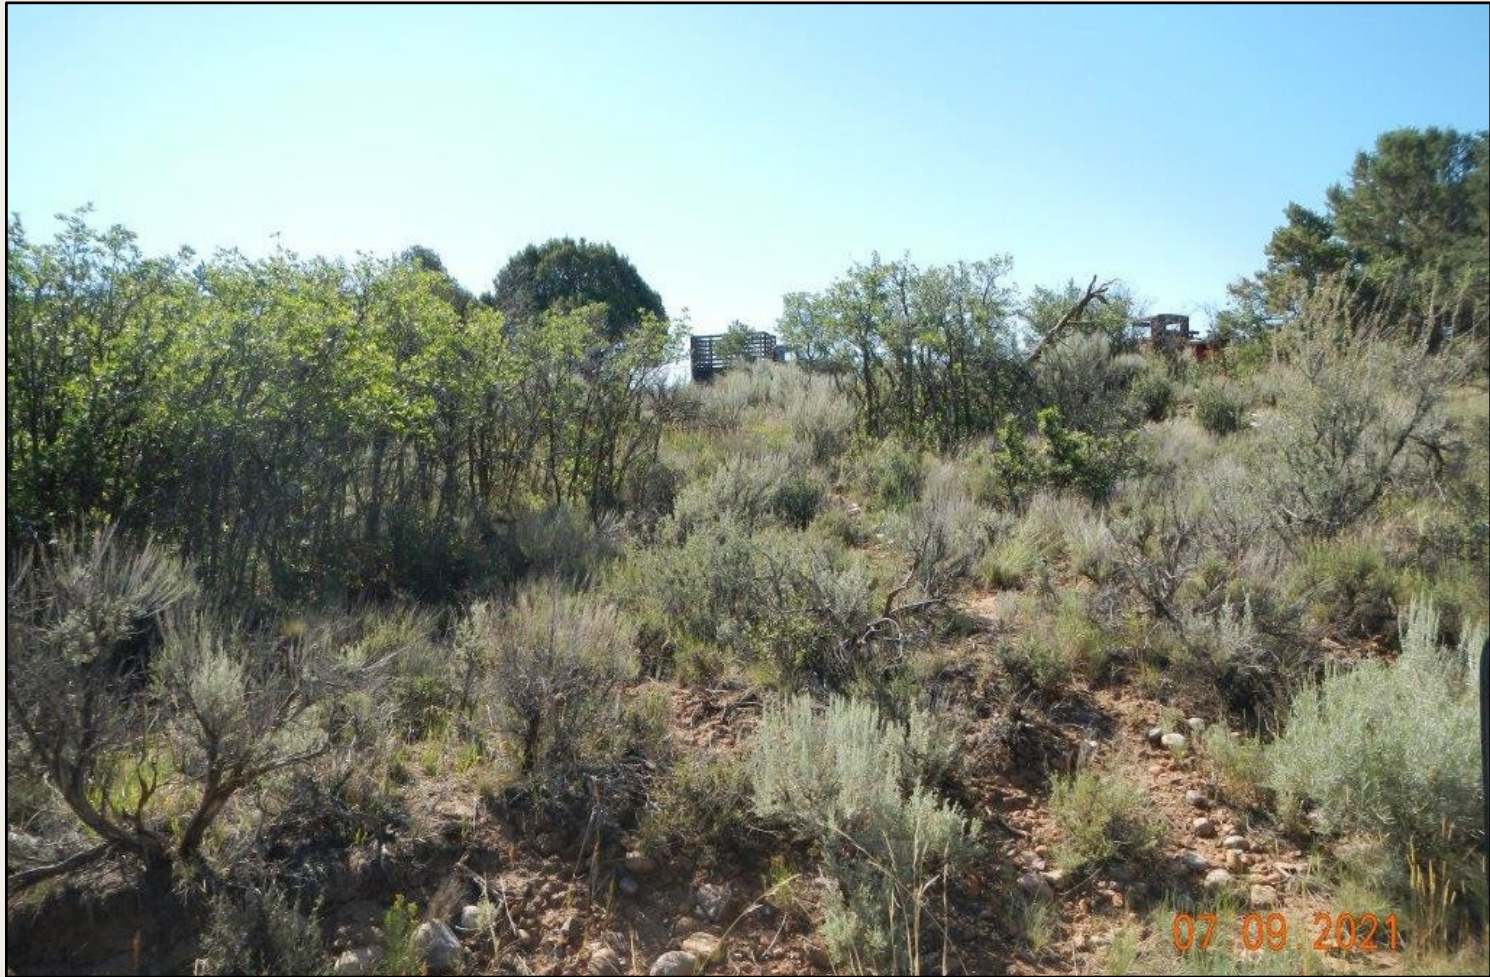
Photo 5. View of reference area comprised of sagebrush shrubland mosaic with gambel oak, pinyon, and juniper trees, with understory of grasses and forbs such as needle and thread, blue grama, and goldenaster.
