Inspection Photos

Operator: LARAMIE ENERGY LLC #10433

Location ID: 324315

Aaron Trujillo
NW Reclamation Specialist
COGCC

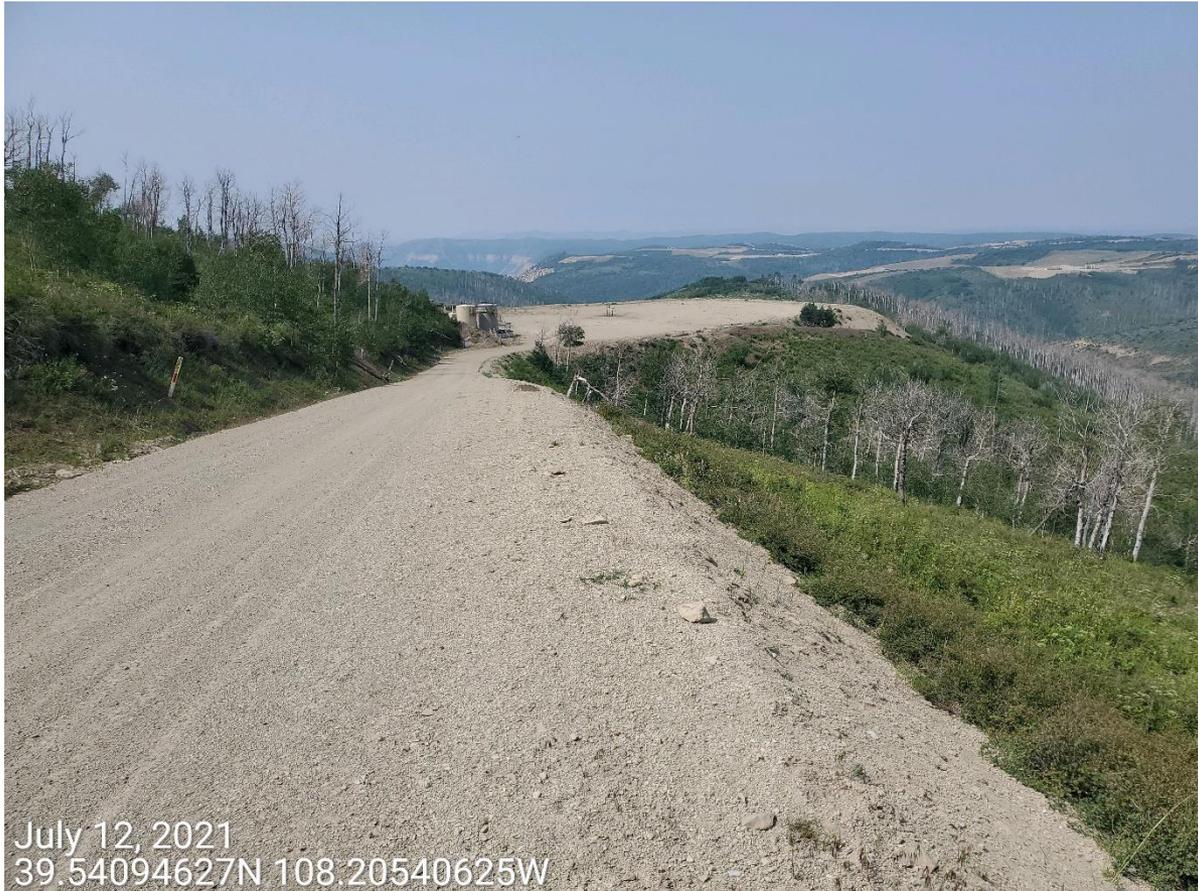
Photo 1: Photo taken from the access road northeast of the Location, facing southwest. Photo shows interim reclamation of areas not needed for production has not been performed in accordance with 1003 Rules.

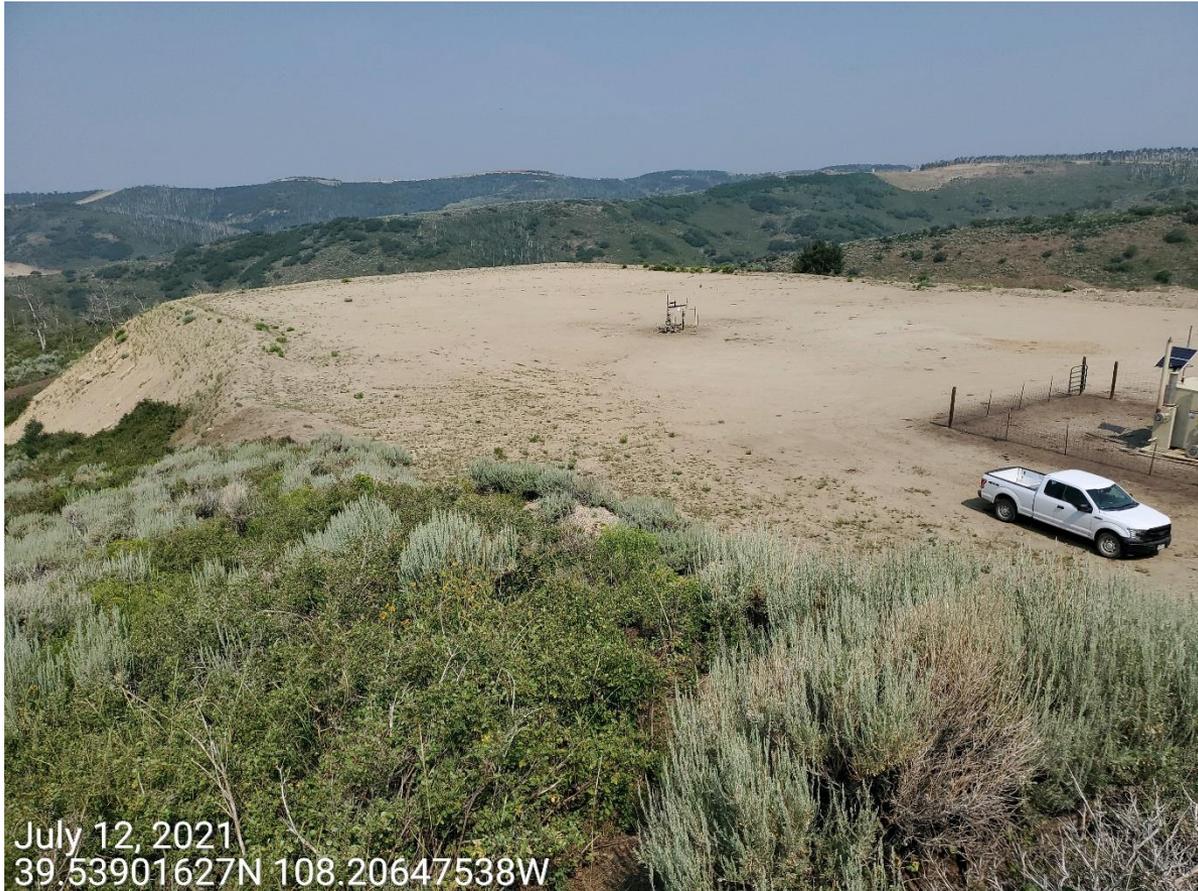
Photo 2: Photo taken from the southeast end of the Location, facing northwest. Photo shows interim reclamation of areas not needed for production has not been performed in accordance with 1003 Rules.

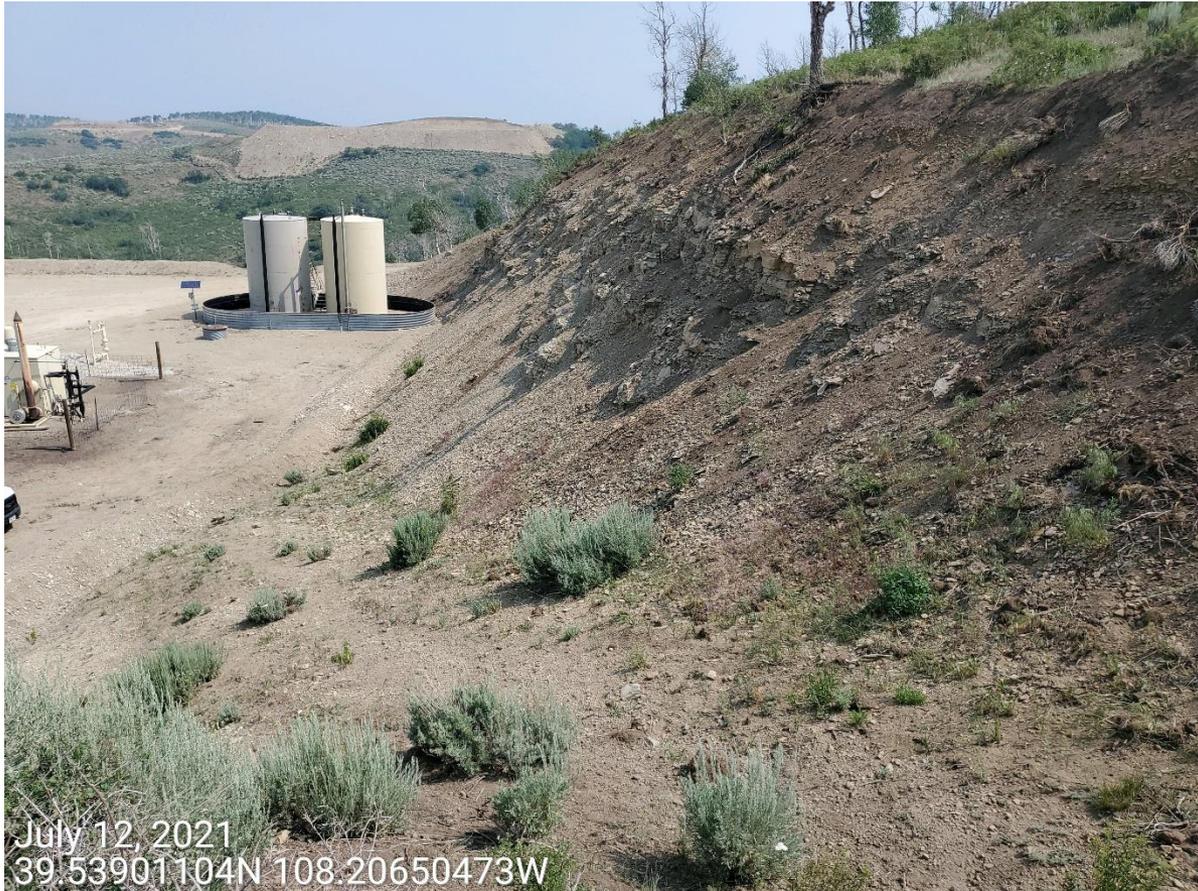
Photo 3: Photo taken from the east end of the Location, facing north. Photo shows control measures to protect/stabilize the cut slopes of the Location remain missing or insufficient.

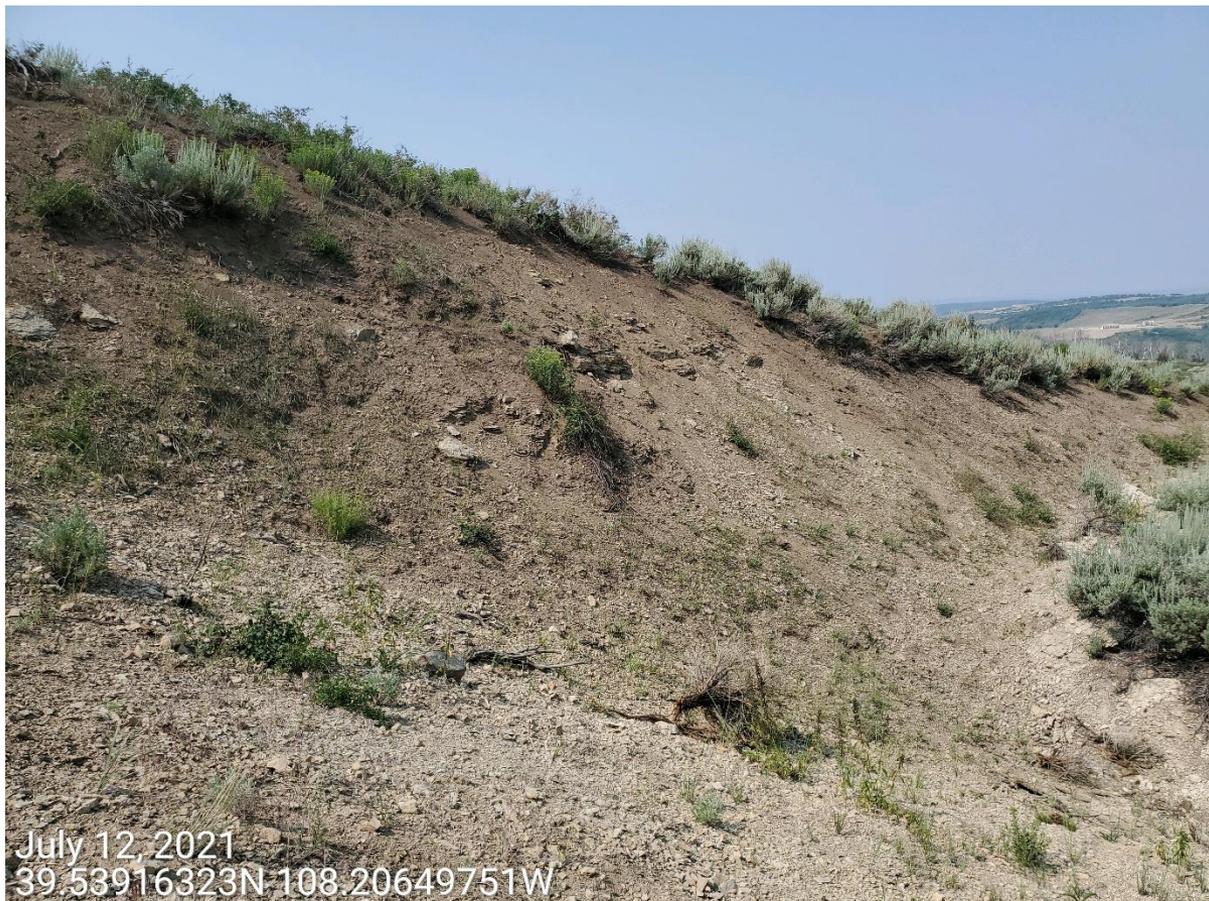
Photo 4: Photo taken from the east end of the Location, facing southwest. Photo shows control measures to protect/stabilize the cut slopes of the Location remain missing or insufficient.

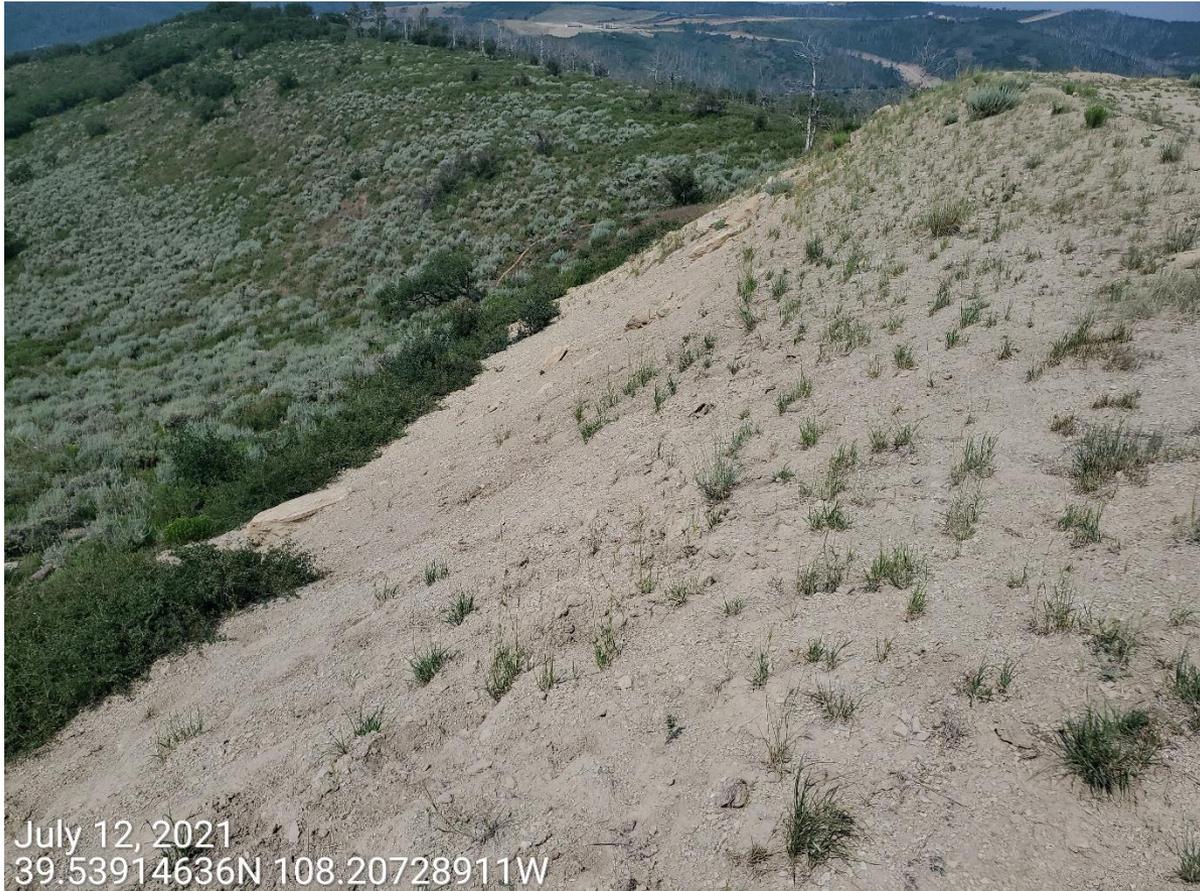
July 12, 2021
39.53914636N 108.20728911W

Photo 5: Photo taken from the south end of the Location, facing west. Photo shows control measures to protect/stabilize the fill slopes of the Location remain missing or insufficient.
