# Inspection Photos

Operator: LARAMIE ENERGY LLC #10433

Location ID: 335889

Garfield County, CO

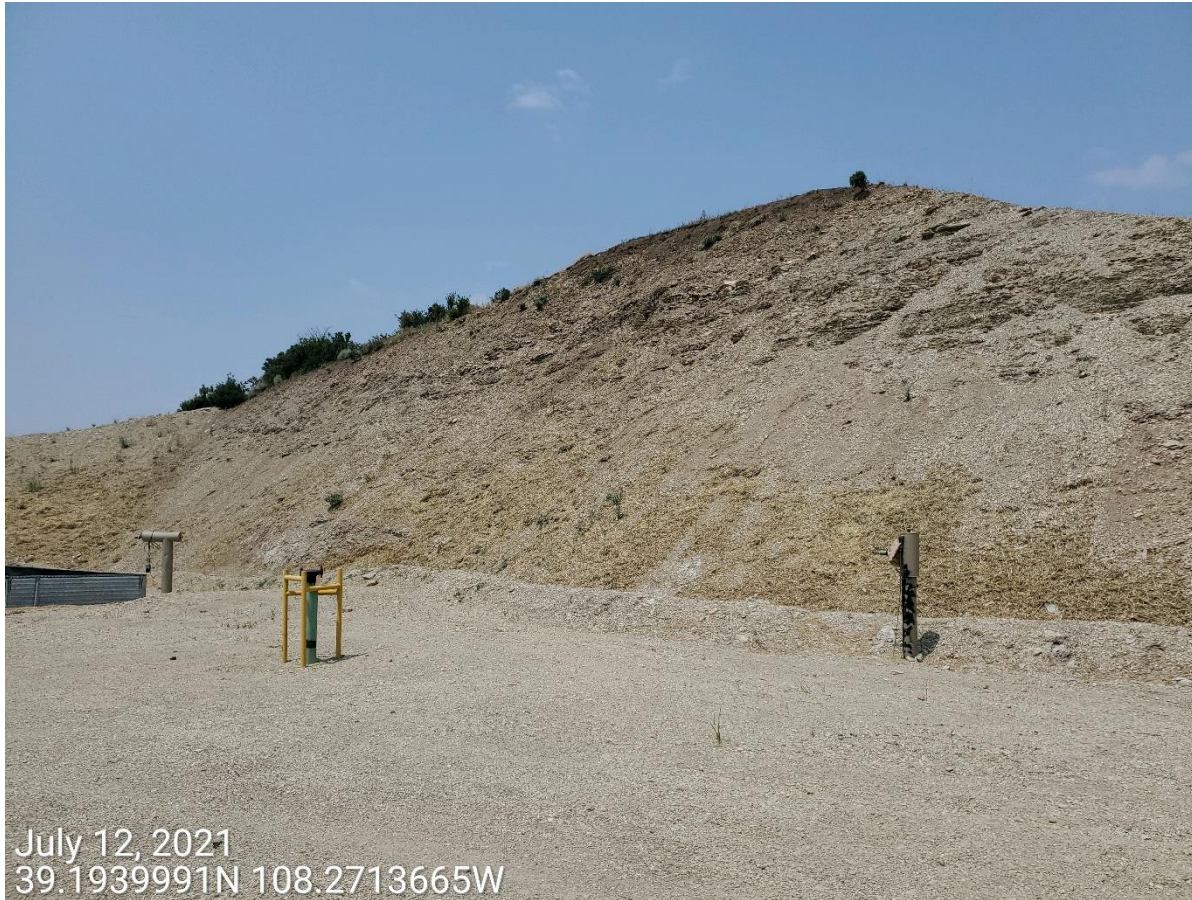
**Photo 1:** Photo taken from the Location, facing west. FIRR No. 402706390 shows Operator installed a soil binder and mulch on the cut slopes of the Location. Photo show BMP is not in proper functioning condition; BMP not adequate for the site's conditions to protect and stabilize cut slopes of the Location.

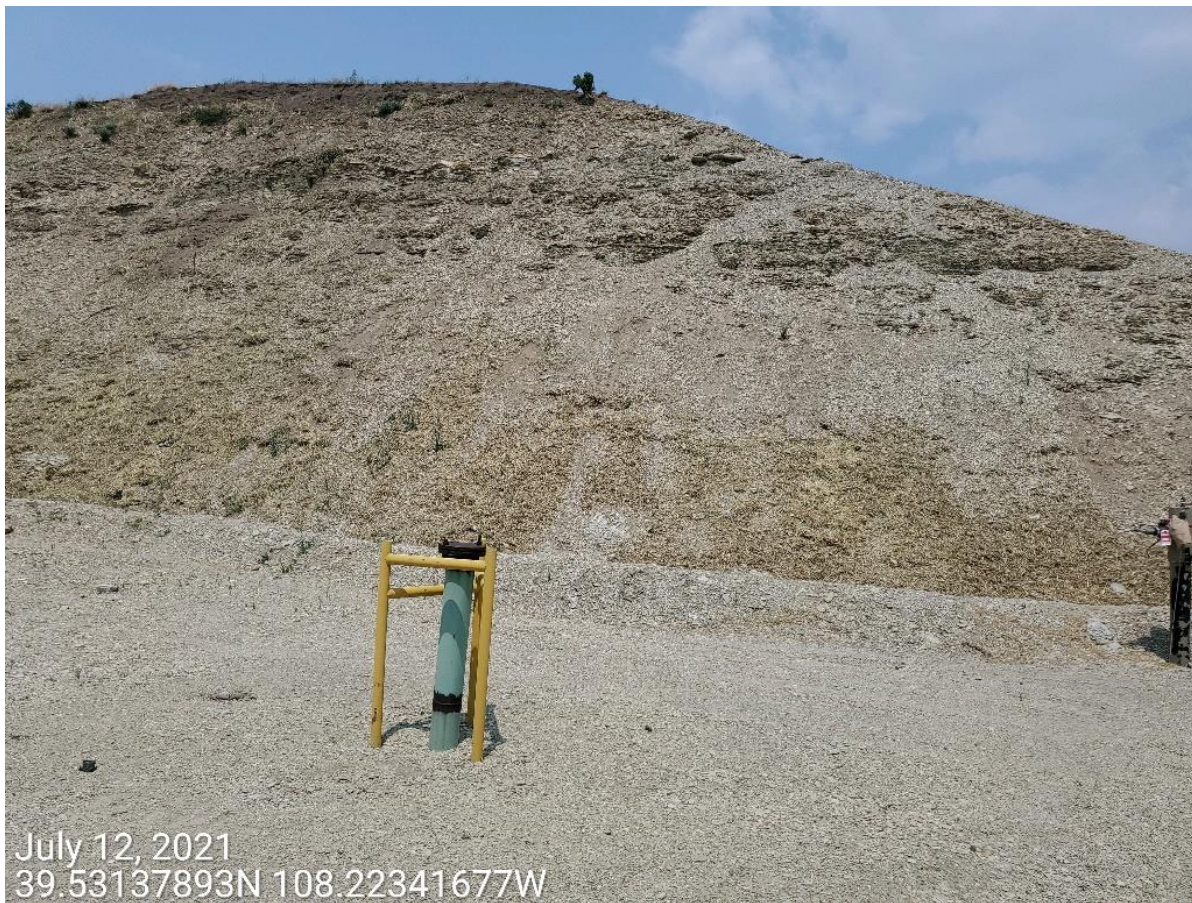
**Photo 2:** See comments under photo 1.

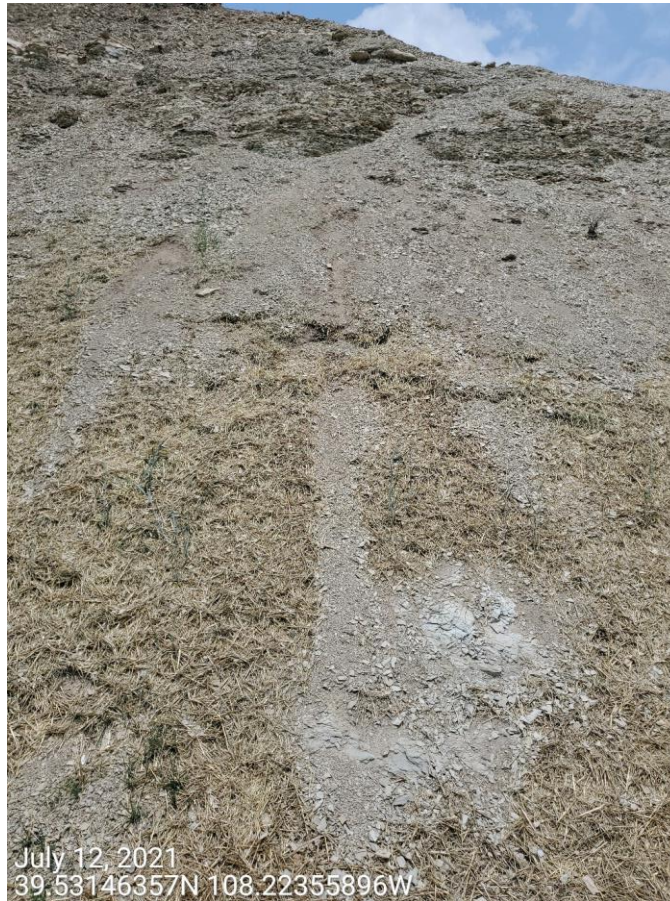
**Photo 3:** See comments under photo 1. Erosion degradation evident.

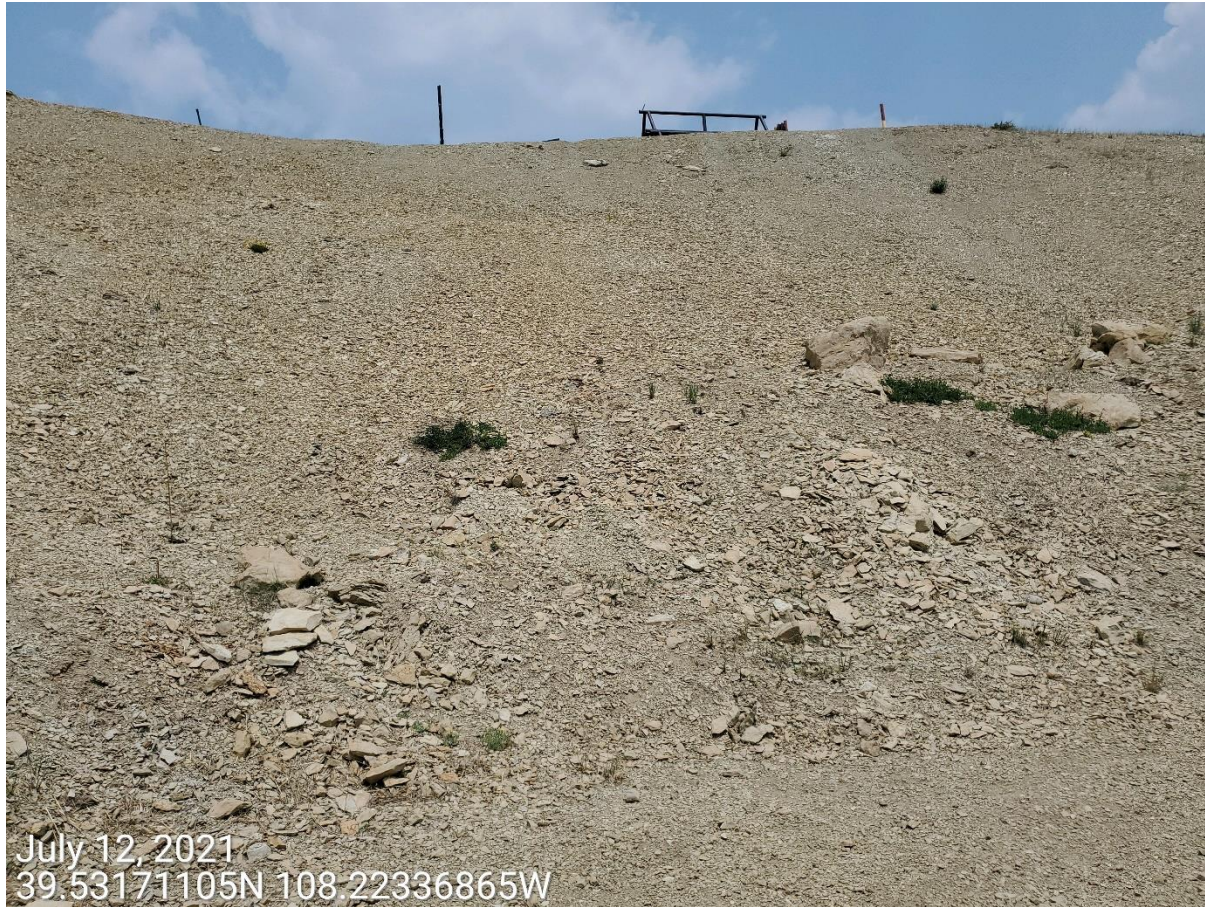
**Photo 4:** Photo taken from the cut slopes on the North end of the Location, facing north. Photo shows BMPs to protect and stabilize the cut slopes of the Location remain missing or insufficient.

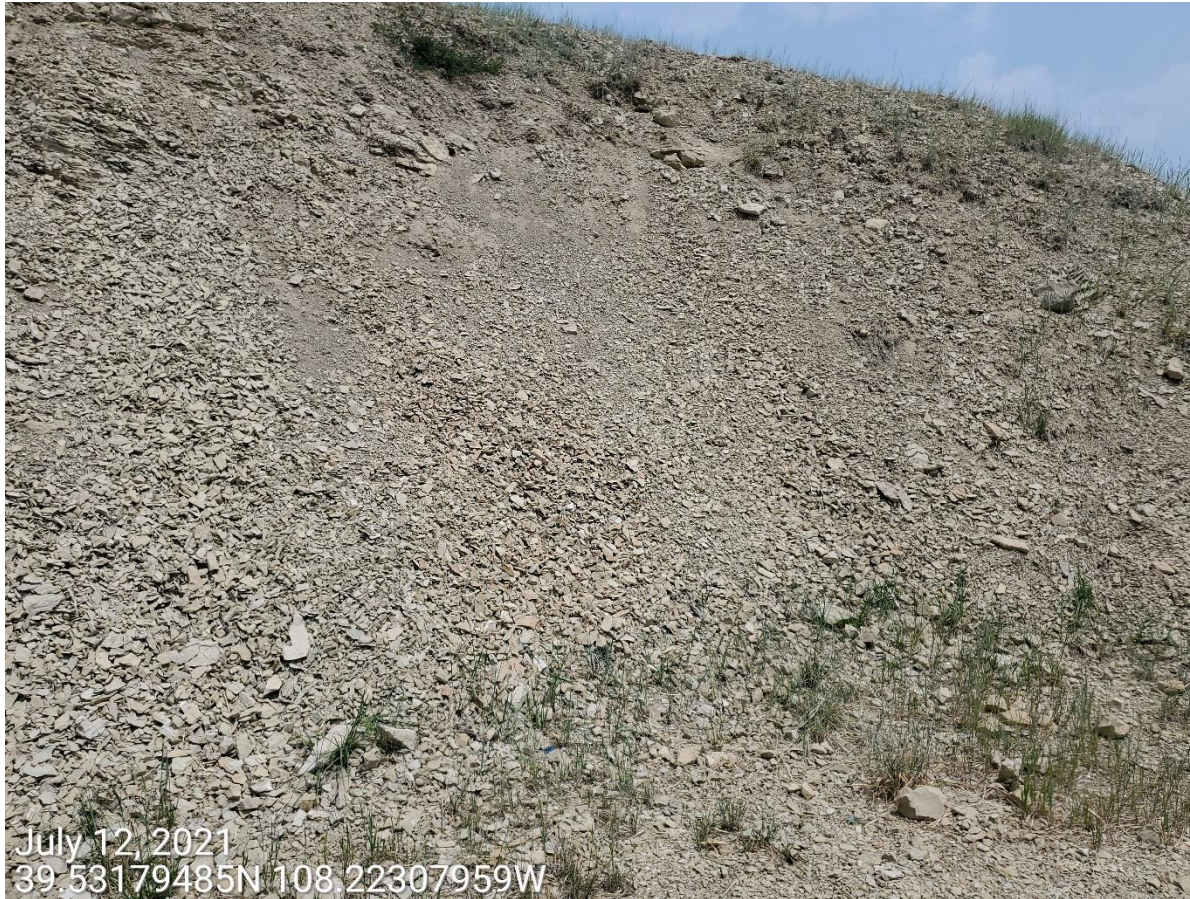
**Photo 5:** Photo taken from the cut slopes on the North end of the Location, facing north. Photo shows BMPs to protect and stabilize the cut slopes of the Location remain missing or insufficient.
