Inspection Photos

Operator: TEP ROCKY MOUNTAIN LLC #96850

Location ID: 452055

Garfield County, CO

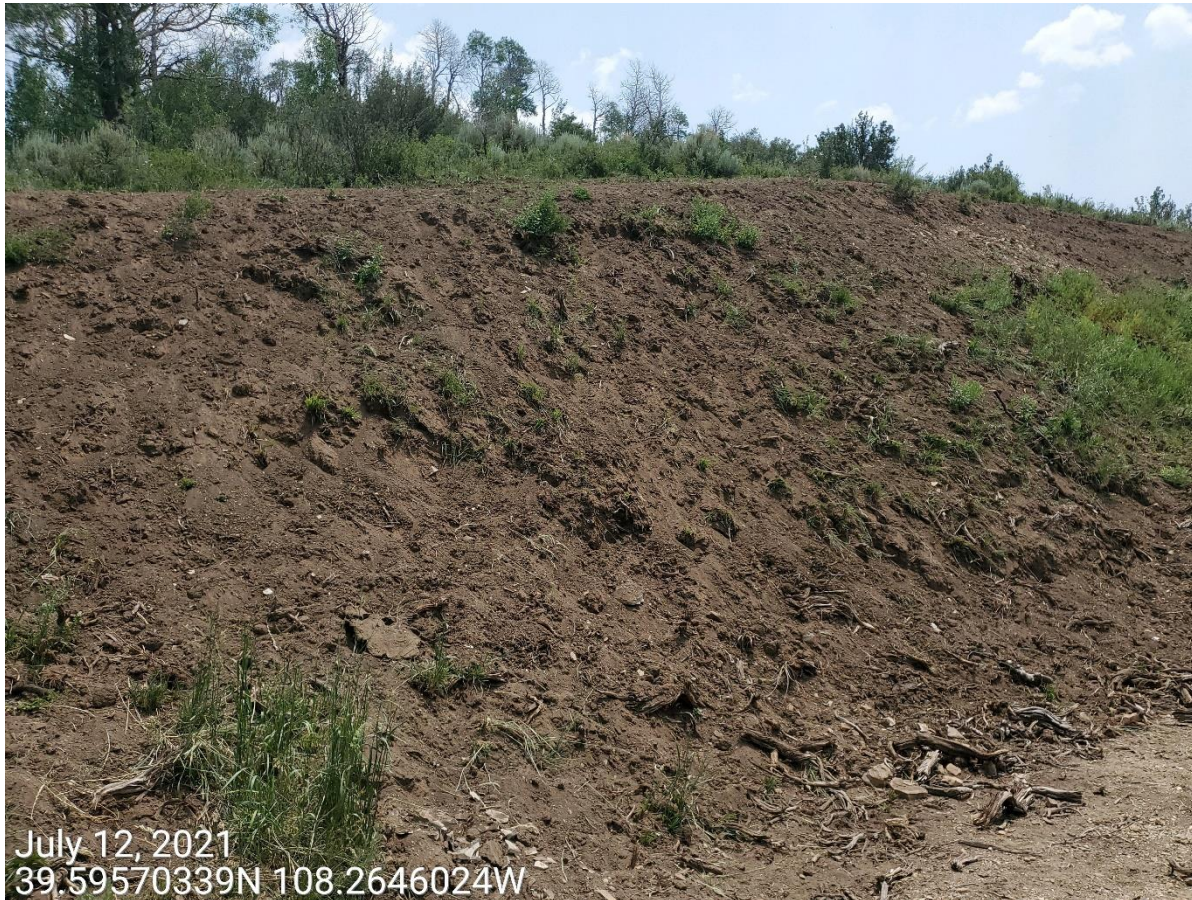
Photo 1: Photo taken from the cut slopes on the east end of the Location. Photo shows control measures to protect and stabilize slopes of the Location remain missing or insufficient; soils predominantly exposed and loose.

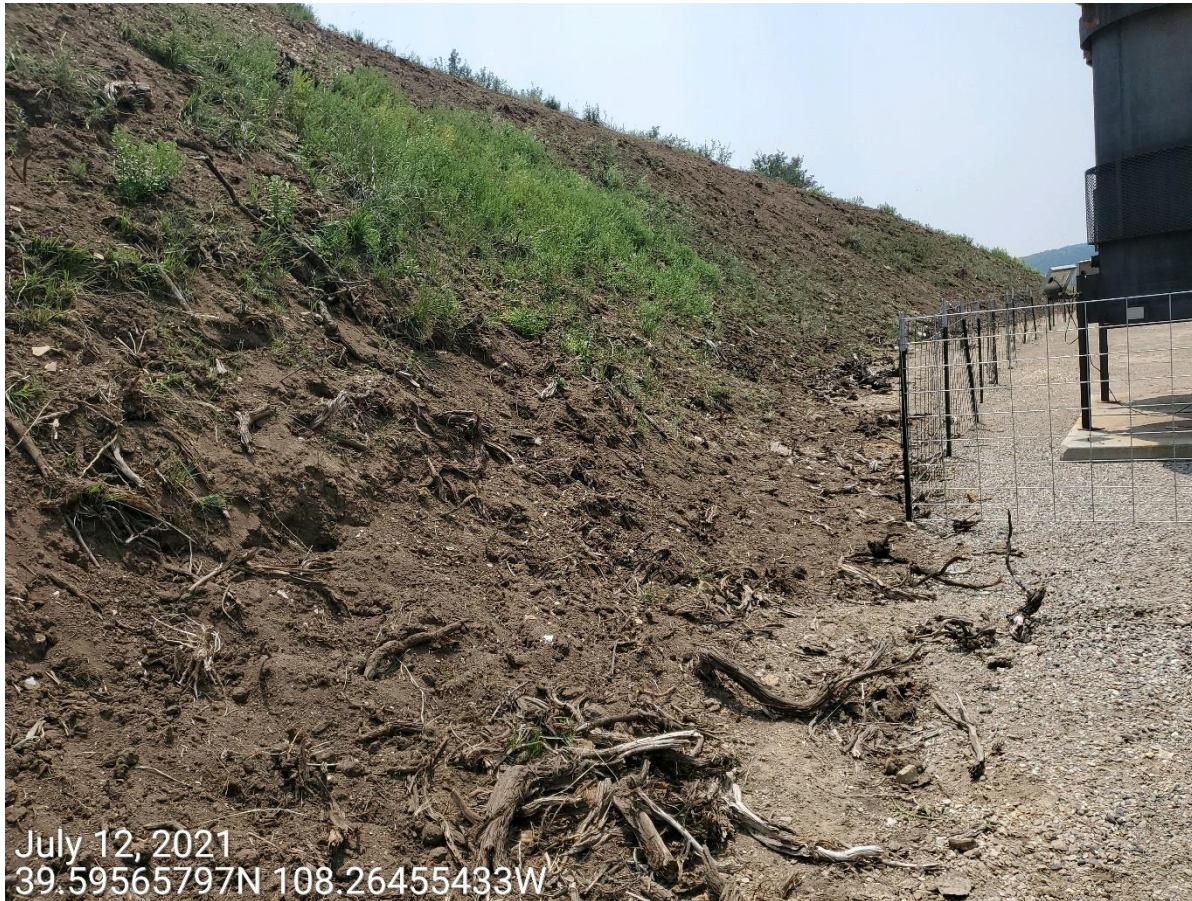
Photo 2: Photo taken from the cut slopes on the east end of the Location. Photo shows control measures to protect and stabilize slopes of the Location remain missing or insufficient; soils predominantly exposed and loose.

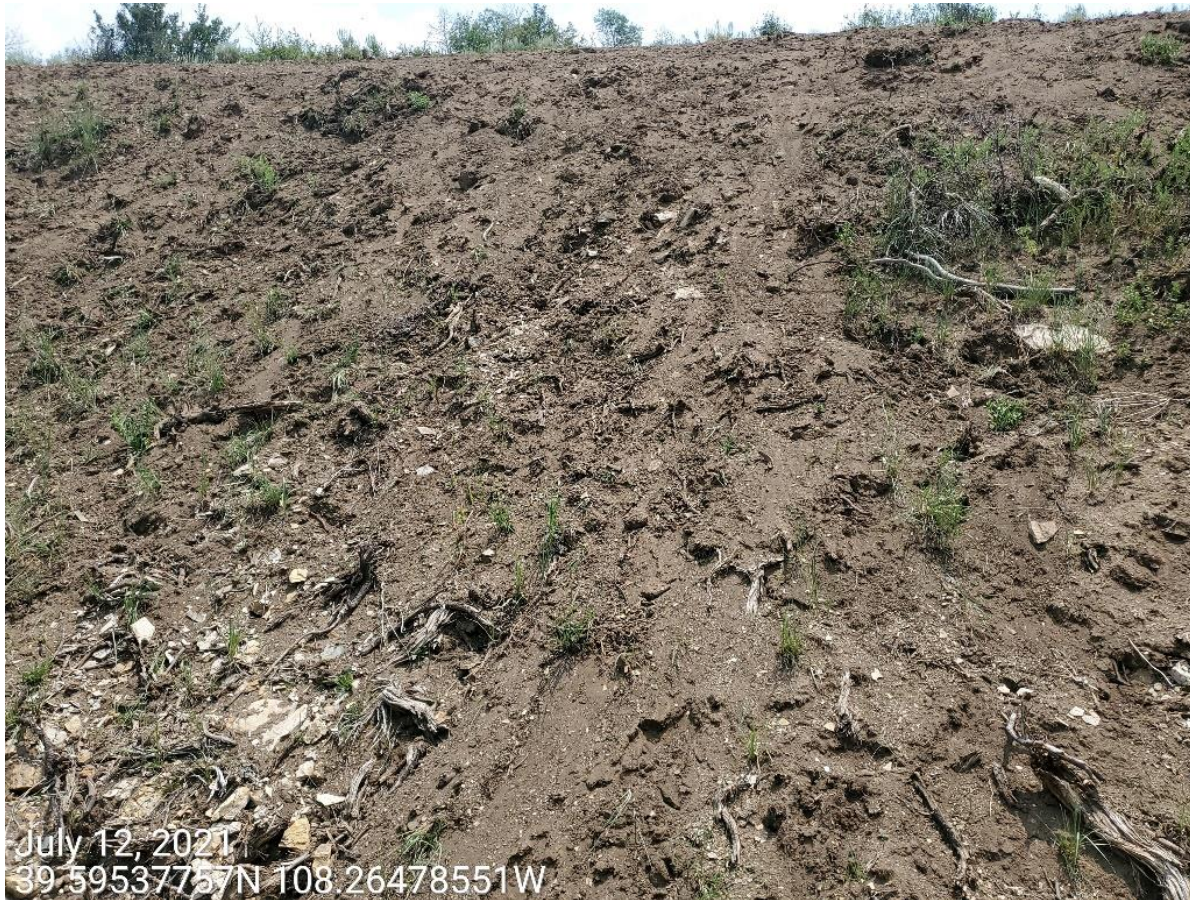
Photo 3: Photo taken from the cut slopes on the east end of the Location. Photo shows control measures to protect and stabilize slopes of the Location remain missing or insufficient; soils predominantly exposed and loose. Erosion degradation evident.

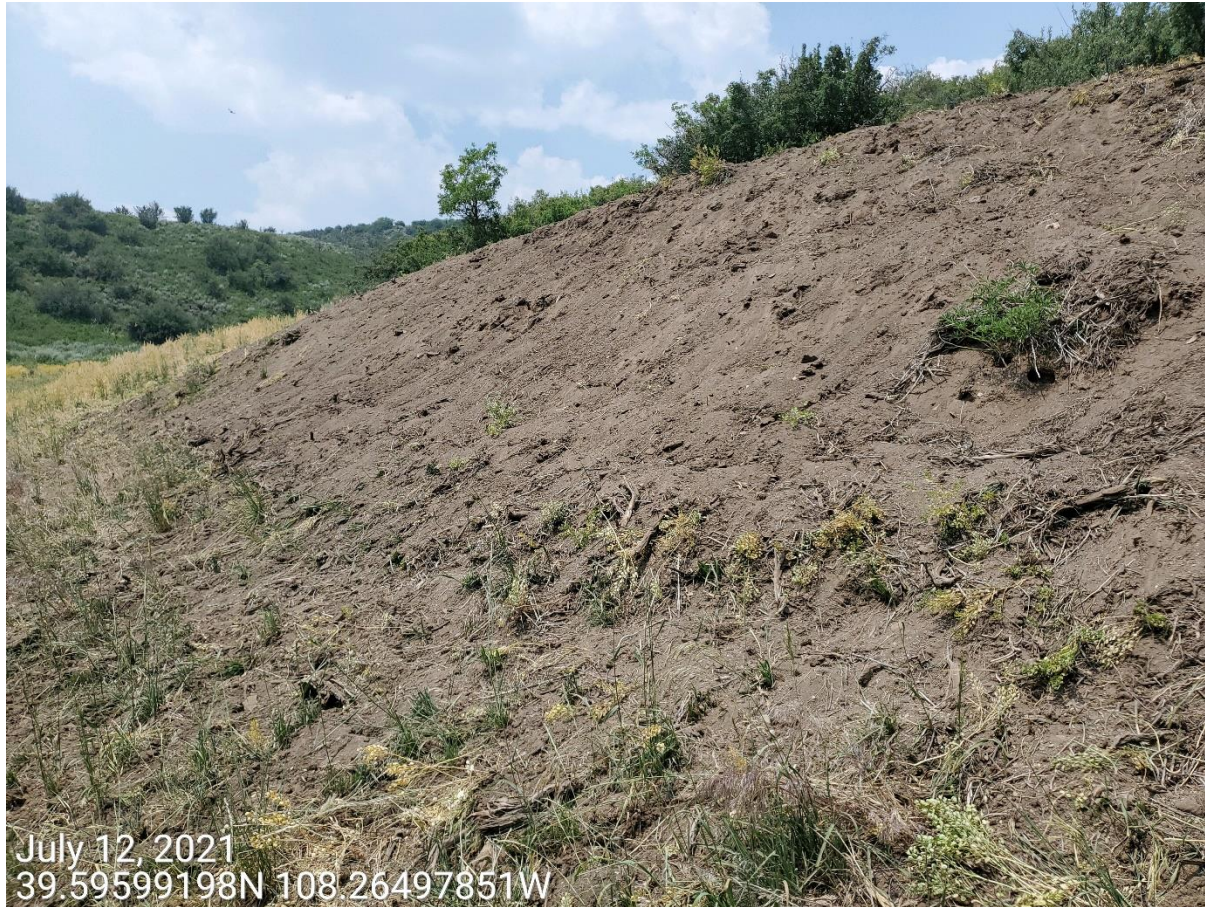
Photo 4: Photo taken from the soil stockpile on the west end of the Location. Photo shows control measures to protect and stabilize slopes of the Location remain missing or insufficient; soils predominantly exposed and loose.

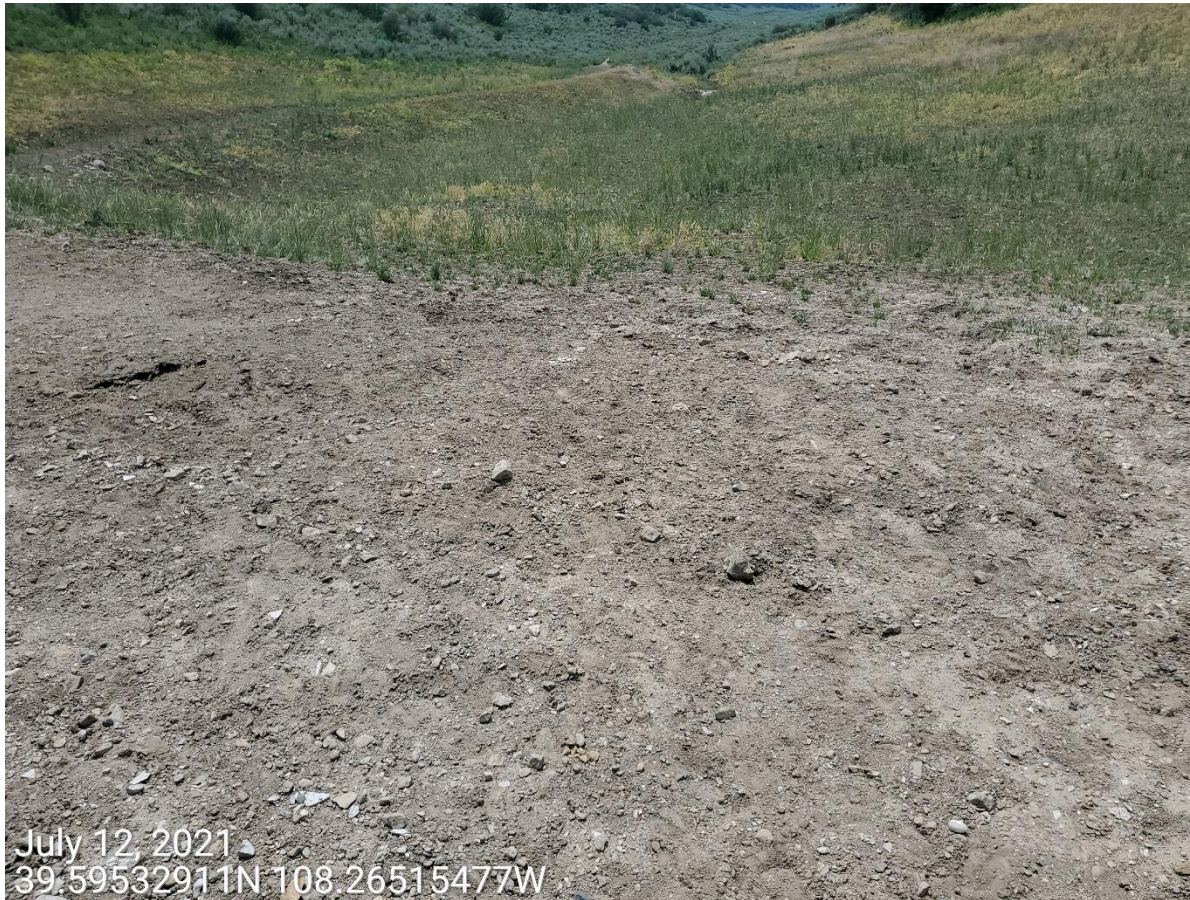
Photo 5: Photo taken from the south end of the Location. Previous inspection observed erosion degradation within area due to stormwater runoff from the Location. Inspection required Operator to implement BMPs to manage runoff. Photo shows erosion has been repaired, however, BMPs to manage runoff from the Location remain missing or insufficient.
