# Construction and Stormwater Inspection

Operator: VERDAD RESOURCES LLC #10651

Location ID: 474767

Inspection Photos  
Location Name:County Line /Pad  
Location ID: 474767

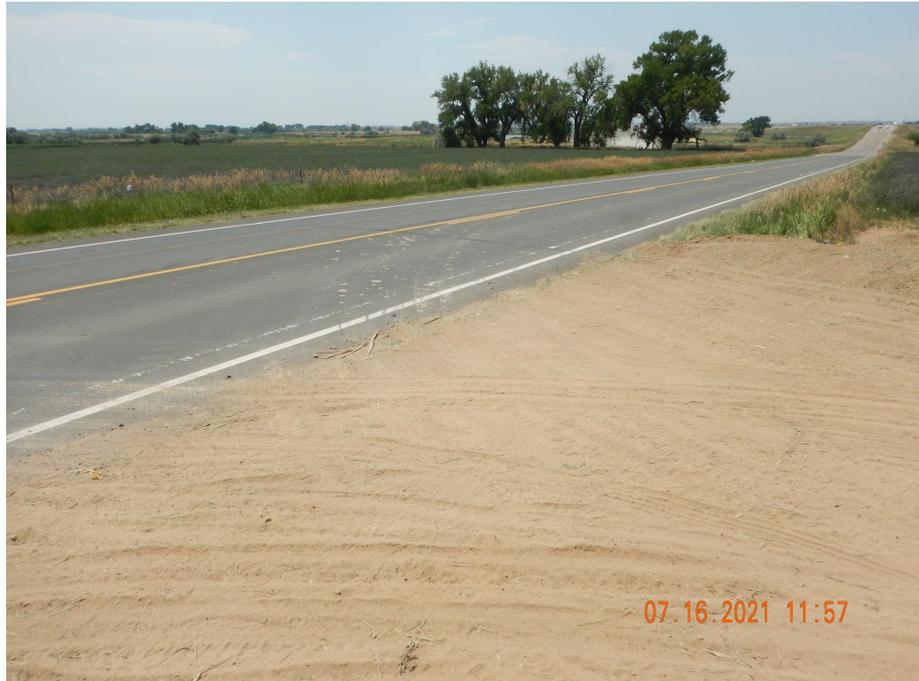
**Photo 1.** Photo taken from the entrance of location, facing West. Photo illustrates current conditions along the county road. At the time of this inspection, no vehicle track out was observed. Operator has not yet installed a vehicle tracking device BMP.

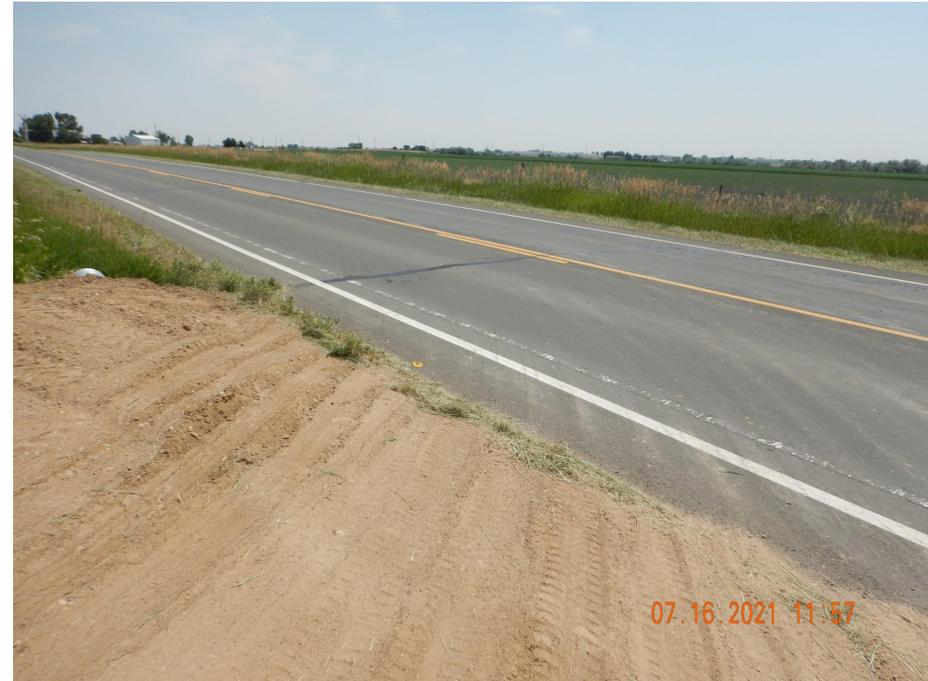
**Photo 2.** Photo taken from the entrance of location, facing East. See comments under Photo 1.

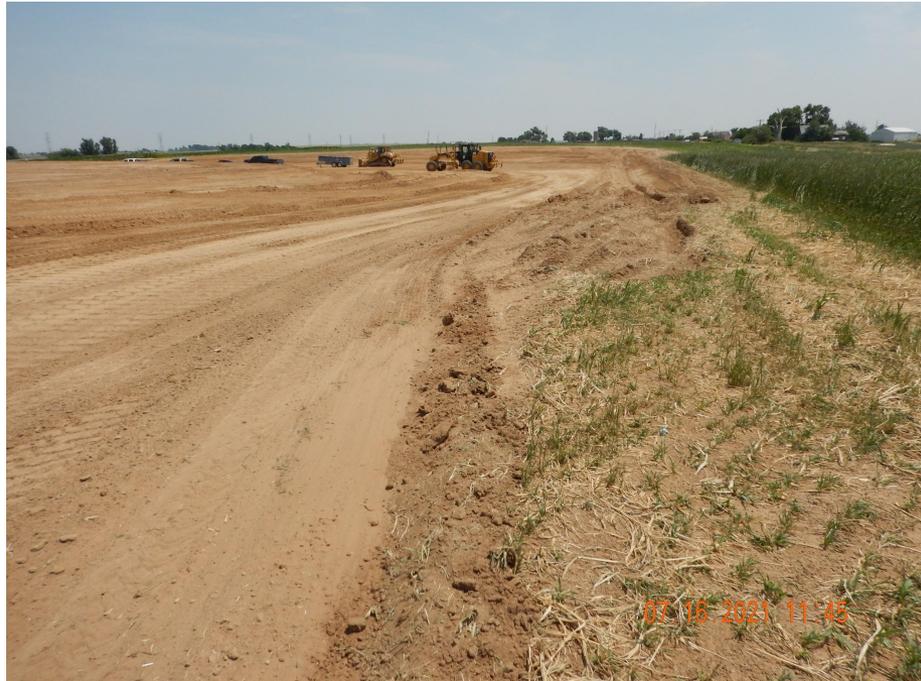
**Photo 3.** Photo taken from the southern location, facing East. Photo illustrates Operator has commenced construction activities and is in process of construction.

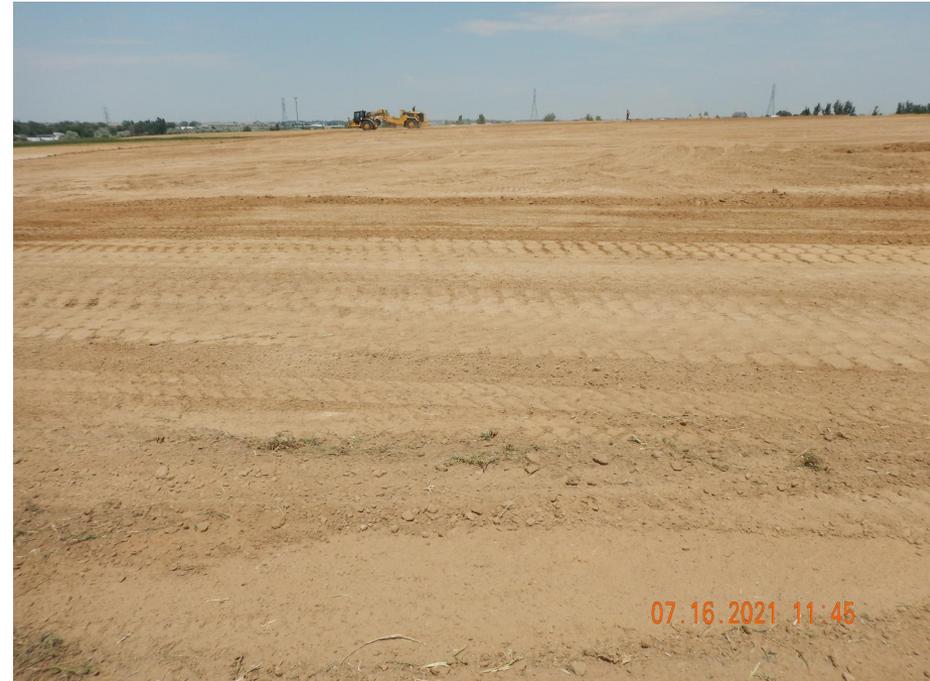
**Photo 4.** Photo taken from the southern location, facing North. See comments under Photo 3.

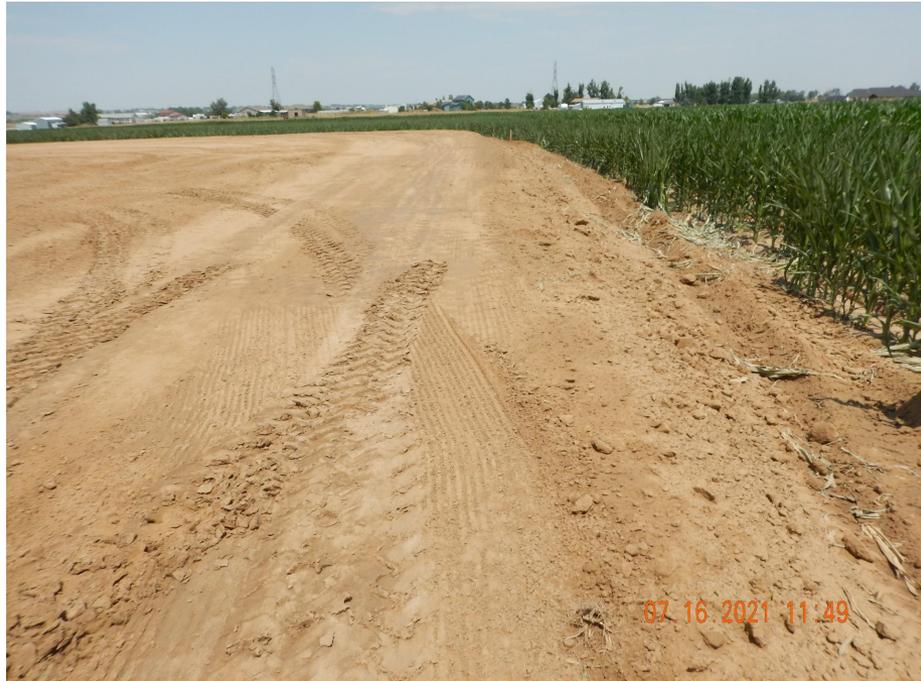
**Photo 5.** Photo taken from the northeastern location, facing North. Photo illustrates Operator has failed to install perimeter stormwater BMPs during construction activities.

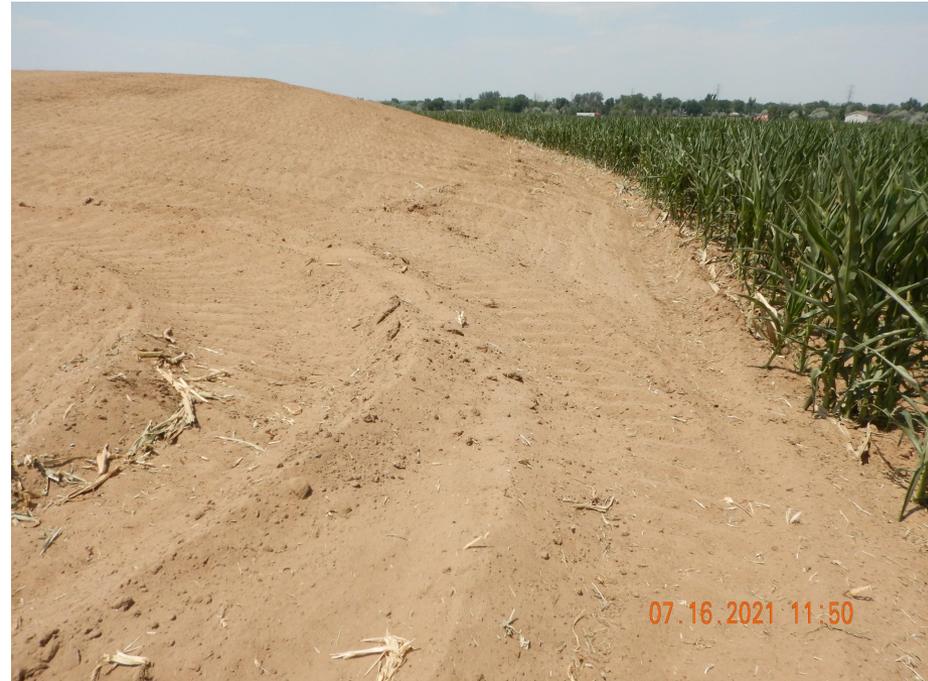
**Photo 6.** Photo taken from the northeastern location (just east of the topsoil stockpile), facing West. See comments under Photo 5.

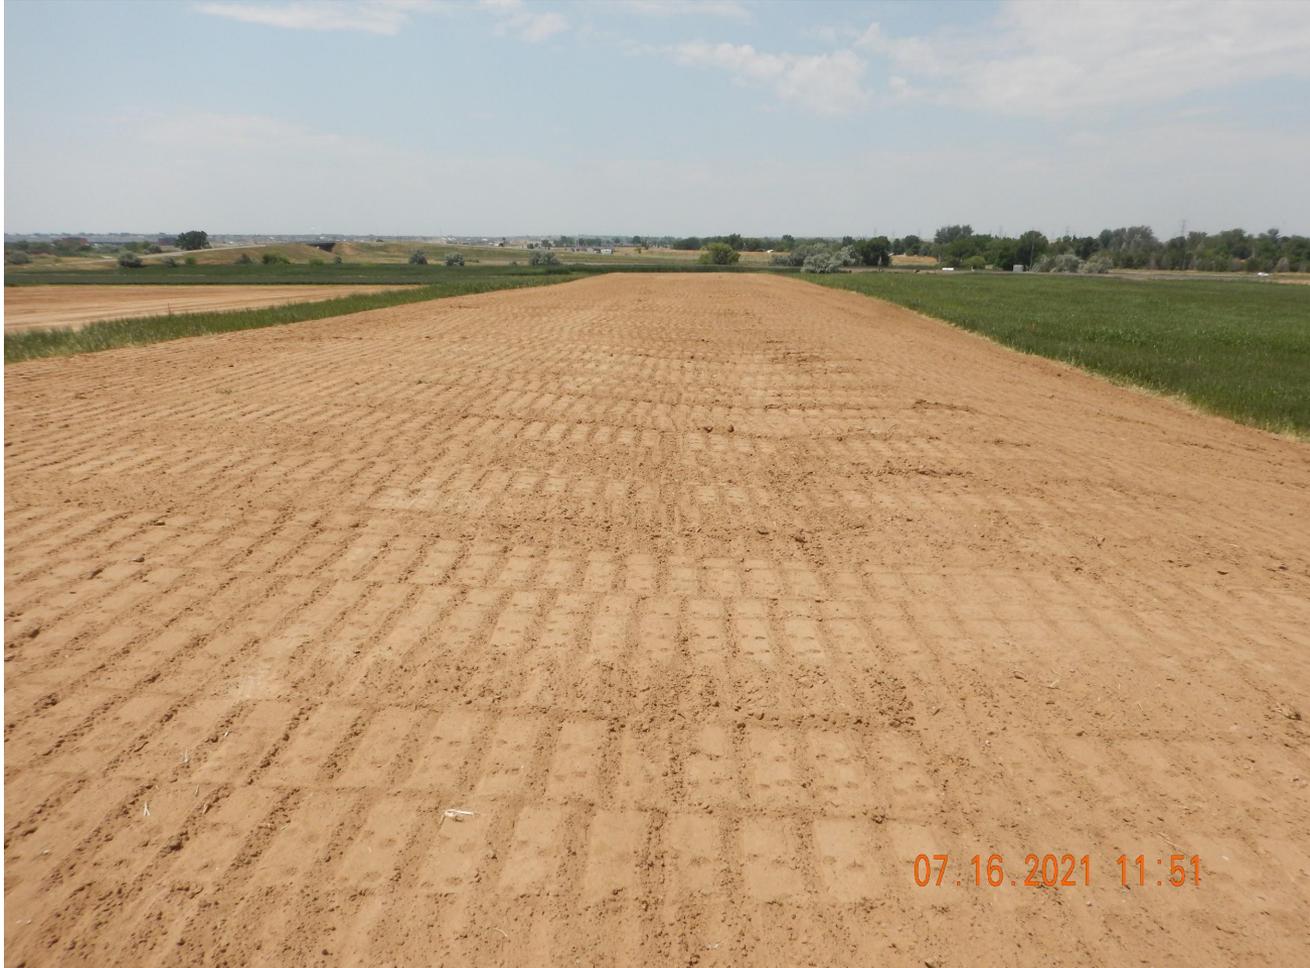
**Photo 7.** Photo taken from the northern location, facing West. Photo illustrates the topsoil stockpile which has been temporarily stabilized with equipment tracking.

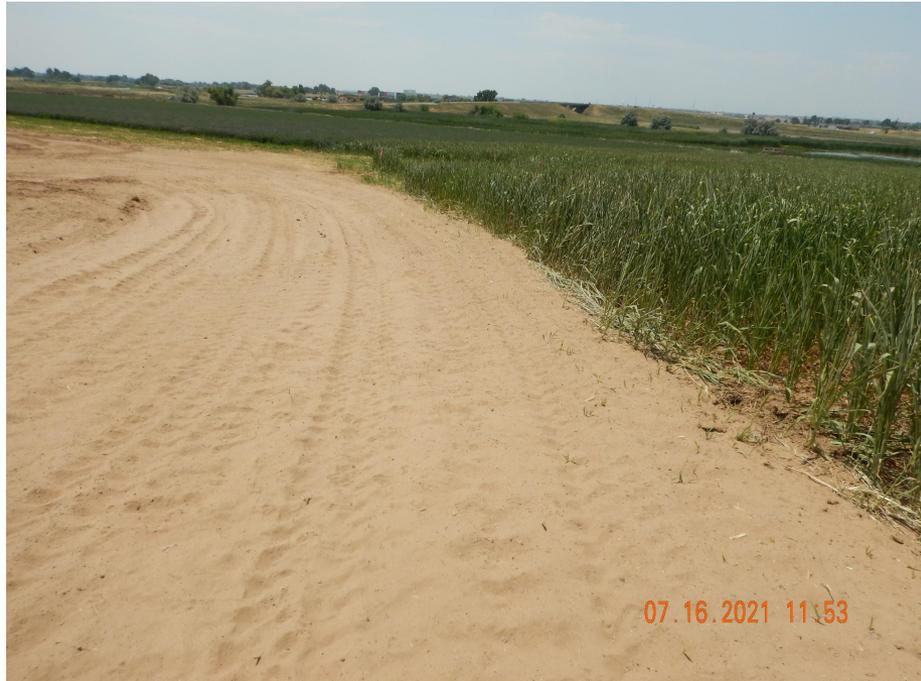
**Photo 8.** Photo taken from the northwestern location, facing West. Photo illustrates Operator has failed to install perimeter stormwater BMPs during construction activities.

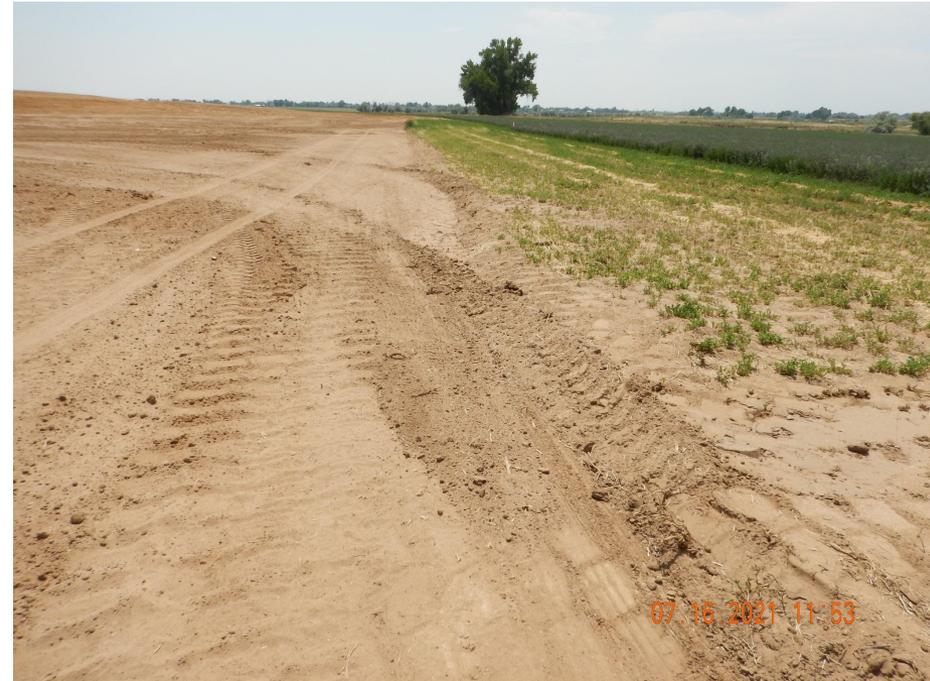
**Photo 9.** Photo taken from the northwestern location, facing South. See comments under Photo 8.

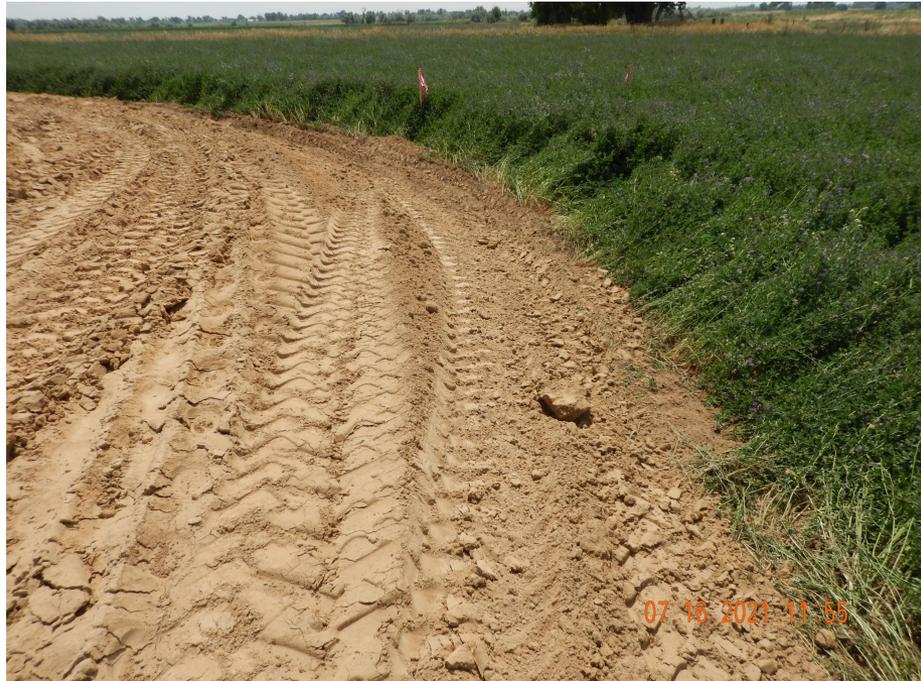
**Photo 10.** Photo taken from the southwestern location, facing South. See comments under Photo 8.

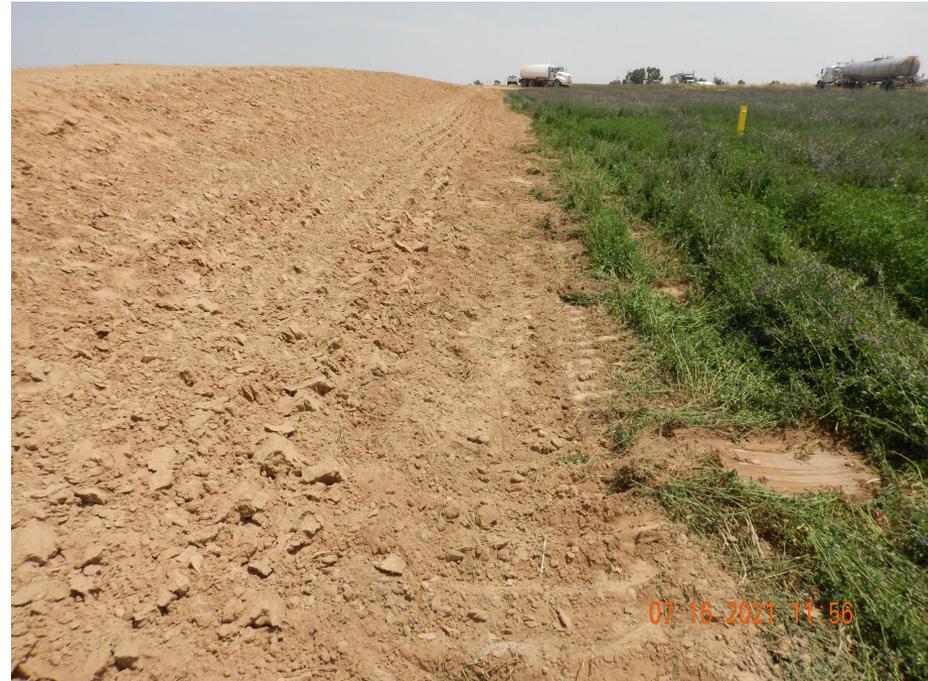
**Photo 11.** Photo taken from the southwestern location, facing East. See comments under Photo 8.
