# Inspection Photos

API: 071-07412

Operator: OGRIS OPERATING LLC

Inspection Date: 7/7/2021

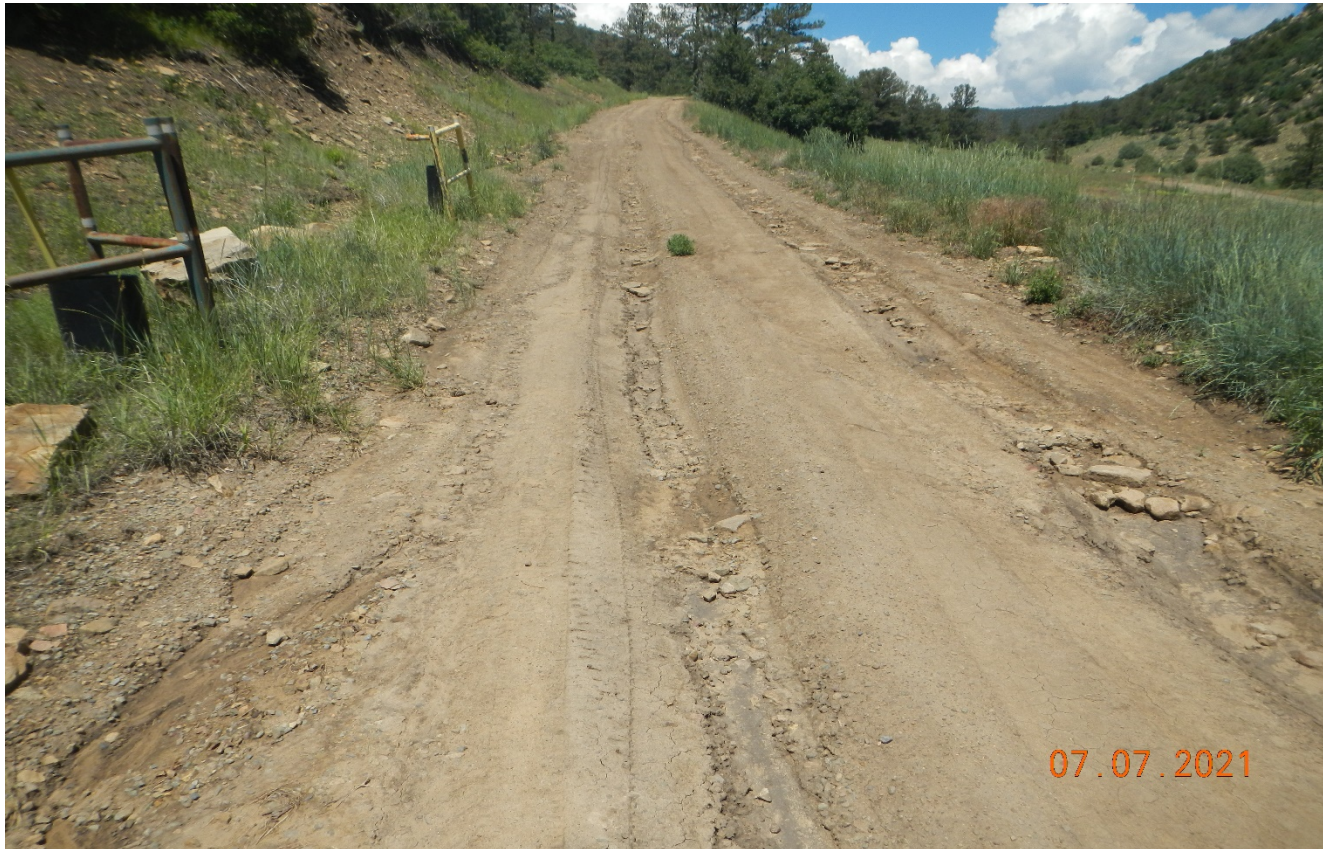
**Photo 1.** There is vehicle rutting at the beginning of the access road from the main road in Bingham Canyon. This section of road is directing stormwater down the road to the main road. BMP's such as gravel and water bars are needed to prevent rutting and road degradation. Previous corrective action was not performed.

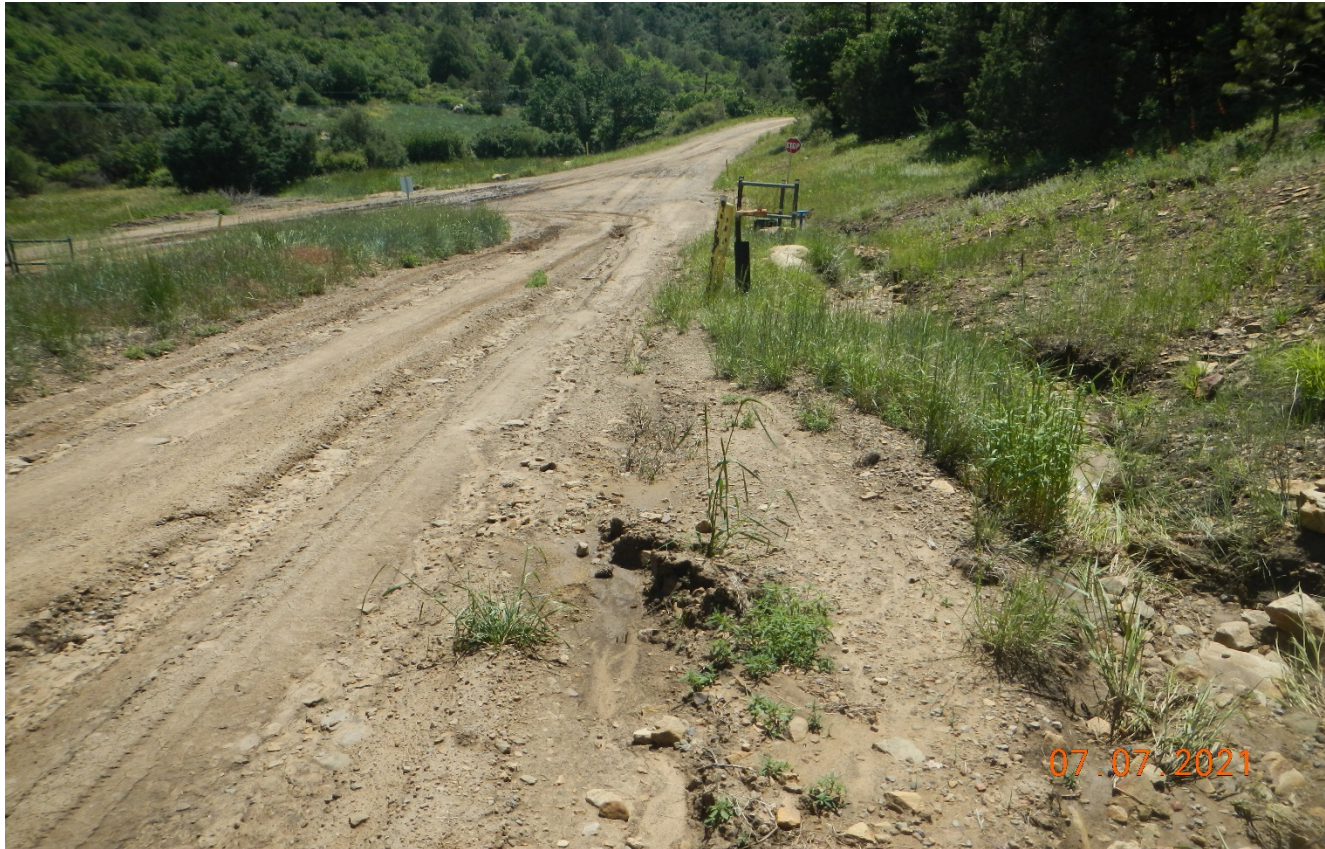
**Photo 2.** Facing back down the access road shows vehicle rutting and erosion. This issue has previously been documented and needs to be repaired and prevented.

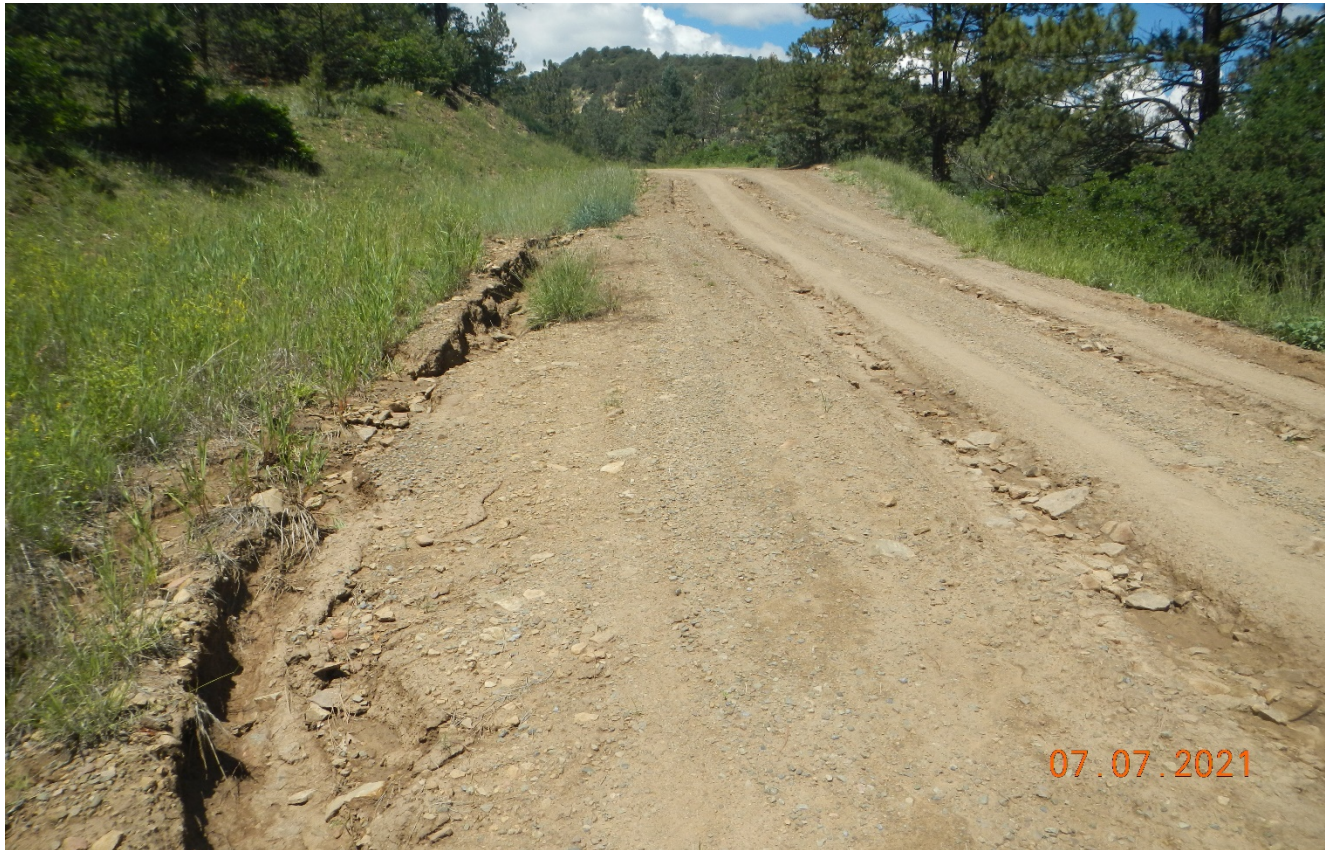
**Photo 3.** Storm water erosion is occurring down the side of the road. BMP's need to be installed to prevent erosion. Previous corrective action was not performed.

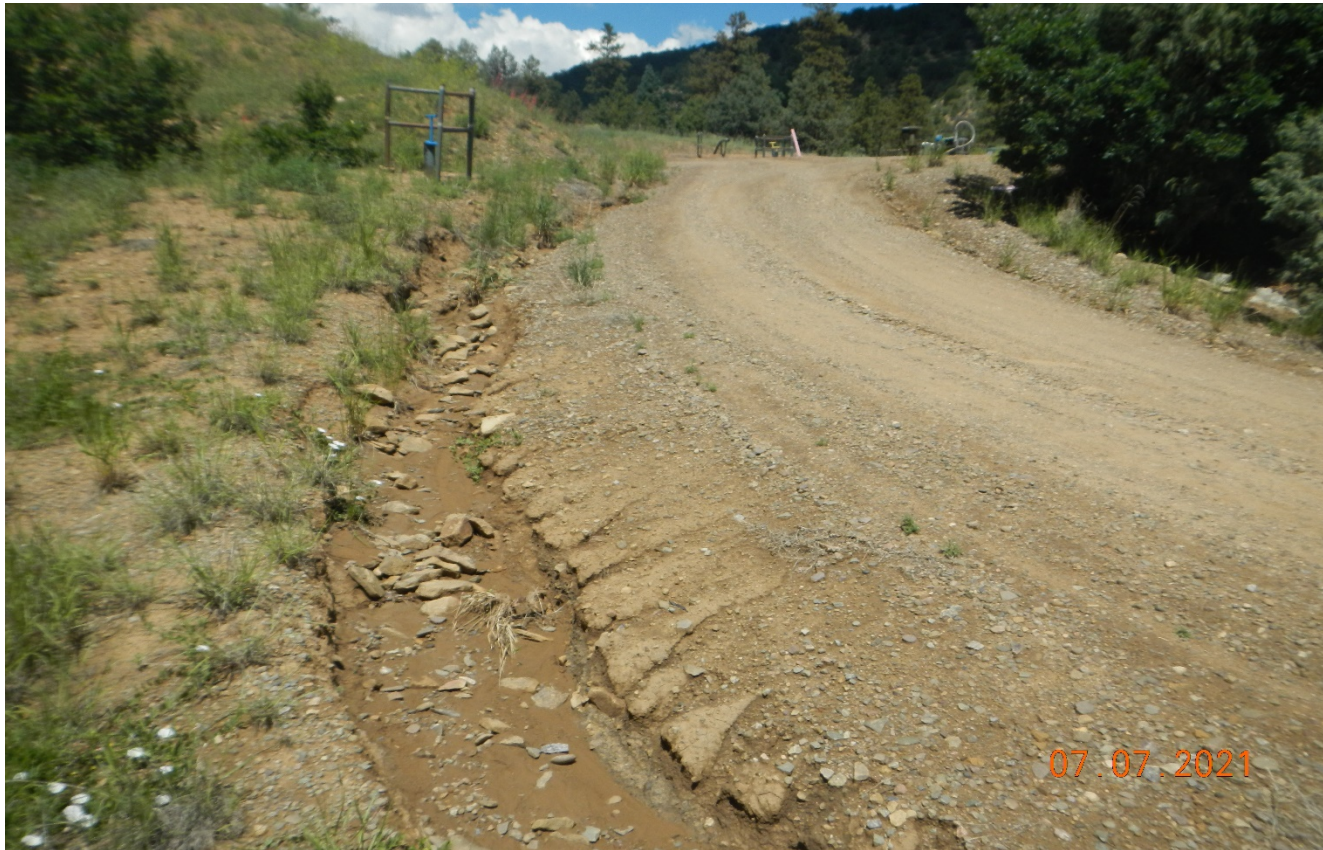
**Photo 4.** Facing along the access road toward the location. Storm water erosion is occurring down the side of the road. BMP's need to be installed to prevent erosion.

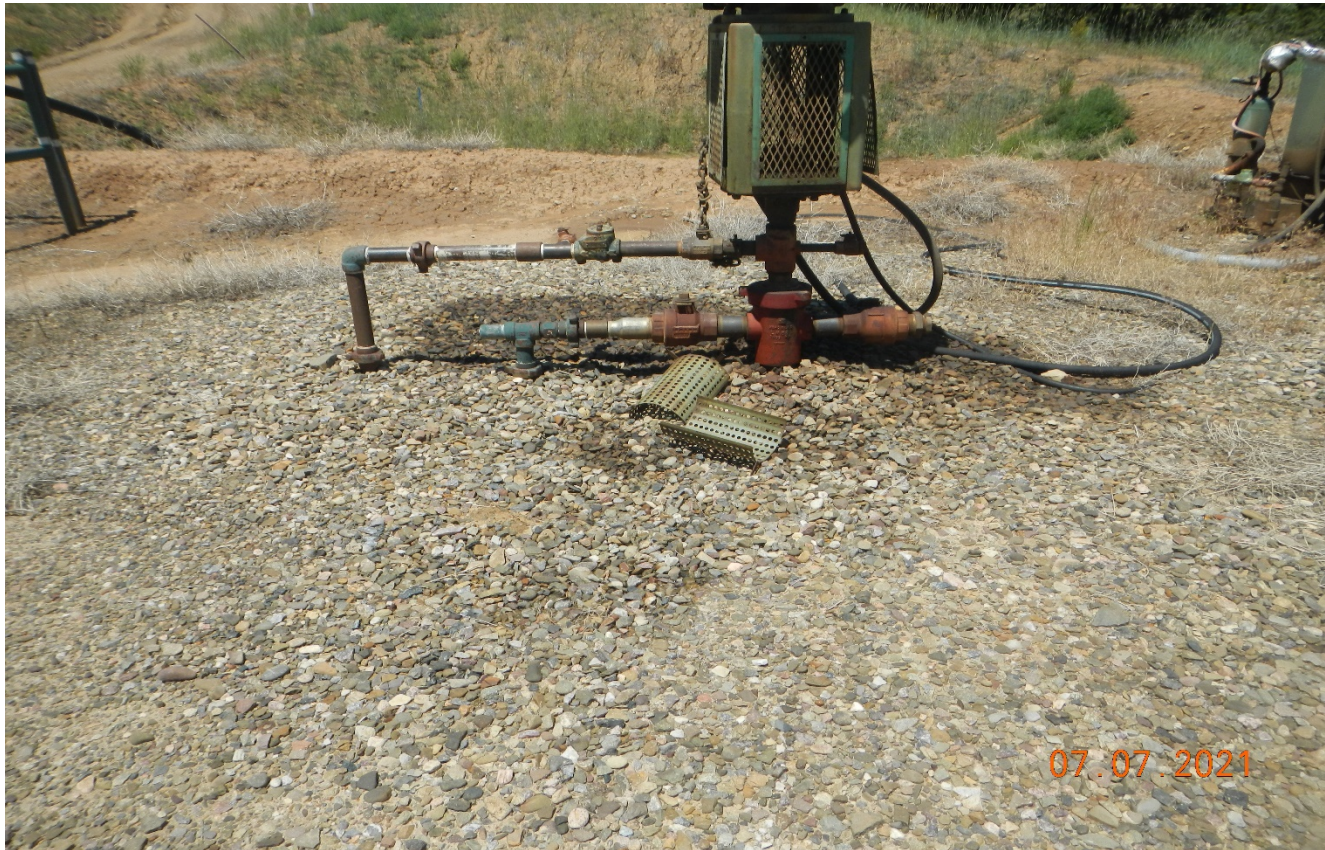
**Photo 6.** There is stained gravel around the wellhead indicating a previous leak.
