Attachment B

WELLHEAD ABANDONMENT FORM

SITE NAME: Dinner 14 B-1 Wellhead							DATE: 7/15/2021	REM. PROJECT #: 18114	WEATHER: 80's Sunny		
SITE DIRECTIONS: HWY 85 / CR 44, 0.1 mi E, N into							CLIENT: PDC - Erin Crawford				
LEGALS AND LAT/LONG: 40.306339, -104.747187							TASMAN PERSONNEL: Jesse Marcus				
SOIL TYPES: Silty Sand - SM							SURFACE GRADIENT: Southwest				
SOIL SAMPLING							FACILITY INFRASTRUCTURE				
Date/Time	Soil Sample ID	PID (ppm)	Visual	Olfactory	Photo?	Grab or Lab Sample?	EQUIPMENT		Quantity		
							Above Ground Storage Tank (AST)				
7/15/2021 11:27	SS01@10'	1519	HC Staining	Strong HC Odor	Yes	Lab	Buried or Partially Buried Vessel				
7/15/2021 11:47	FLR01@4'	457.3	HC Staining	HC Odor	Yes	Grab	Separator				
7/15/2021 11:48	WHS01-N@0-6"	0.5	No Staining	No Odor	Yes	Grab	Emission Control Device (ECD)				
7/15/2021 11:49	WHS01-W@0-6"	2.3	No Staining	No Odor	Yes	Grab	Dump Line				
7/15/2021 11:50	WHS01-S@0-6"	0.1	No Staining	No Odor	Yes	Grab	Wellhead		1

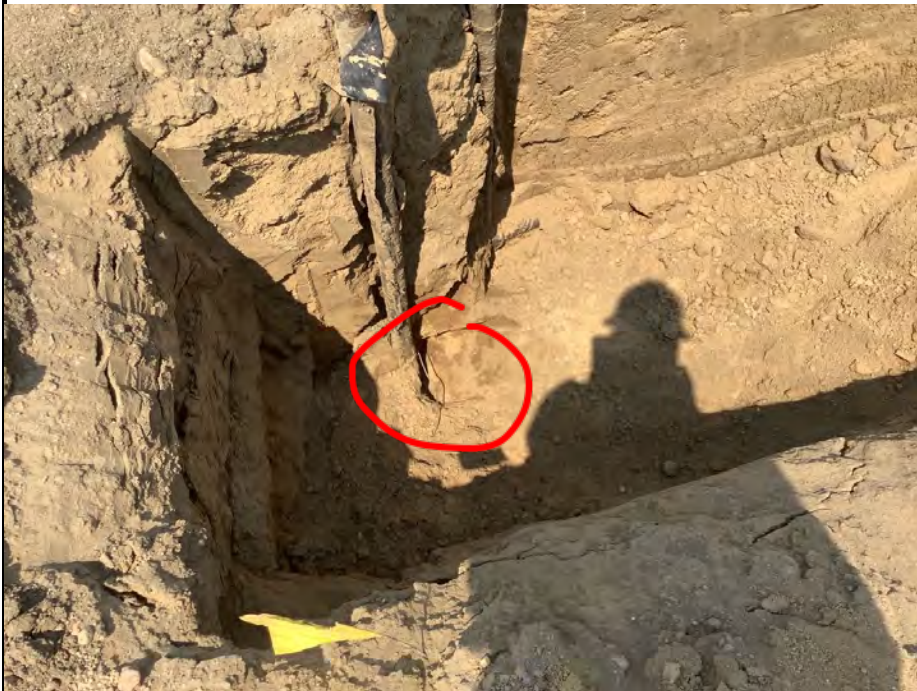
Equipment ID:		Equipment Type:		Equipment ID:		Equipment Type:			
Material:		Volume:		Material:		Volume:		Contents:	
Notes/Conditions: FL01-01 @ 4'					Notes/Conditions: FL01-02 @ 4'
