# Inspection Photos

Operator: SG INTERESTS I LTD - 77330

Location ID: 414132

Gunnison County, CO

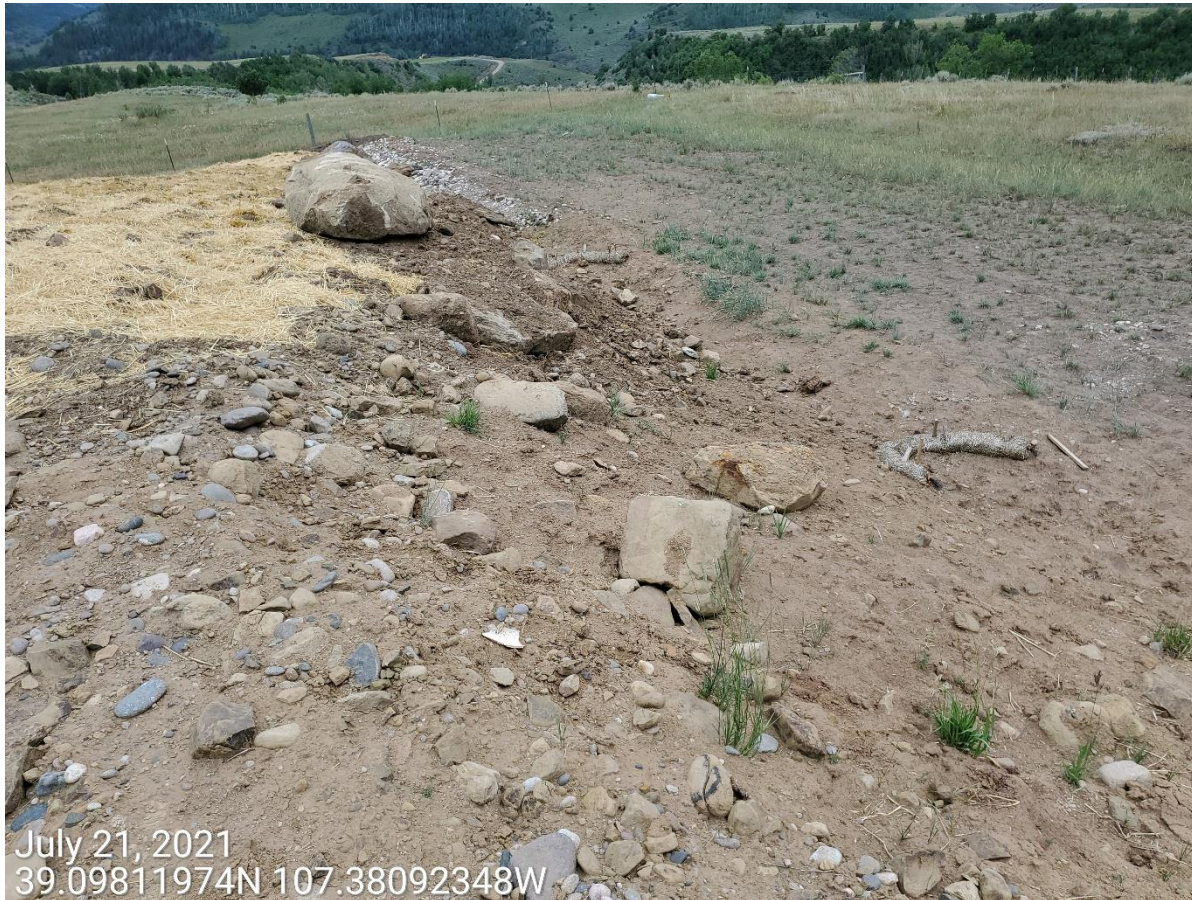
**Photo 1:** Photo taken from the west end of the Location, facing south. Photo shows control measures to protect and stabilize the slopes on the west end of the Location remain missing, or insufficient.

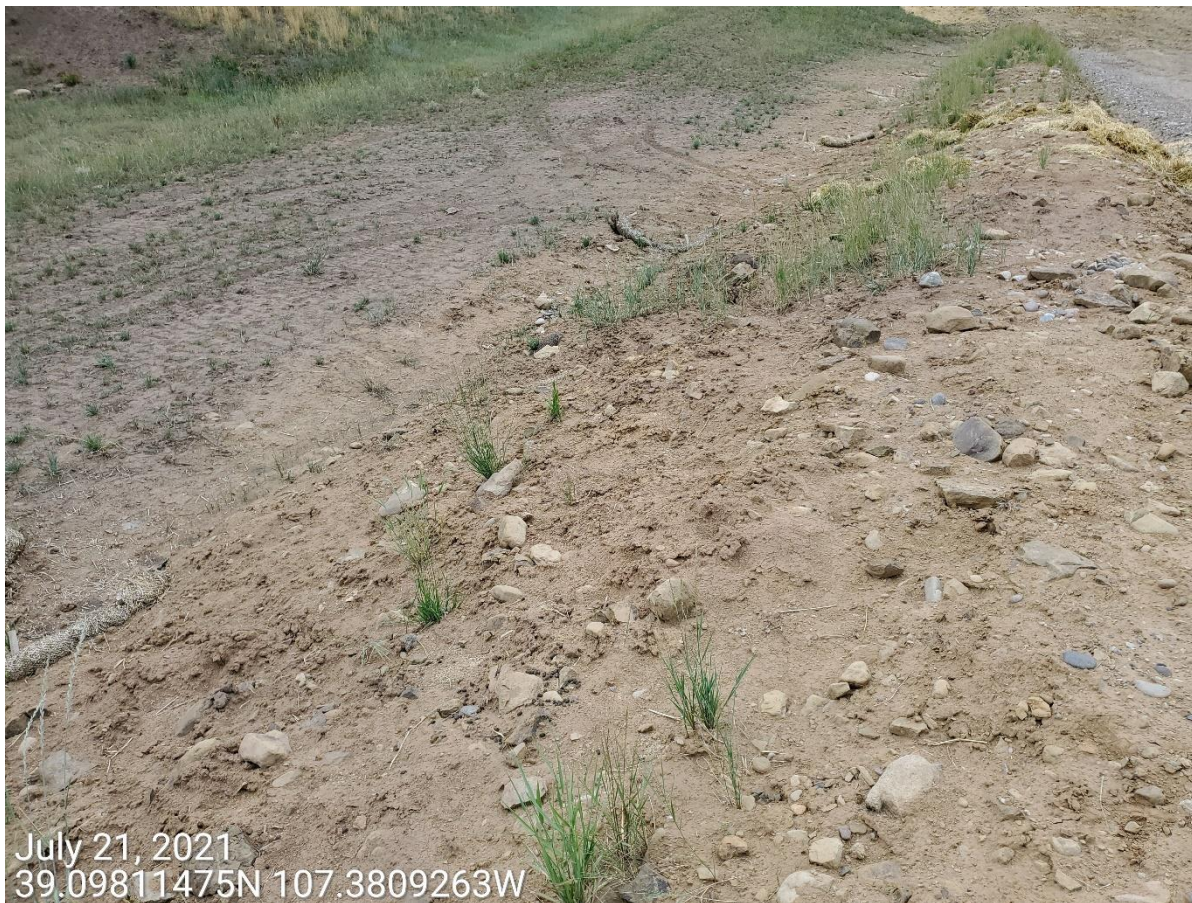
**Photo 2:** Photo taken from the west end of the Location, facing northwest. Photo shows control measures to protect and stabilize the slopes on the west end of the Location remain missing, or insufficient.

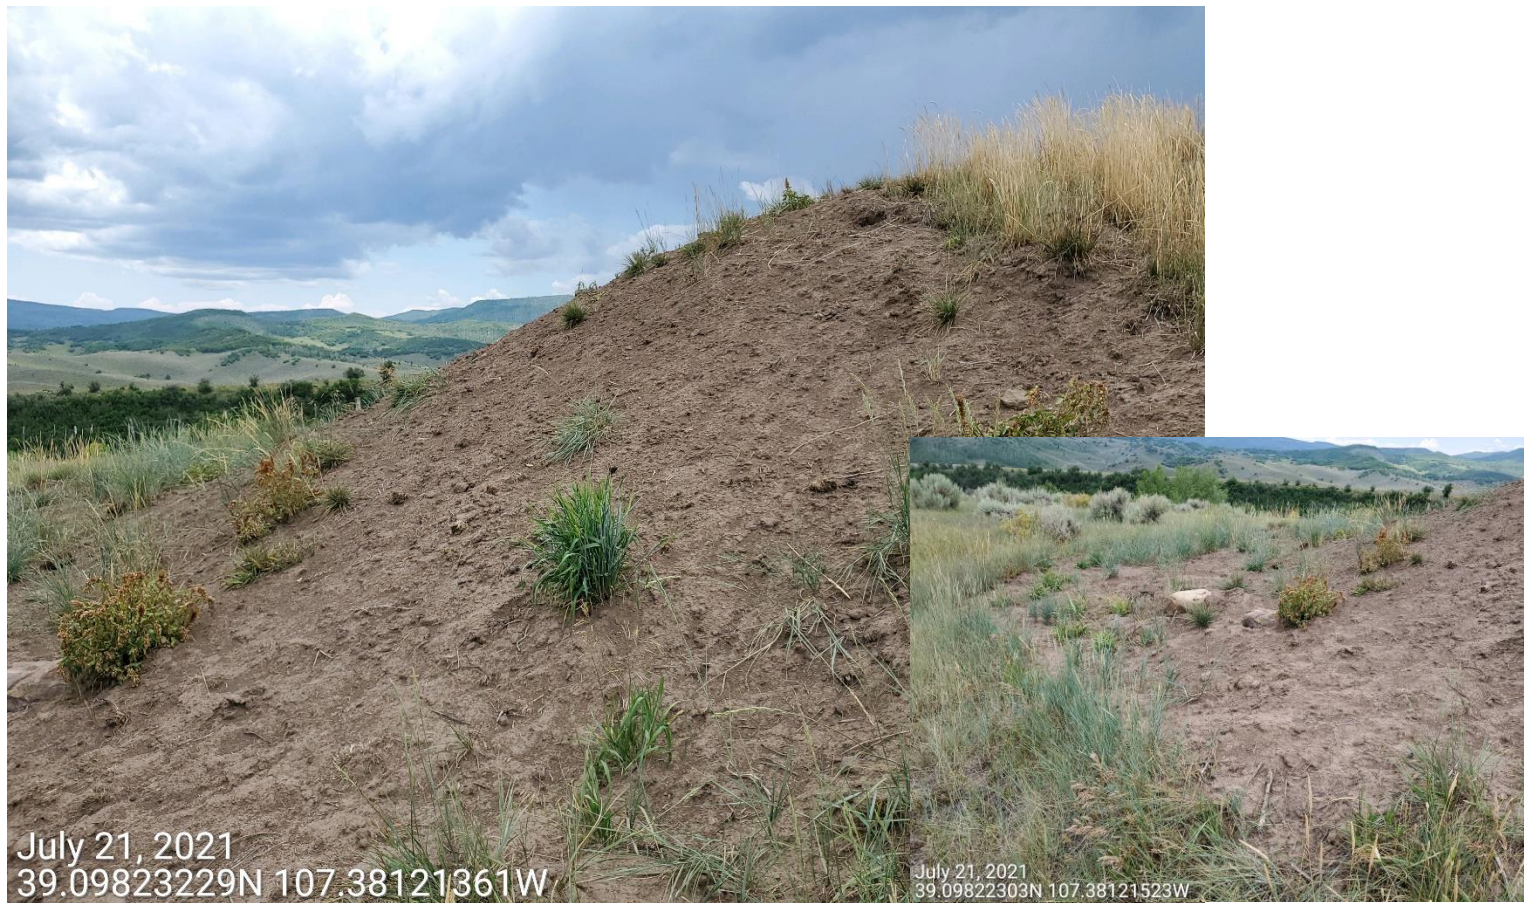
**Photo 3:** Photo taken from the topsoil stockpile on the northwest end of the Location. Photos show control measures to protect and stabilize the soils at the stockpile remain missing, or insufficient.

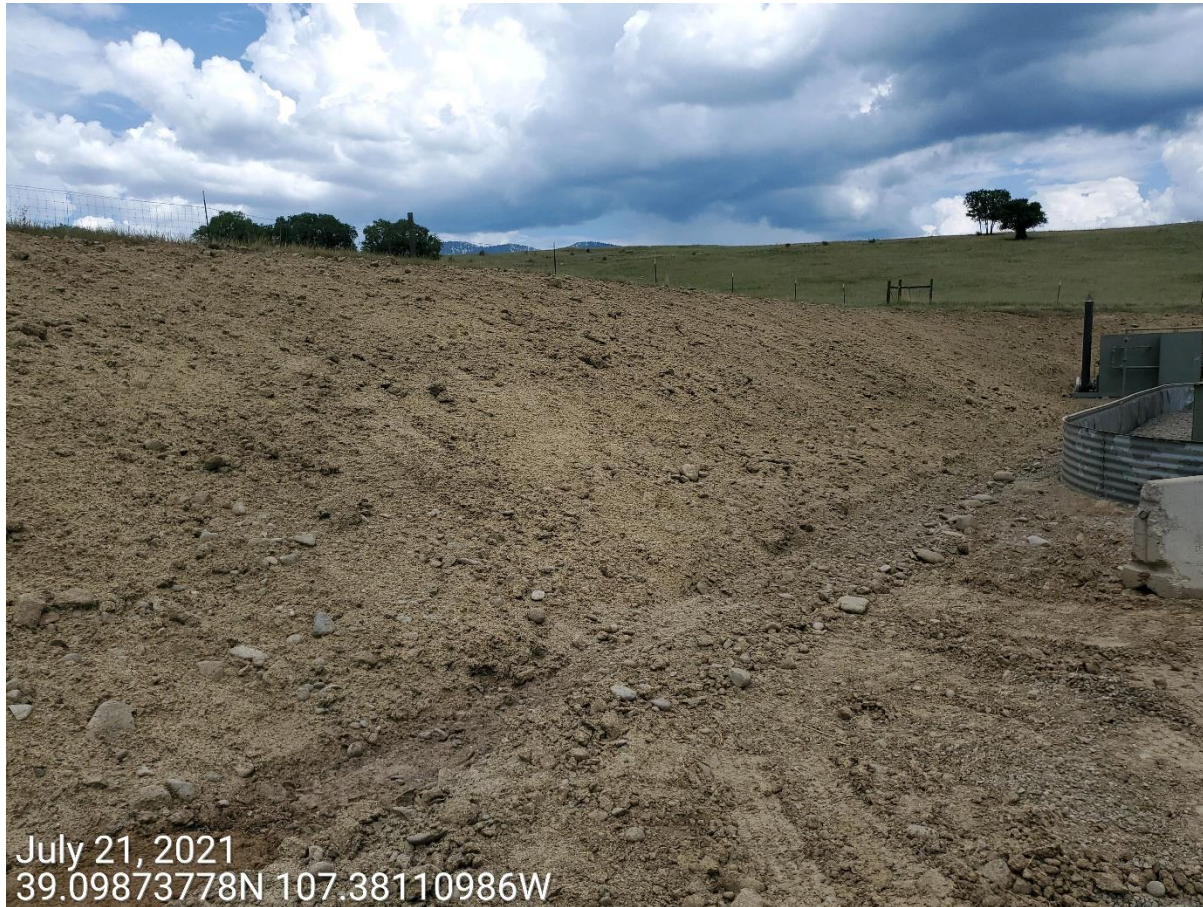
July 21, 2021  
39.09873778N 107.38110986W

**Photo 4:** Photo taken from the cuts lope on the north end of the Location, facing northeast. Photo shows slopes have been regraded, and a hydromulch applied to stabilize the soils. This portion of the CA has been addressed.

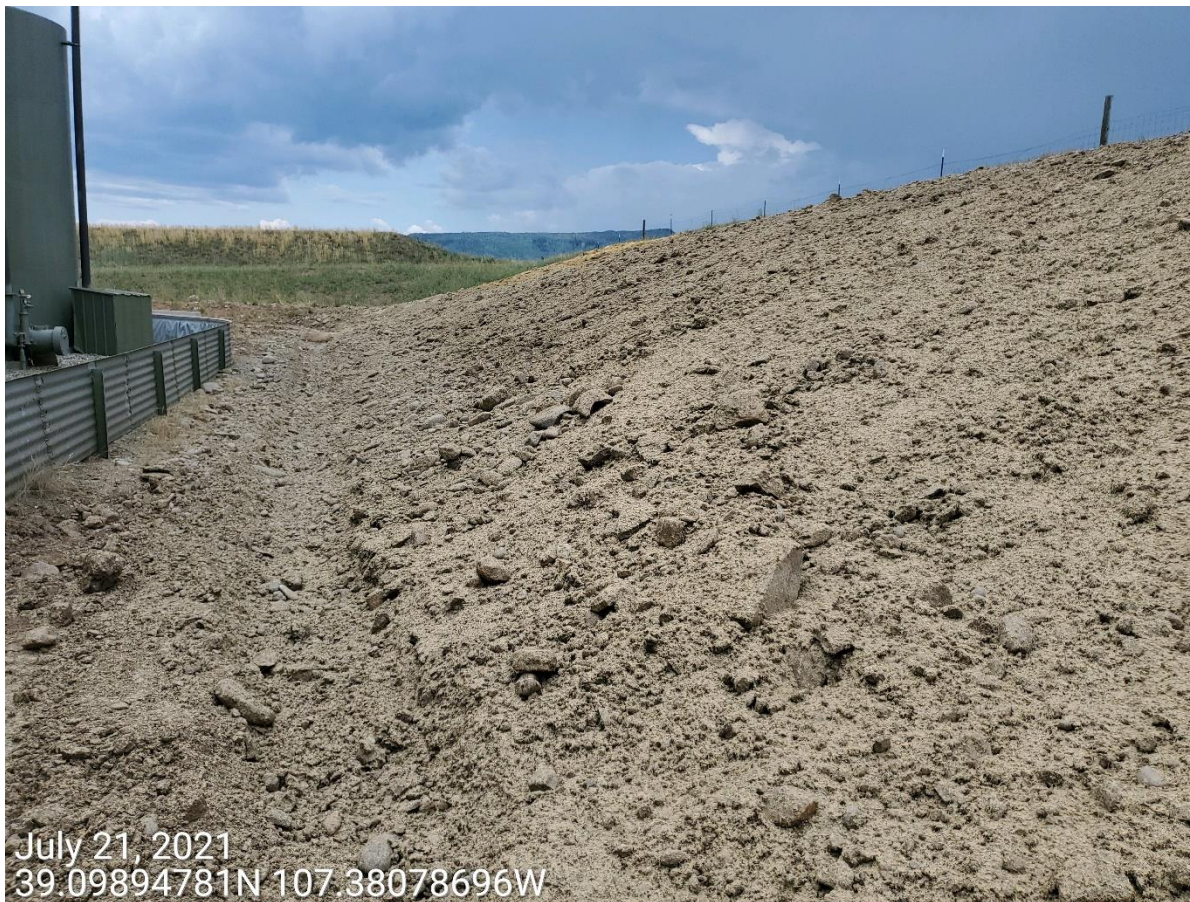
**Photo 5:** Photo taken from the cuts lopes on the north end of the Location, facing west. Photo shows slopes have been regraded, and a hydromulch applied to stabilize the soils. This portion of the CA has been addressed.
