# Inspection Photos

Operator: CAERUS PICEANCE LLC - 10456

Location ID: 414880

COGCC

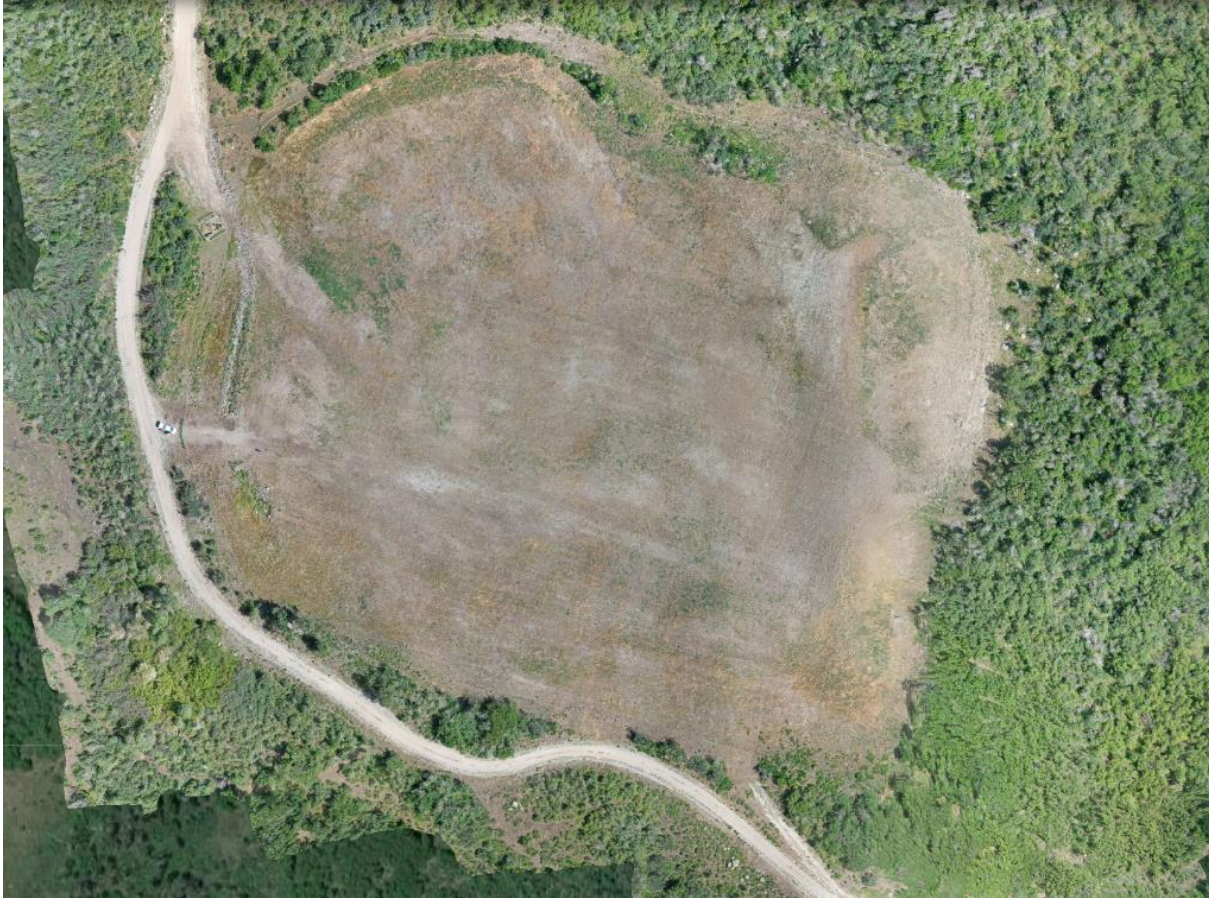
**Photo 1:** On 7/22/2021, Reclamation Specialist mapped the Location with the use of a small UAS. Photo shows aerial image of the location.

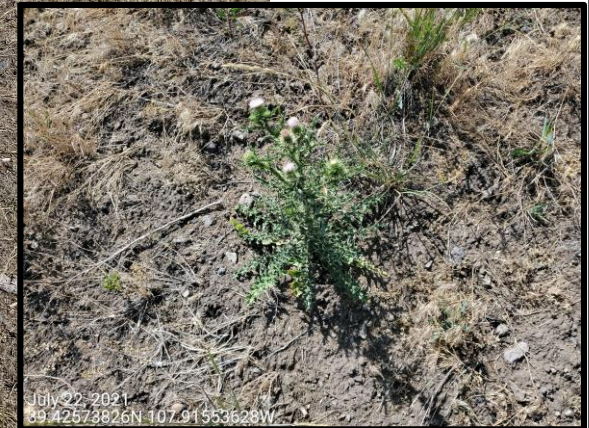
**Photo 2:** Photo taken from the Location. Photo provides example of noxious weeds observed remaining on the Location. Noxious weeds observed appears to be Plumeless thistle, houdstongue and bindweed.

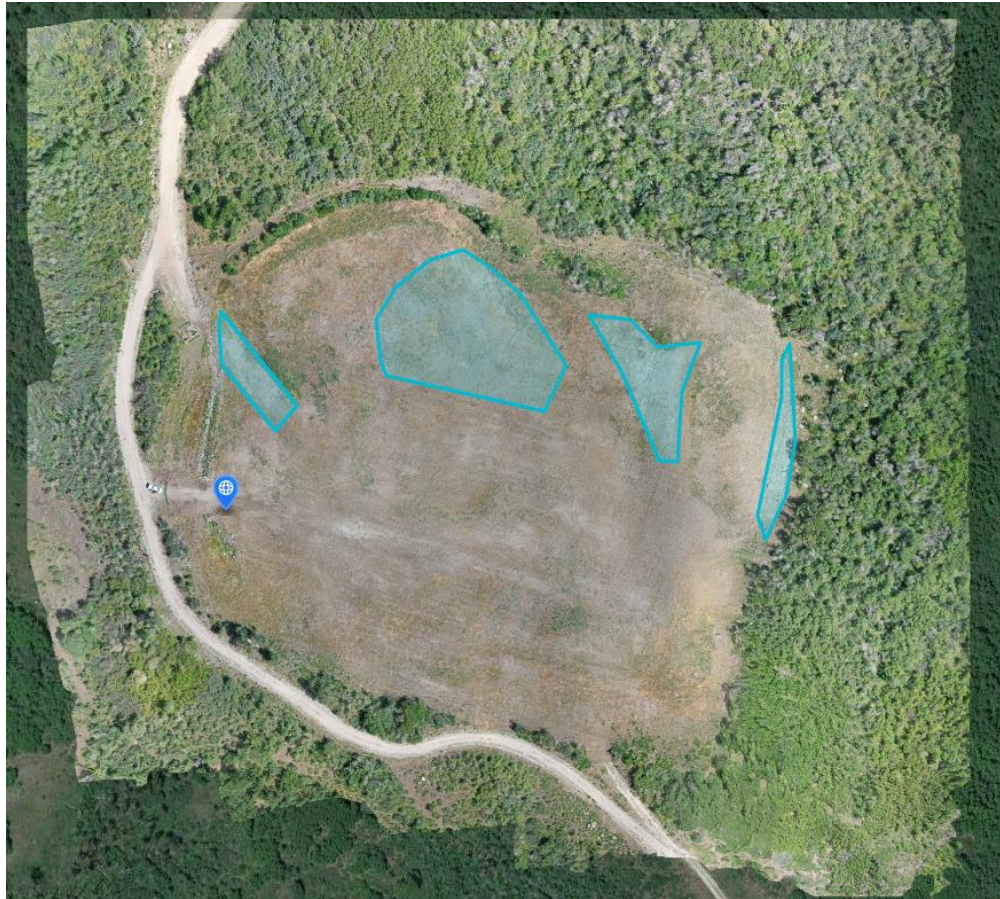
**Photo 3:** Photo shows example of areas on the north/northeast end of the Location where desirable plant germination/establishment was not evident, or not progressing towards 1004 Standards.

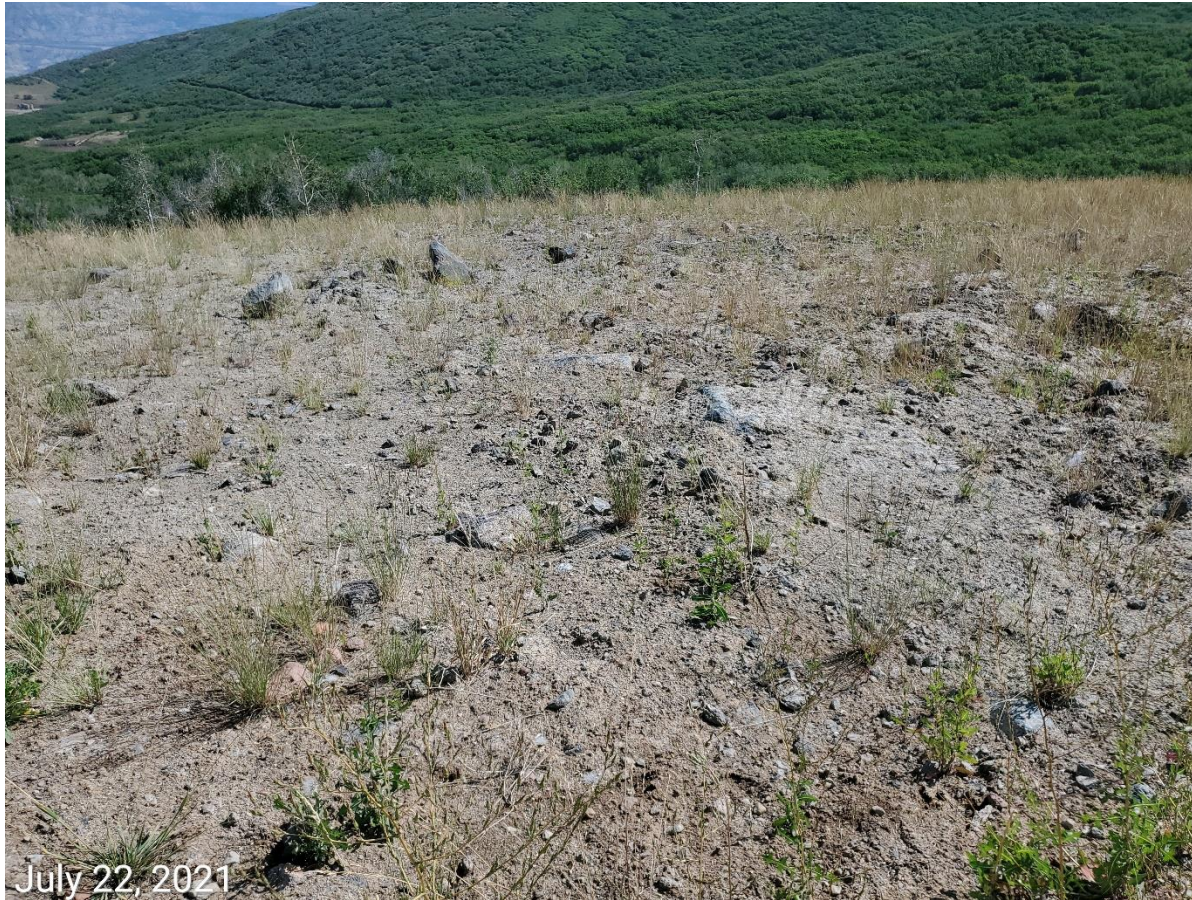
**Photo 3.b:** It was observed that areas on the north/northeast end of the Location is not progressing towards 1004 standards. Photo shows example of areas observed.

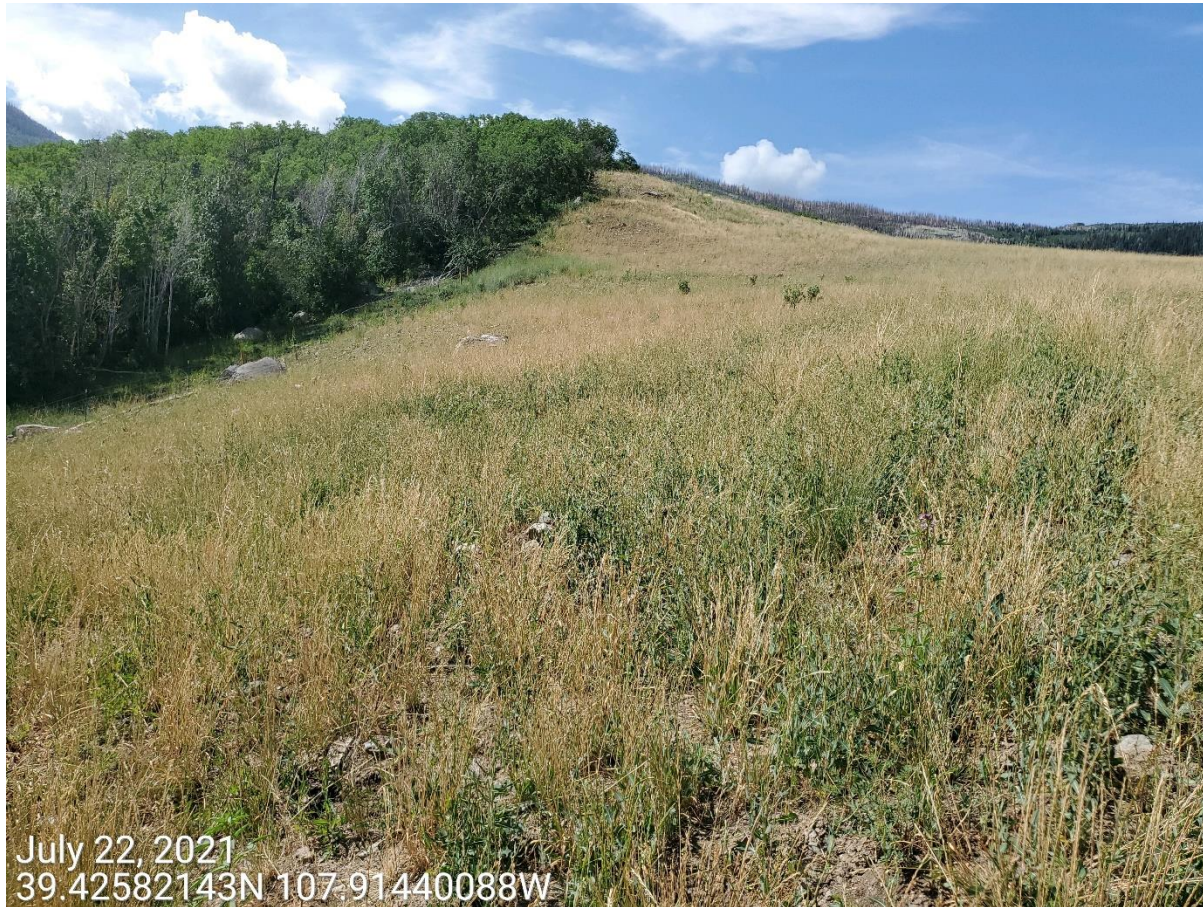
**Photo 4:** Photo taken from the east end of the Location, facing south. Photo shows example of areas observed where reclamation is progressing towards 1004 standards.

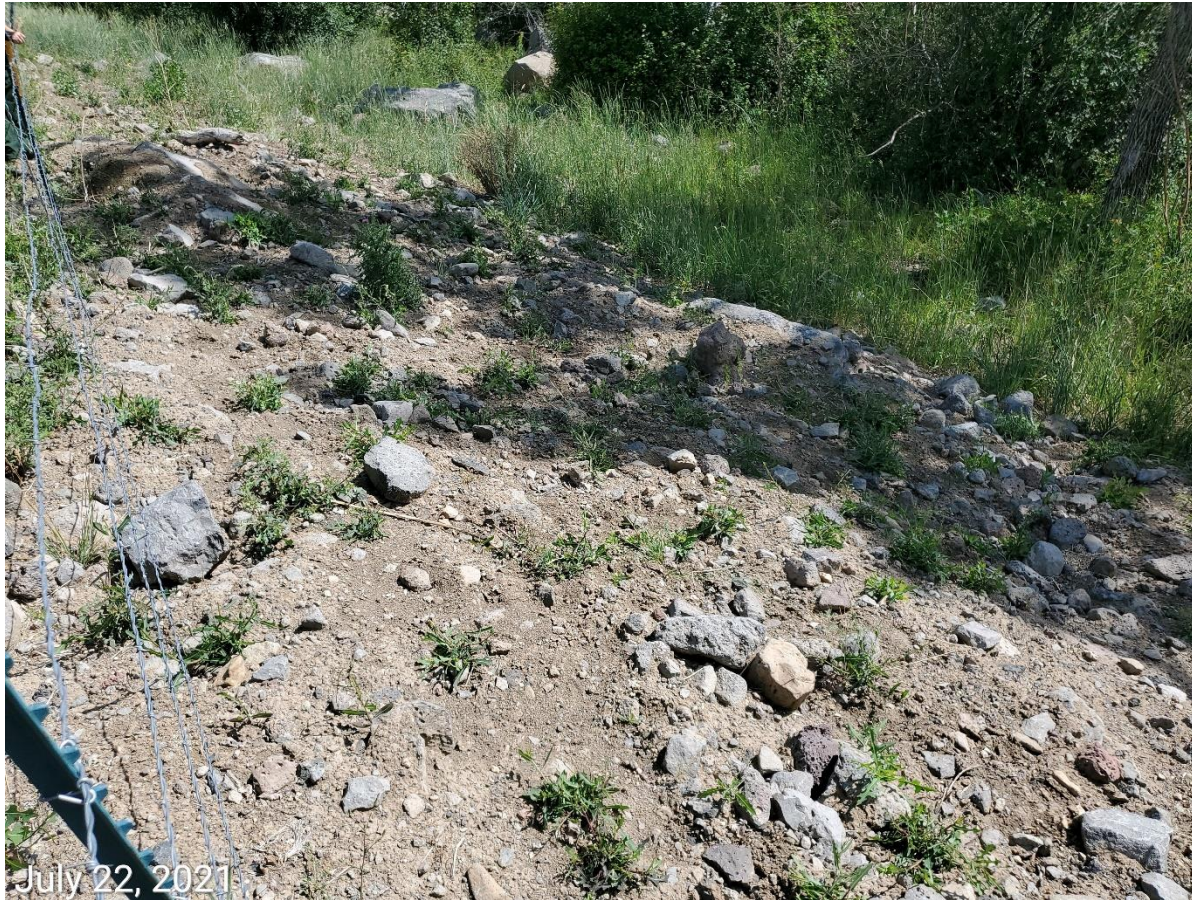
**Photo 5.b:** Photo shows areas of the Location's disturbance, on the east side of the fence line, that is not progressing towards 1004 standards.

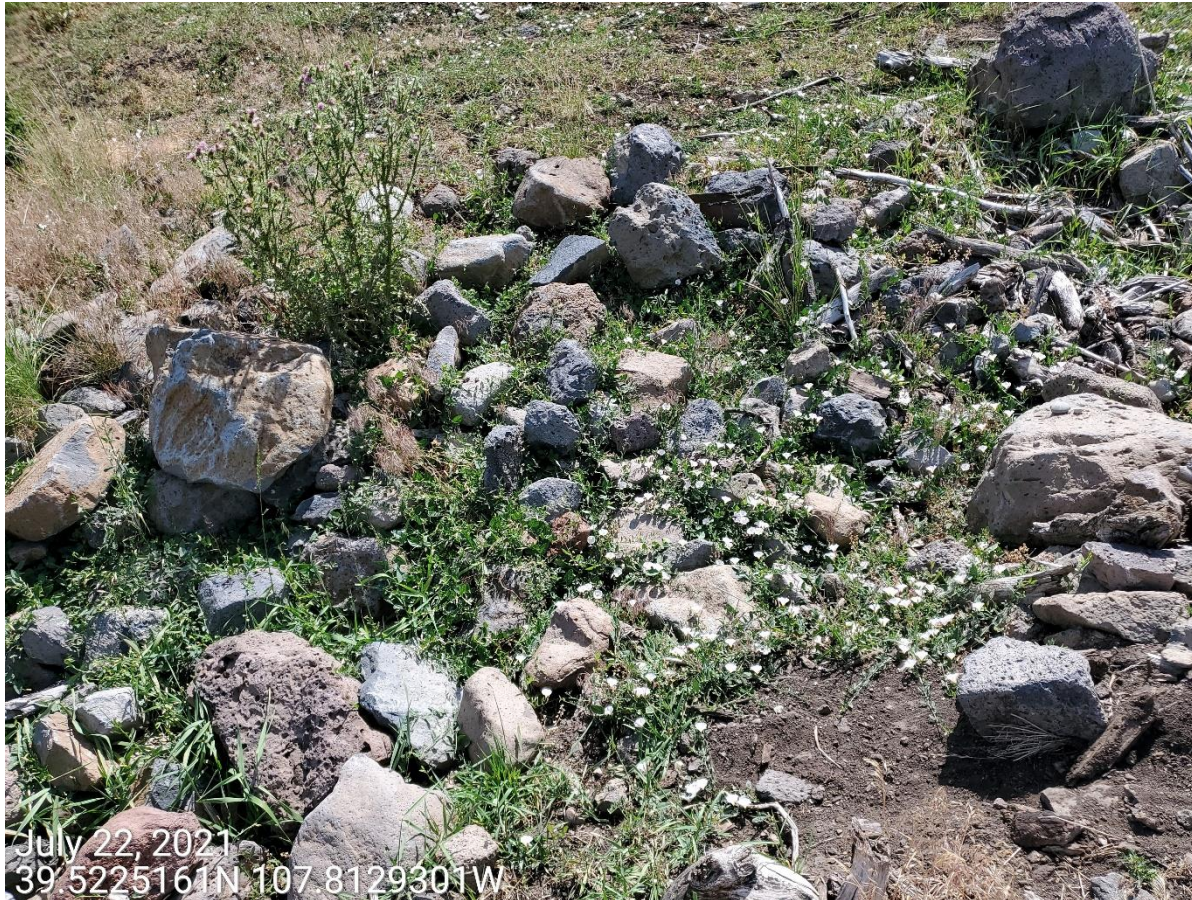
**Photo 6:** Photo shows noxious weed (bindweed) establishment observed on the northwest end of the Location.

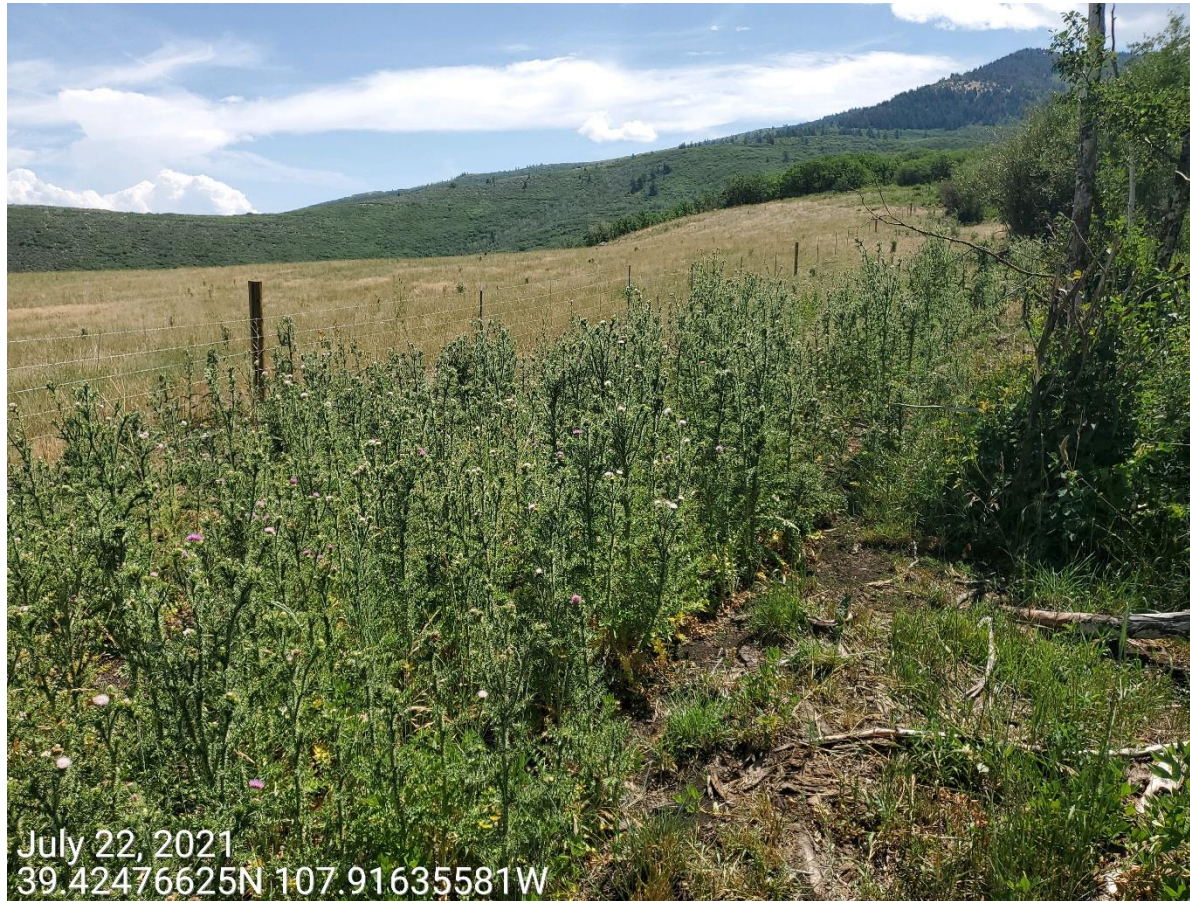
July 22, 2021  
39.42476625N 107.91635581W

**Photo 7:** Photo shows noxious weed establishment (Plumeless thistle) along the fence on the south end of the Location.

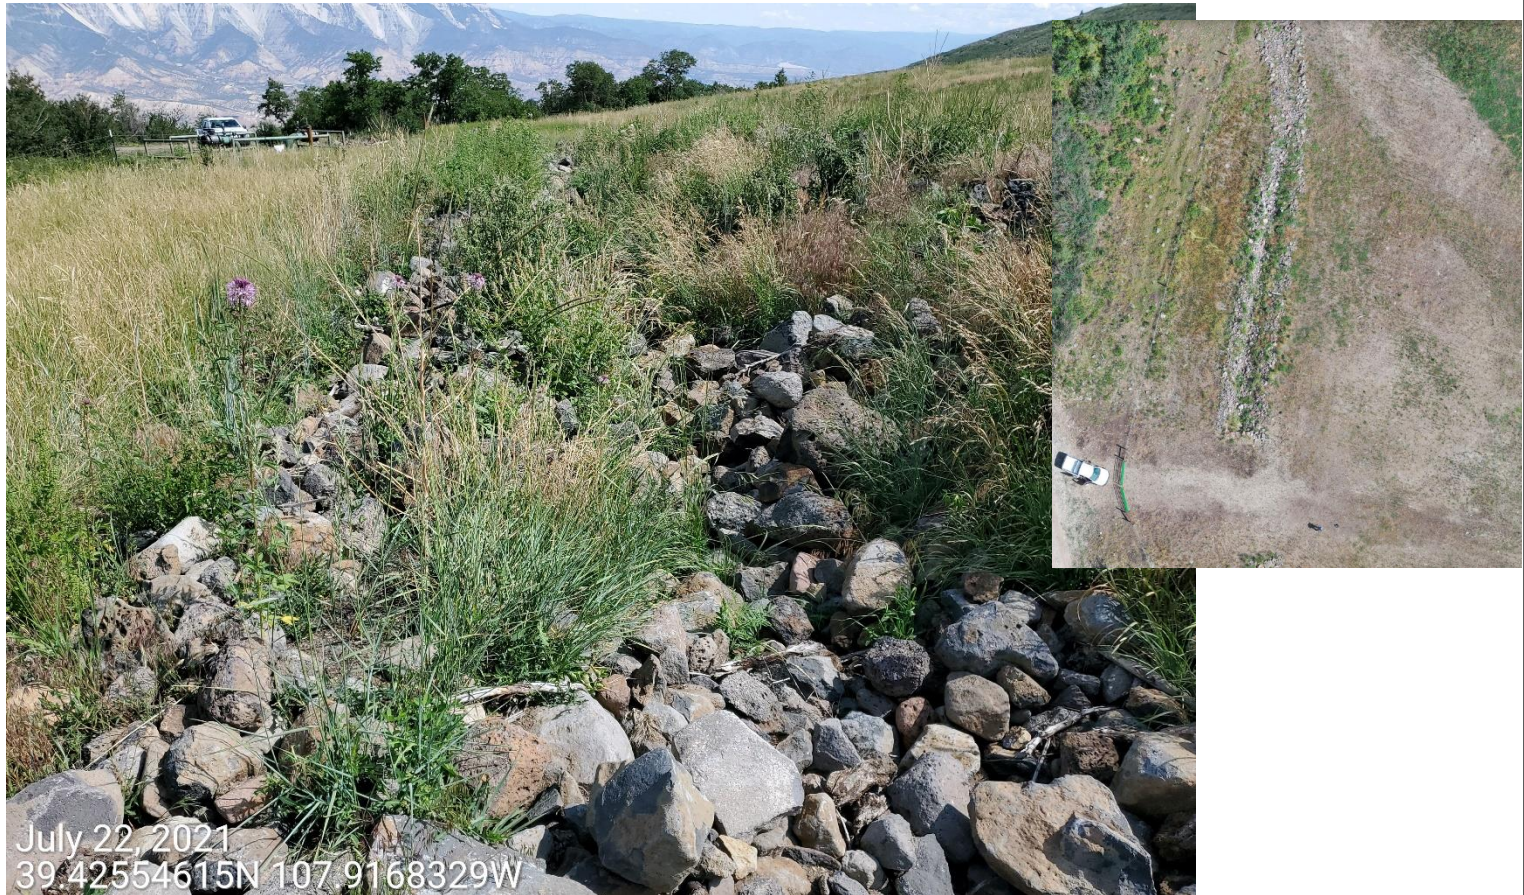
**Photo 8:** Shows stormwater diversion ditch remaining on the west end of the Location. Ditch should be removed/reclaimed if no longer required; ditch and culvert will required removal for site to receive a passing final inspection.

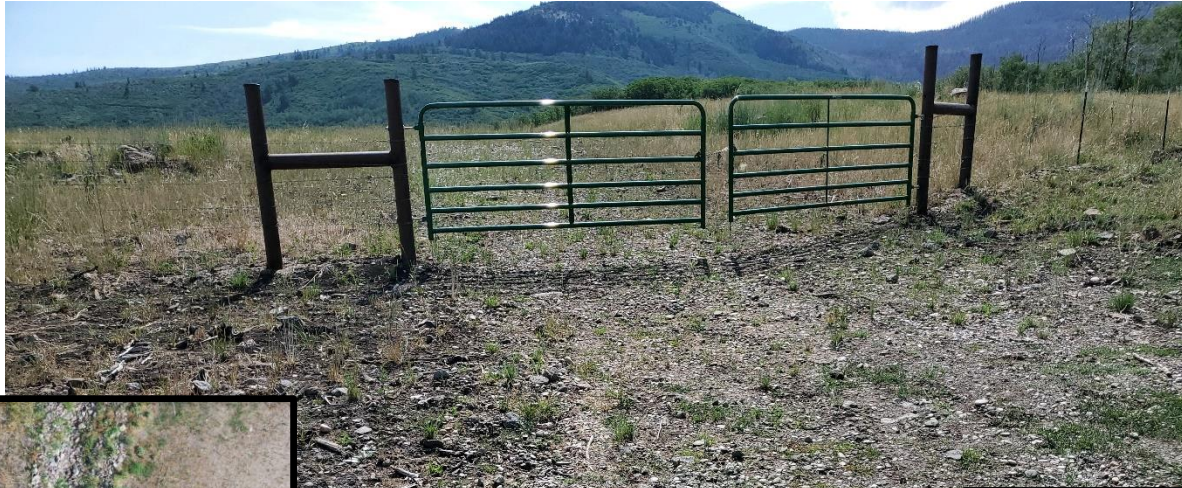
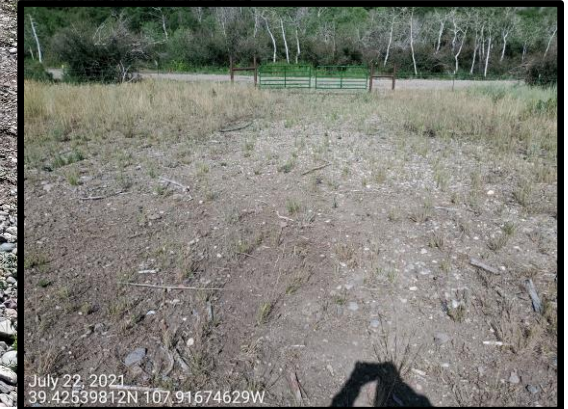
**Photo 9:** Photo taken from the Location entrance on the east end of the Location. Photo shows areas of the entrance has not been reclaimed in accordance with 1004 Rules; gravel/road base and culvert remaining. Areas require reclamation.

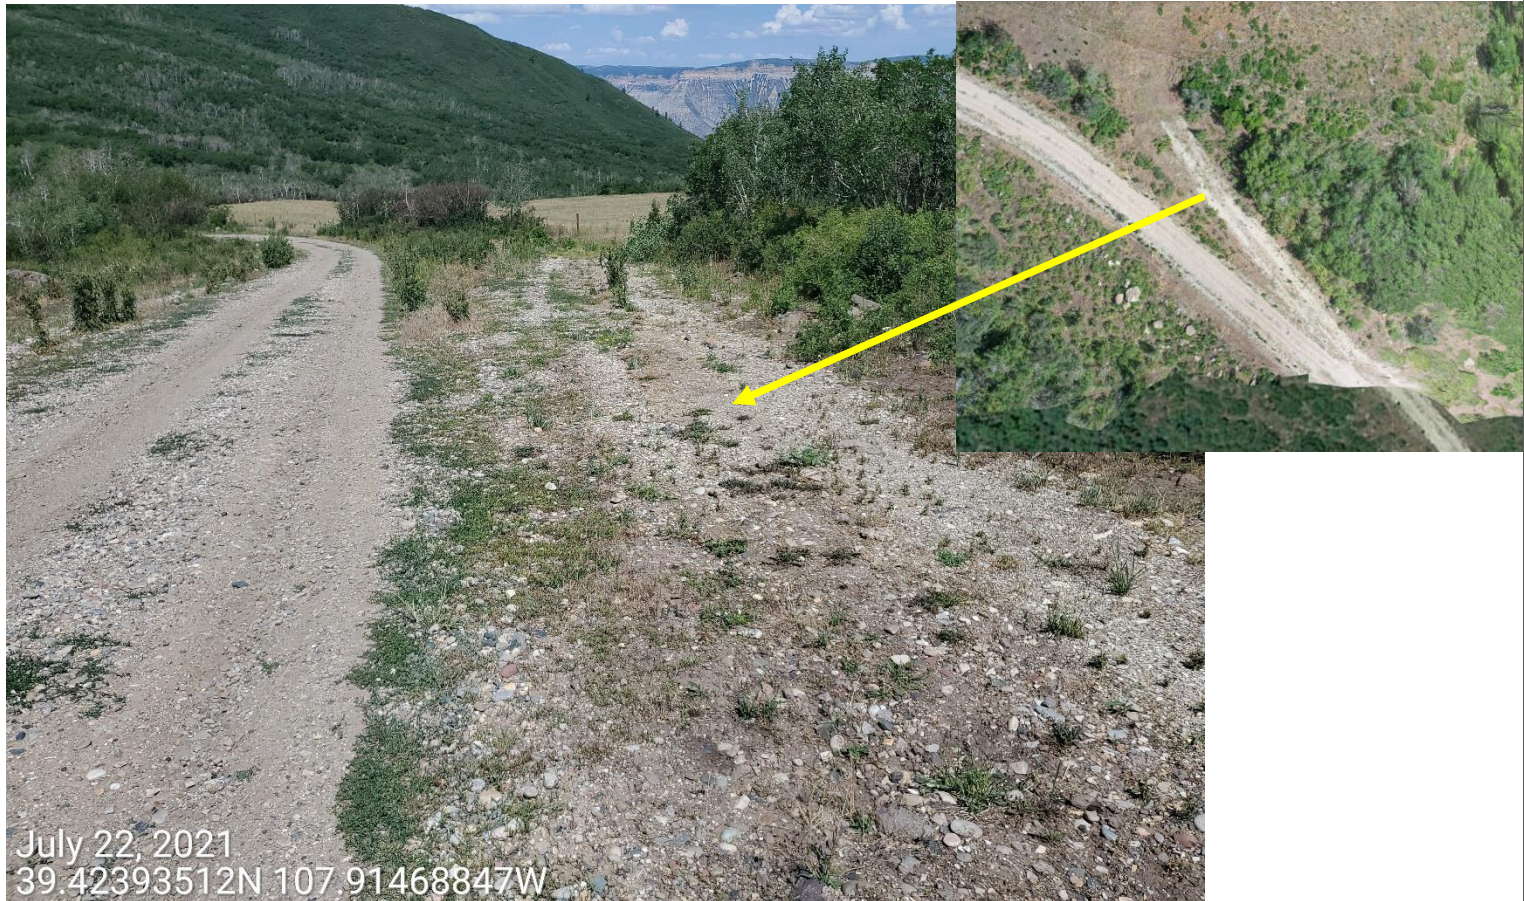
July 22, 2021  
39.42393512N 107.91468847W

**Photo 10:** Photo taken from the south end of the Location, facing north. Photo shows the former access road leading into the Location has not been entirely reclaimed. Road requires reclamation.
