Inspection Photos

Operator: TEP ROCKY MOUNTAIN LLC - 96850

Location ID: 334713

Garfield County, CO

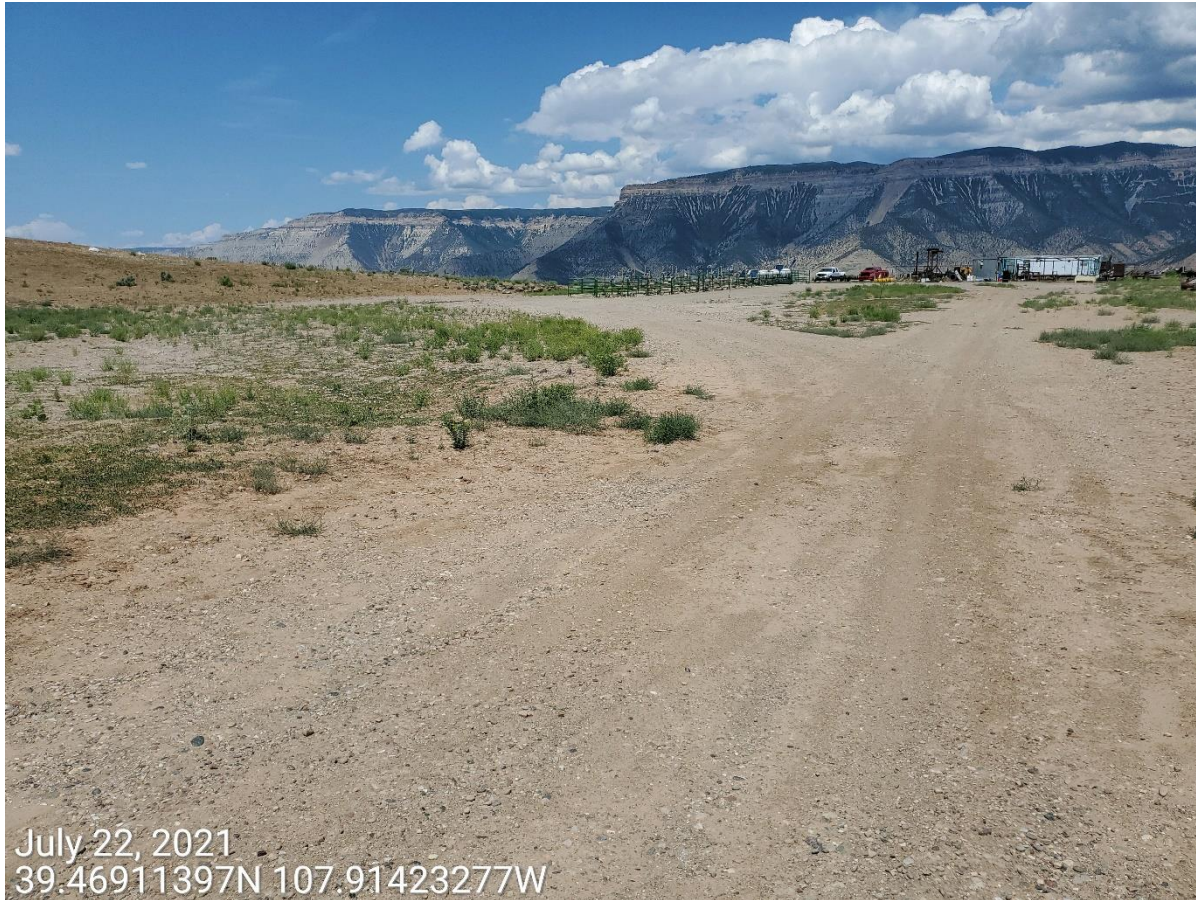
Photo 1: Photo taken from the south end of the Location, facing north. Photo provides overview of the Location. Green vegetation in photo observed to be undesirable plant species (*Kochia* sp., *Salsola* sp.) established on the Location; weeds require management in accordance with Rule 606.c.

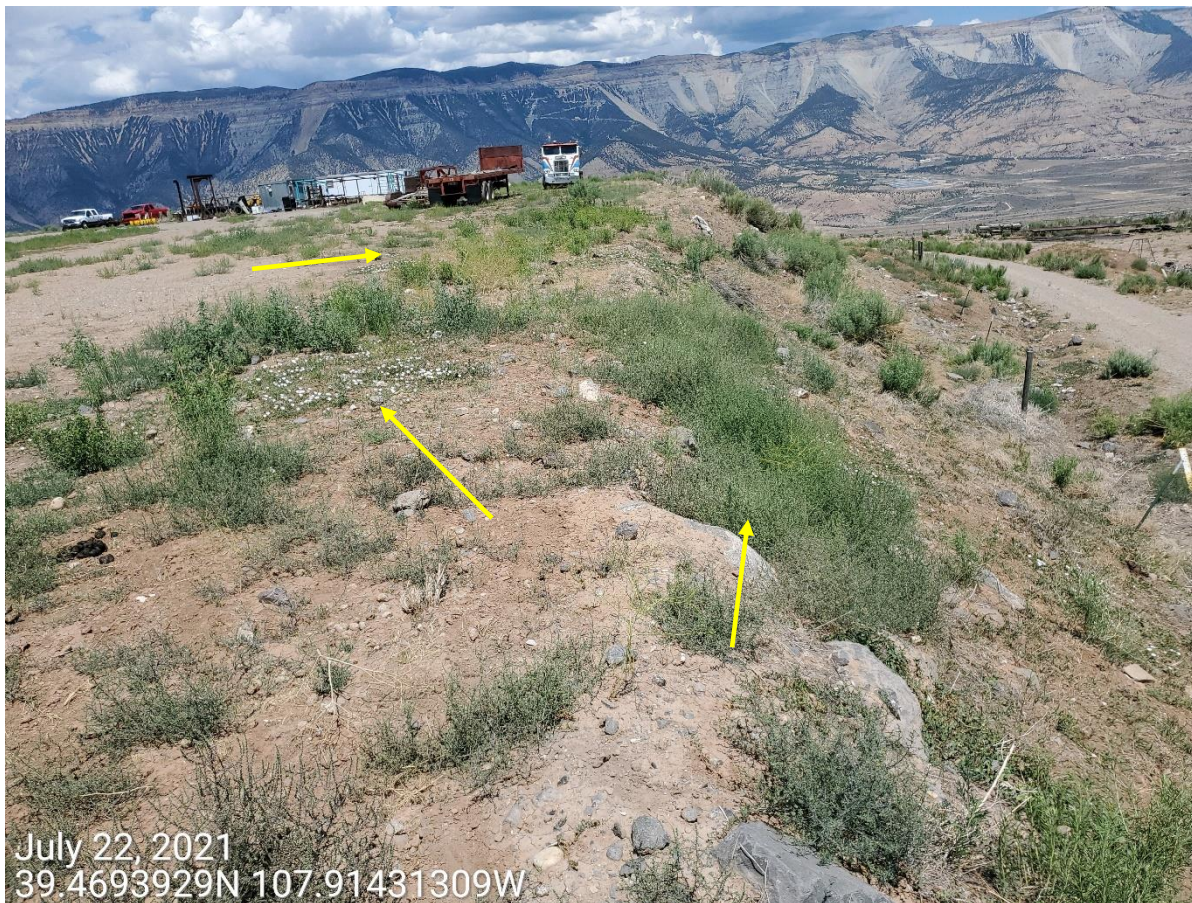
Photo 2: Photo taken from the east end of the Location, facing north. Photo shows noxious weeds and undesirable plant species (*Kochia* sp., *Salsola* sp.) established on the Location; weeds require management in accordance with Rule 606.c and Rule 1003.f.

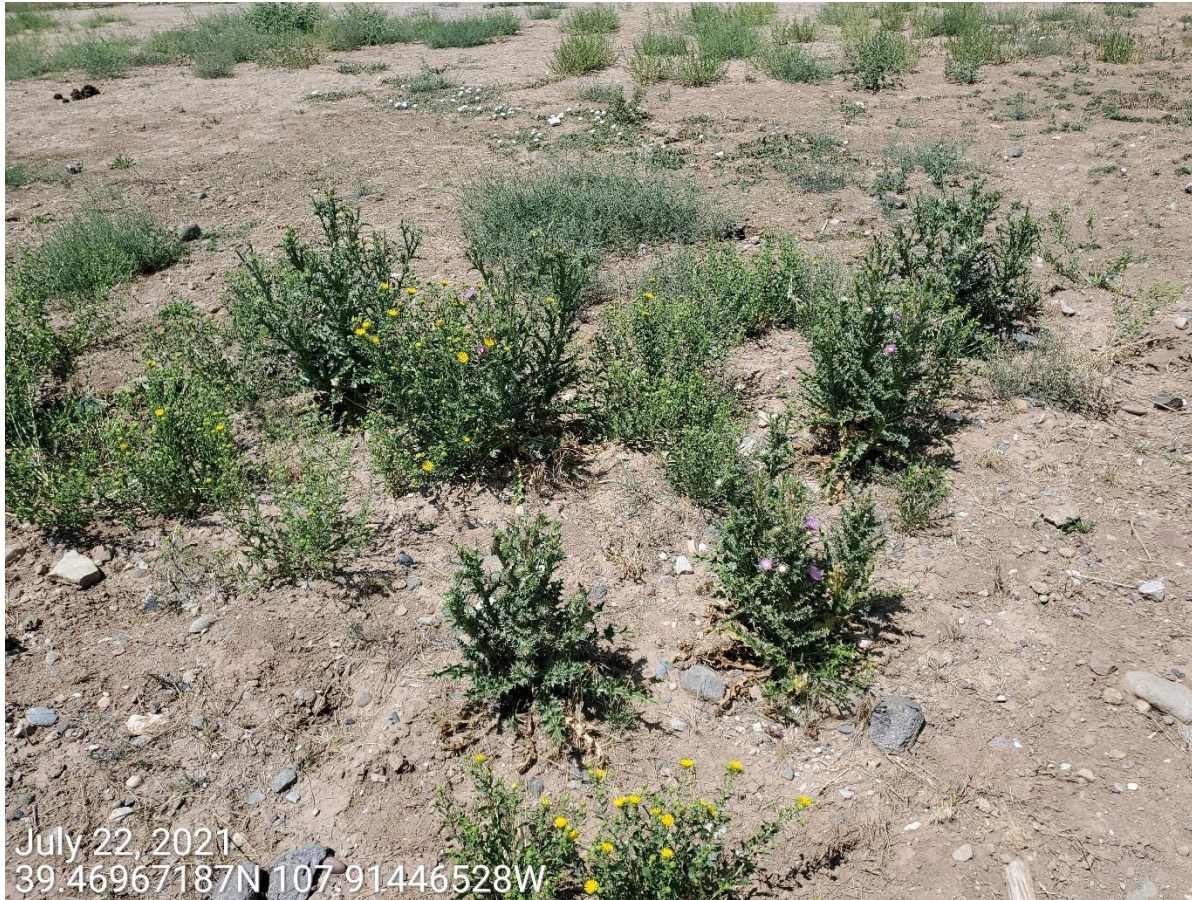
Photo 3: Photo shows noxious weeds established on the Location.

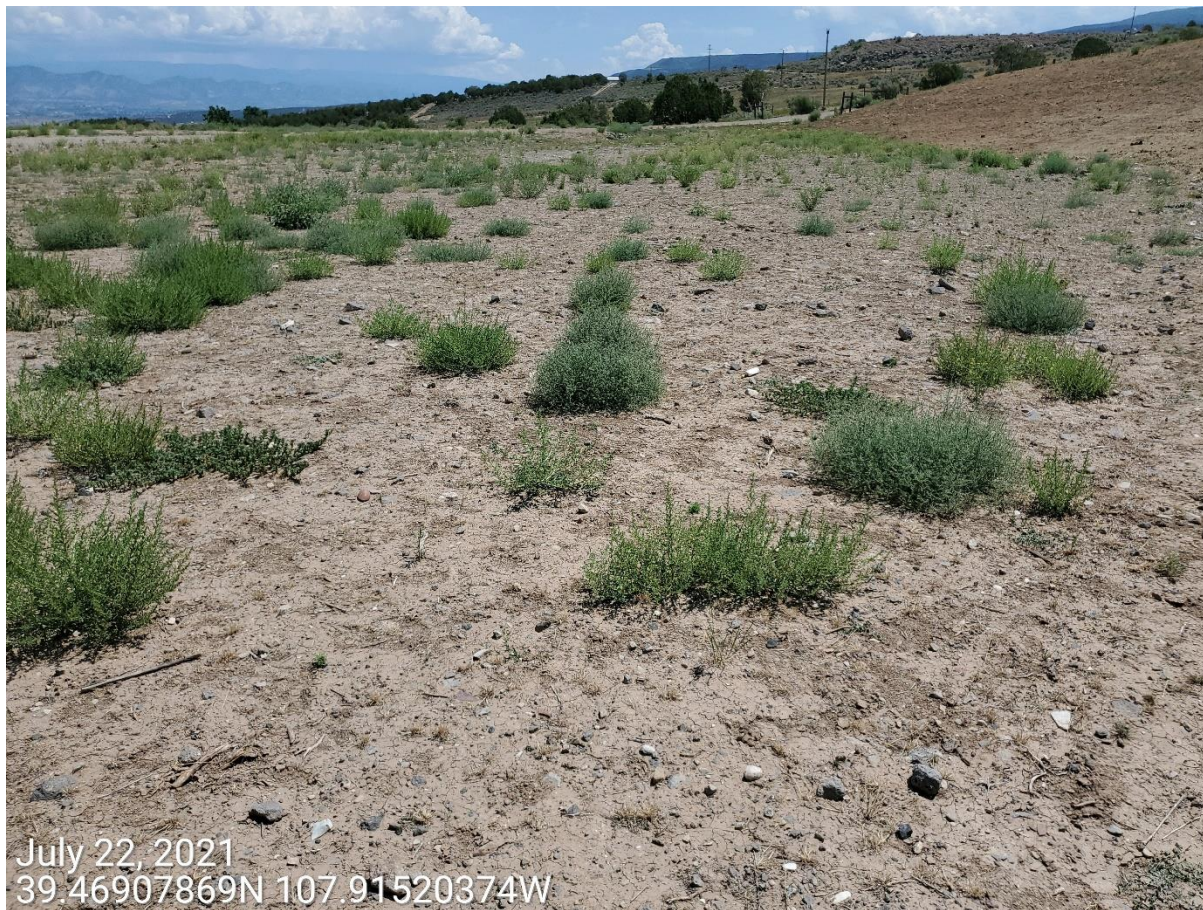
Photo 4: Photo taken from the southwest corner of the Location, facing east. Photo shows example of Undesirable Plant Species (Kochia sp., Salsola sp.) established on the Location.

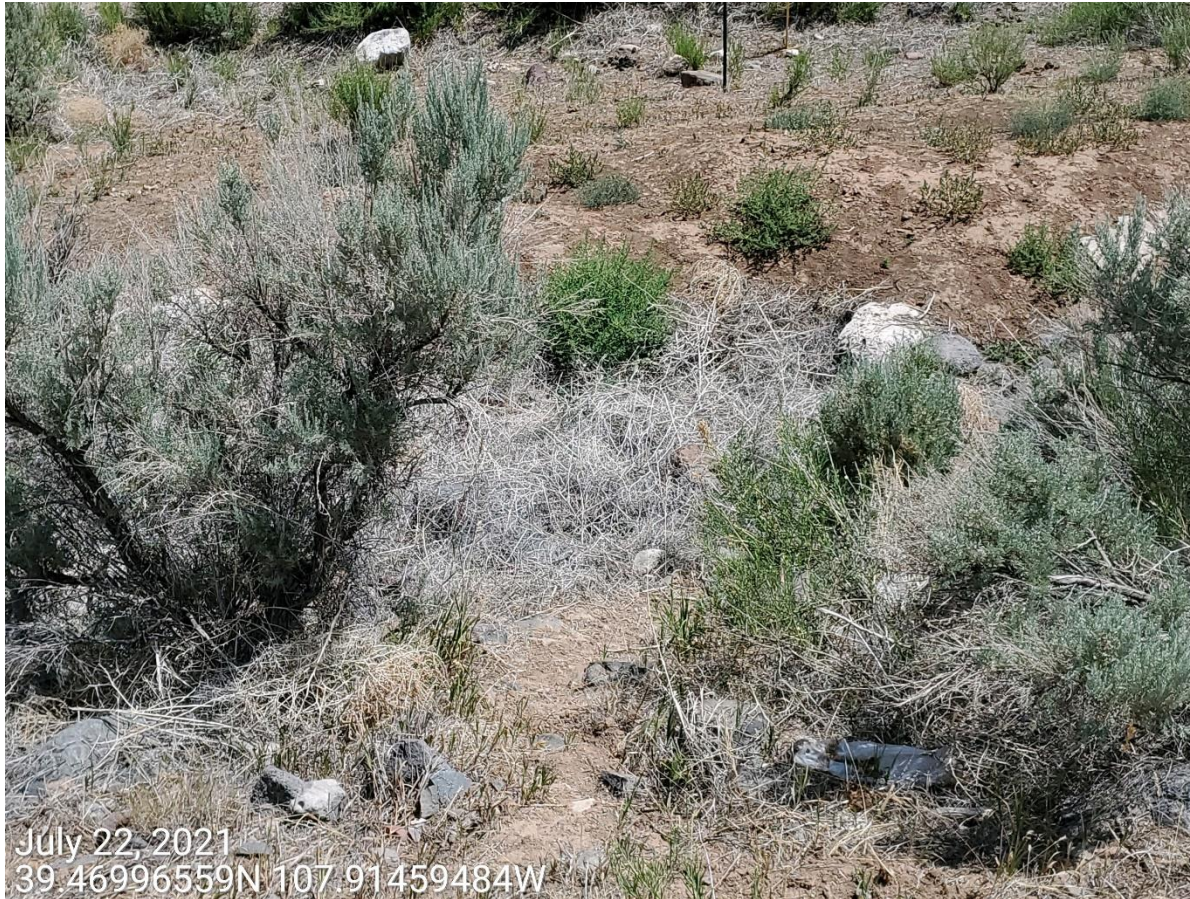
Photo 5: Photo taken from the west end of the Location. Photo shows example of weed debris accumulation observed within the vegetation and on the slopes of the Location.

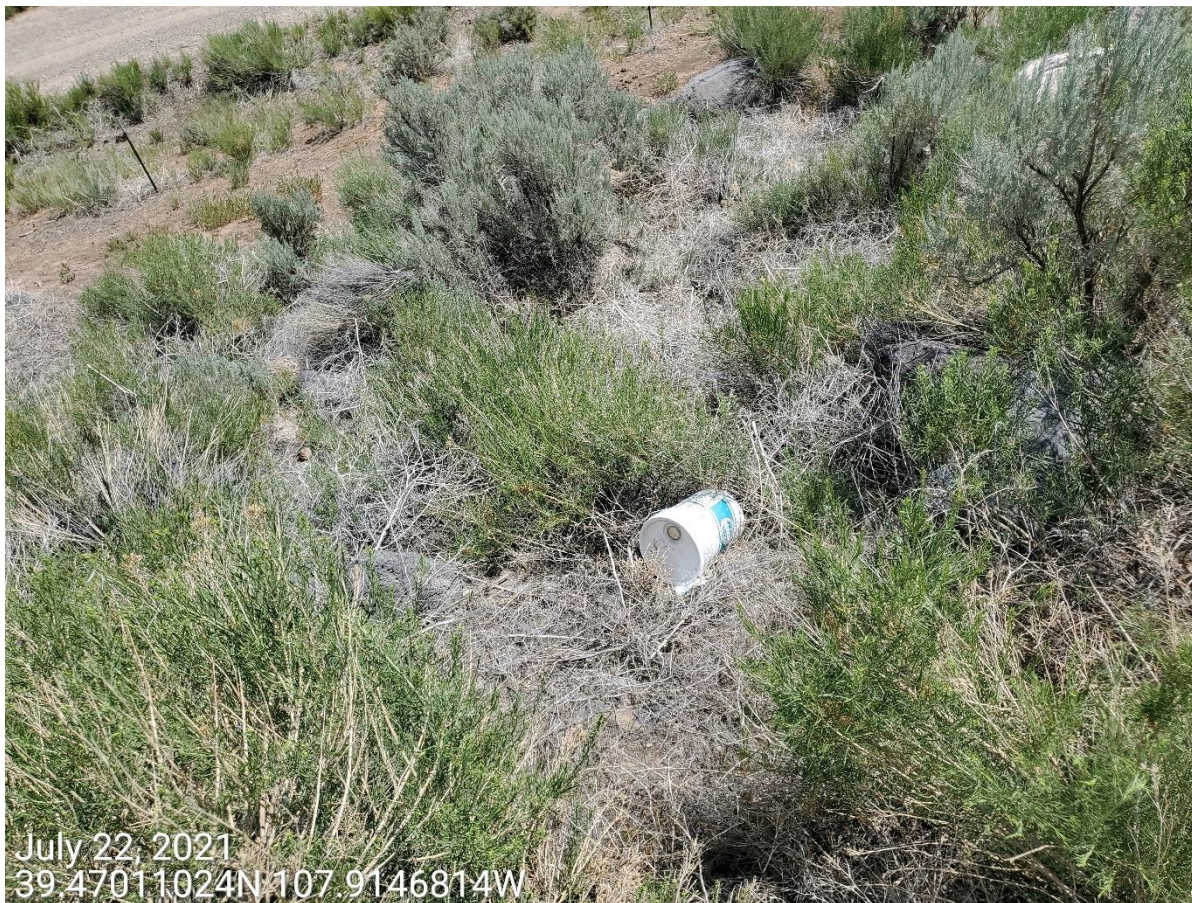
Photo 6: Photo taken from the west end of the Location. Photo shows example of weed debris accumulation and trash observed within the vegetation and on the slopes of the Location.

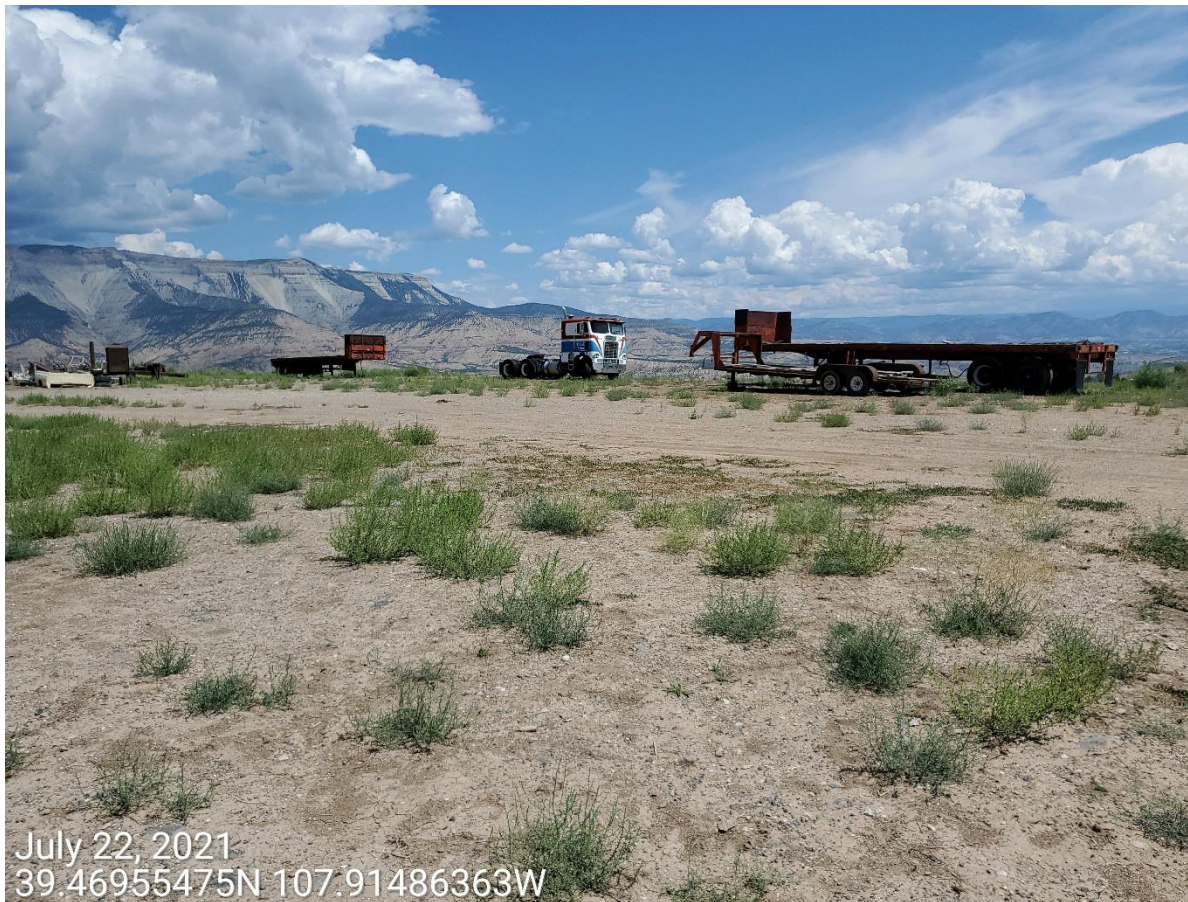
July 22, 2021
39.46955475N 107.91486363W

Photo 7: Photos 7-9 shows various equipment, vehicles, trailers, and trash observed stored on the north end of the Location. Pursuant to Rule 606, storage of equipment, vehicles, trailers, etc... not necessary for use on the Location is prohibited.
