# Inspection Photos

Operator: TEP ROCKY MOUNTAIN LLC - 96850

Location ID: 475753

Garfield County, CO

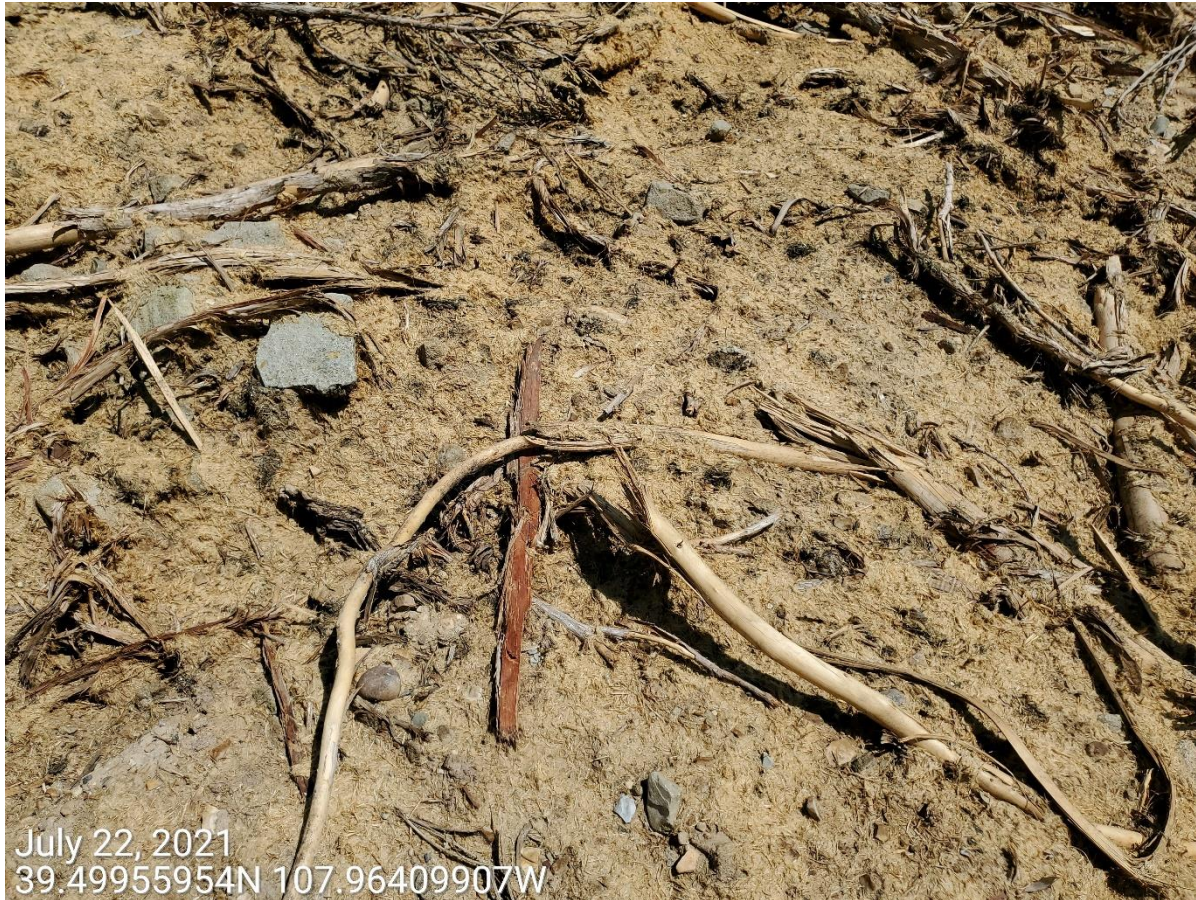
**Photo 1:** Photo taken from the interim areas of the Location. Location reclaimed Spring 2021; desirable plant germination was largely not observed on the interim areas. Additional seeding may be required to ensure Location progresses towards 1003 standards.

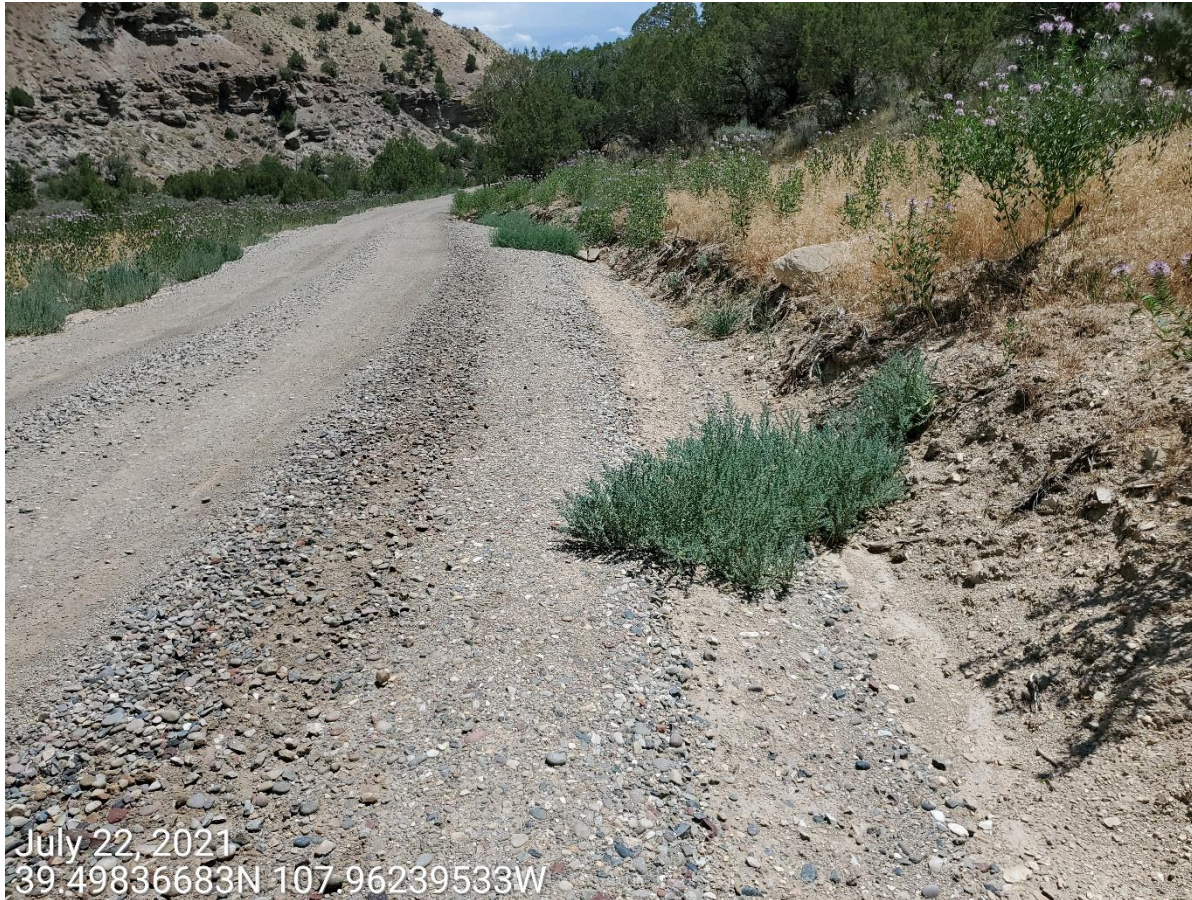
**Photo 2:** Photo taken from the access road. Photo shows example of noxious weeds (Halogeton) observed along the access road.

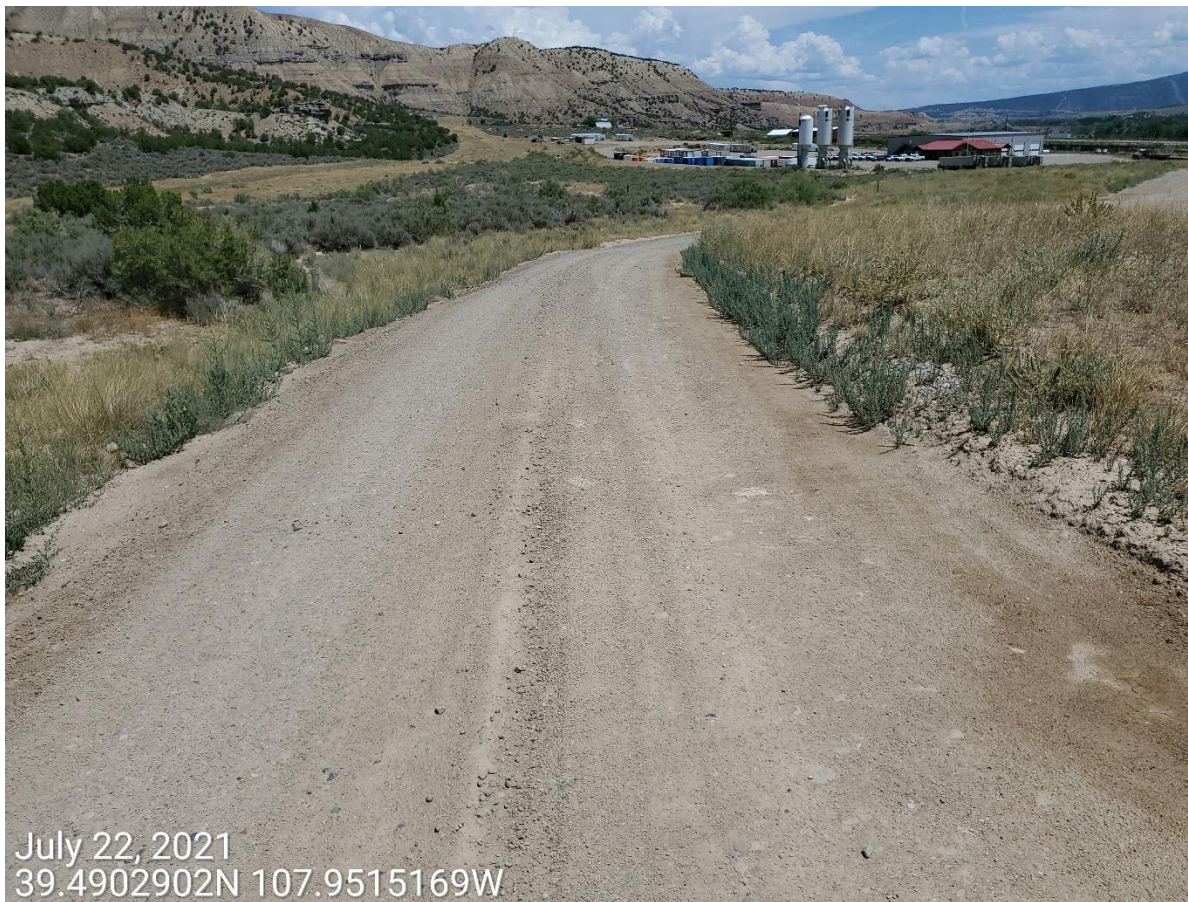
**Photo 3:** Photo taken from the access road. Photo shows example of noxious weeds (Halogeton) observed along the access road.
