Inspection Photos

7/22/2021

Operator: CAERUS PICEANCE LLC #10456

Location ID: 335822

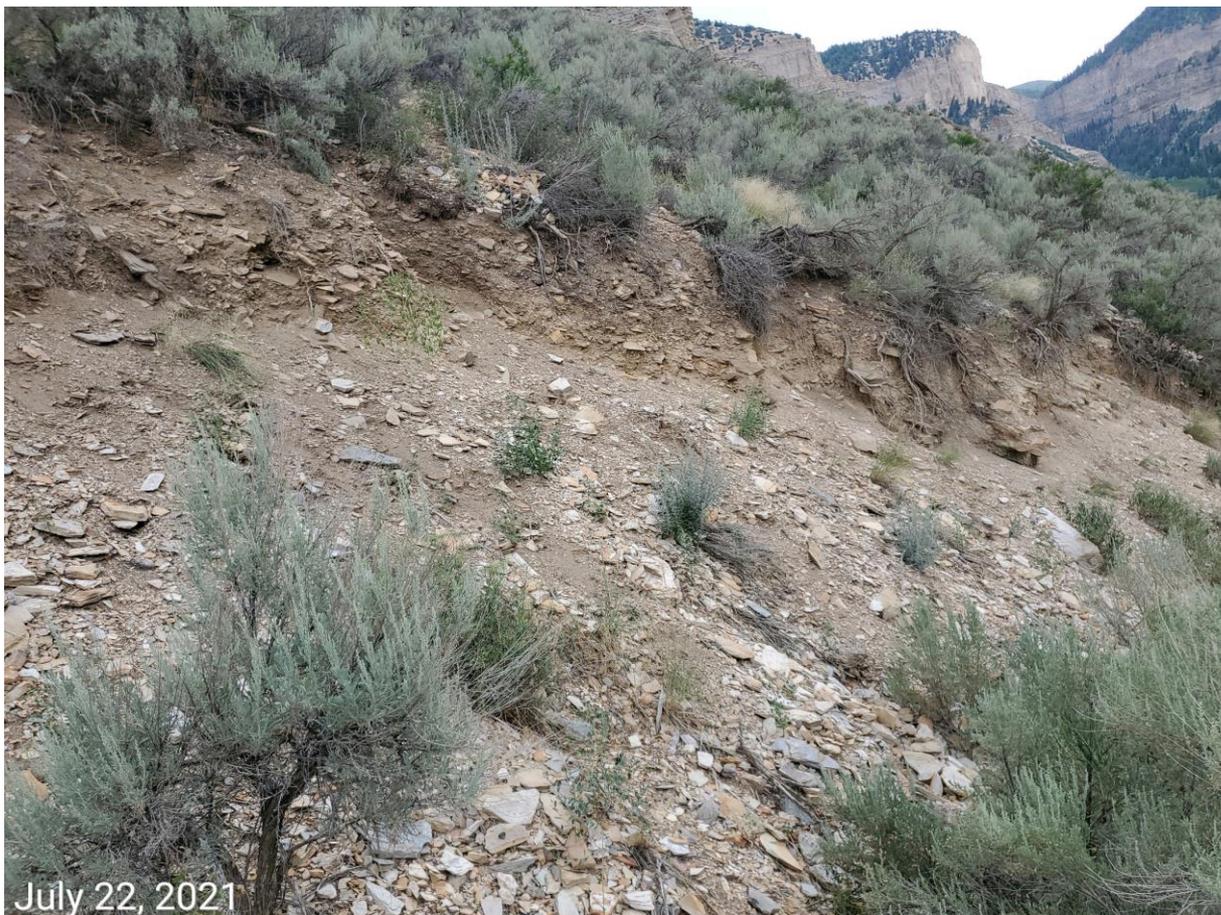
Photo 1: Photo taken from the diversion ditch along the north end of the Location, facing northeast. Photo shows example of areas within the ditch that are not stabilize resulting in erosion degradation offsite and up the slope. BMPs to protect and stabilize the slopes remain missing or insufficient.

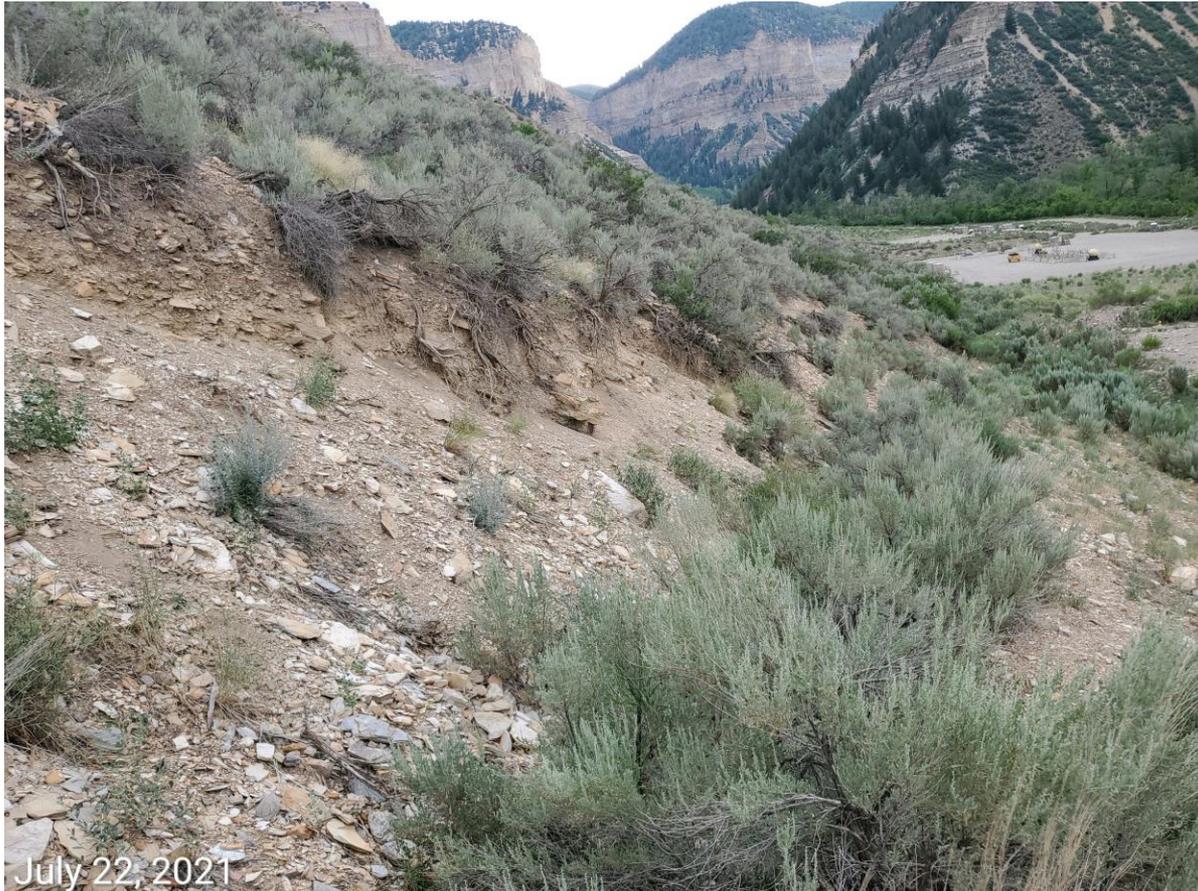
Photo 2: Photo taken from the diversion ditch along the north end of the Location, facing northeast. Photo shows example of areas within the ditch that are not stabilize resulting in erosion degradation offsite and up the slope. BMPs to protect and stabilize the slopes remain missing or insufficient.

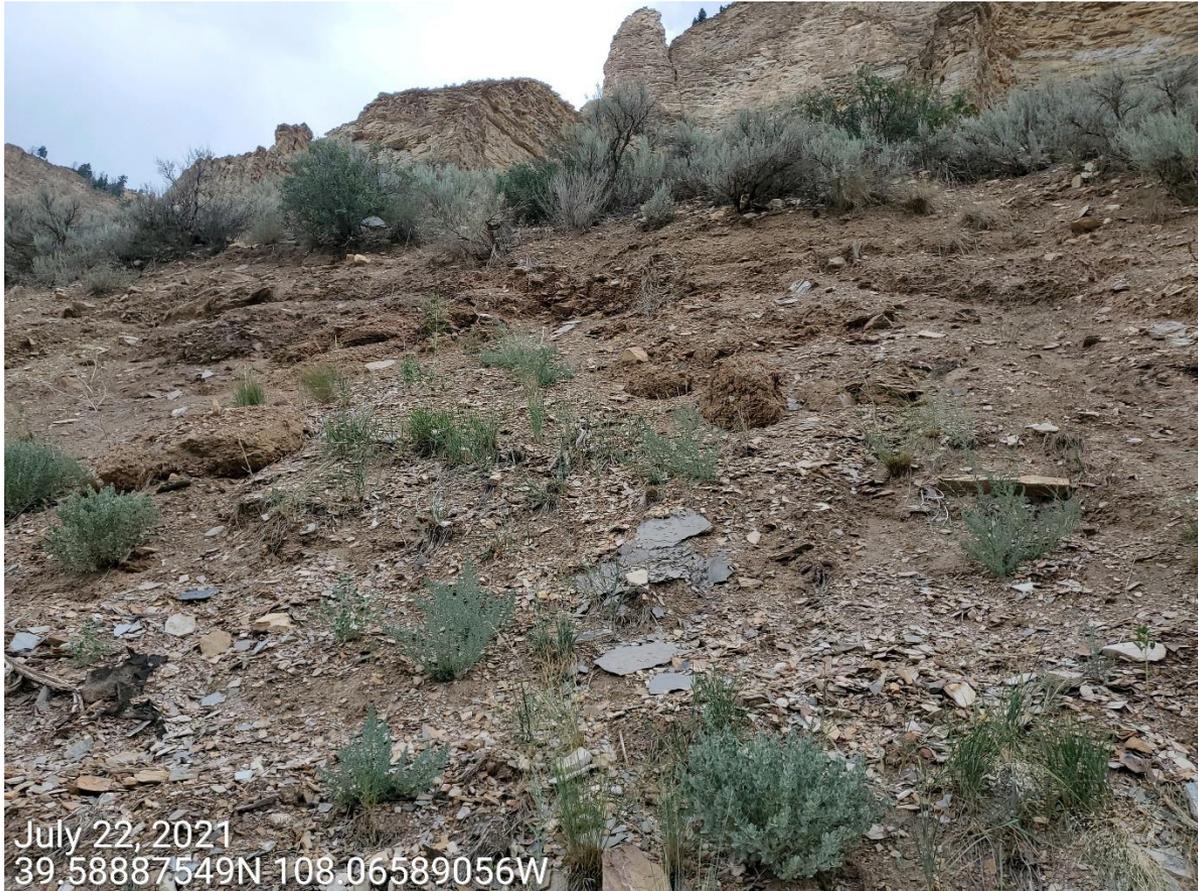
Photo 3: Photo taken from the interim slopes on the north end of the Location. Photo shows erosion degradation on the slopes; unable to find evidence that additional reclamation has been performed on these areas. BMPs to protect/stabilize slopes remain missing or insufficient.
