# Inspection Photos

Operator: CAERUS PICEANCE LLC - 10456

Location ID: 335669

COGCC

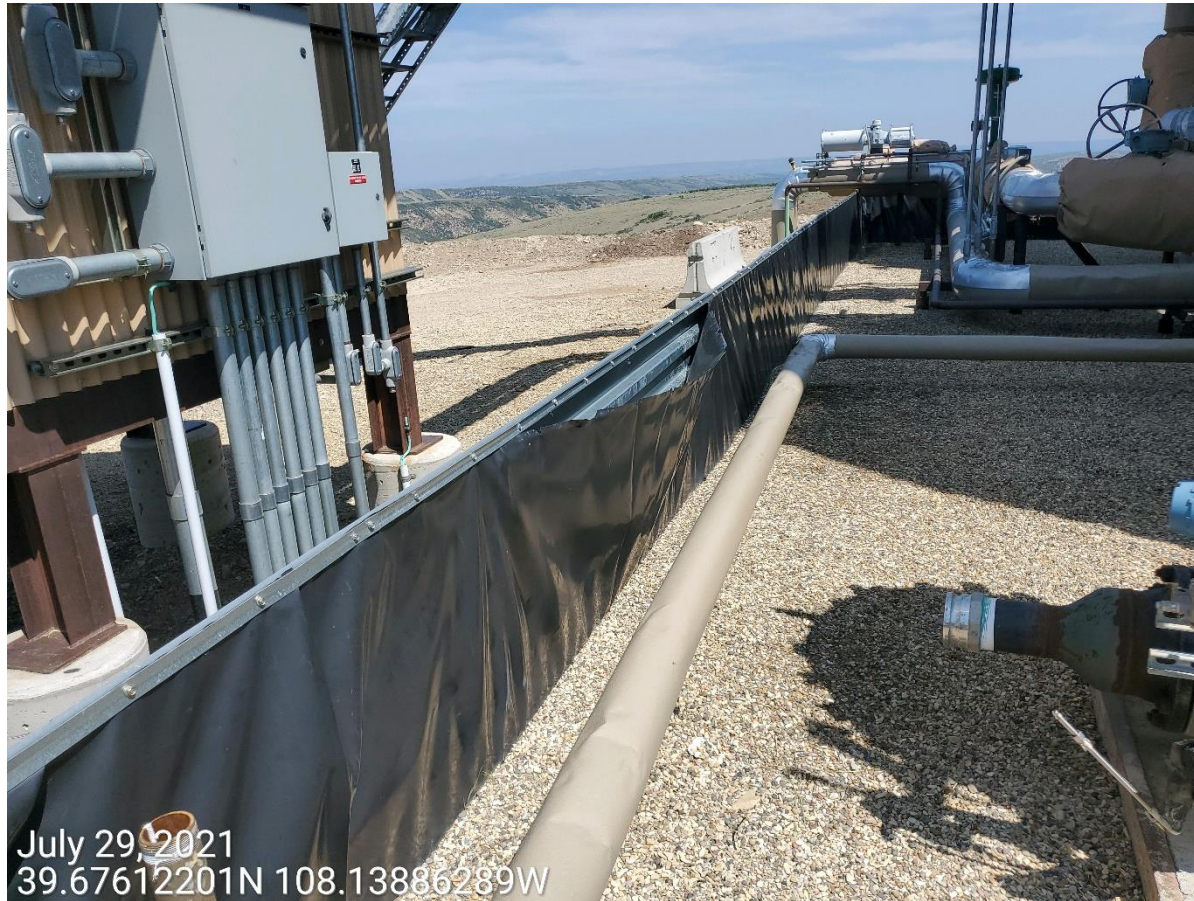
**Photo 1:** Photo taken from west end of the tank battery. Photo shows liner within secondary containment is in disrepair.

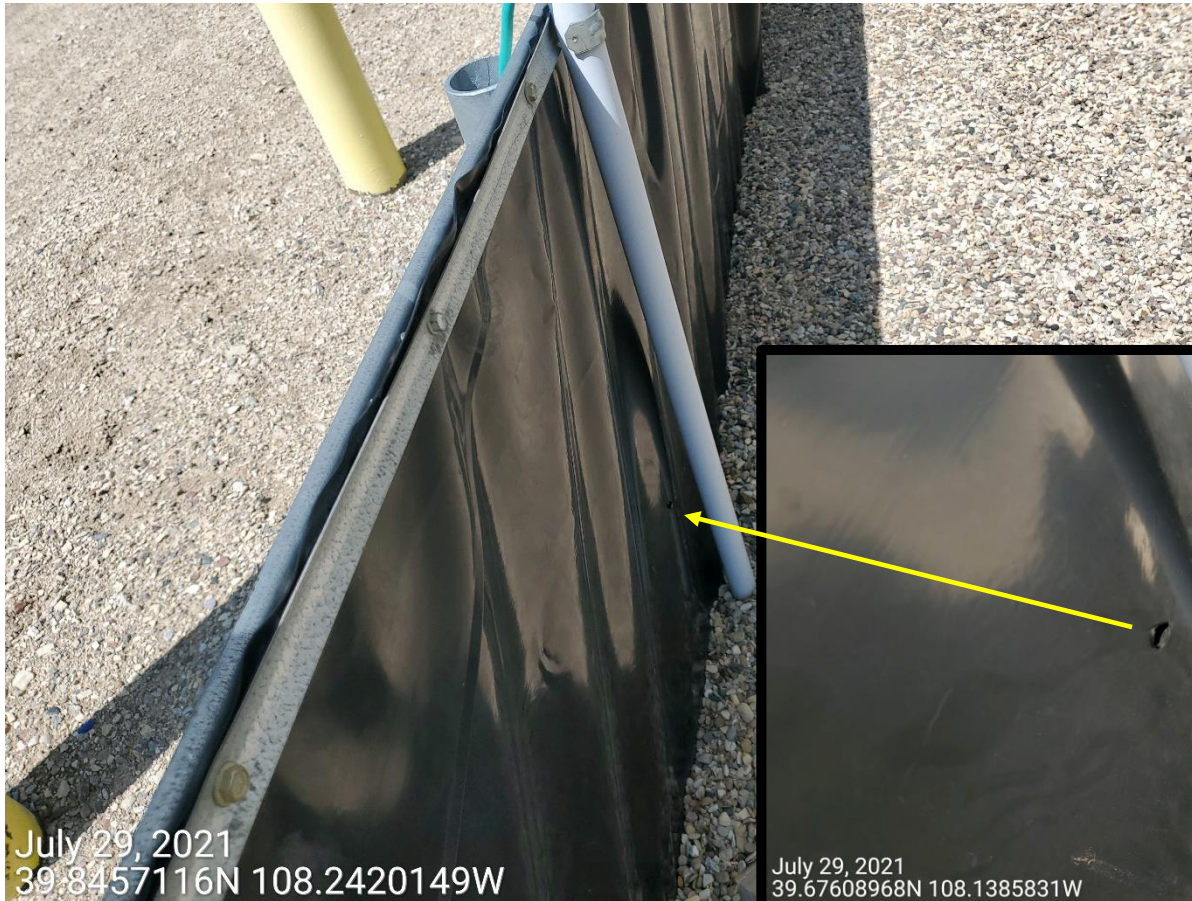
**Photo 2:** Photo taken from the liner on the south end of the tank battery. Photo shows tear in liner.

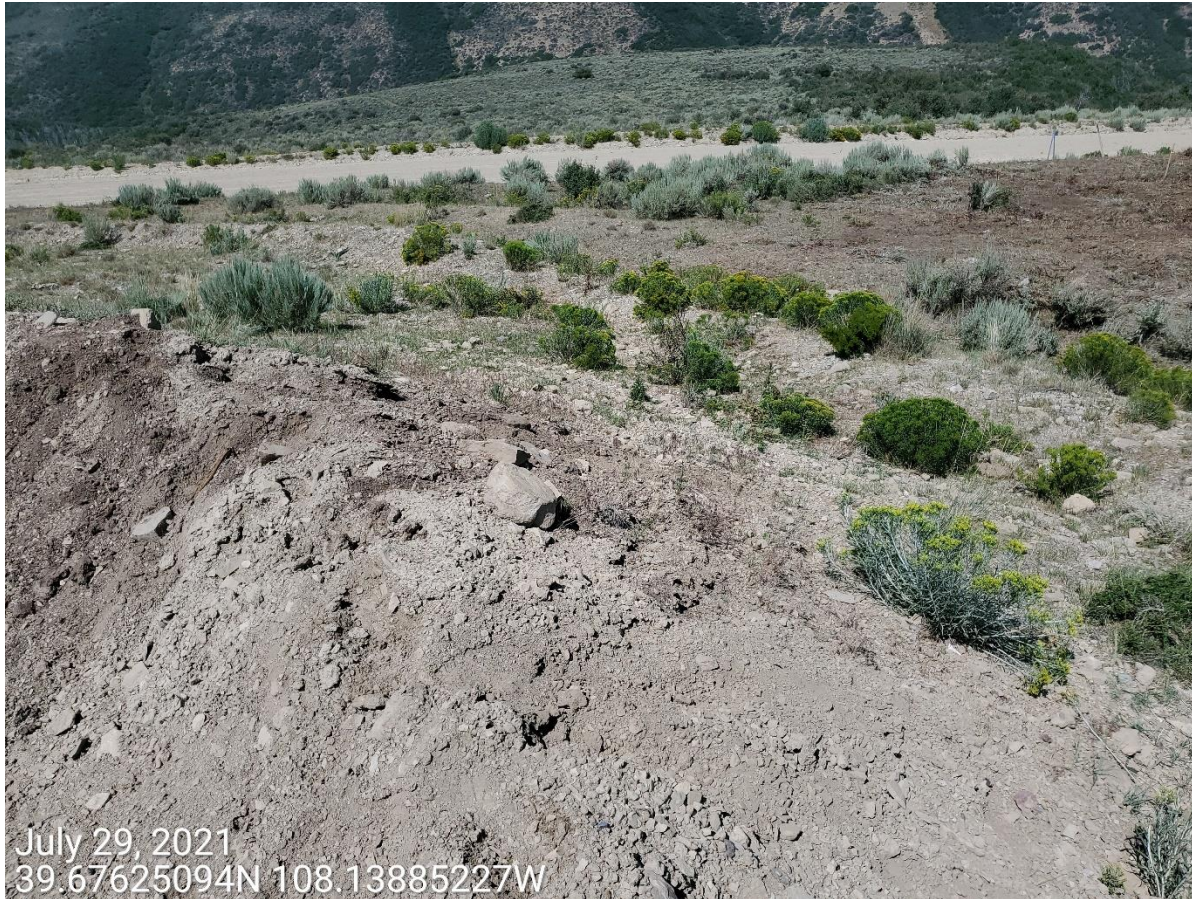
**Photo 3:** Photo taken from the north end of the Location, facing west. Photo shows slopes that remain loose material at risk to erosion; control measures to protect and stabilize slopes remain missing or insufficient.

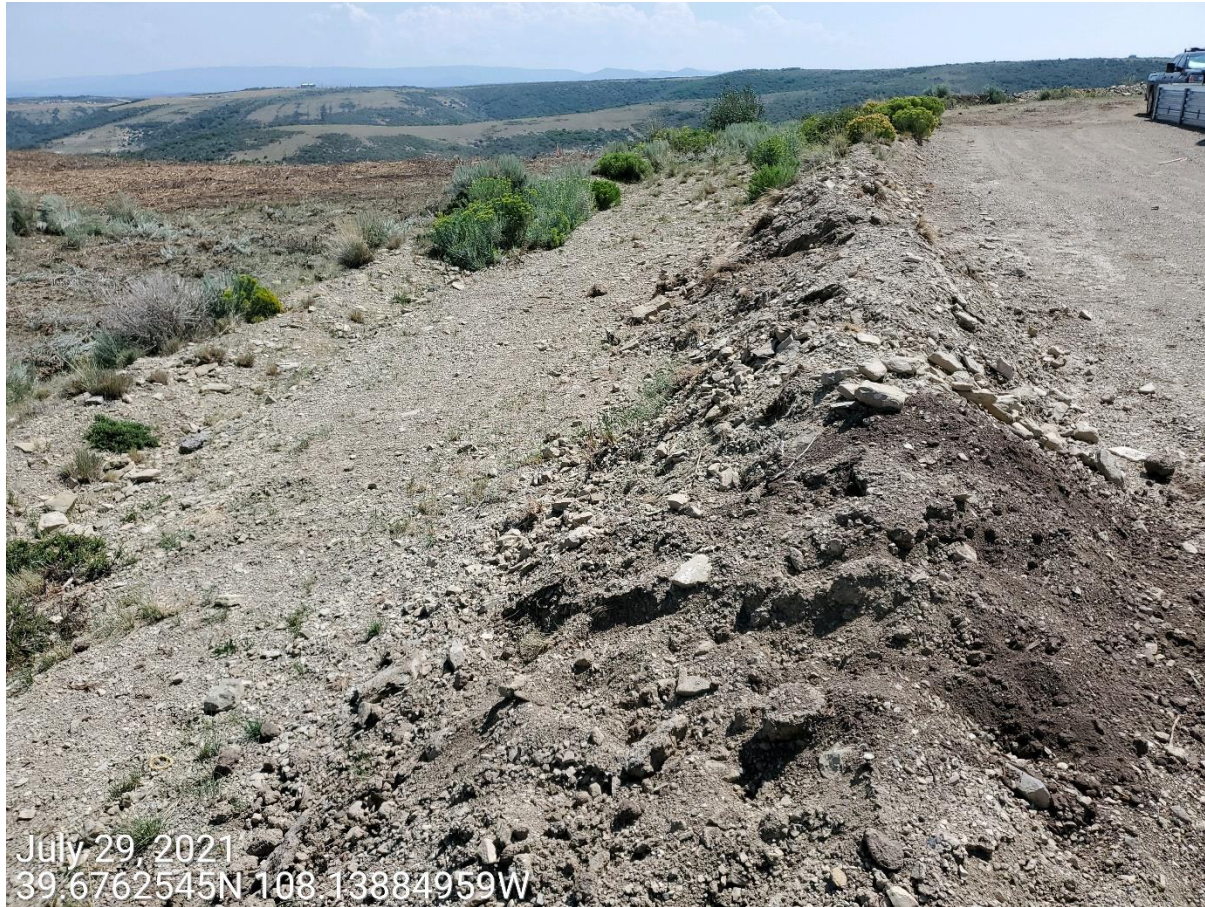
**Photo 4:** Photo taken from the north end of the Location, facing east. Photo shows slopes that remain loose material at risk to erosion; control measures to protect and stabilize slopes remain missing or insufficient.
