Inspection Photos  
Operator: Simcoe  
API: 067-08707  
Date: 7/29/2021

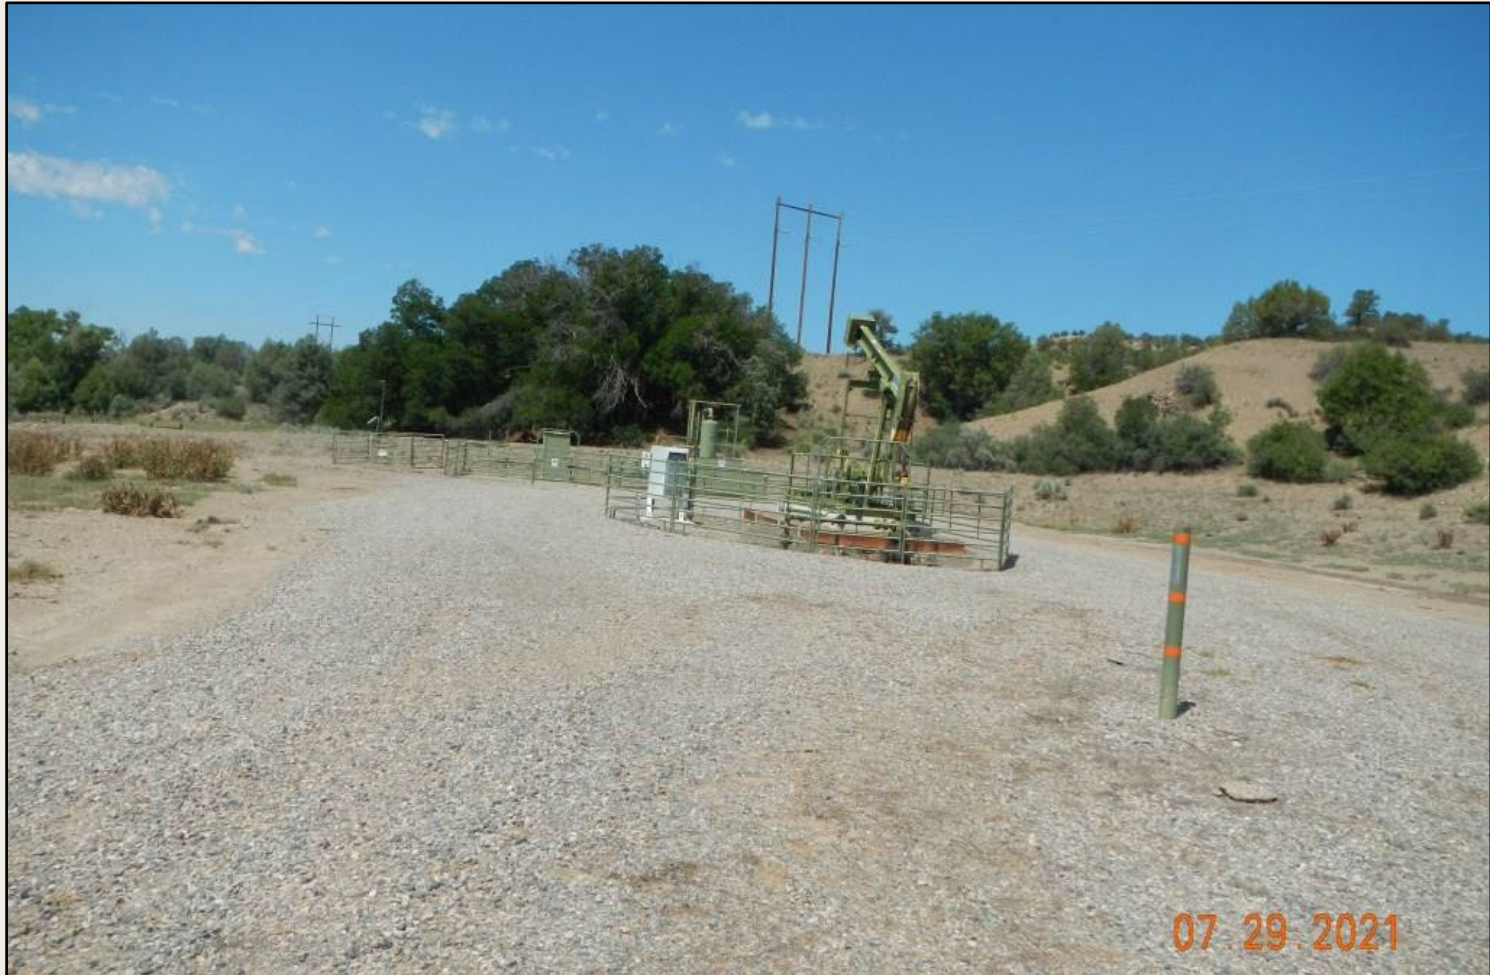
Photo 1. View of the project area from the well pad entrance facing center.

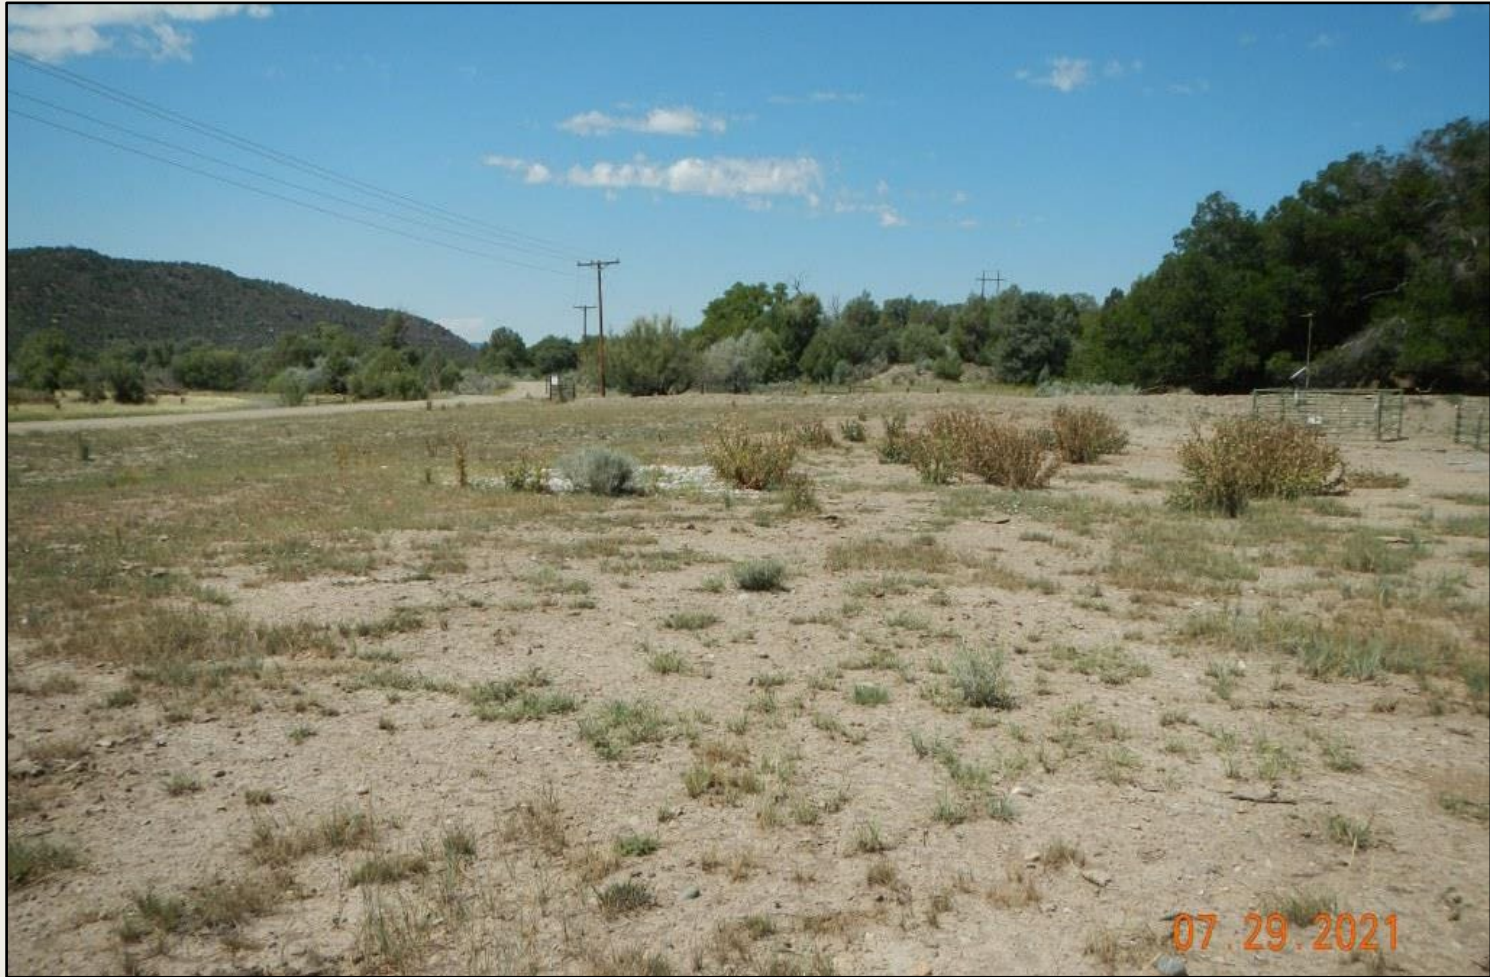
Photo 2. View of the southern project area from the southeastern corner facing westward. Revegetation is progressing within the project area with western wheatgrass, James galleta, and crested wheatgrass. Dense musk thistles observed.

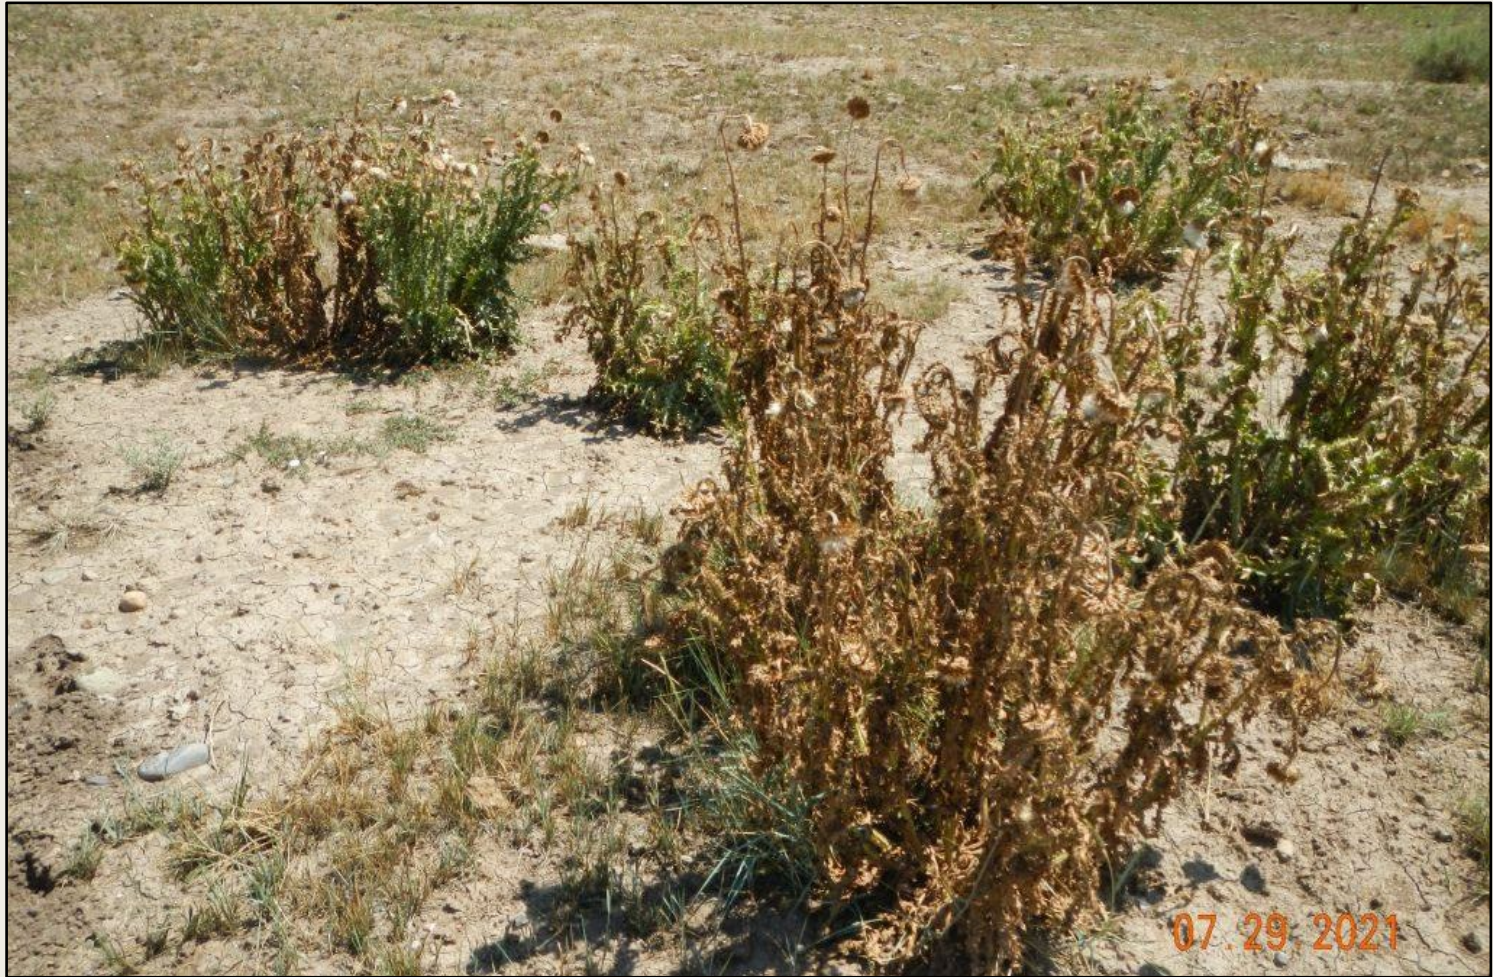
Photo 3. View of musk thistles within the project area in a flowering and seed dispersing condition. Approximately 150 individuals observed.
