Final Reclamation Inspection

Operator: PDC ENERGY INC - 69175

Location ID: 306265

Inspection Photos
Location Name: REEMAN #11-5
Location ID: 306265

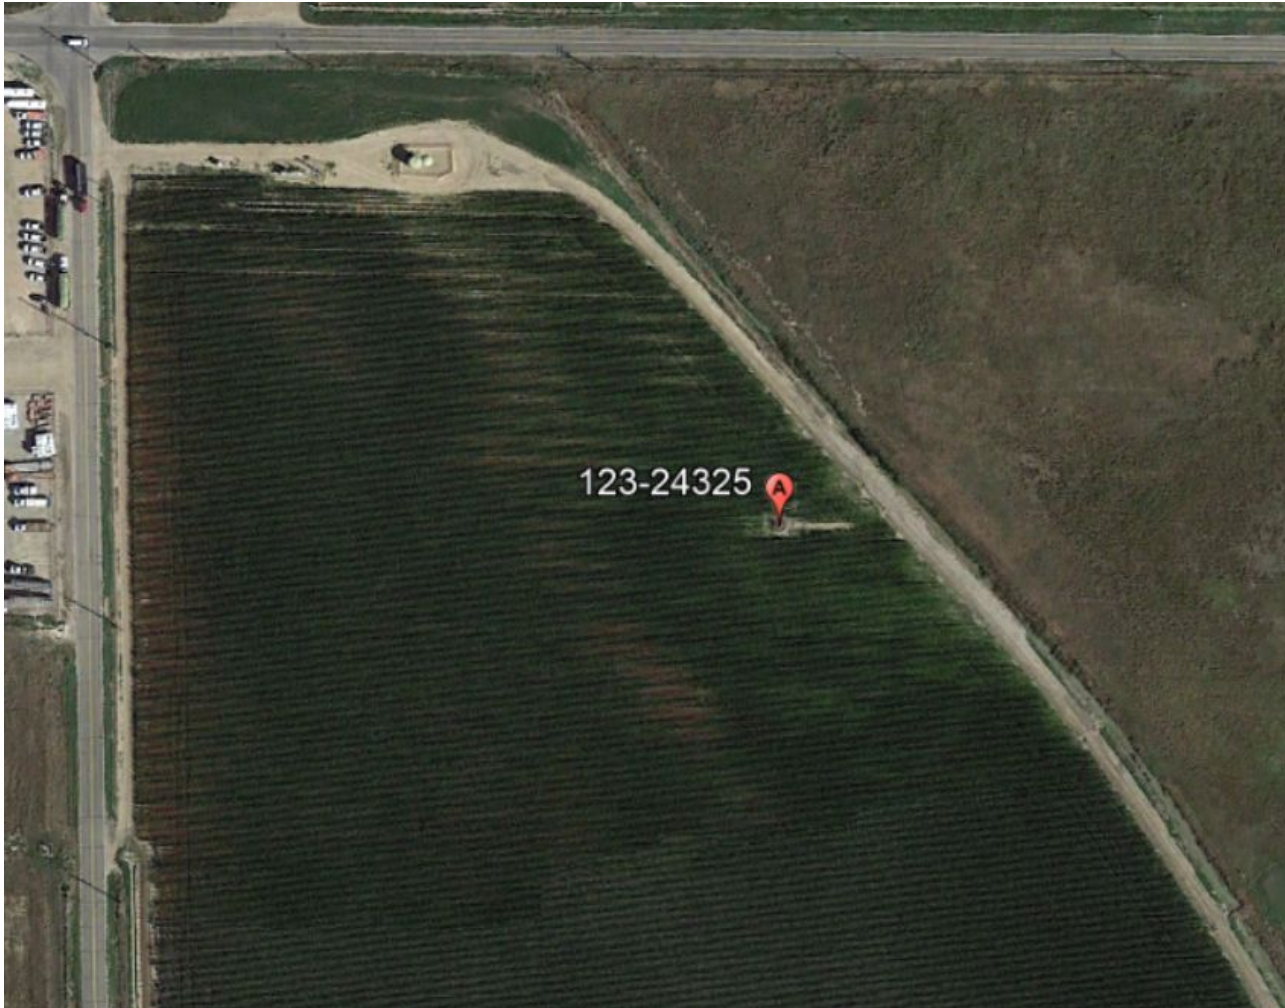
Photo 1. Google Earth aerial imagery taken 9/7/2016 during active operations. Photo illustrates the well location, well location access road and the offsite tank battery location.

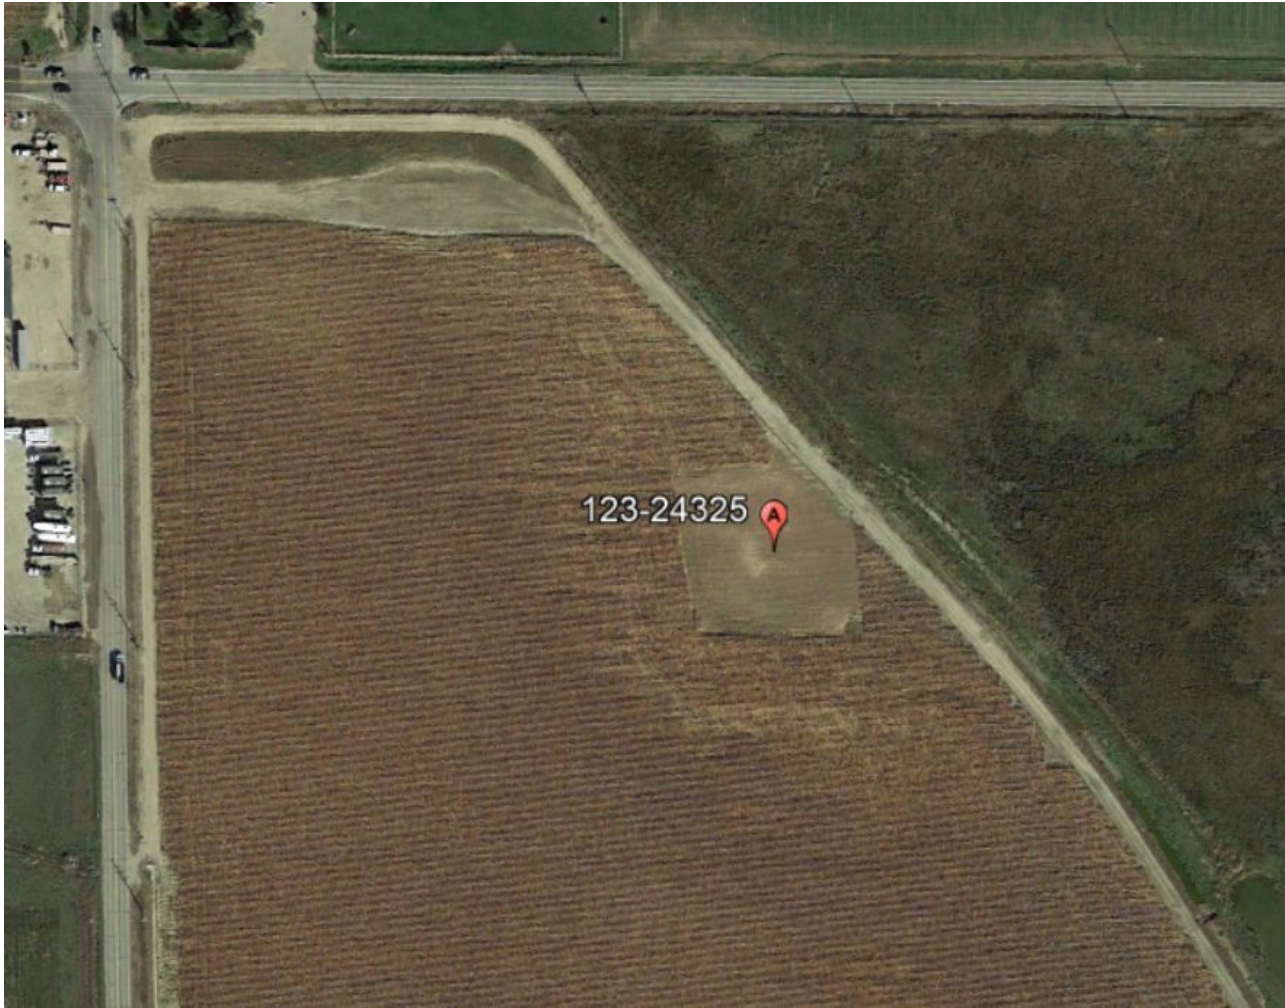
Photo 2. Google Earth aerial imagery taken 10/14/2017 post plugging operations.

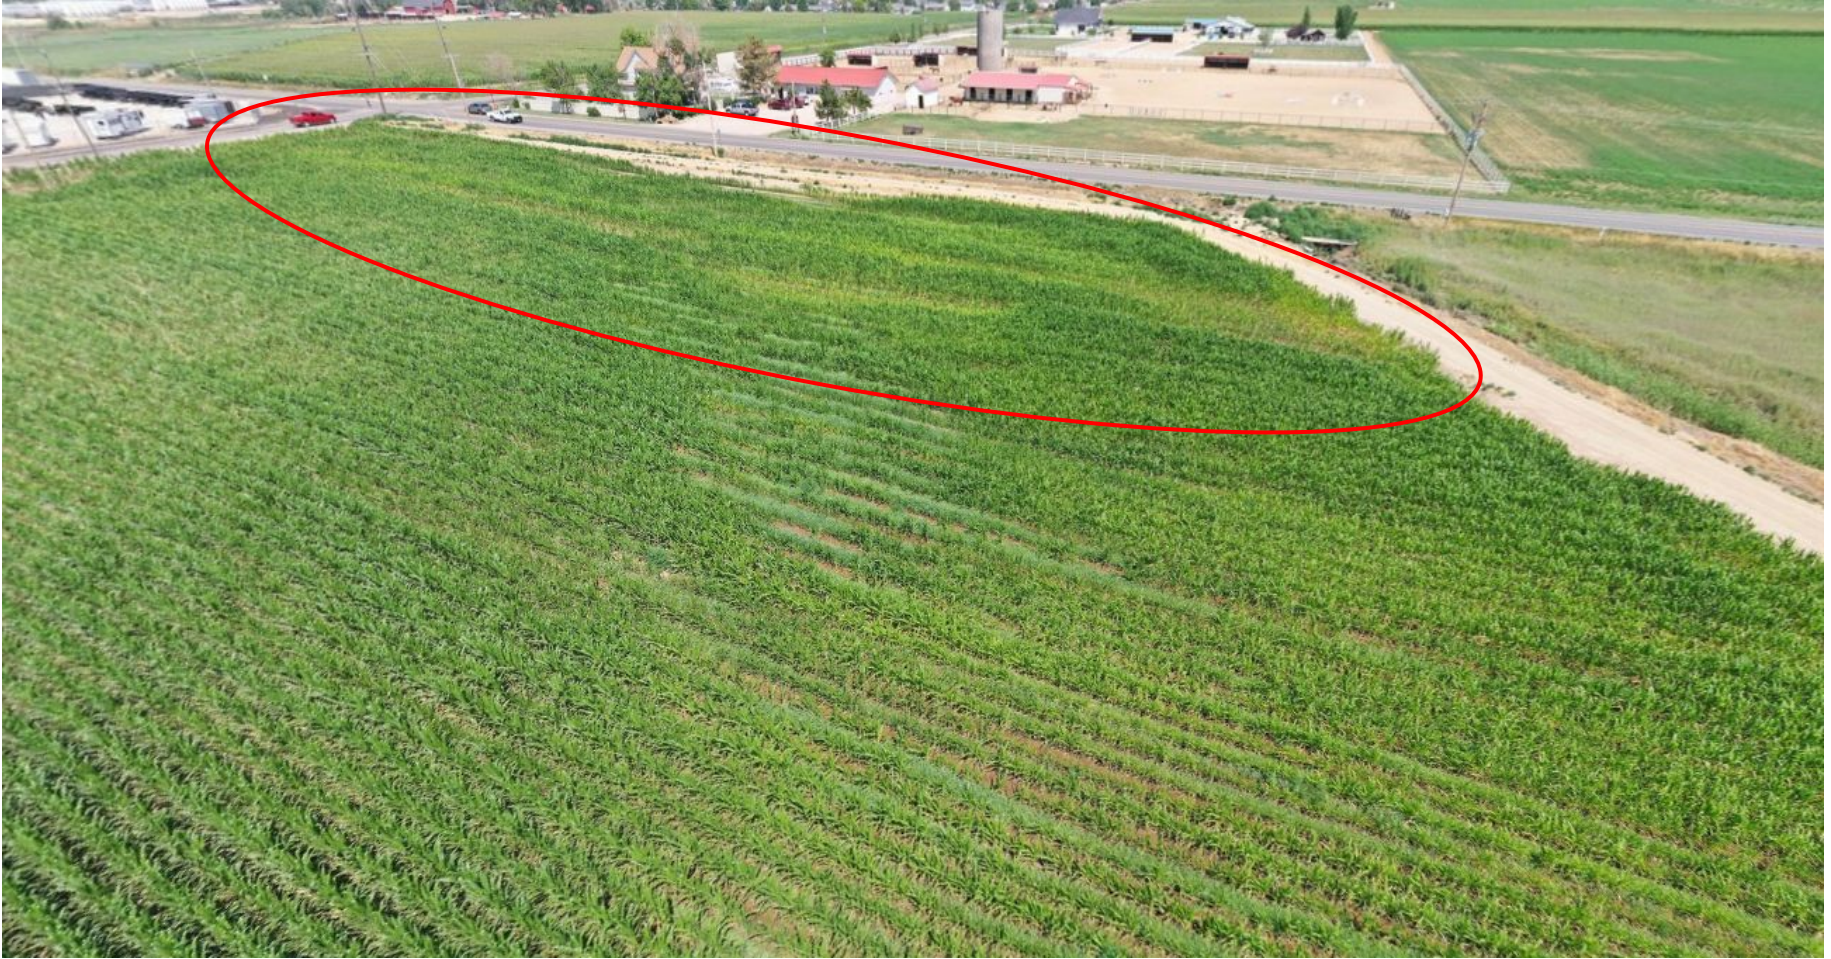
Photo 3. Drone aerial imagery taken from the wellhead, facing Northwest. Photo illustrates the associated tank battery is not reflective of reference area crops.

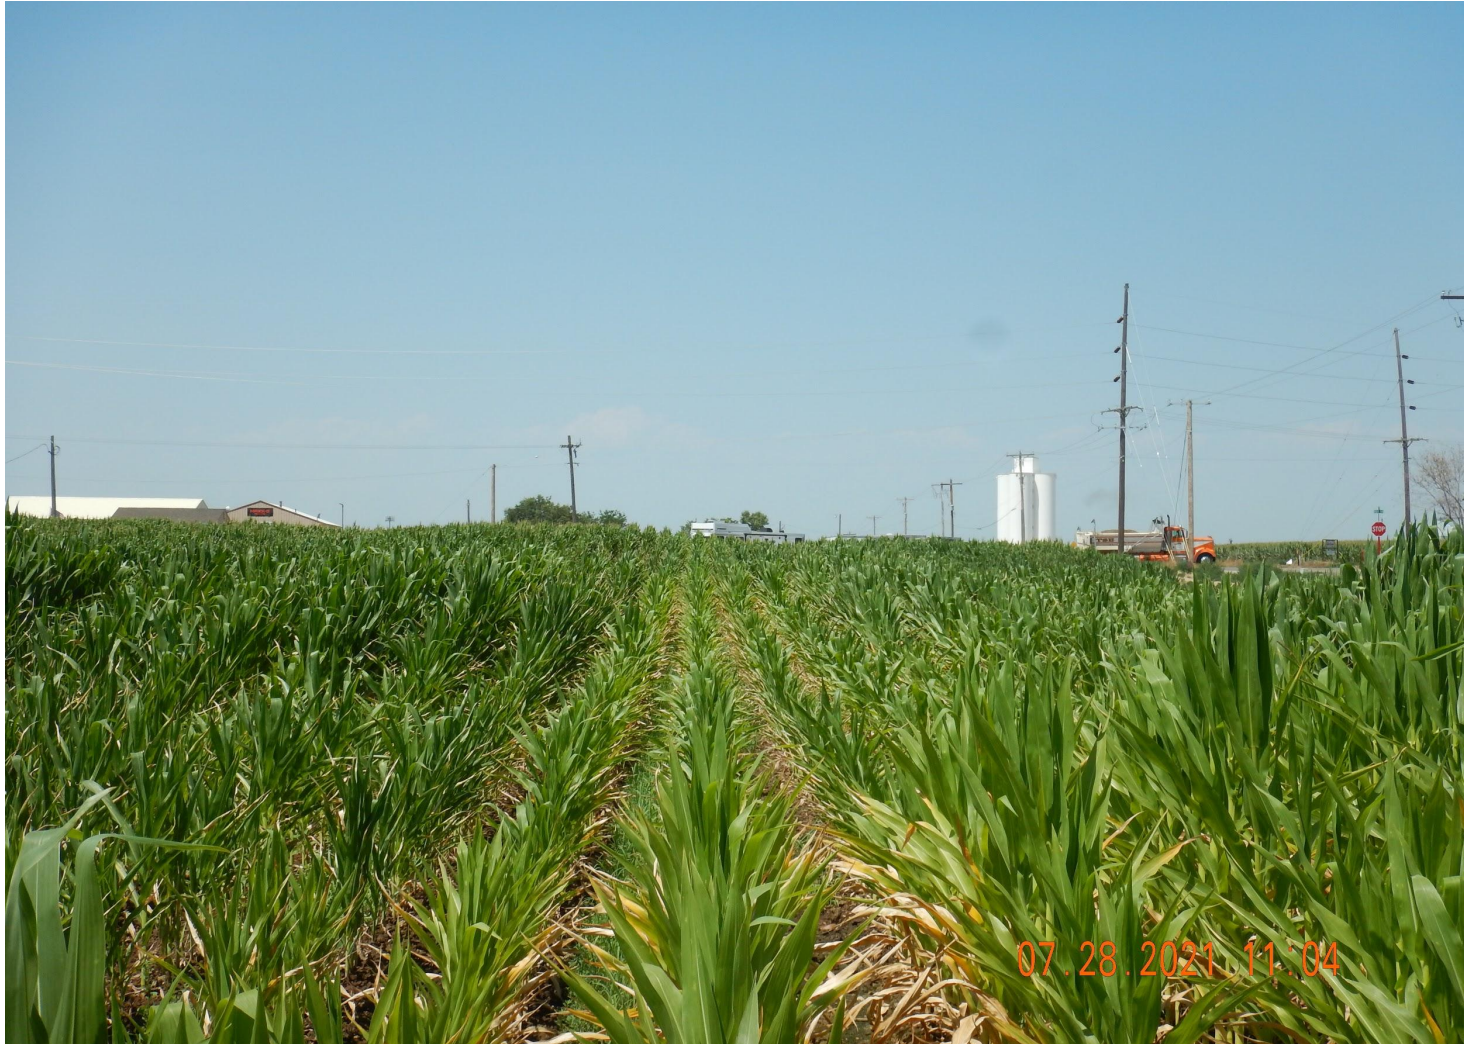
Photo 4. Photo taken from the eastern associated offsite tank battery, facing West. Photo illustrates the crop height is less than half of the reference areas throughout a majority of the location.

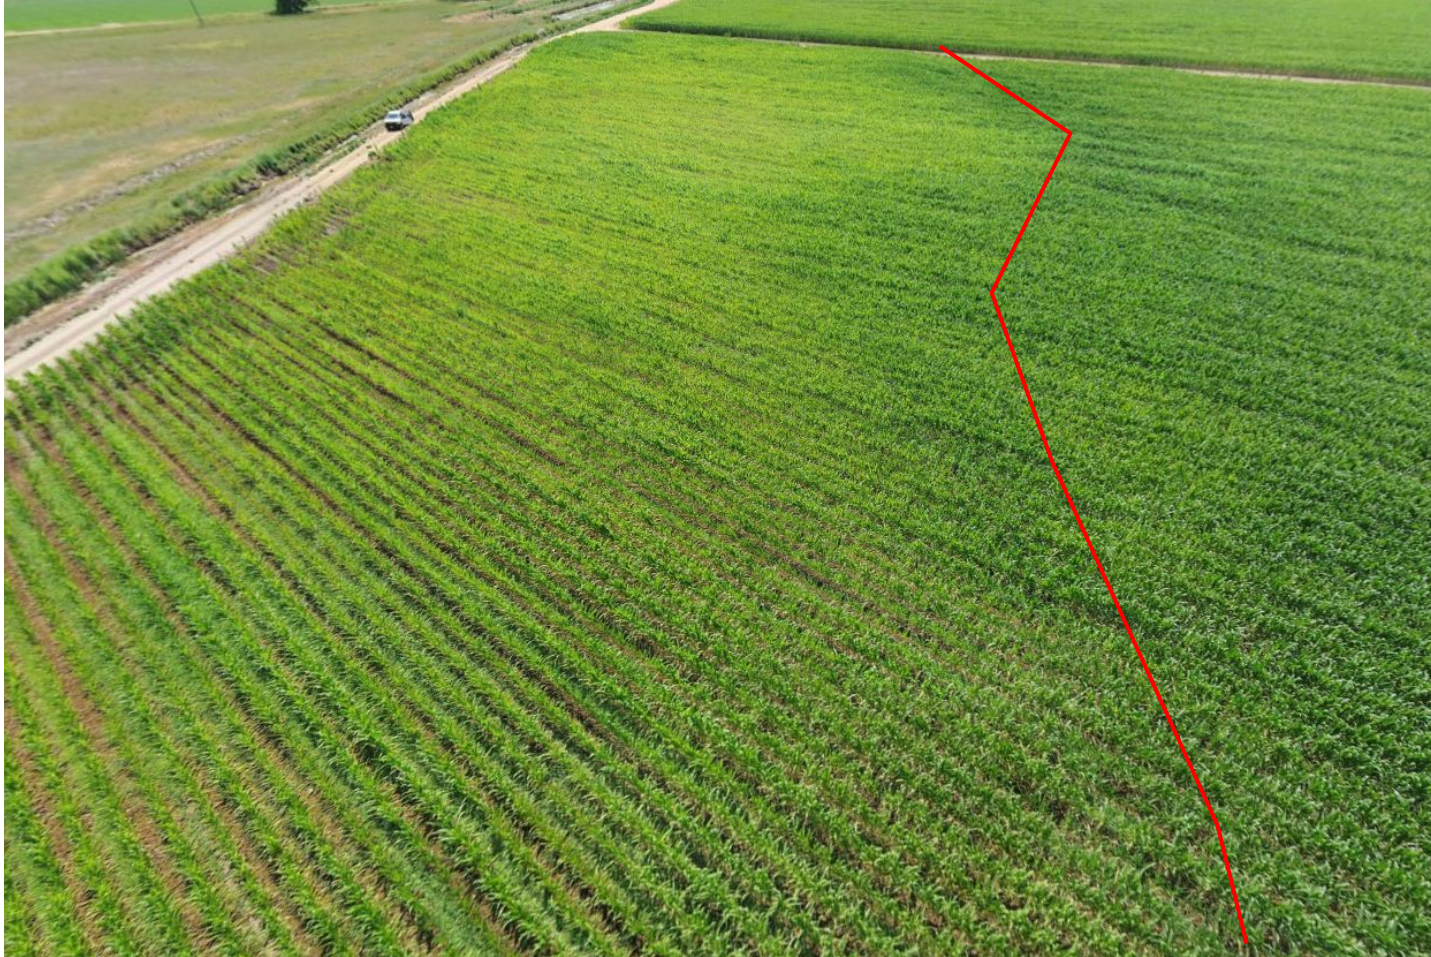
Photo 5. Drone aerial imagery taken from the wellhead, facing South. Photo illustrates the well location and the majority of the eastern reference field has stunted crop growth compared to the western field.
