Final Reclamation Inspection

Operator: PDC ENERGY INC - 69175

Location ID: 330731

Inspection Photos
Location Name: CARLSON 43-7
Location ID: 330731

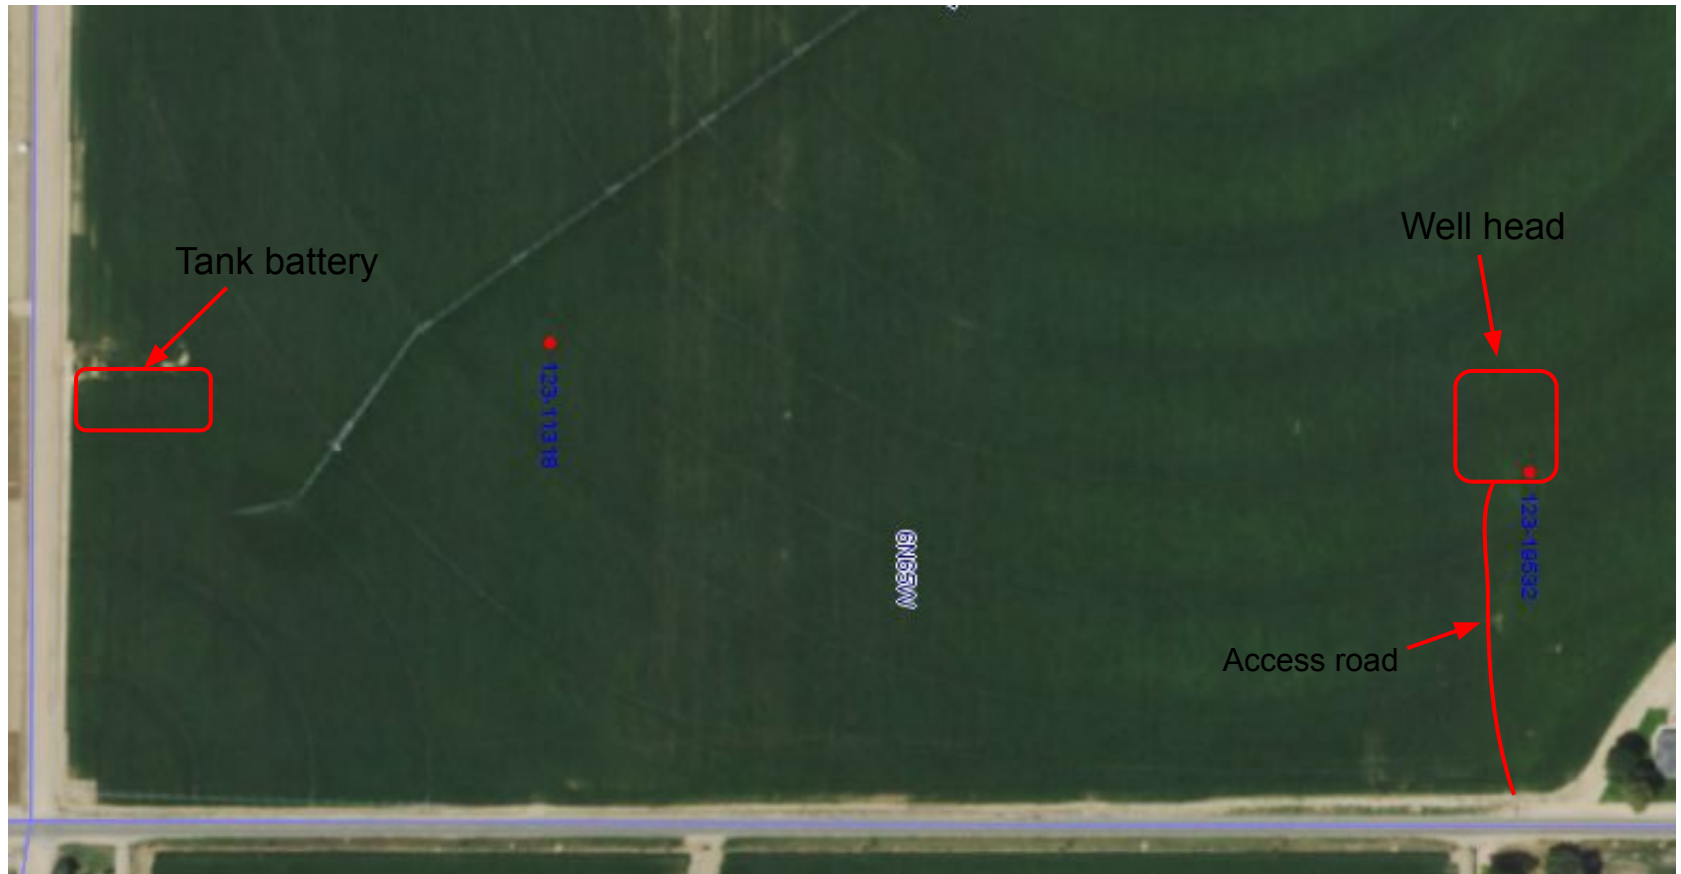
Photo 1. 2019 aerial imagery shows the well location, access road and associated tank battery.

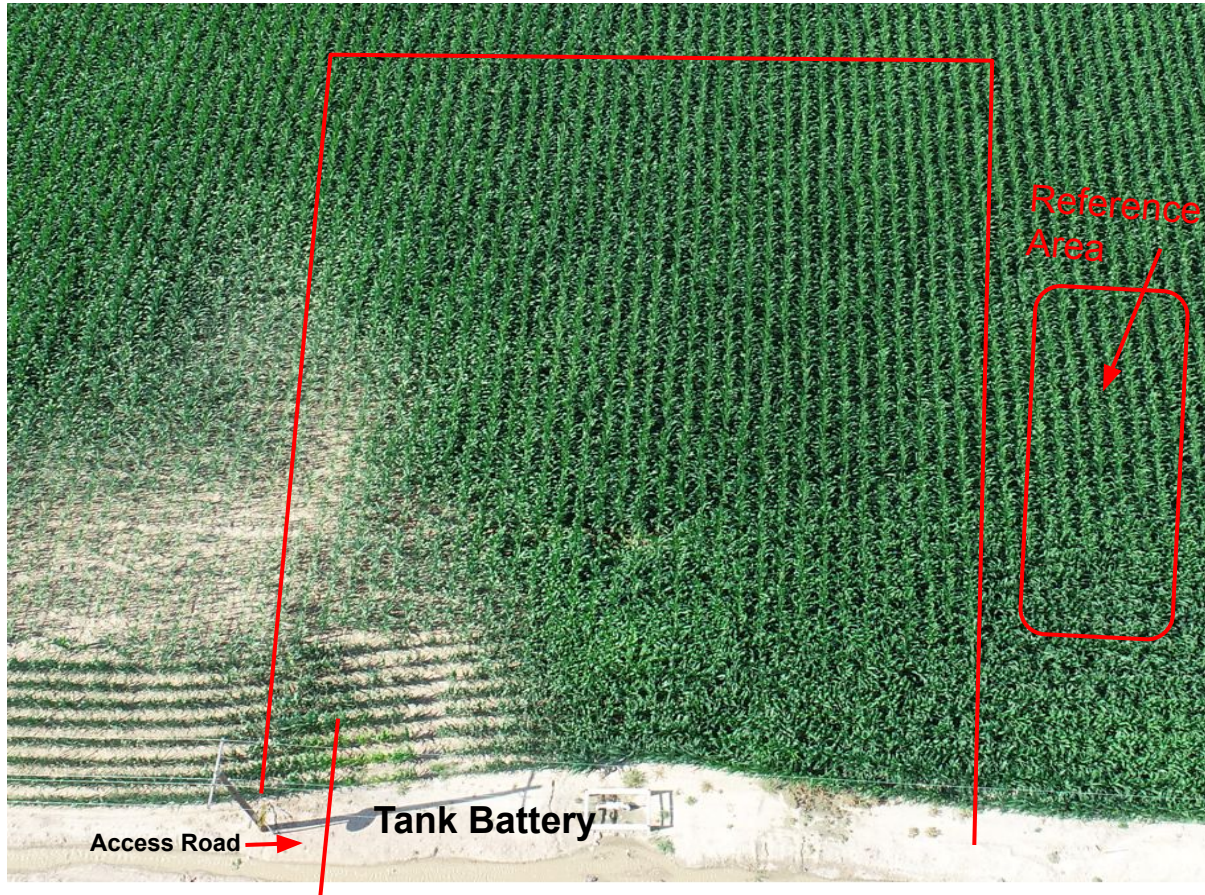
Photo 2. Overview photo of tank battery and access road using a drone. Photo illustrates that the tank battery (outlined in red) appears to meet final reclamation requirements. Note: SW section of tank battery shows stunted growth, however location is in the corner of the crop field where a majority of the water doesn't reach; stunted growth also appears in other corners of the crop field.

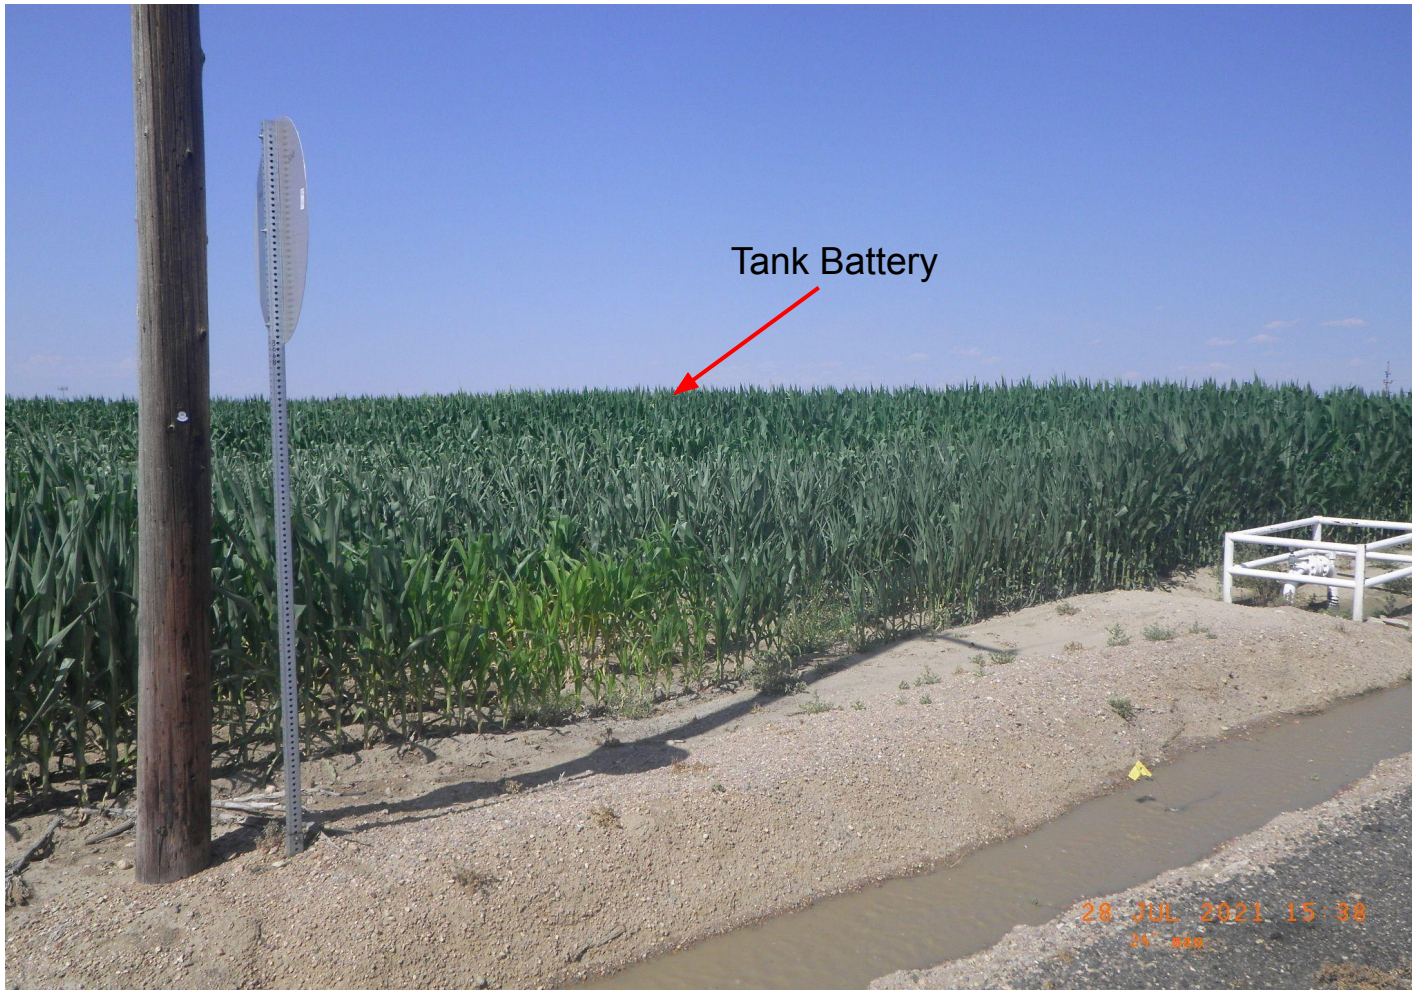
Photo 3. Photo taken at Southwest corner of tank battery looking Northeast, photo shows stunted crop growth in SW corner of tank battery. Majority of tank battery crop is consistent with reference area crop.

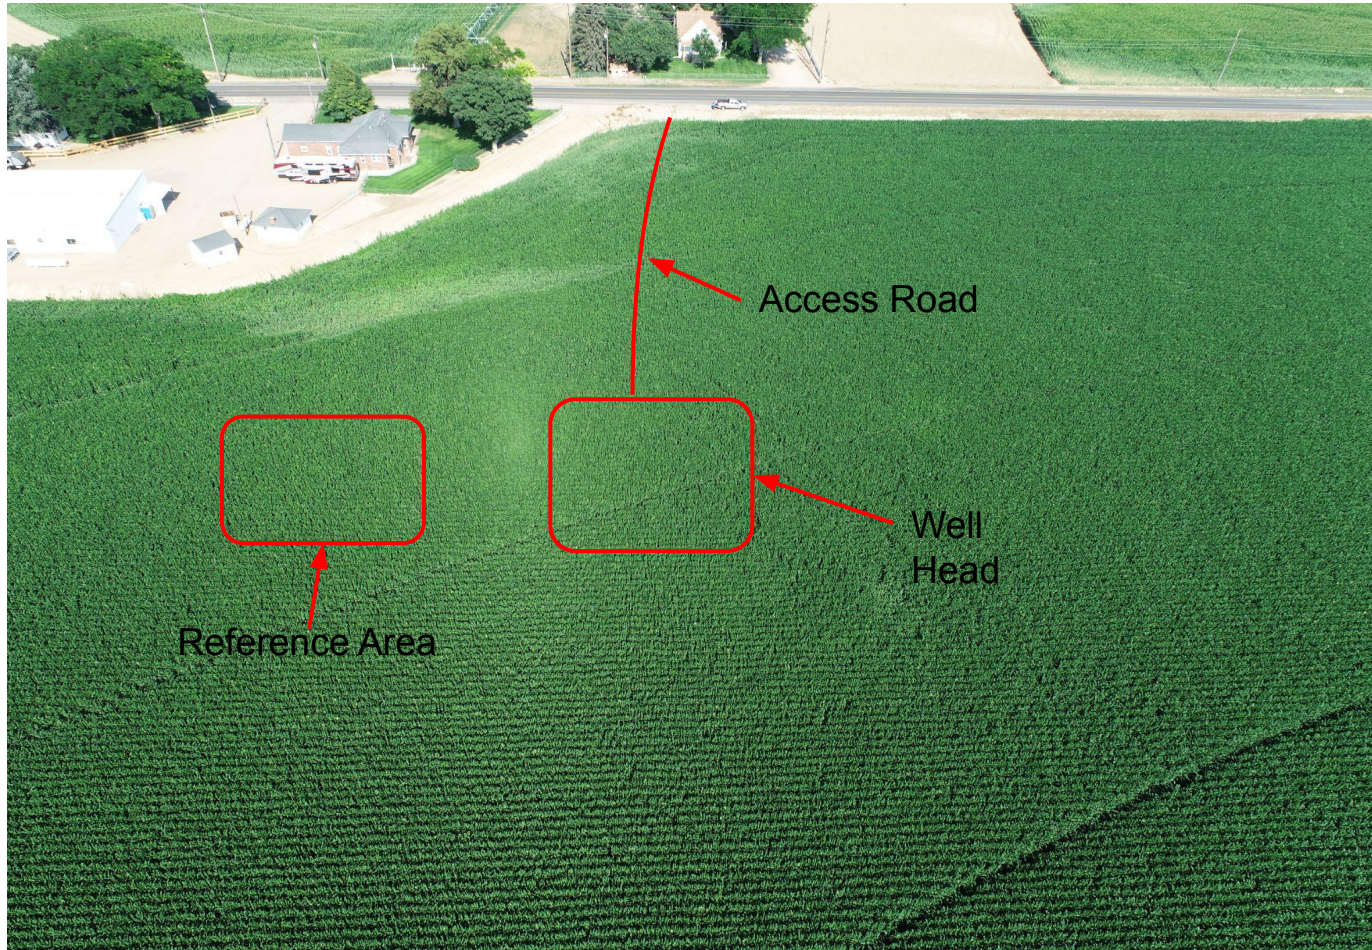
Photo 4. Overview Photo taken using a drone from middle of crop field looking East towards access road and Well head. Photo shows the well location and access road appears to meet final reclamation requirements.

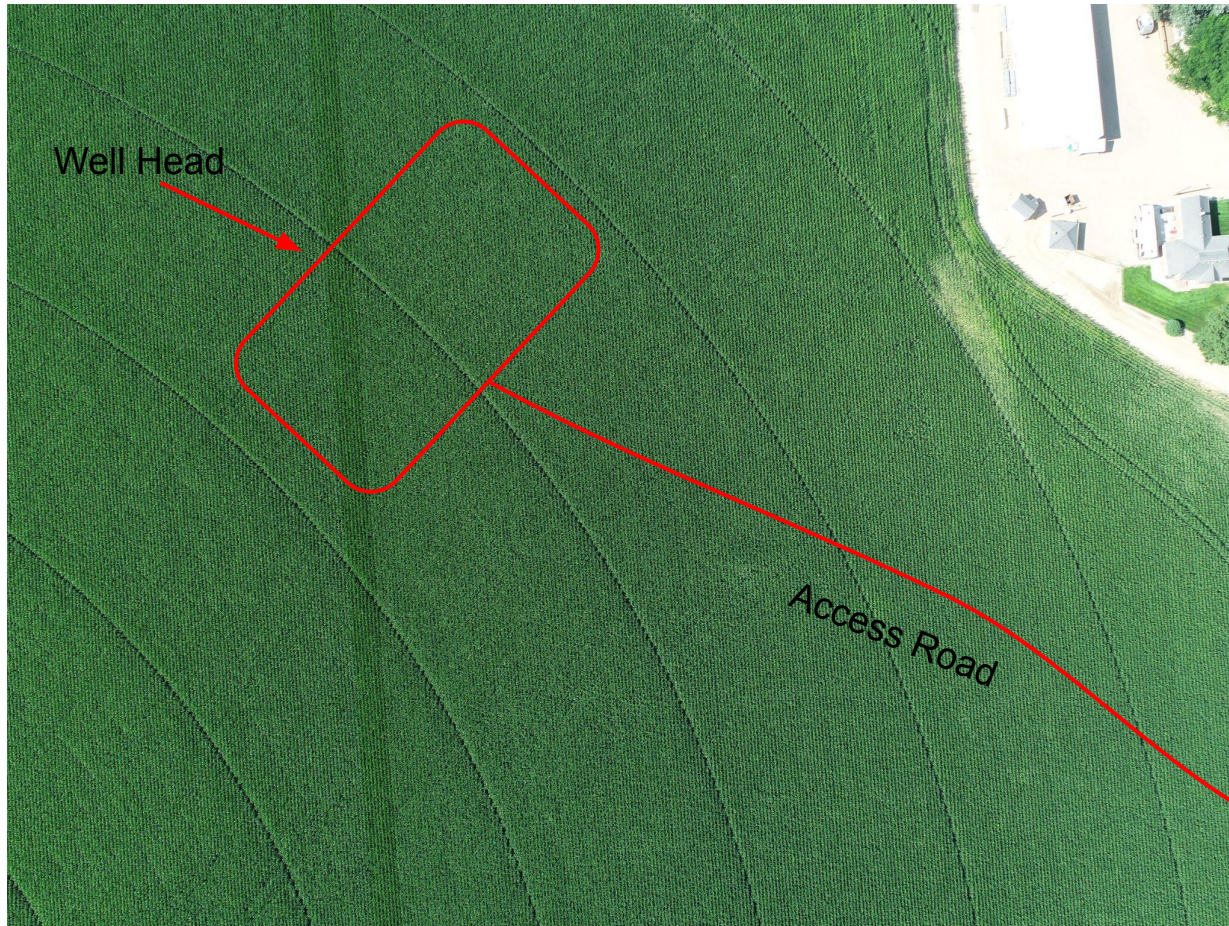
Photo 5. Overview photo taken using a drone (up is Northwest) shows in more detail well pad and access road appear to meet final reclamation requirements.
