MEMORANDUM

Re: OHWM Assessment of Cool Creek for the Irwin Taylor Well Pad and Access Road in Elbert County, Colorado

Photo Log for the Proposed Irwin Taylor Well Pad and Access Road in Elbert County, Colorado
OHWM Assessment

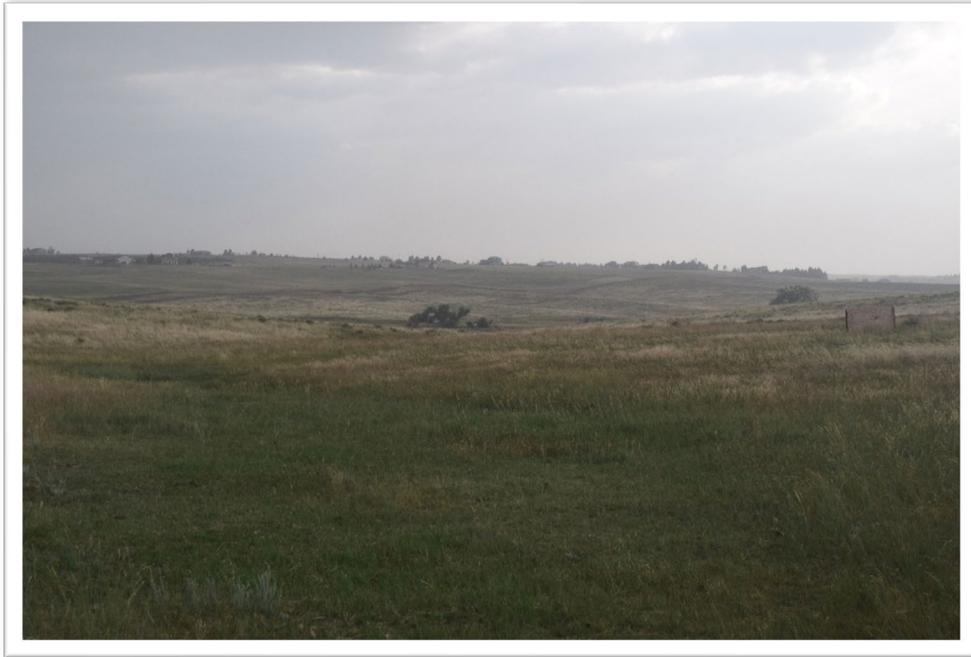
Photo 1. Overview of the riparian corridor from the well site facing west.

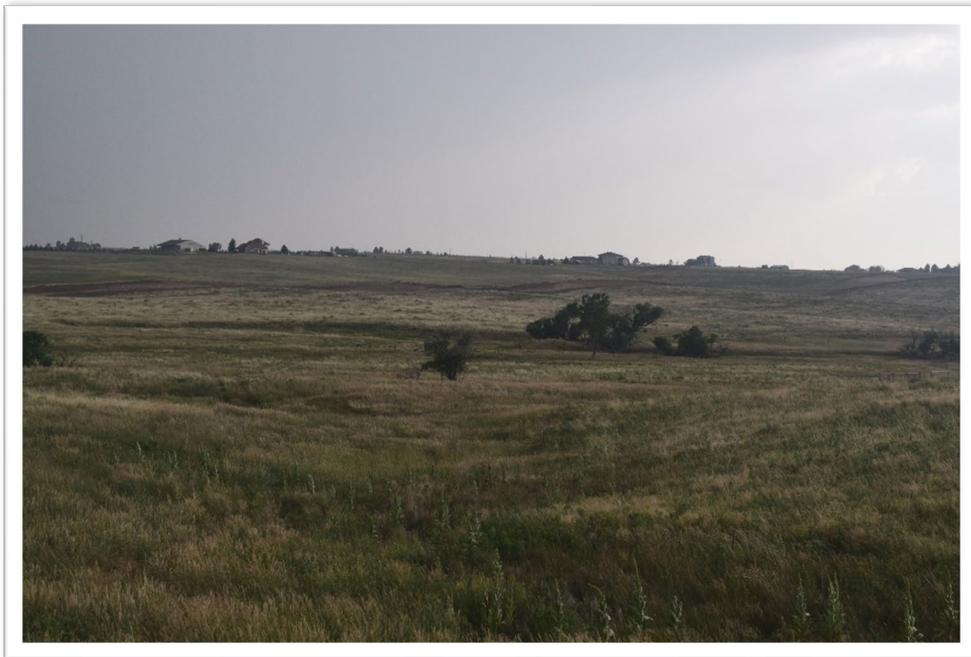
Photo 2. Overview of the riparian corridor from the site facing west showing sparse tree cover.

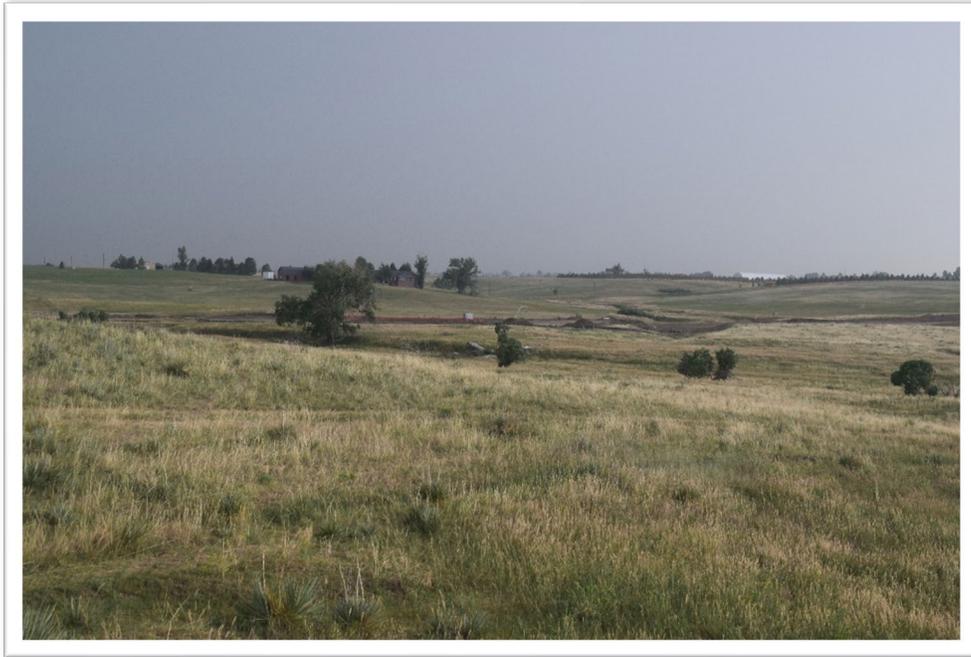
Photo 3. Overview of the riparian corridor from the site facing southwest towards the County Road construction.

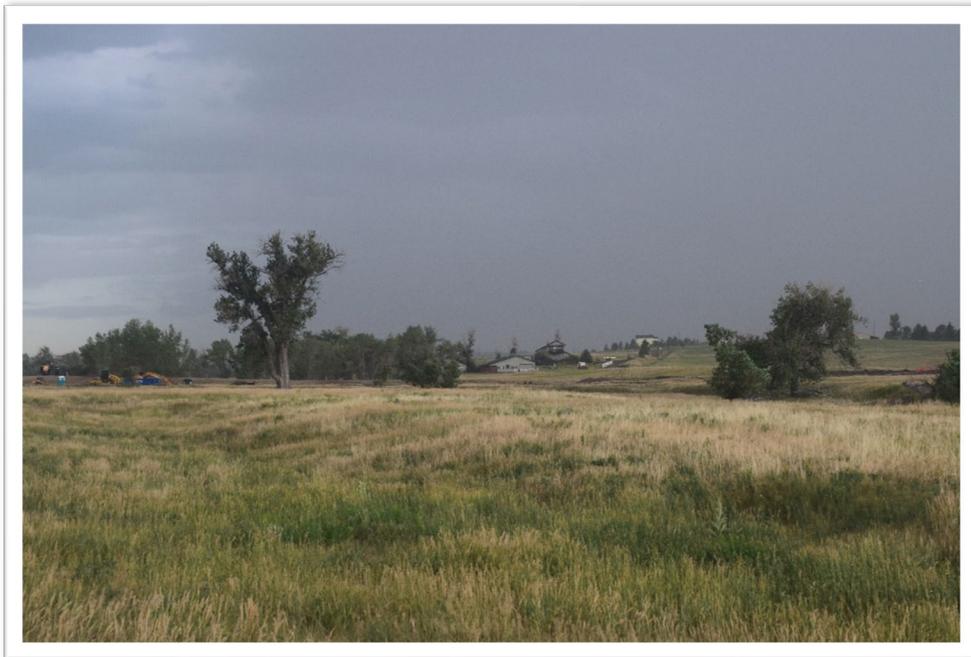
Photo 4. View from within the riparian corridor showing an abundance of upland vegetation (smooth brome) and a lack of OHWM indicators.

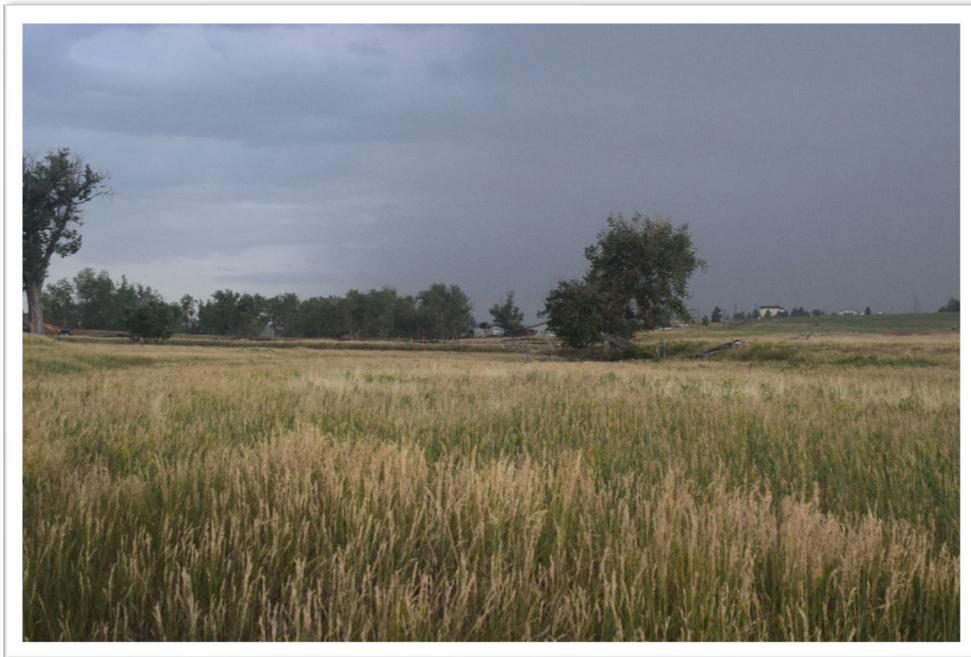
Photo 5. View of the smooth brome community within the riparian corridor. This vegetation community is the same as that of the community outside the corridor.

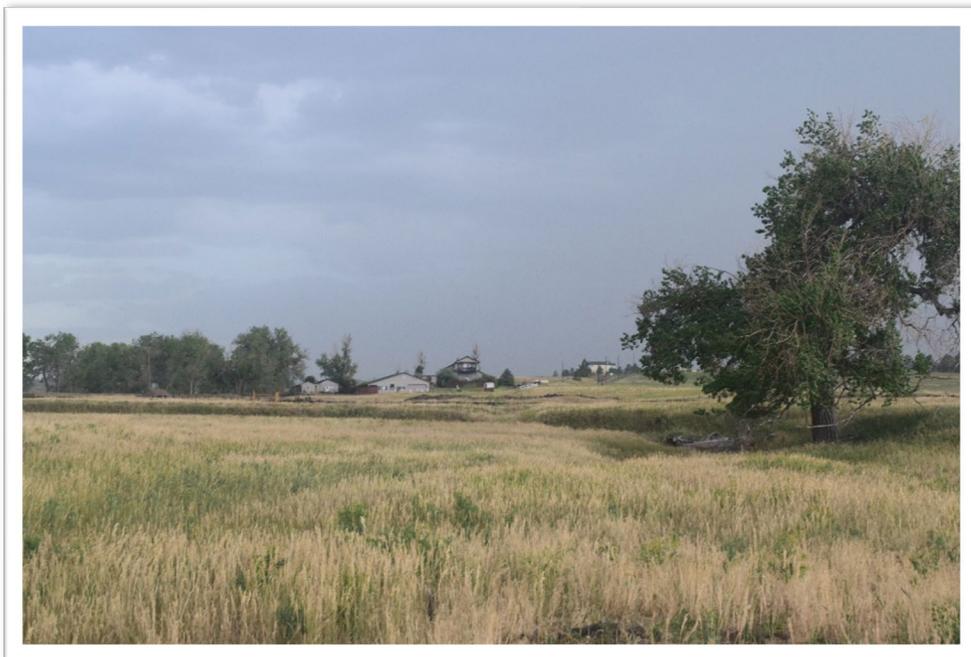
Photo 6. View of riparian corridor showing no OHWM indicators. The area does not exhibit bed and bank characteristics, destruction of terrestrial vegetation, bent/matted vegetation, shelving, or wracking.

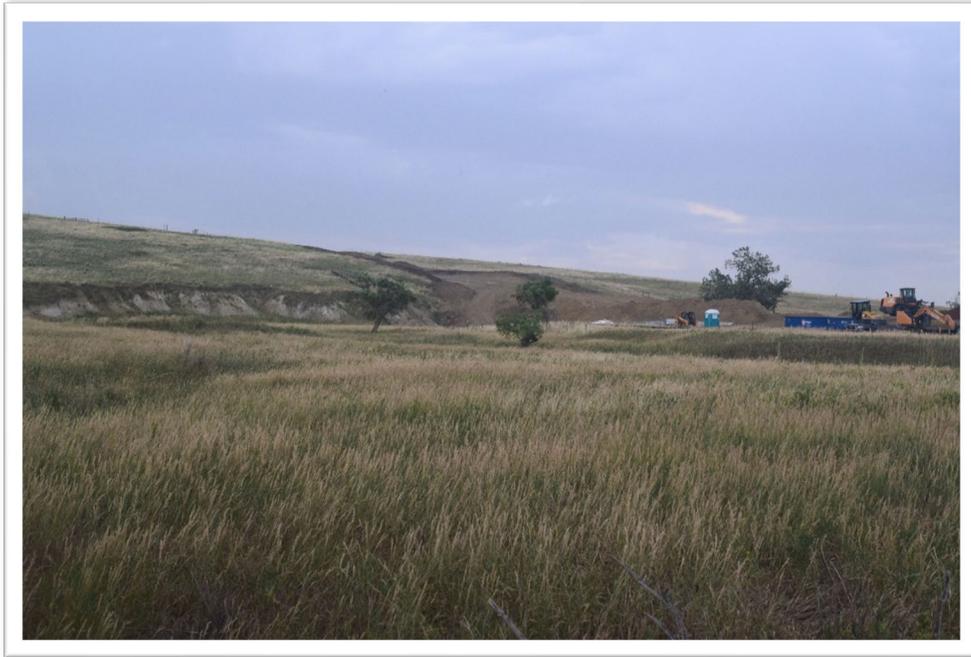
Photo 7. View showing the continued dominance of the upland vegetation community within the riparian corridor and continued lack of OHWM indicators.

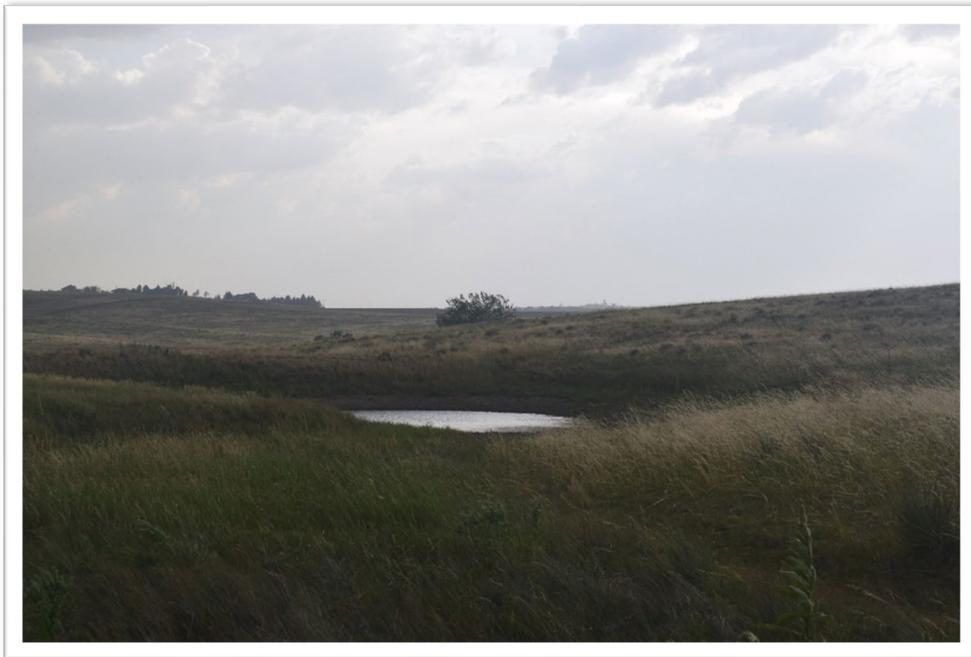
Photo 8. View of man-made cattle pond west of the site facing west.

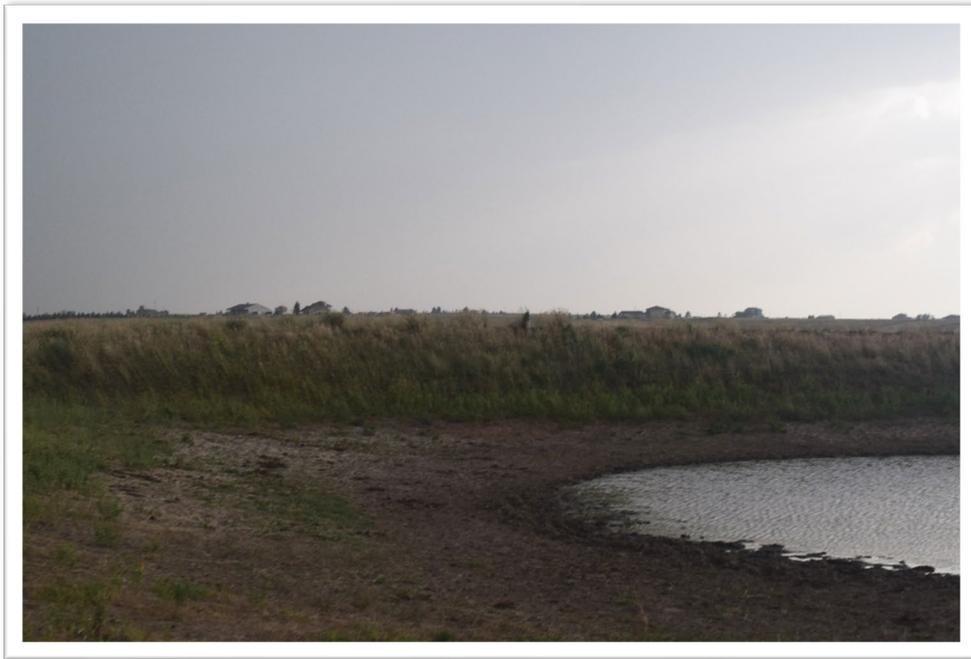
Photo 9. Close up view of the southwest side of the cattle pond showing no connected bed and banks or loss of vegetation indicative of continued surficial flow.

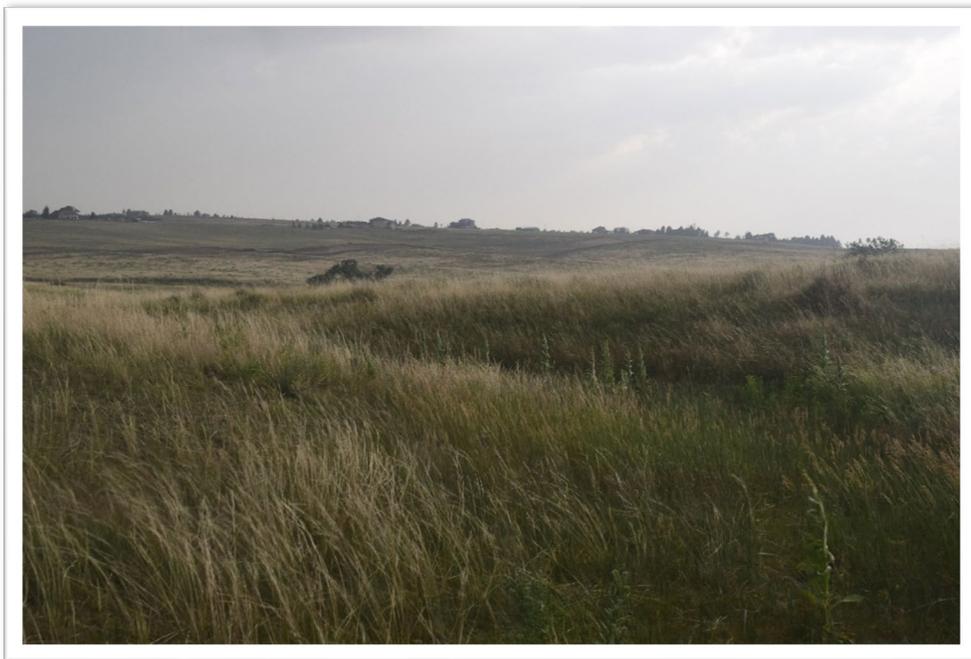
Photo 10. View of upland vegetated swale lacking OHWM indicators. The area exhibits no change in vegetation community, destruction of terrestrial communities, debris, sedimentation, or bed and bank characteristics.
