# Inspection Photos

Operator: CAERUS PICEANCE LLC # 10456

Location ID: 479149

Aaron Trujillo  
NW Reclamation Specialist  
COGCC

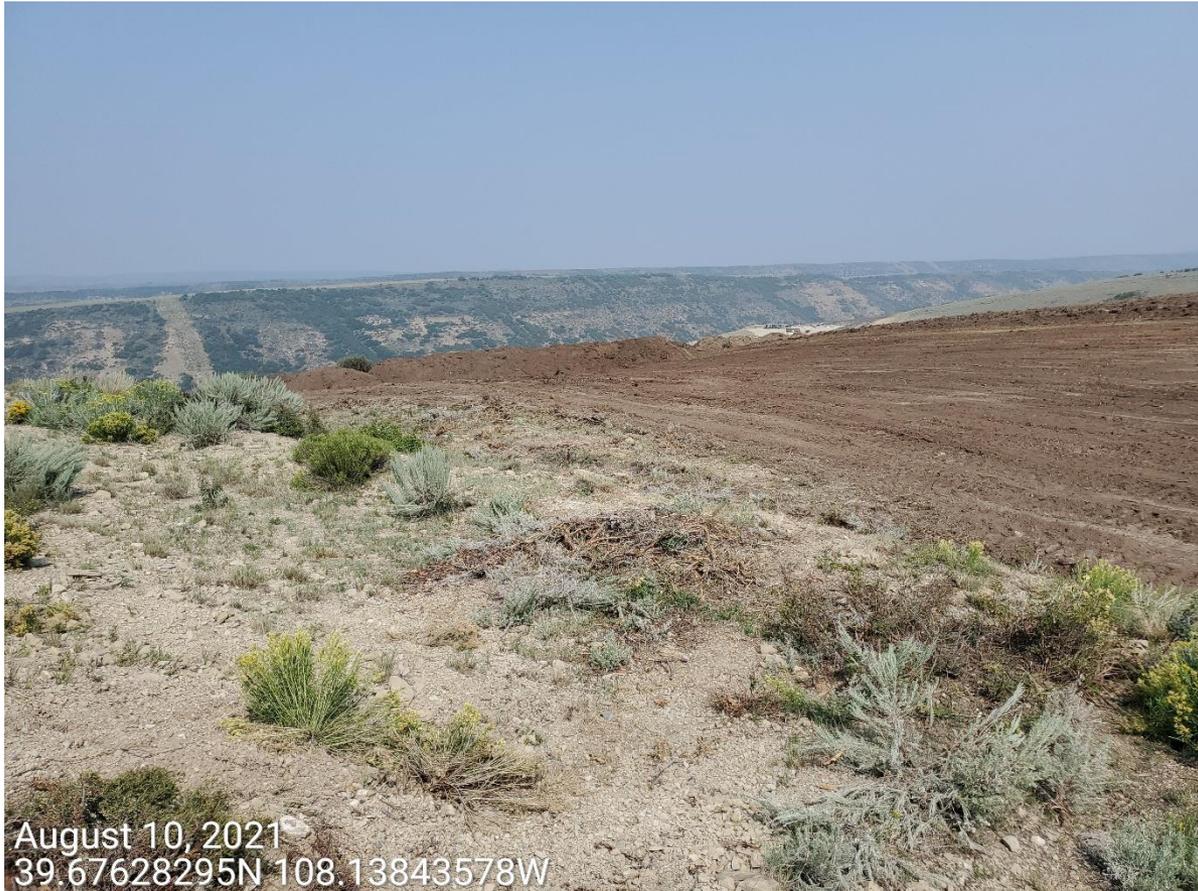
**Photo 1:** Photo taken from the south end of the Location, facing northwest. Photos 1-3 provide an overview of the Location from northwest, north to northeast; topsoil salvage operations in process at time of inspection.

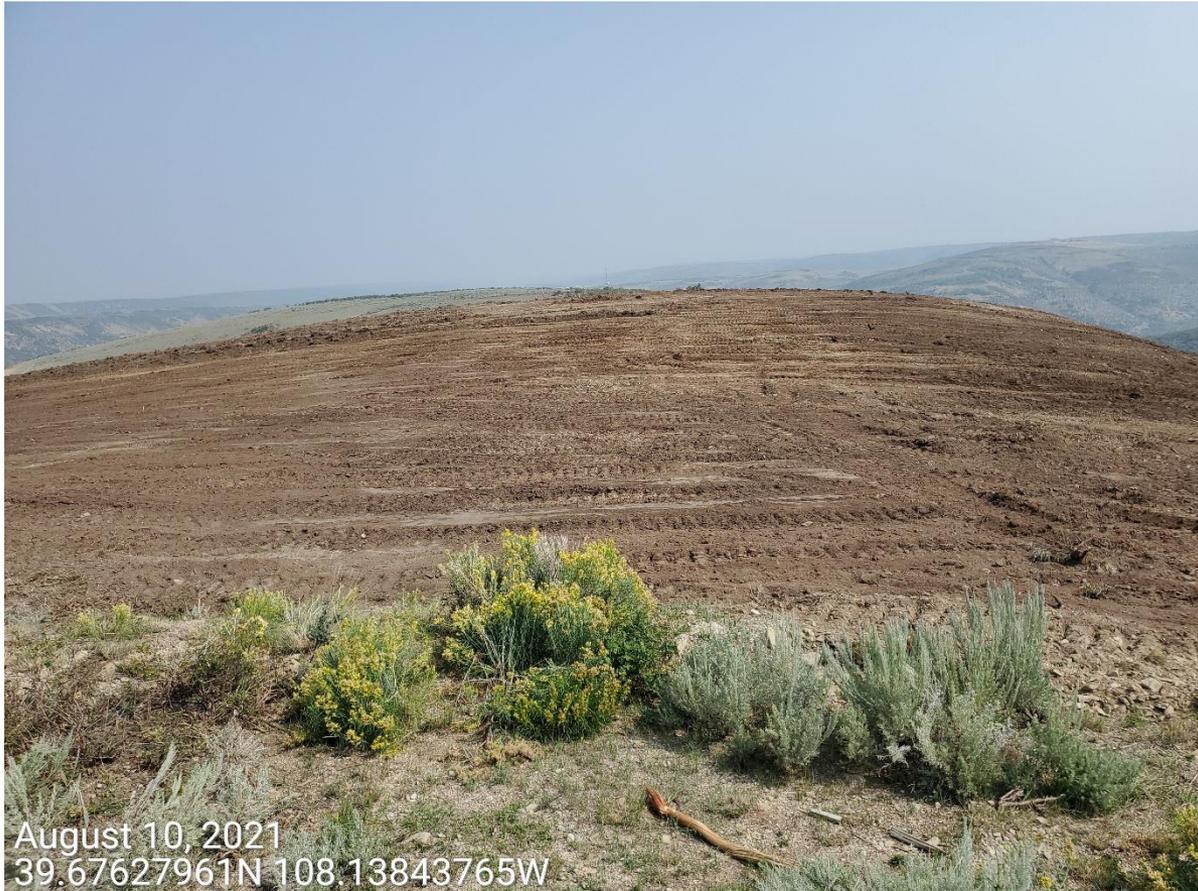
**Photo 2:** See comments under photo 1.

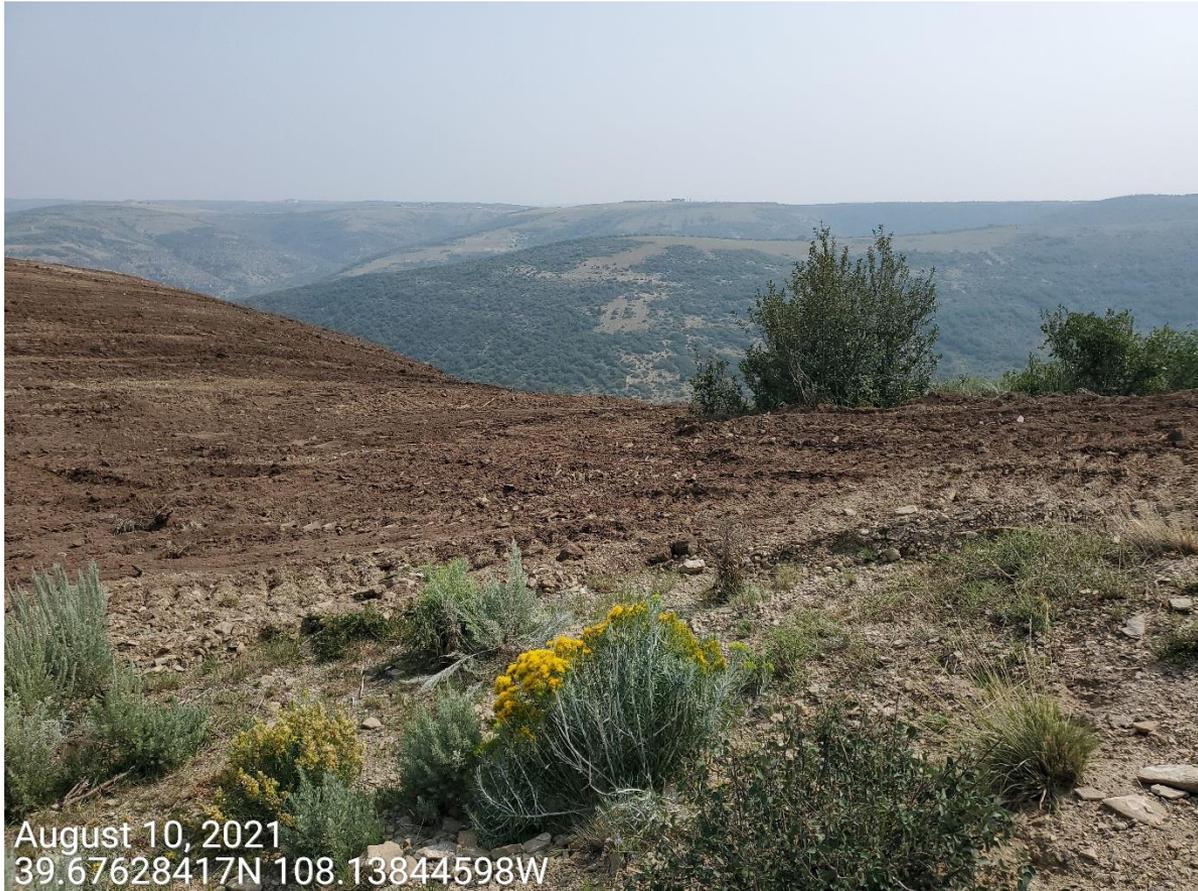
**Photo 3:** See comments under photo 1.

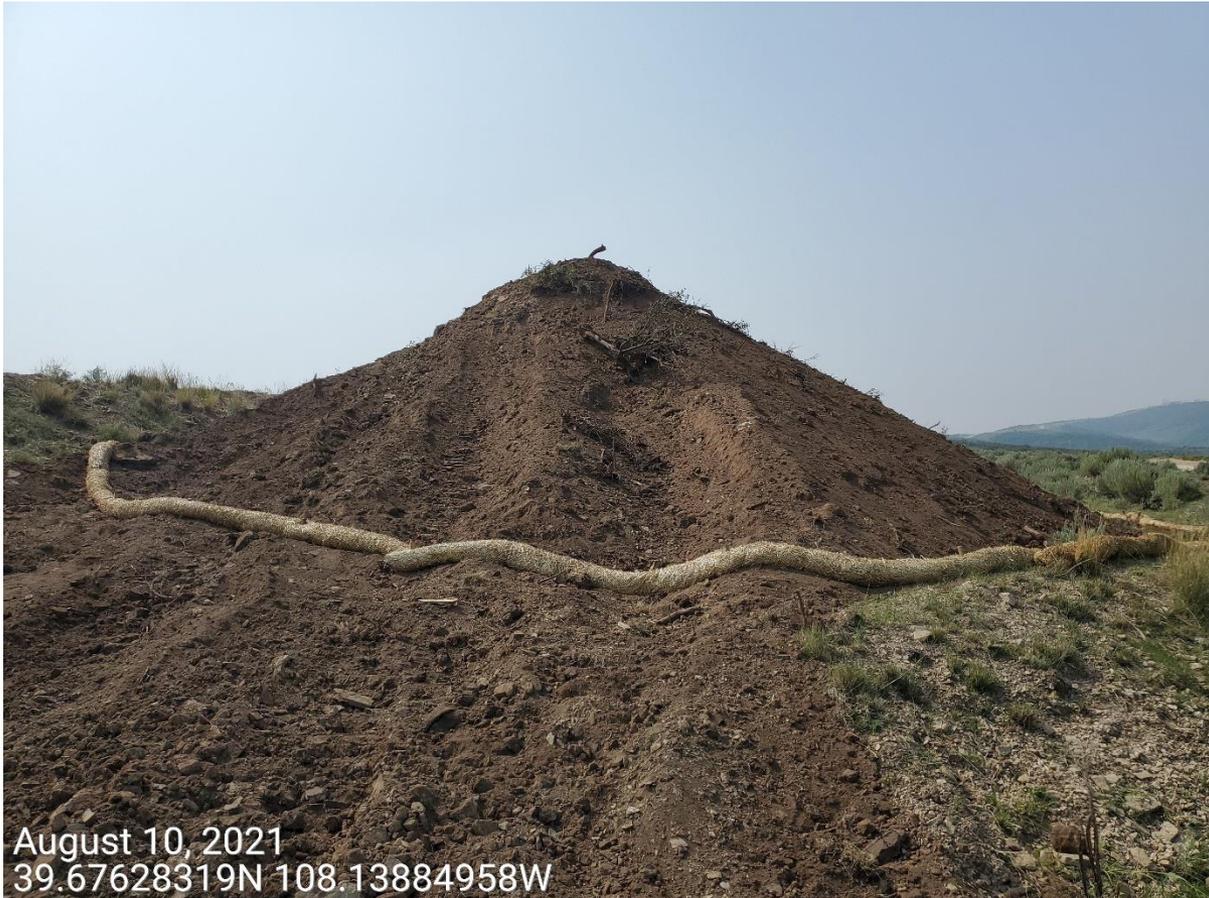
**Photo 4:** Photo shows example of stockpiled soils with a erosion log installed at base; BMPs to stabilize and protect soils currently missing.

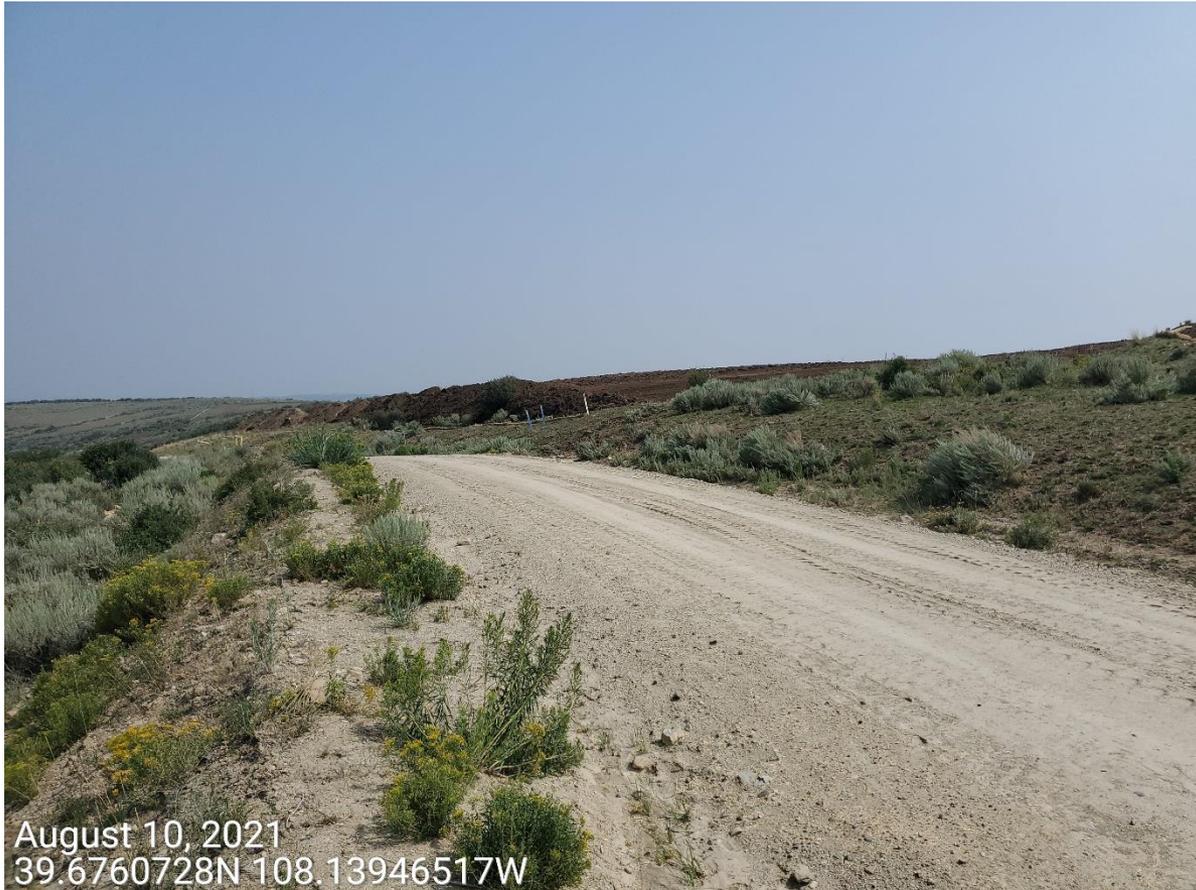
**Photo 5:** Photo taken from the access road southwest of the Location. Photo shows the areas identified in the Location and construction drawings to be the Location entrance. Signage at the Location entrance not observed.
