# Inspection Photos

Operator: CAERUS PICEANCE LLC # 10456

Location ID: 335904

Garfield County, CO

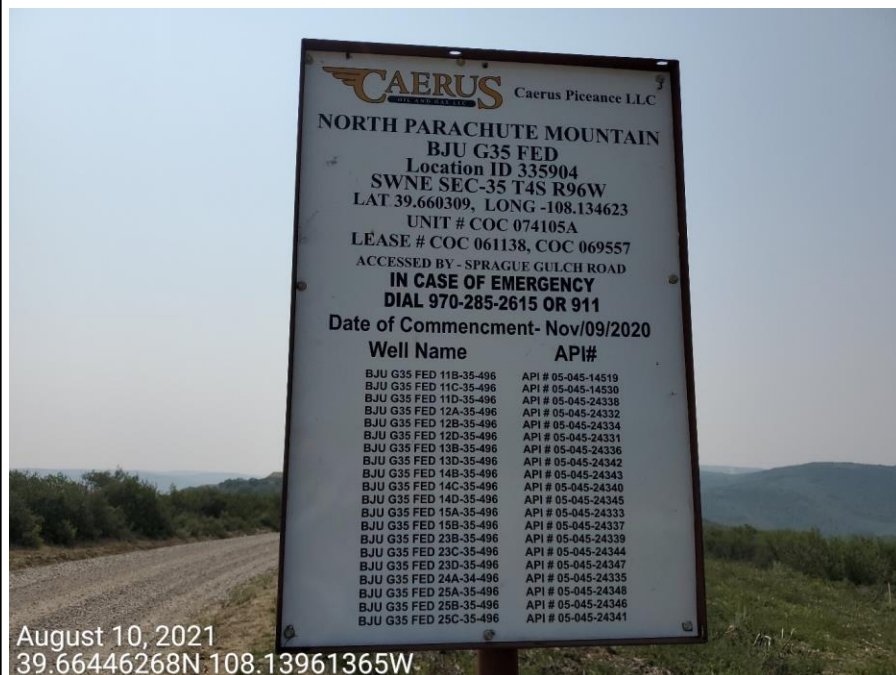
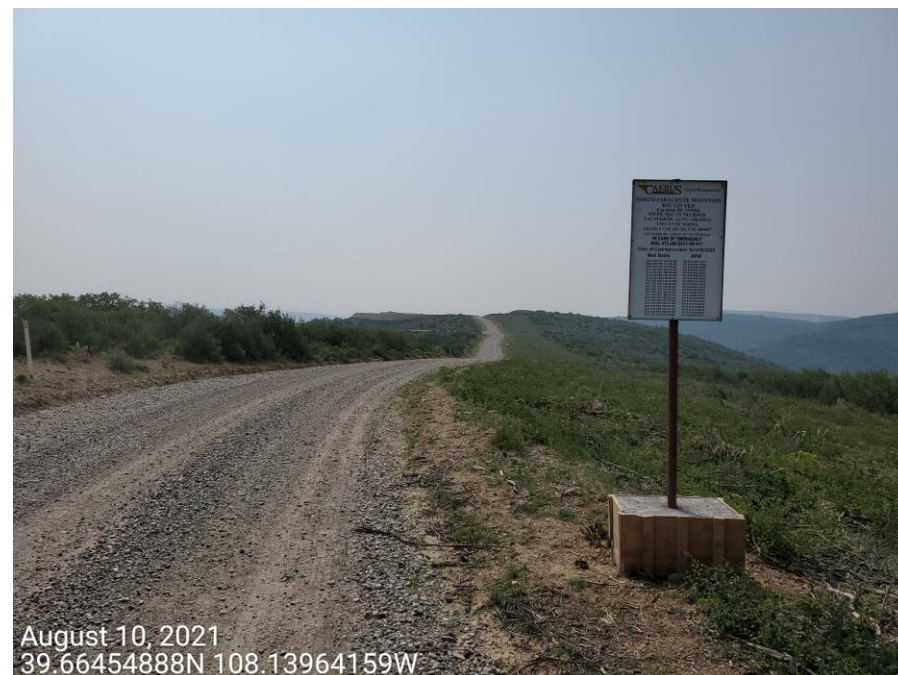
**Photo 1:** Photos show signs installed at the Location entrance (left photo), and along the access road north of the Location (right photo).

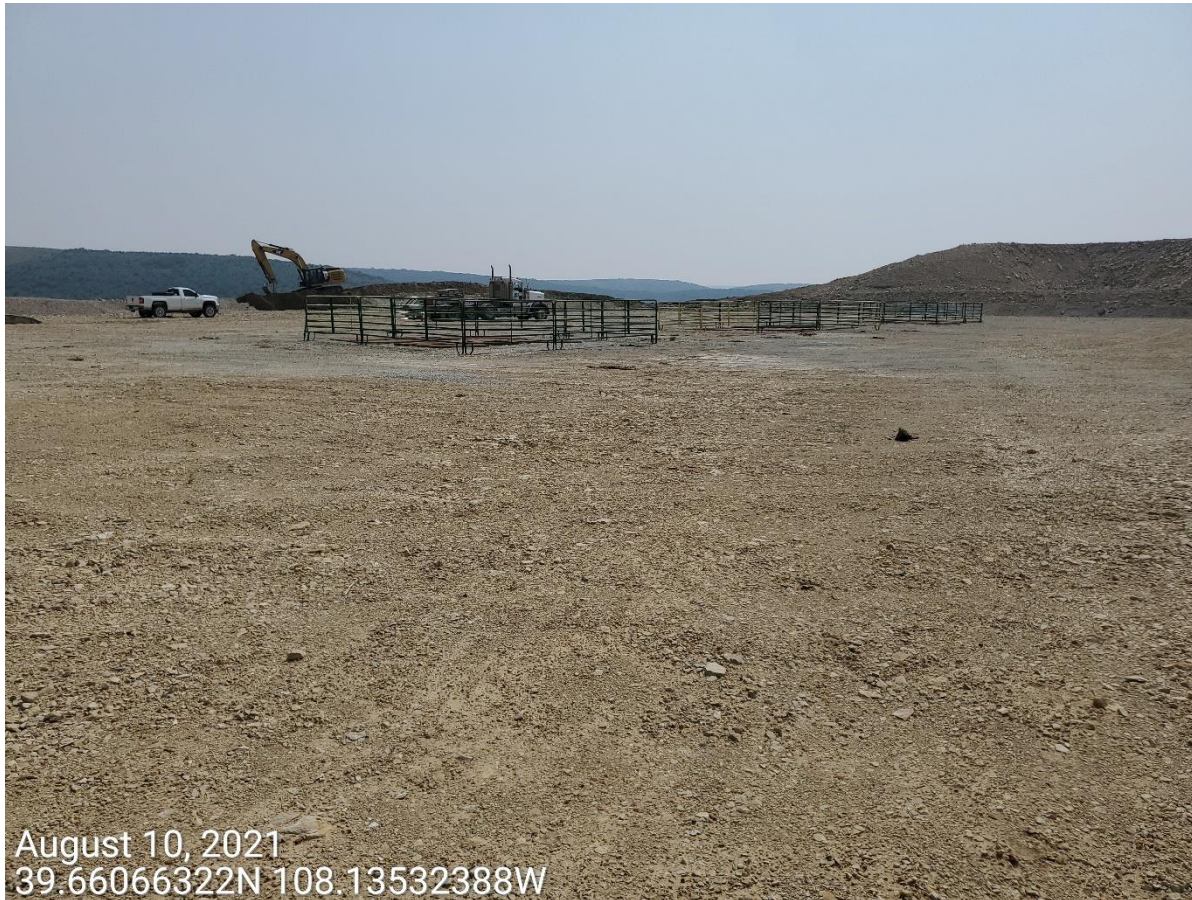
August 10, 2021  
39.66066322N 108.13532388W

**Photo 2:** Photo shows well conductors remaining on the Location.

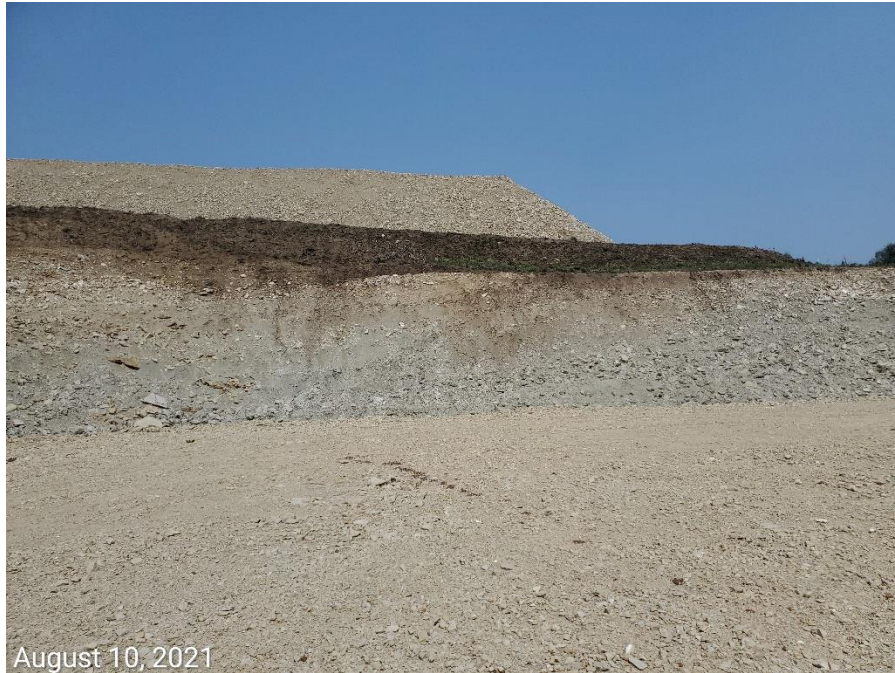
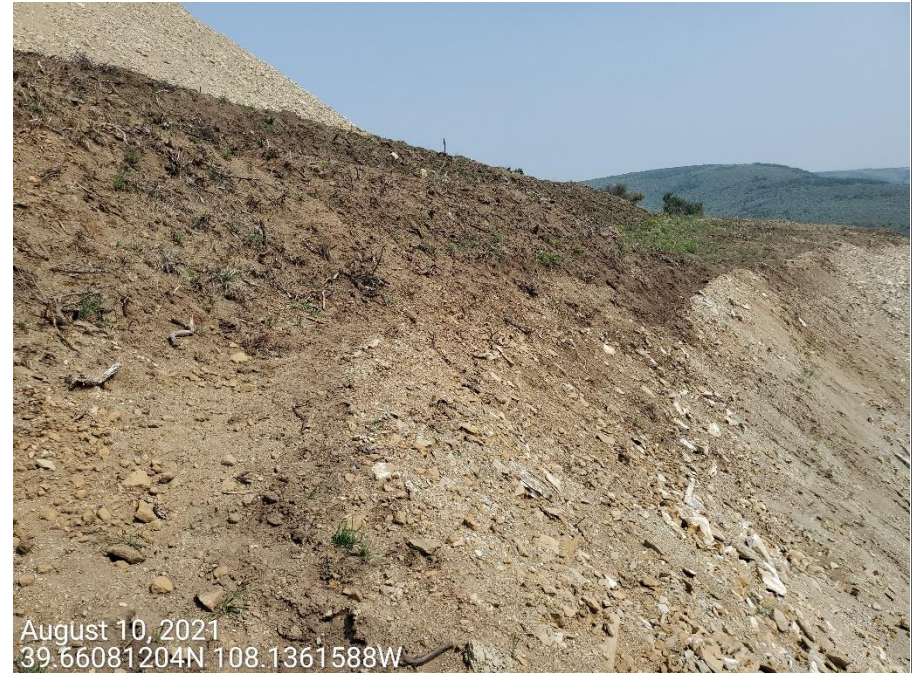
**Photo 3:** Photos shows examples of the cut slopes (left photo), and topsoil stockpiles (right photo). BMPs to protect and stabilize the cut/fill slopes of the Location, and stockpiled soils remain missing or insufficient.

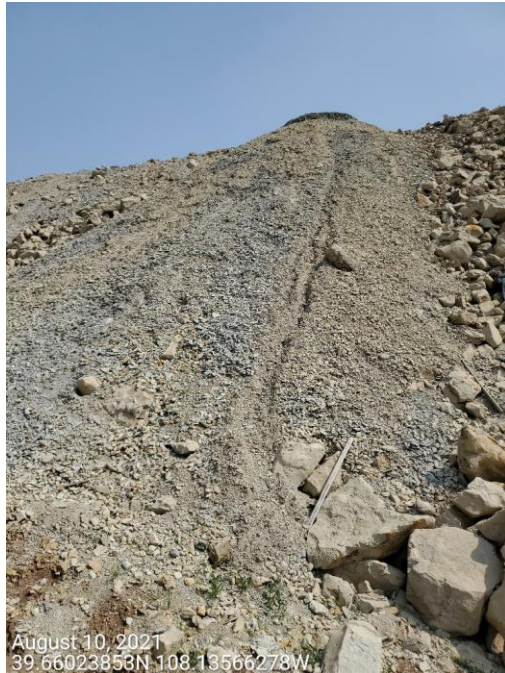
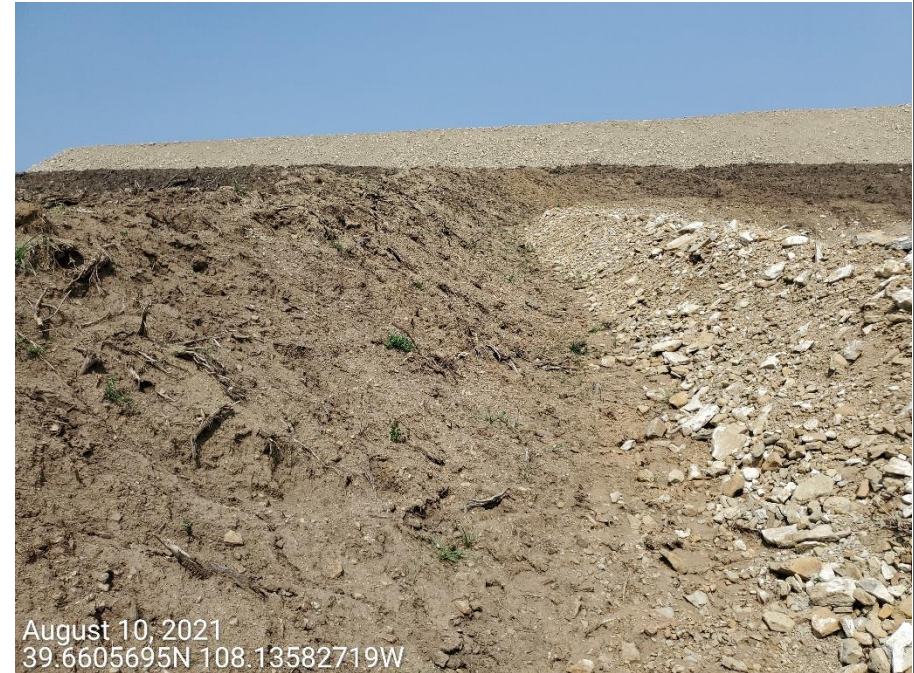
**Photo 4:** Photos shows examples of the fill slopes (left photo), and topsoil stockpiles (right photo). BMPs to protect and stabilize the cut/fill slopes of the Location, and stockpiled soils remain missing or insufficient.

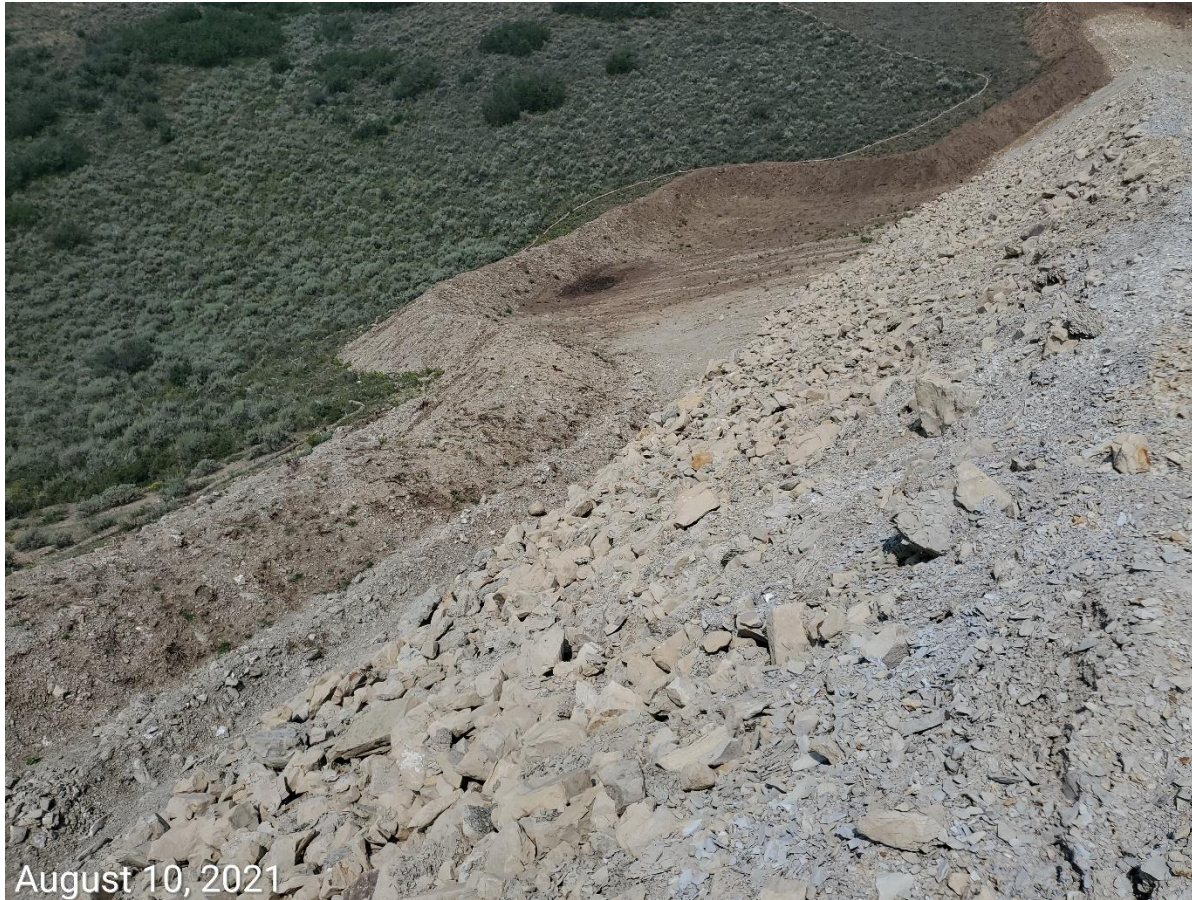
**Photo 5:** Photo taken from the west end of the Location. Photo shows control measures to protect/stabilize slopes remain missing or insufficient. Photo also shows example where topsoil has been utilized at the base of the fill slopes/subsoils of the Location, as a berm and sediment trap/pond to manage stormwater. Photo shows Topsoil has not been properly separated and protected, is being mixed with subsoil, and is at risk for loss due to stormwater discharge displacing the topsoil. A second trap/pond exists on the east end of the Location.

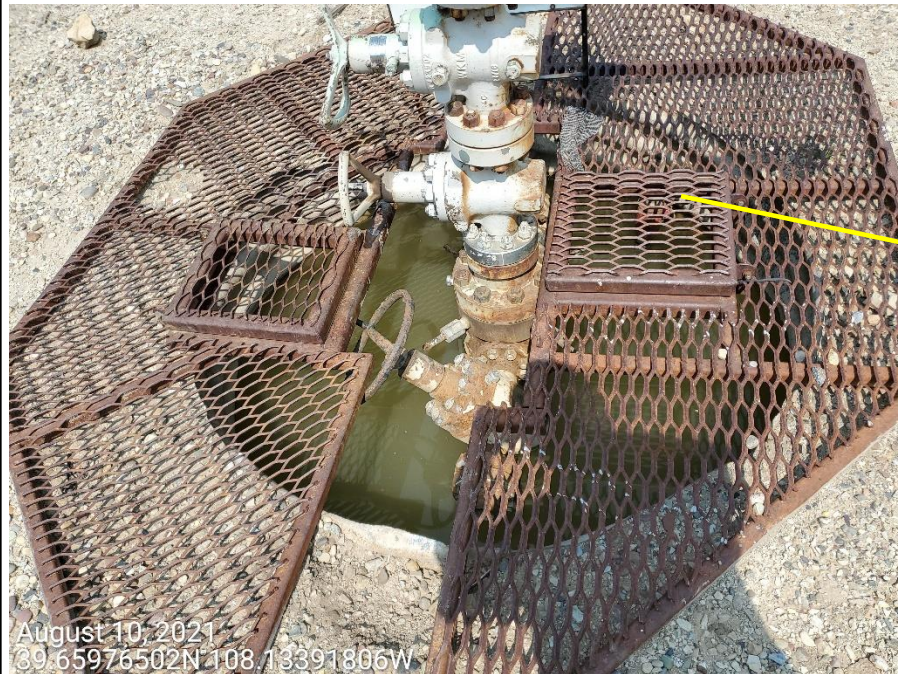
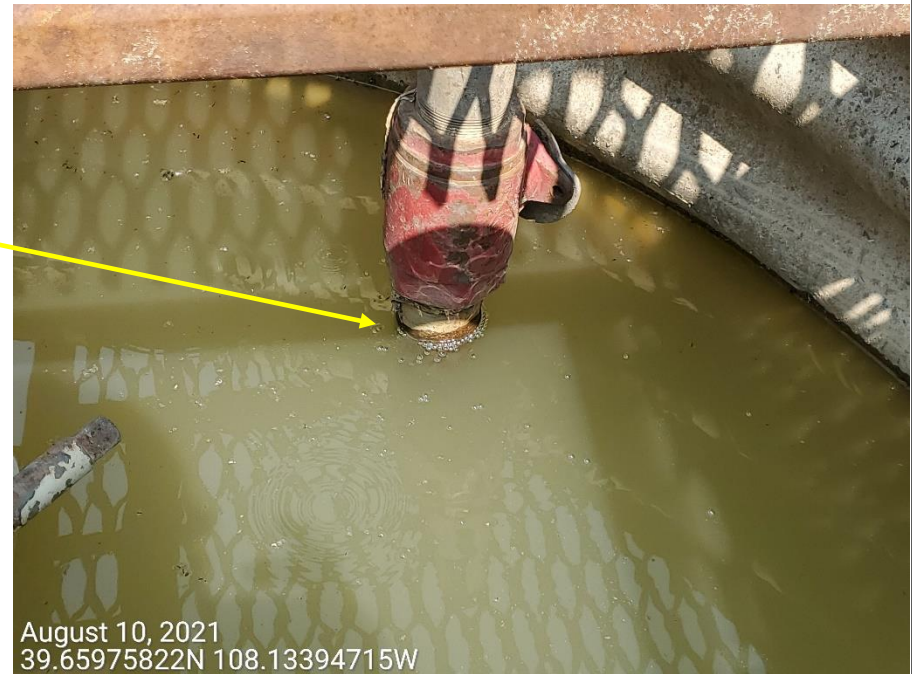
**Photo 6:** Photo of well API 05-045-14529. Gas was observed to be leaking from what appears to be the bradenhead at well API #05-045-14529. Photo also shows cellar filled with fluids

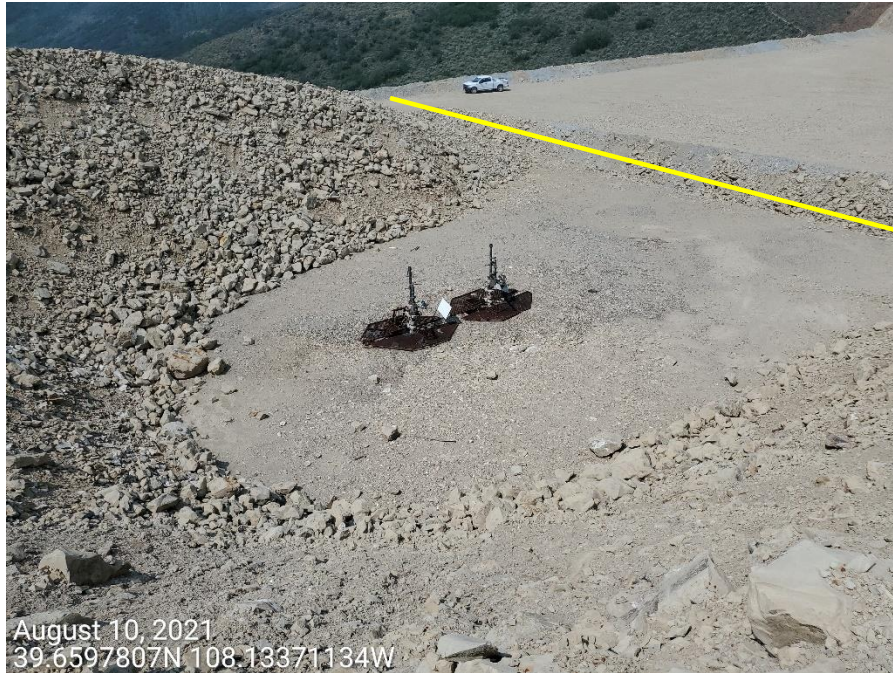
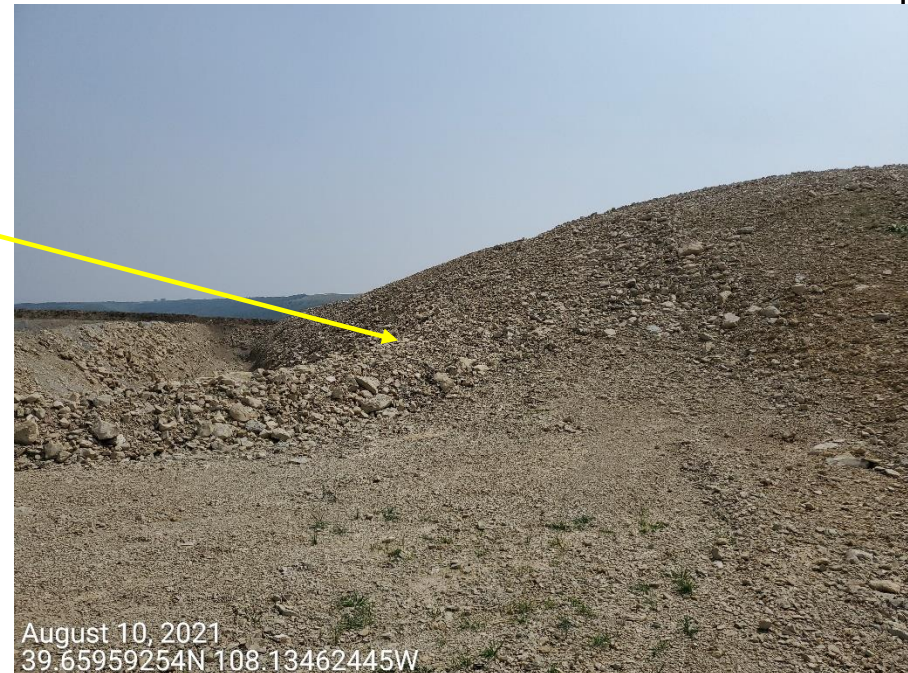
**Photo 7:** Photo on left taken from on top of the slopes above the TA wells facing west. Photo on the right taken from the southwest corner of the pad facing east towards the wells. Photo shows access to the TA wells is currently limited/restricted due to the contouring of the Location during recent pad expansion; slopes have been constructed along the eastern, southern and western perimeter of the wells; a pit has been constructed on the northern perimeter of the wells.
