Inspection Photos

8/10/2021

Operator: CAERUS PICEANCE LLC #10456

Location ID: 457122

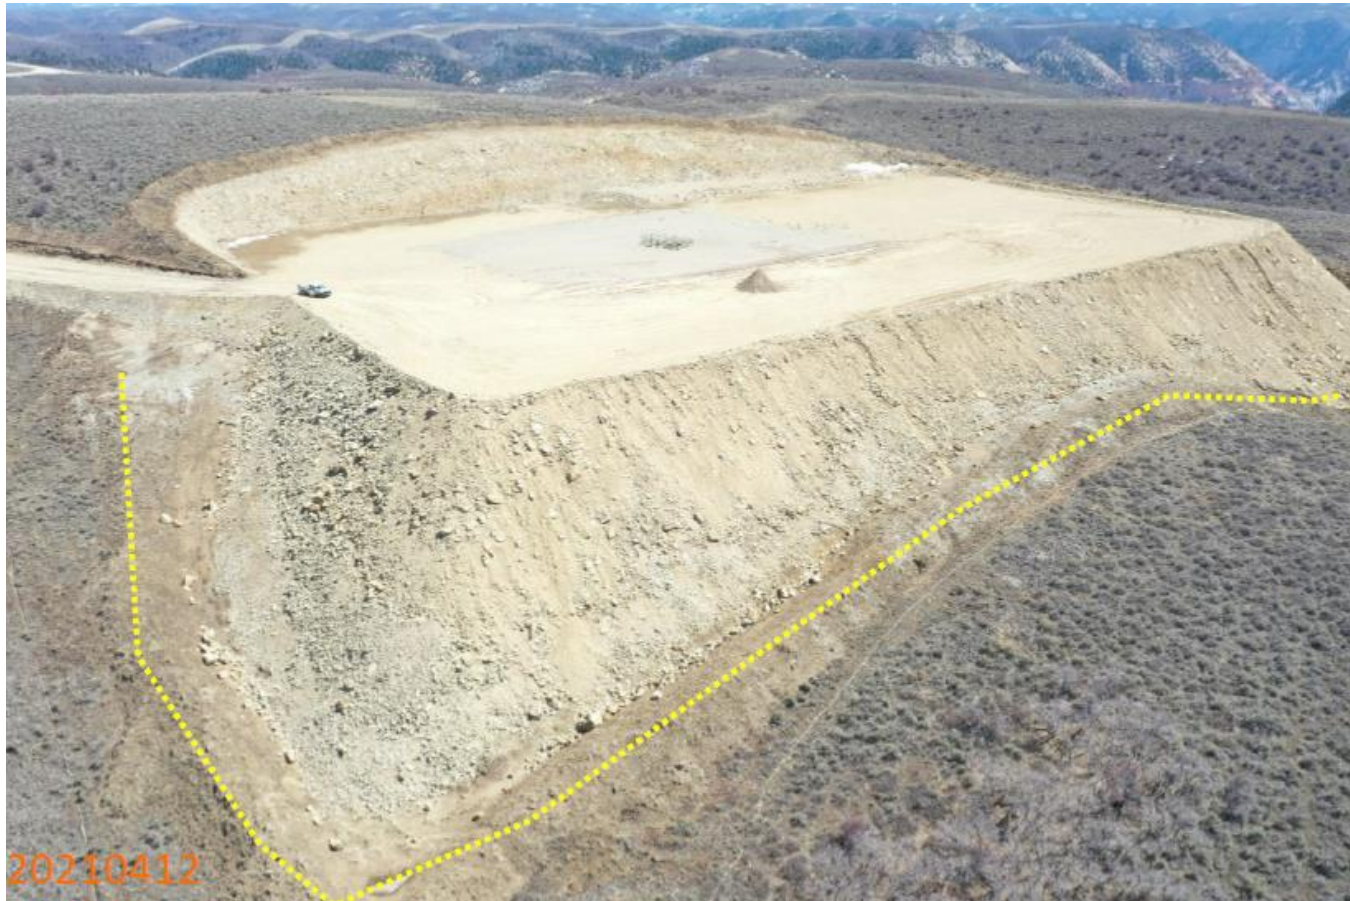
Photo 1: Photos 1-3 used from the 4/12/2021 inspection; photos provide an aerial overview of the Location. Photos show BMPs to protect and stabilize the slopes of the Location are missing or insufficient. It was observed in this inspection that conditions remain unchanged, or have worsened since the 4/12/2021 inspection; erosion degradation evident; large cracks within the fill slope remains; BMPs to address stabilization concerns remain missing.

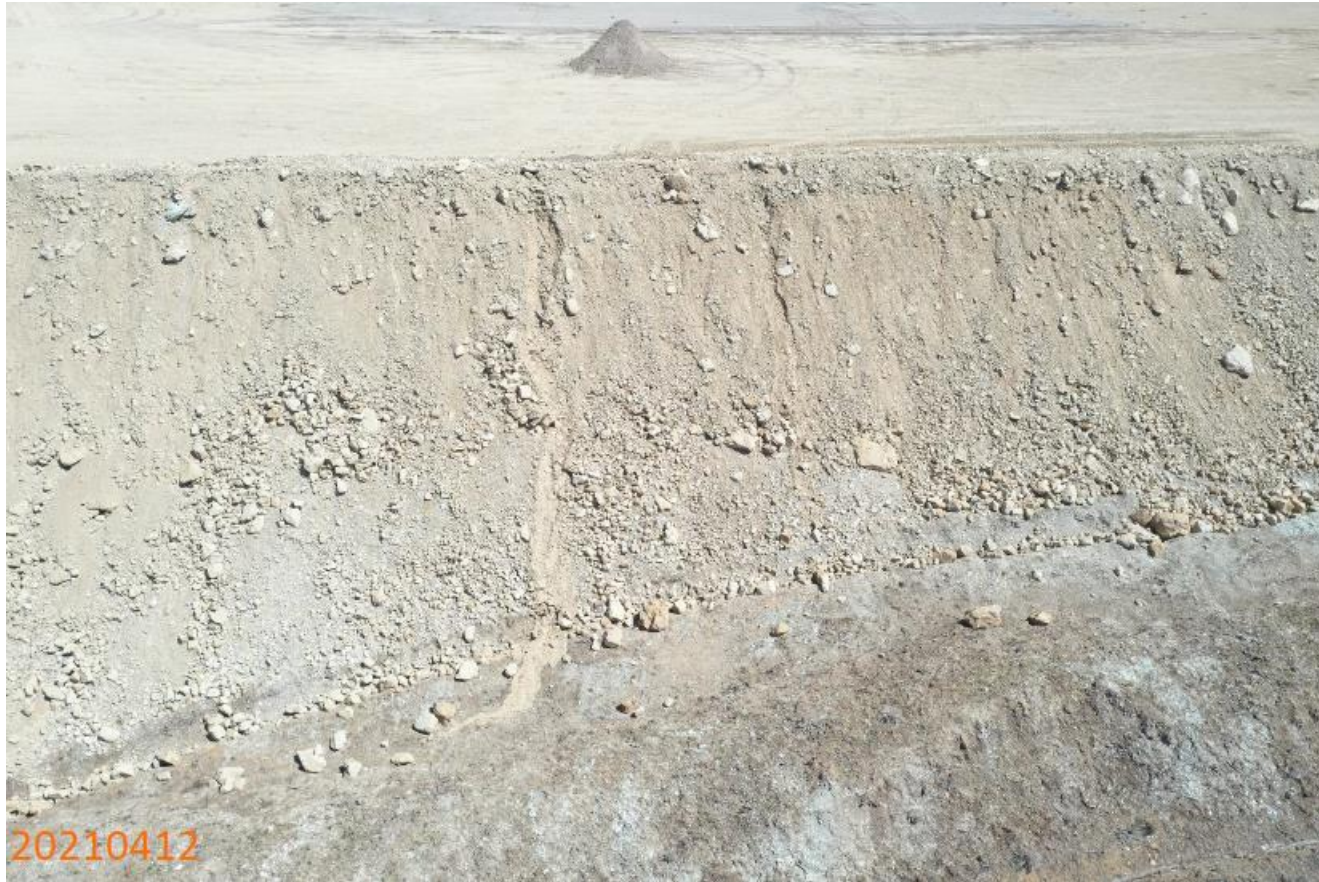
Photo 2: See comments under photo 1.

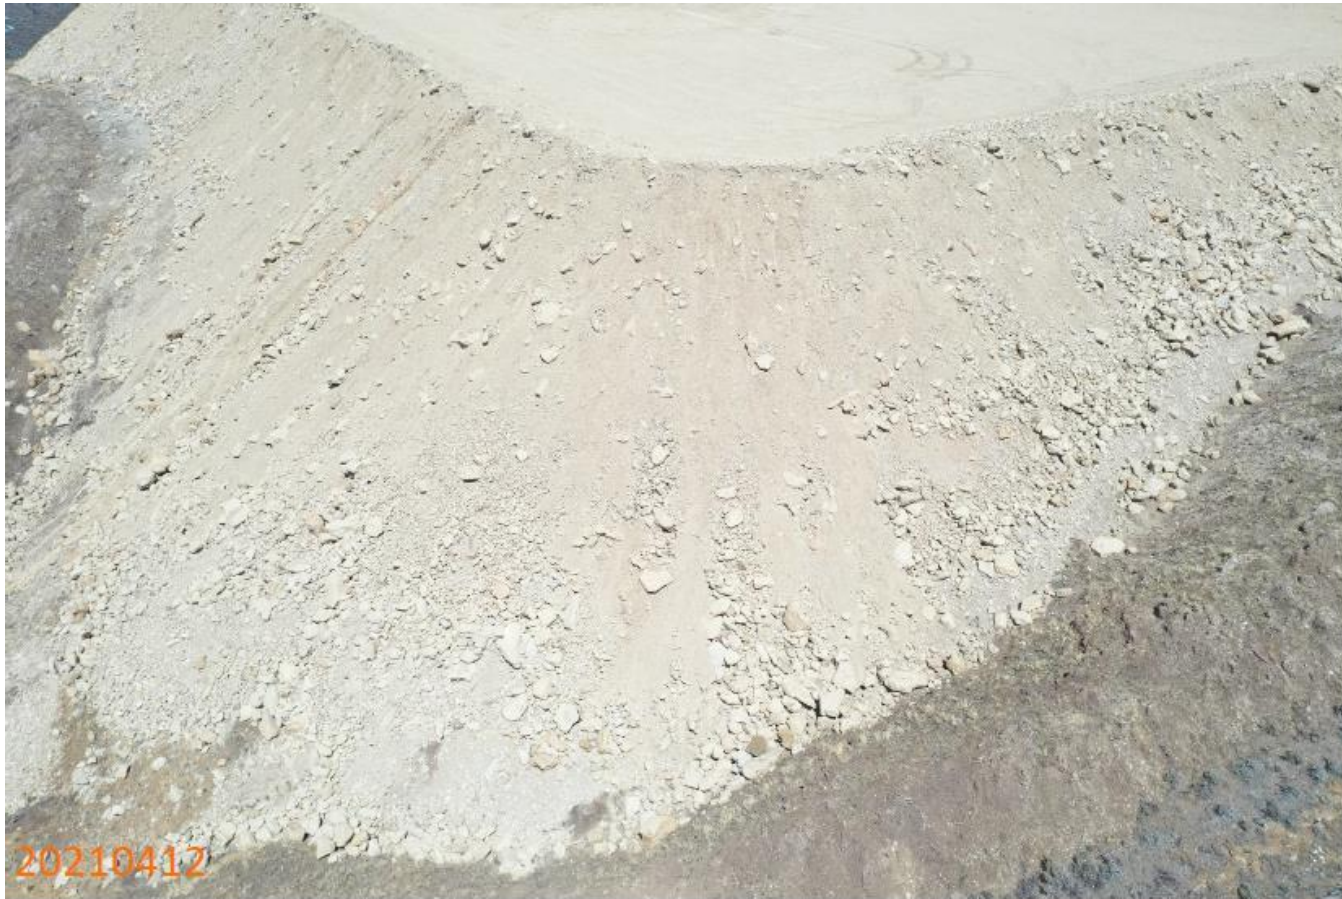
Photo 3: See comments under photo 1.

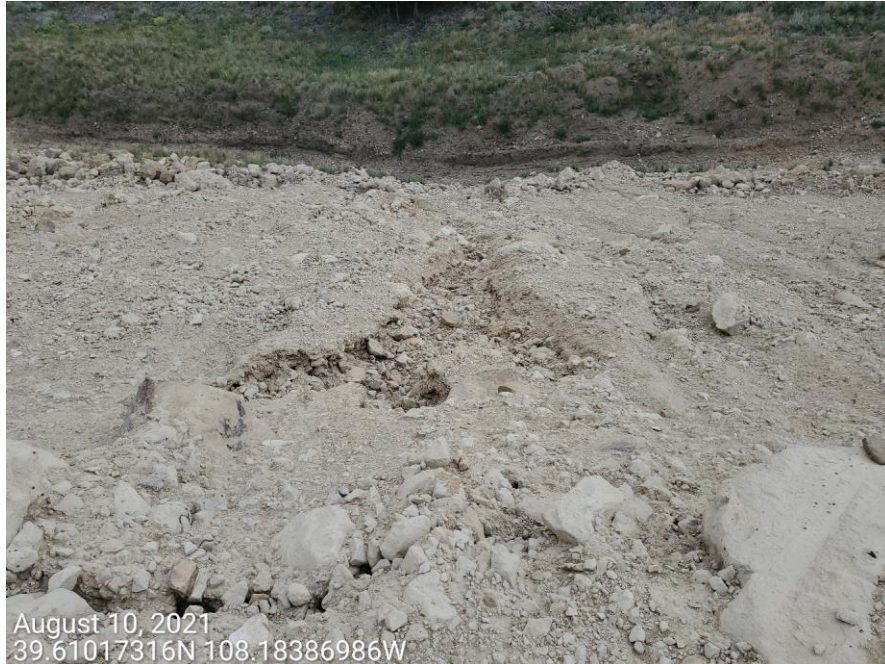
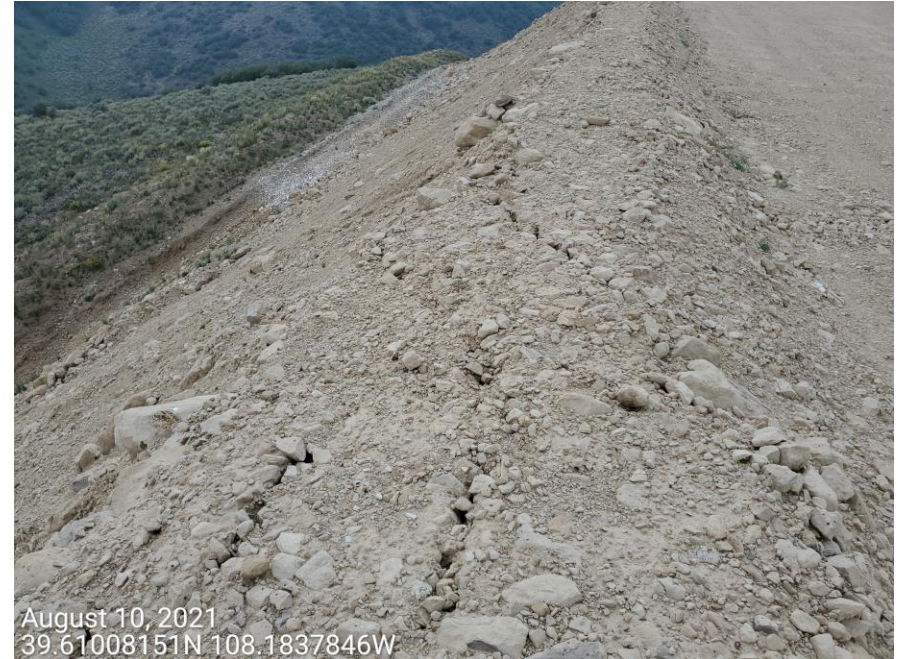
Photo 4: Photo taken from the fill slopes of the Location. Photos show BMPs to protect and stabilize slopes of the Location remain missing or insufficient.

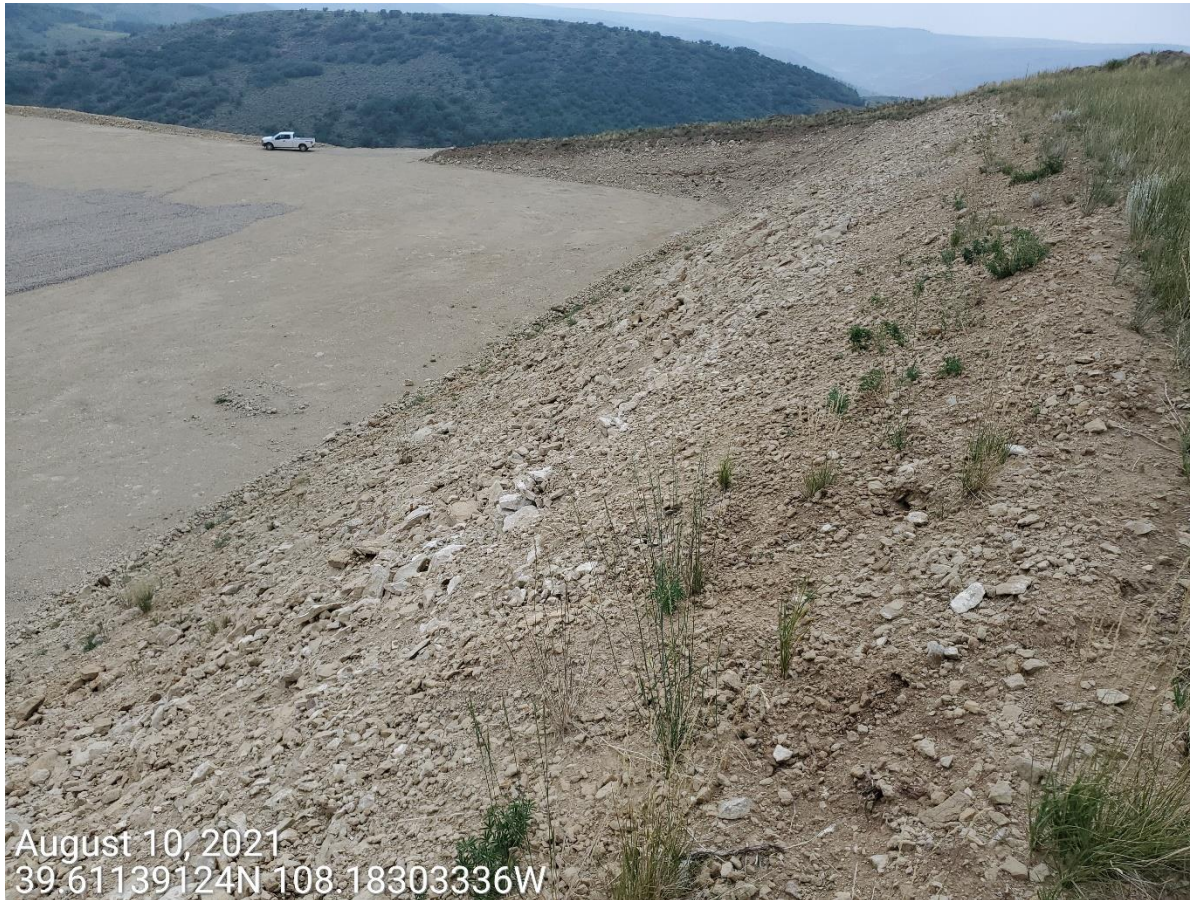
Photo 5: Photo taken from the cut slopes of the Location. Photos show BMPs to protect and stabilize slopes of the Location remain missing or insufficient.

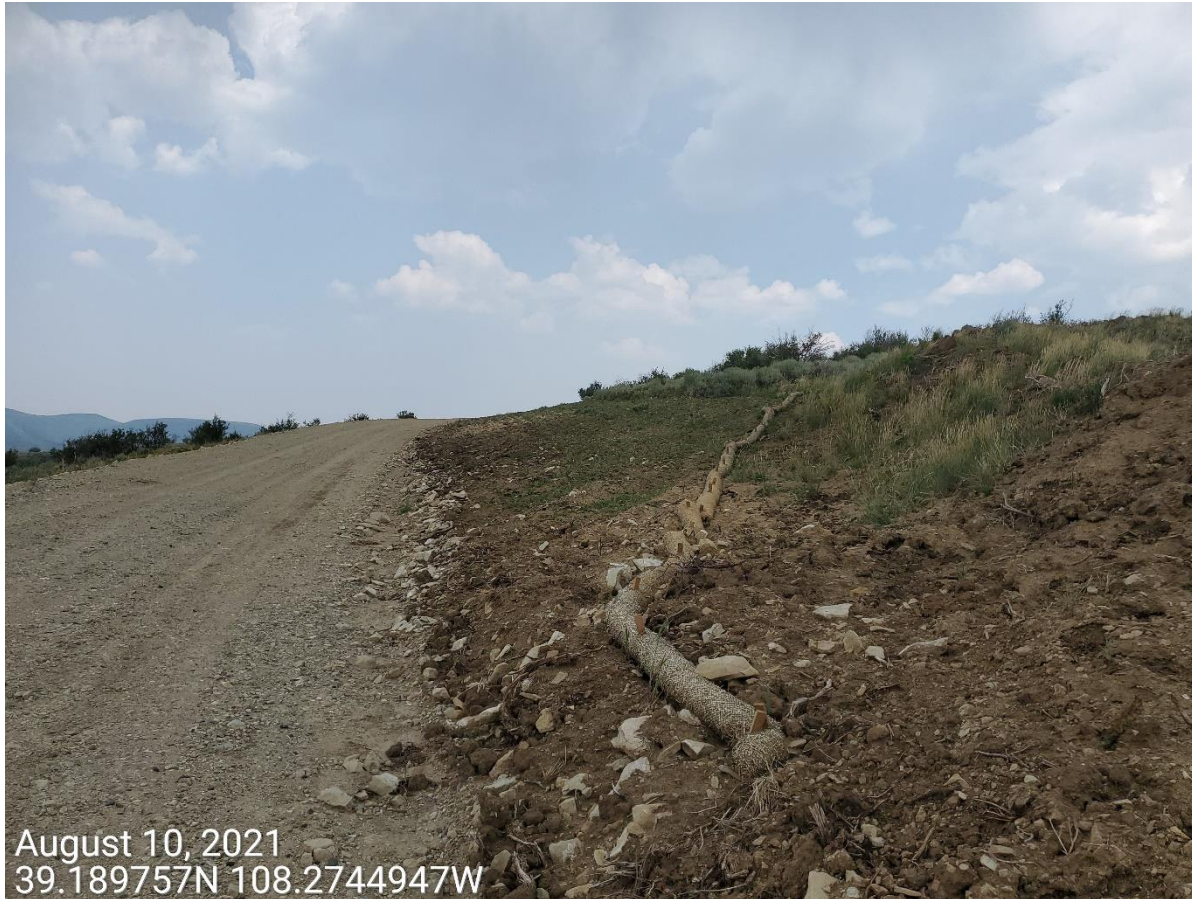
Photo 6: Photo taken from the access road. Photo shows cut slopes of the access road have been regraded; areas reclaimed and hydromulch applied.

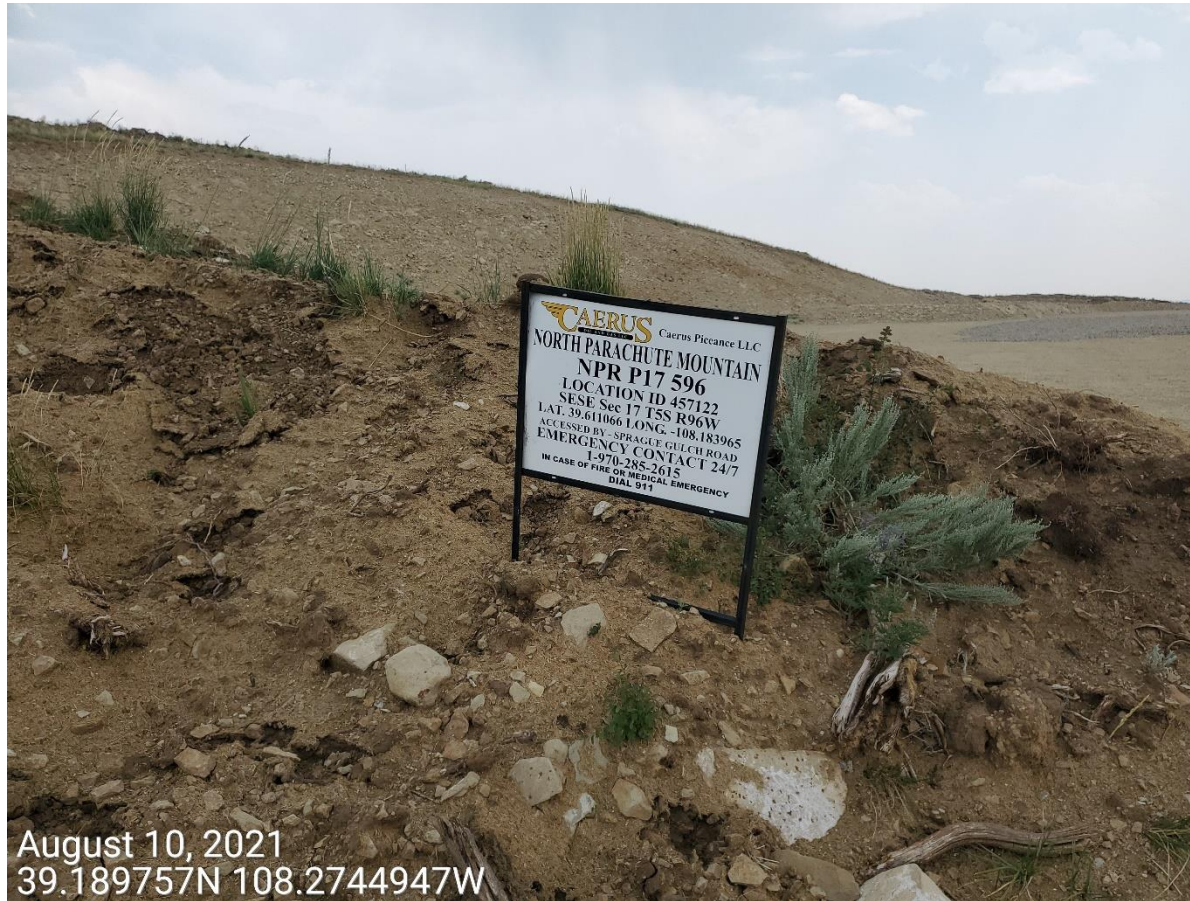
Photo 7: Photo taken from the Location entrance. Photo shows Location signage has been installed.

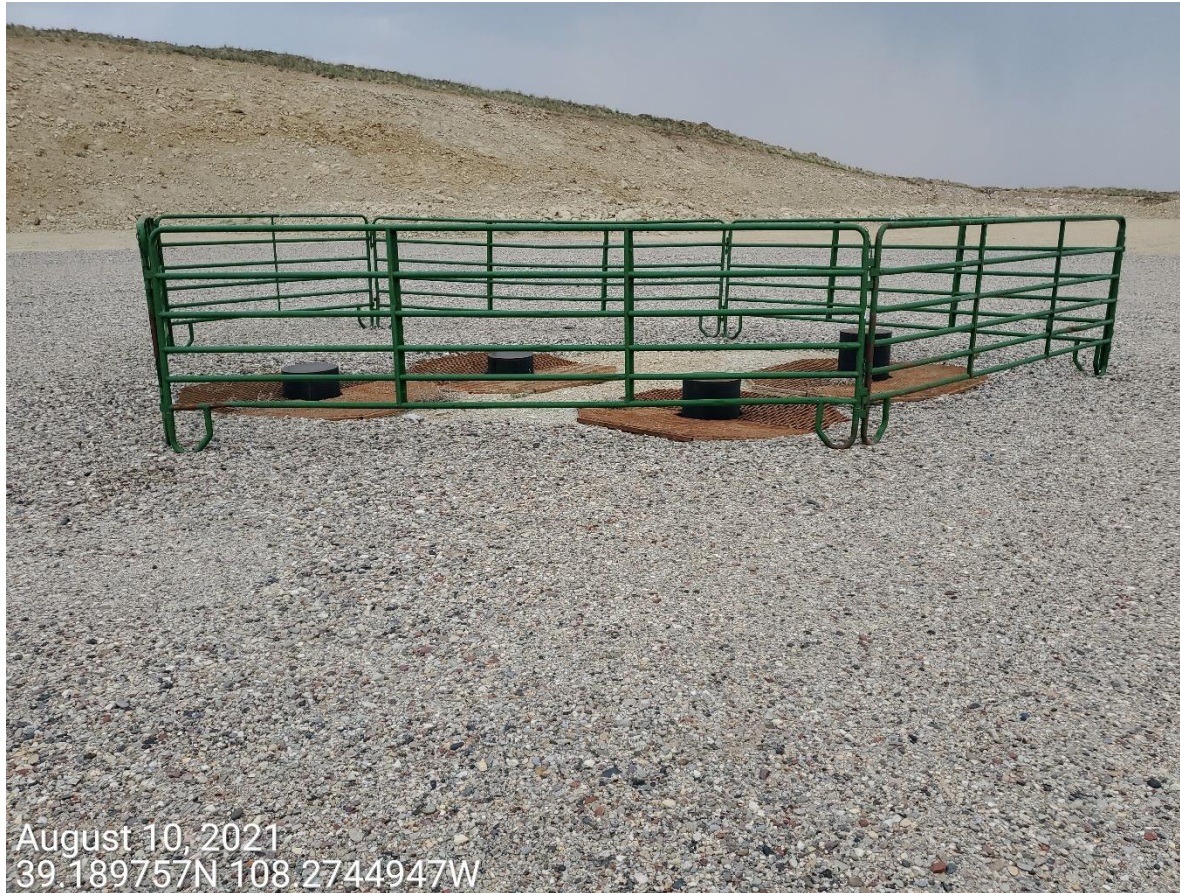
Photo 8: Photo shows 4 conductors remain on the location; no drilling operations have commenced.
