Inspection Photos

Operator: LARAMIE ENERGY LLC - 10433

Location ID: 449070

Mesa County, CO

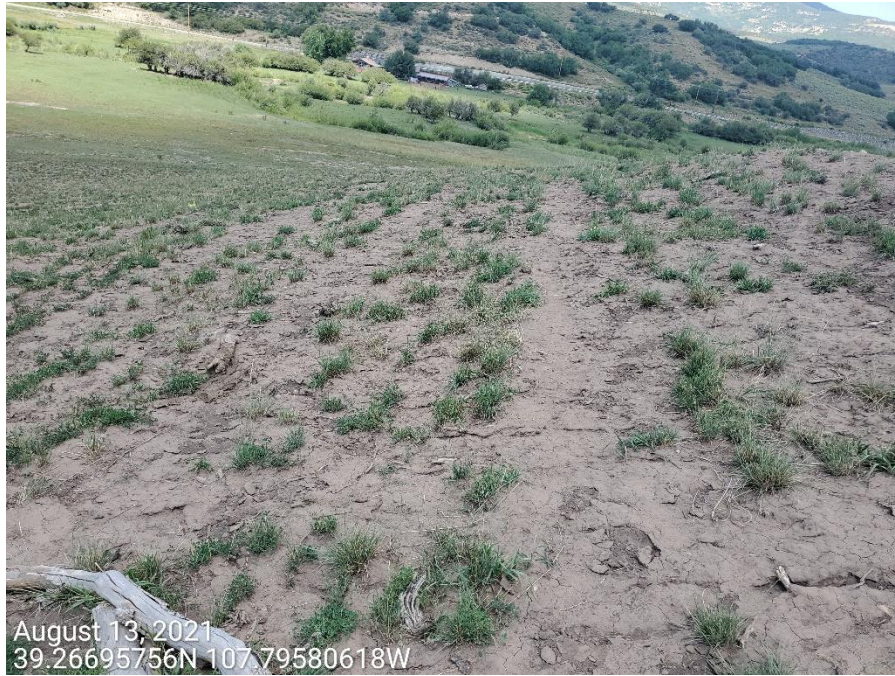
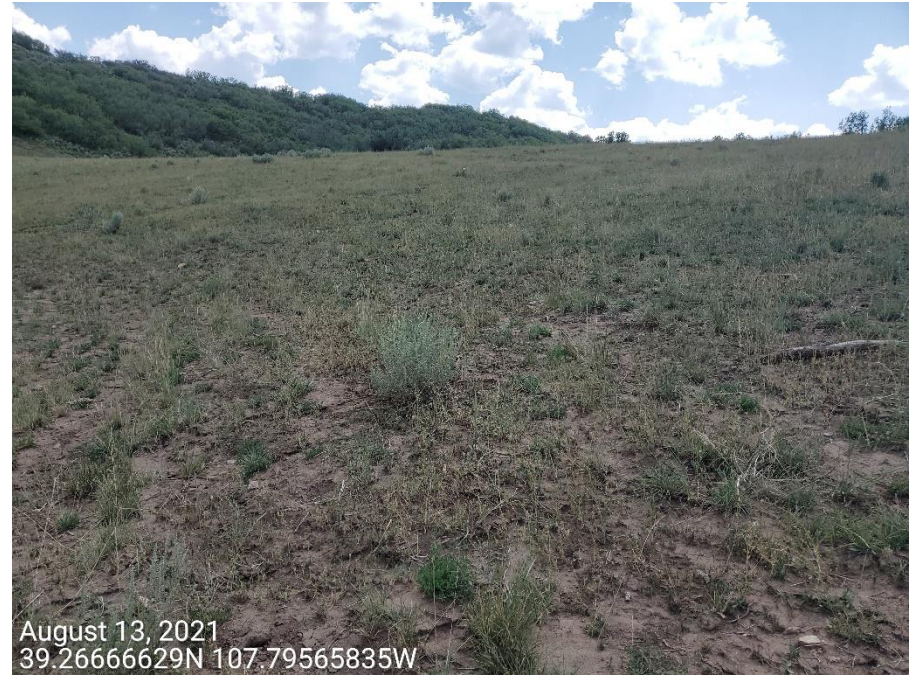
Photo 1: Photos taken from the interim areas of the Location. Photo on left shows interim areas on the west end of the Location. Photo shows areas where uniform establishment is not occurring and inter-seeding is needed. Photo on right shows interim areas on the south end of the Location where uniform establishment is occurring.

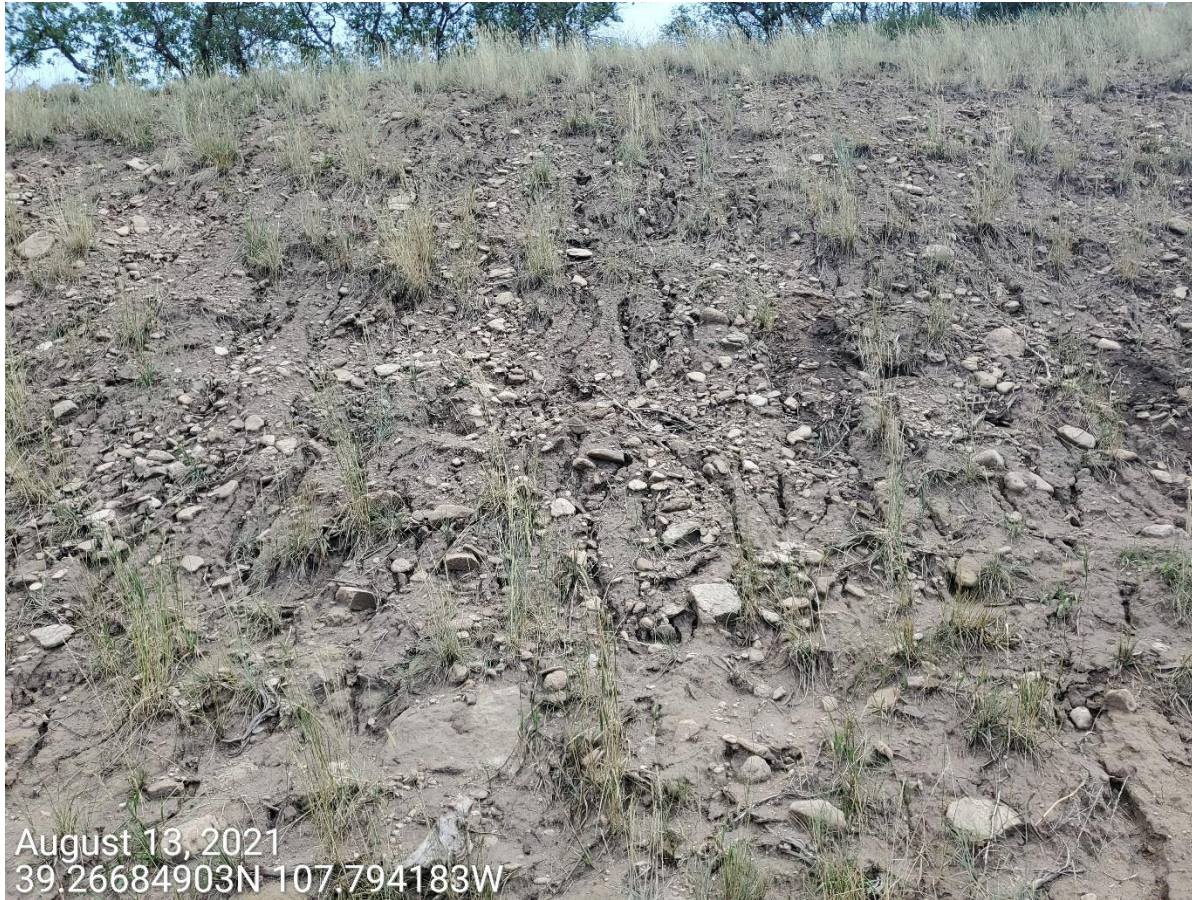
Photo 2: Photo taken from the west end of the Location. Photo shows areas where uniform establishment is not occurring and inter-seeding is needed. Photo also shows BMPs to stabilize the slopes are missing or insufficient.

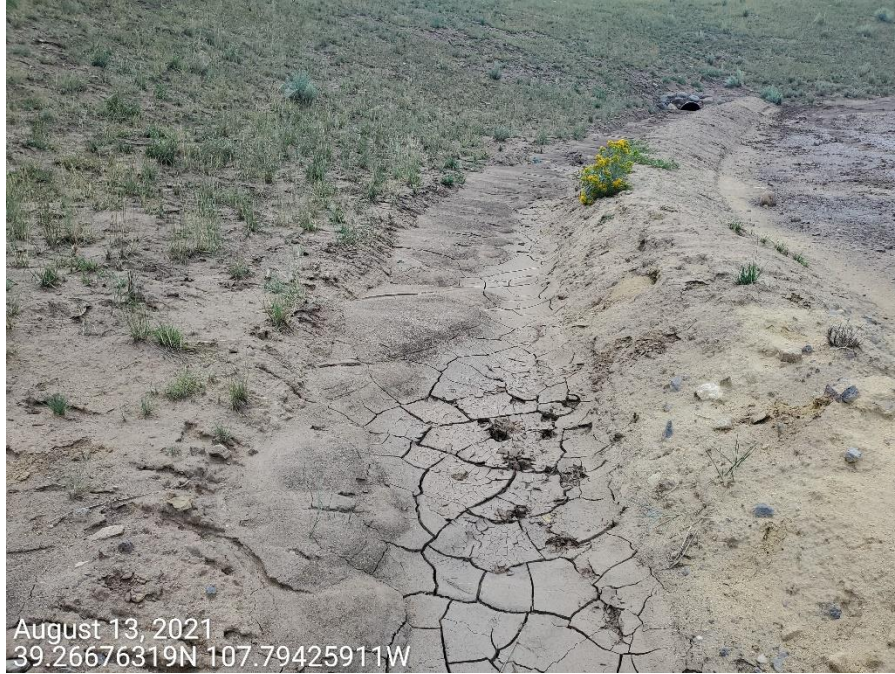
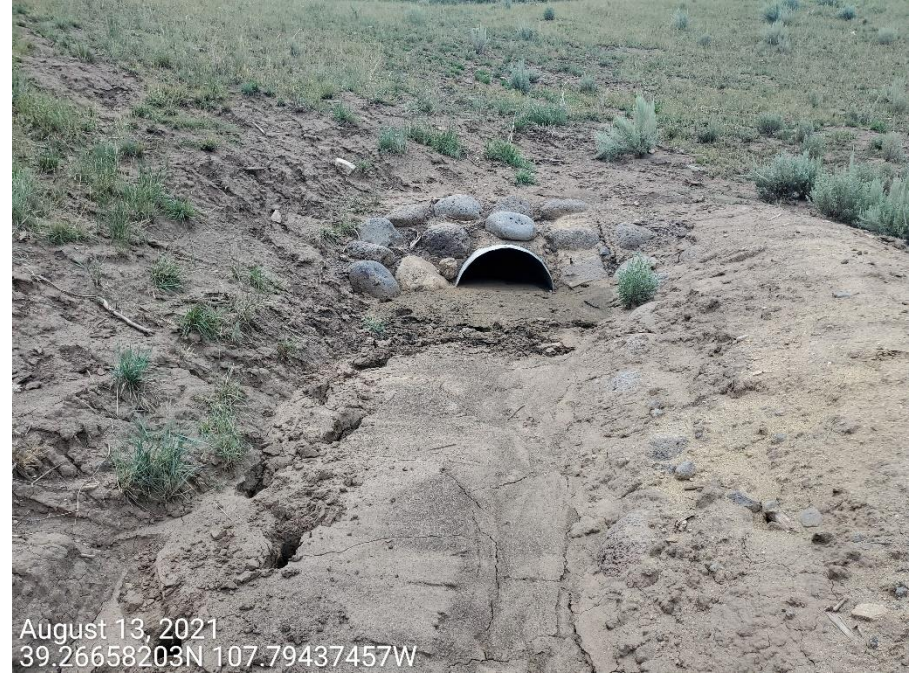
Photo 3: Photo shows sediment is filling ditch and culvert on the Location.
