Attachment B

TANK BATTERY DECOMMISSIONING FORM

SITE NAME: Miller 5 Excavation							DATE: 8/11/2021	REM. PROJECT #: 18732	WEATHER: 70's Sunny	
SITE DIRECTIONS: CR30/HWY 85, 1.5 mi E, N into							CLIENT: PDC - Paul Ruiz			
LEGALS AND LAT/LONG: 40.203401, -104.793862							TASMAN PERSONNEL: Jesse Marcus			
SOIL TYPES: Lean Clay - CL							SURFACE GRADIENT: West			
SOIL SAMPLING							FACILITY INFRASTRUCTURE			
Date/Time	Soil Sample ID	PID (ppm)	Visual	Olfactory	Photo?	Grab or Lab Sample?	EQUIPMENT		Quantity	
							Above Ground Storage Tank (AST)			
8/11/2021 09:51	B@9.5	54.6	HC Staining	Slight HC Odor	Yes	Grab	Buried or Partially Buried Vessel			
8/11/2021 11:28	N@7'	451.5	HC Staining	Strong HC Odor	Yes	Grab	Separator			
8/11/2021 11:27	W@5', GS01@5'	1639	HC Staining	Strong HC Odor	Yes	Grab	Emission Control Device (ECD)			
8/11/2021 10:27	S@5', GS02@5'	630.3	HC Staining	HC Odor	Yes	Grab	Dump Line			
8/11/2021 11:29	E@7', GS03@ 8'	560.9	HC Staining	HC Odor	Yes	Grab	Wellhead

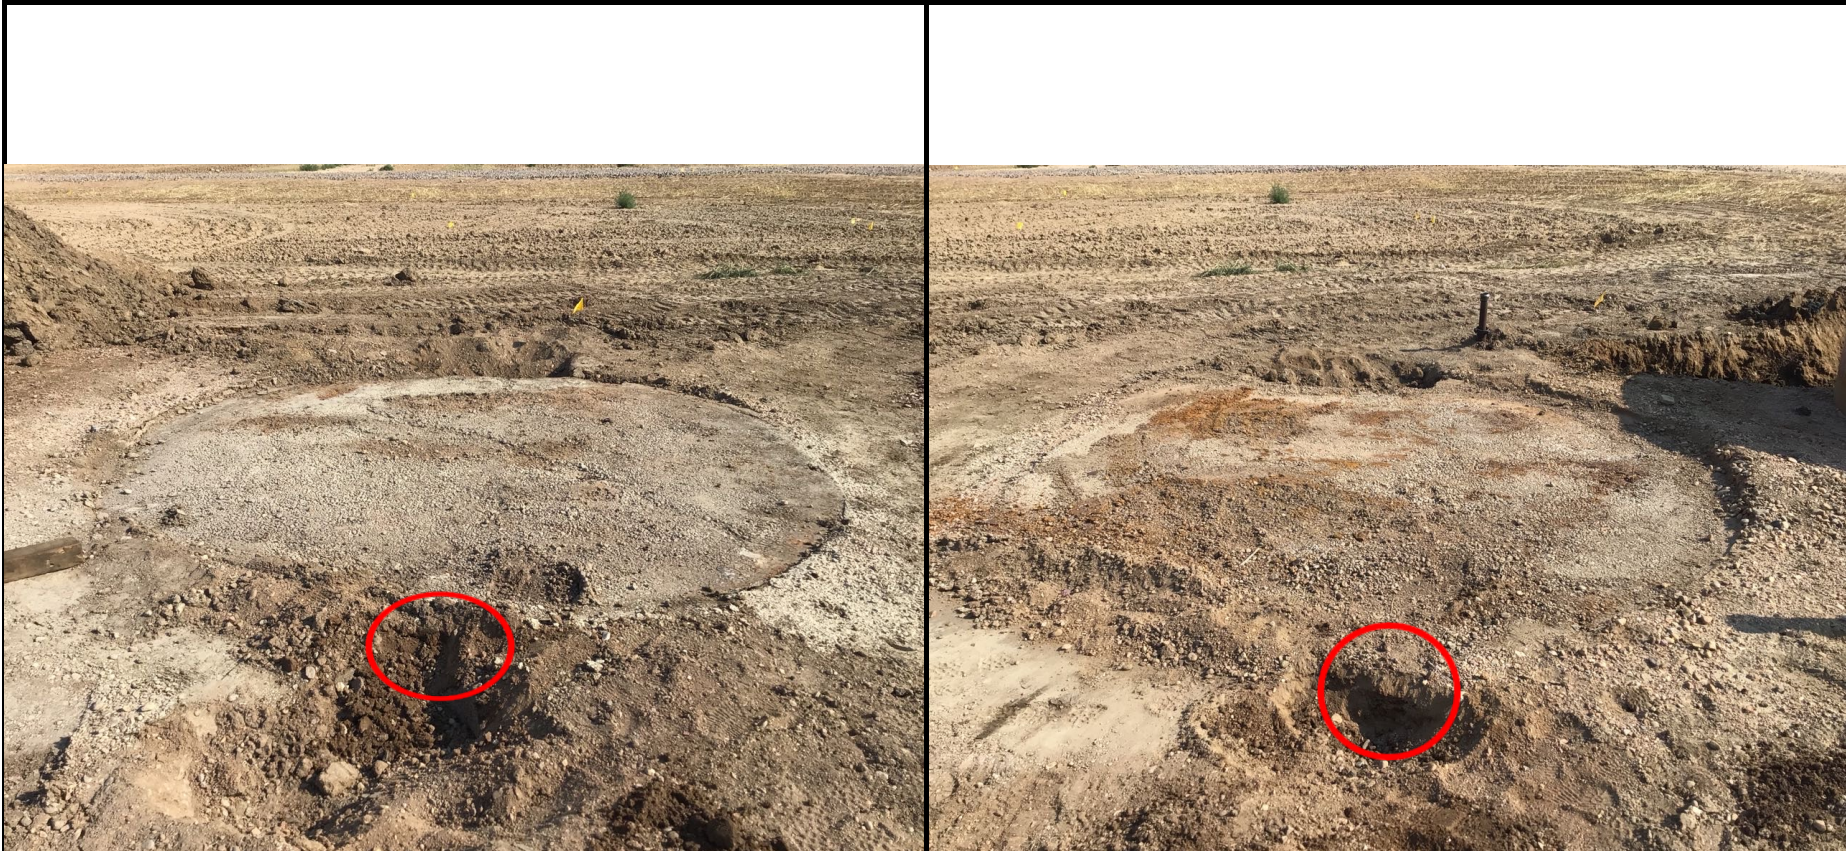
Equipment ID: AST01 footprint		Equipment Type:		Equipment ID: AST02 & footprint		Equipment Type:	
Material:	Volume:	Contents:		Material:	Volume:	Contents:	
Notes/Conditions: West tank				Notes/Conditions: East tank

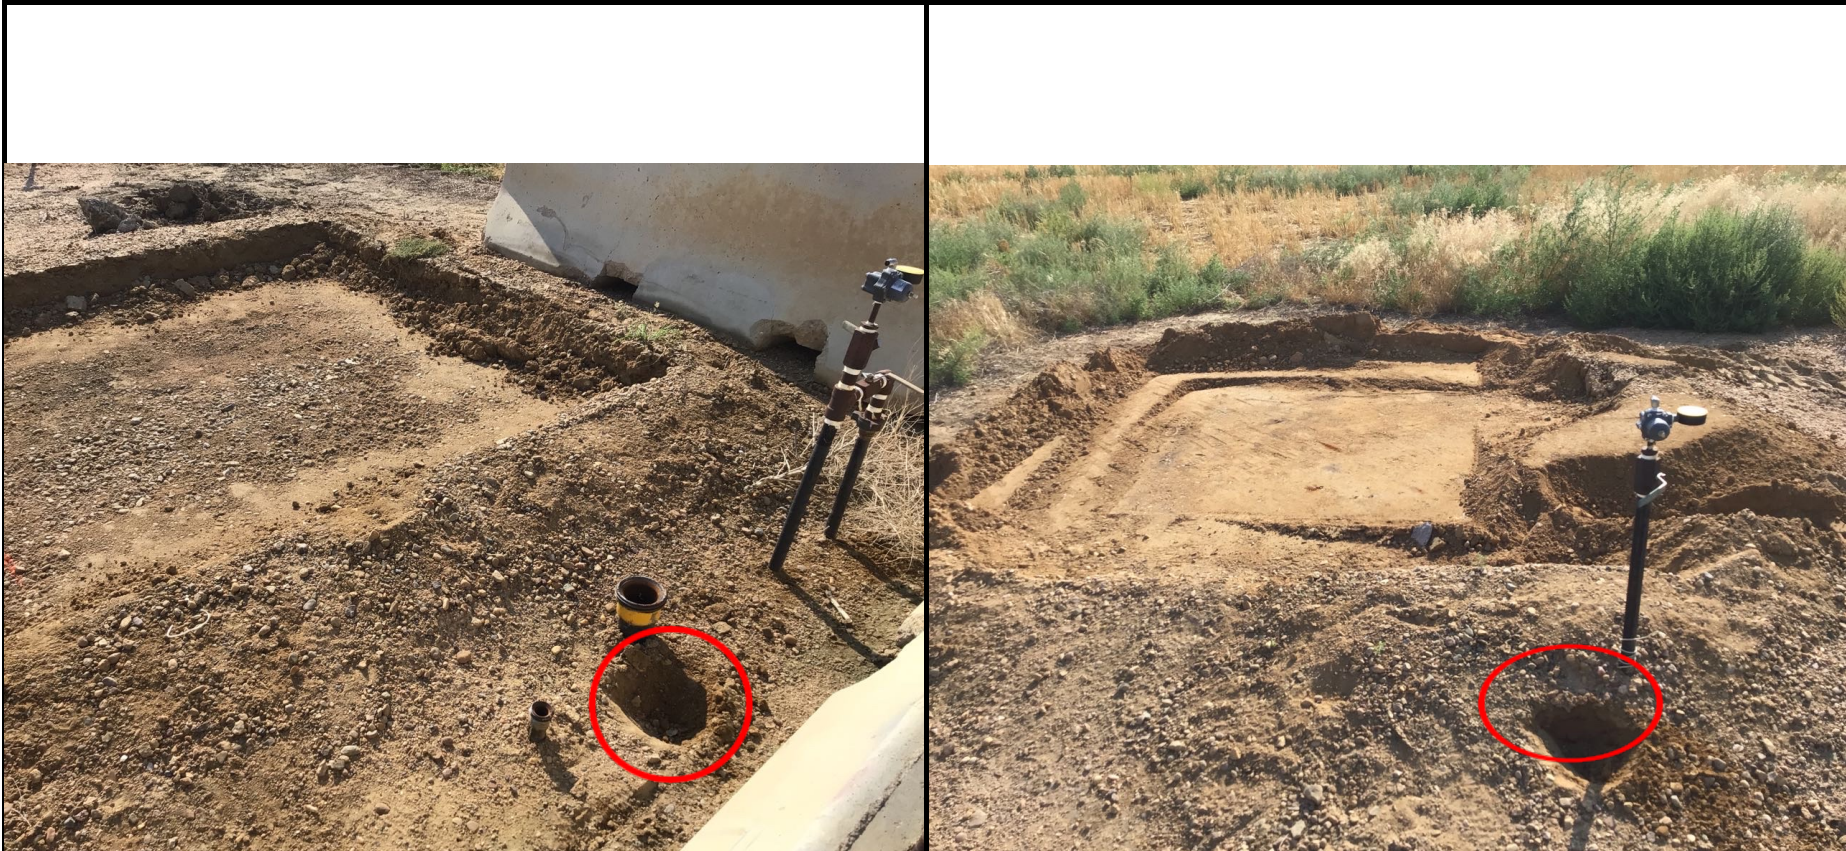
Equipment ID: ECD01		Equipment Type:	
Material:	Volume:	Contents:	
Notes/Conditions: West flare

Equipment ID: ECD02		Equipment Type:	
Material:	Volume:	Contents:	
Notes/Conditions: East flare

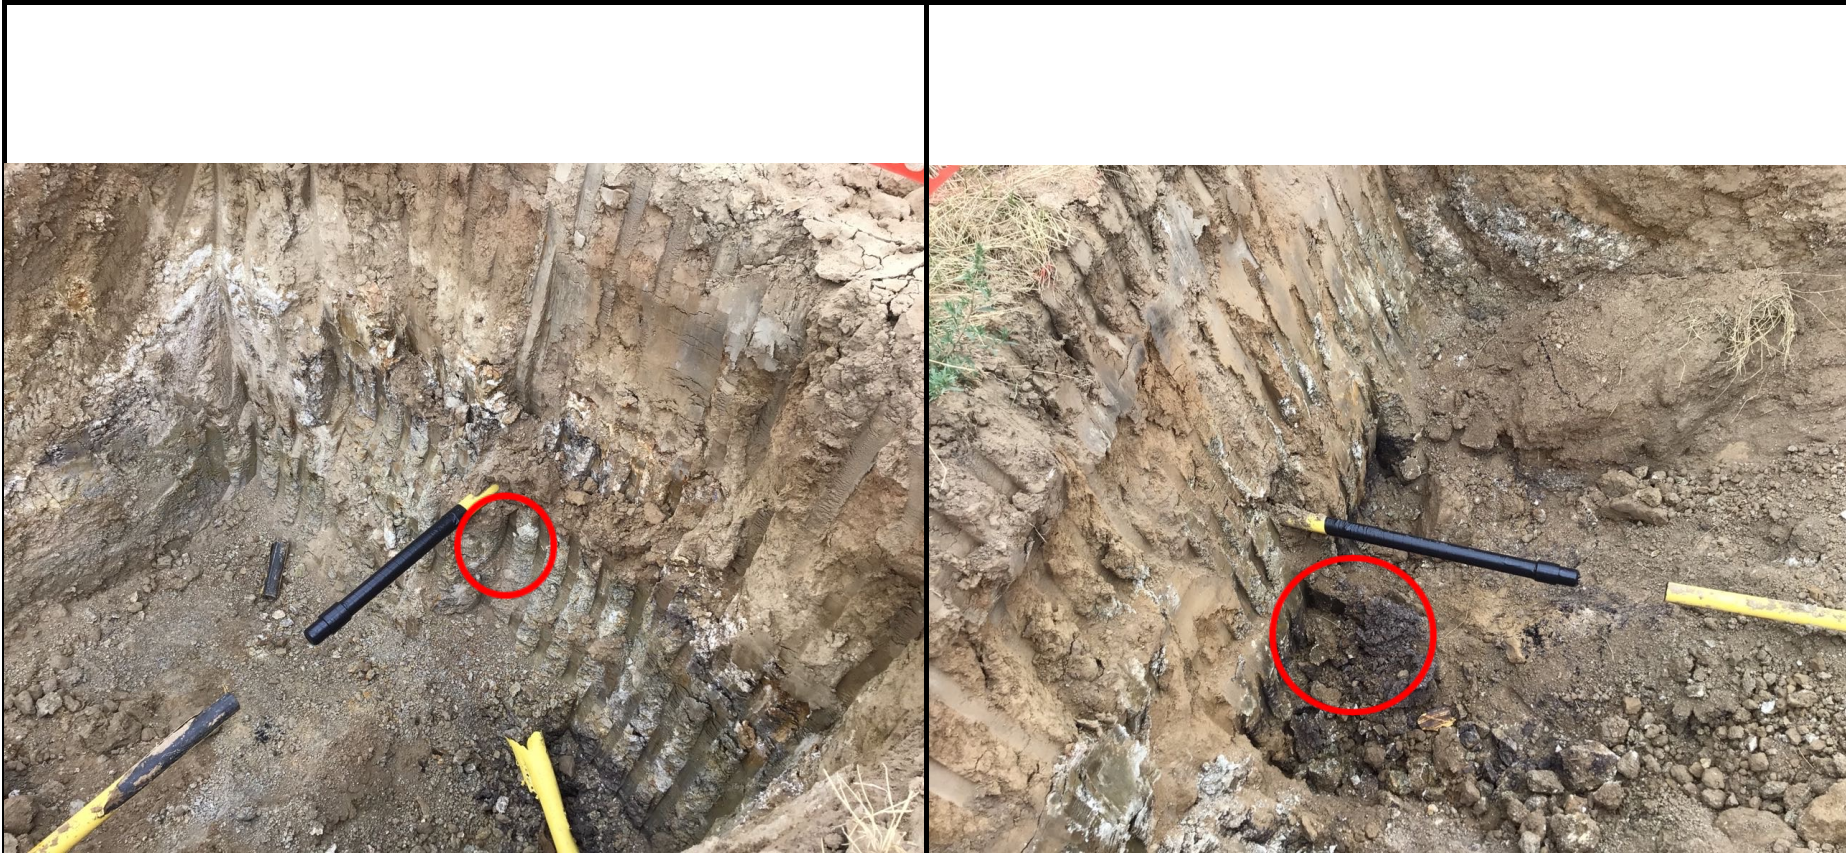
Equipment ID: DL01-01		Equipment Type:		Equipment ID: DL01-02		Equipment Type:	
Material:	Volume:	Contents:		Material:	Volume:	Contents:	
Notes/Conditions:				Notes/Conditions:

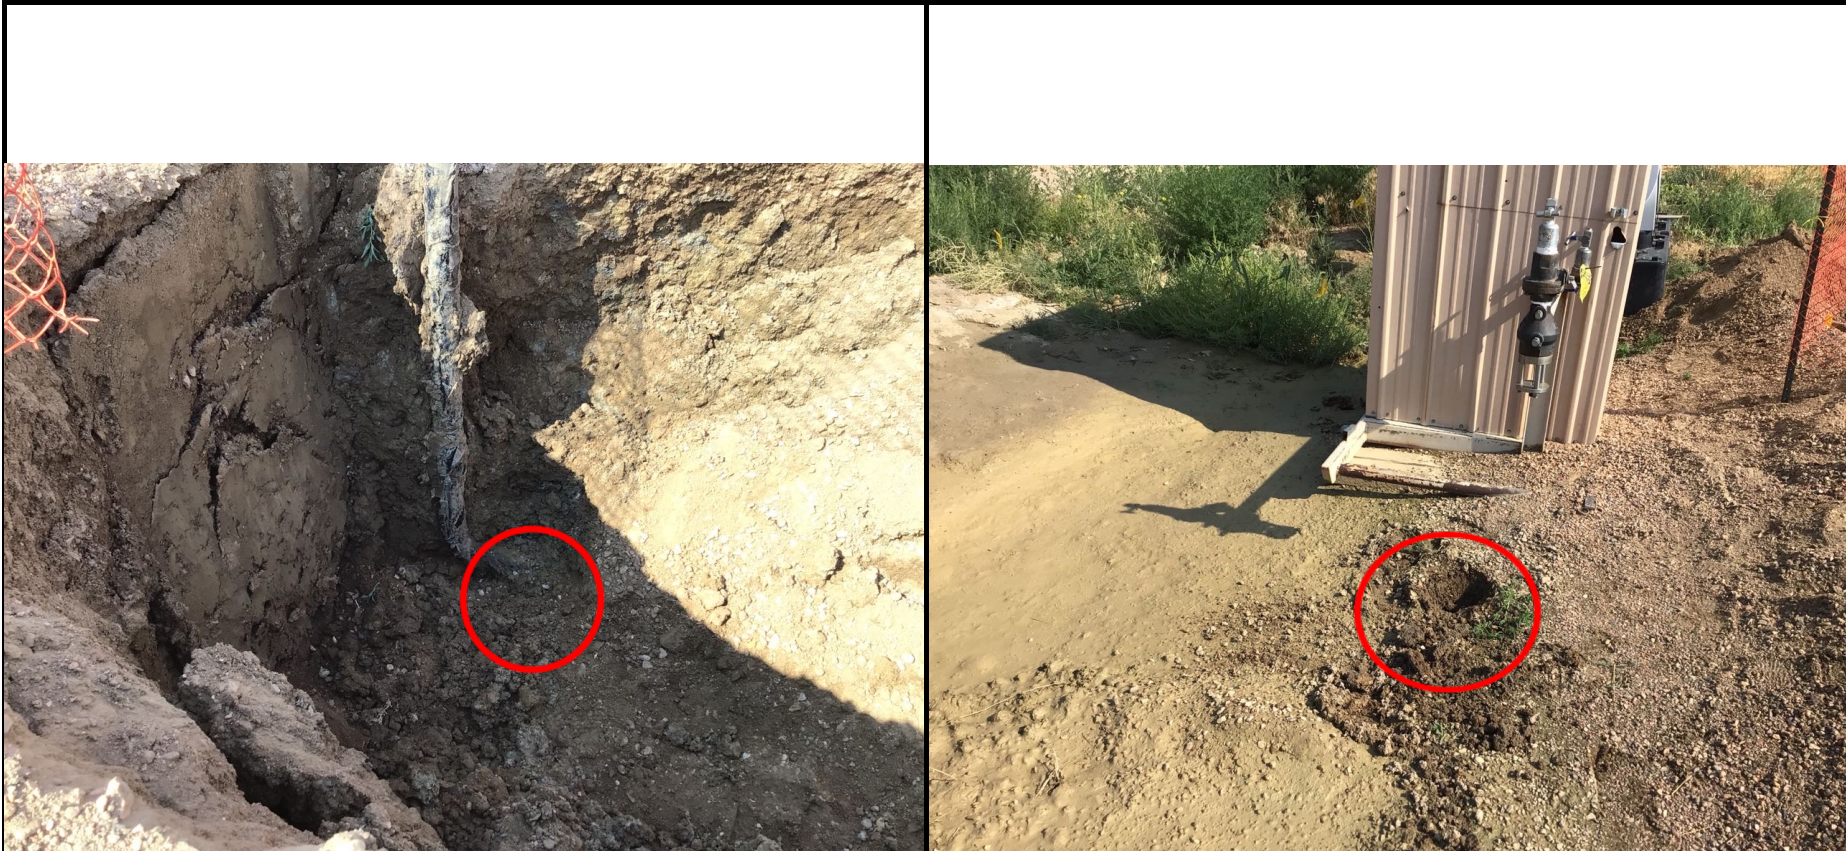
Equipment ID: Sep01-fl		Equipment Type:	
Material:	Volume:	Contents:	
Notes/Conditions:

Equipment ID: MH01		Equipment Type:	
Material:	Volume:	Contents:	
Notes/Conditions: Moisture observed on surface from nearby ag operations drainage

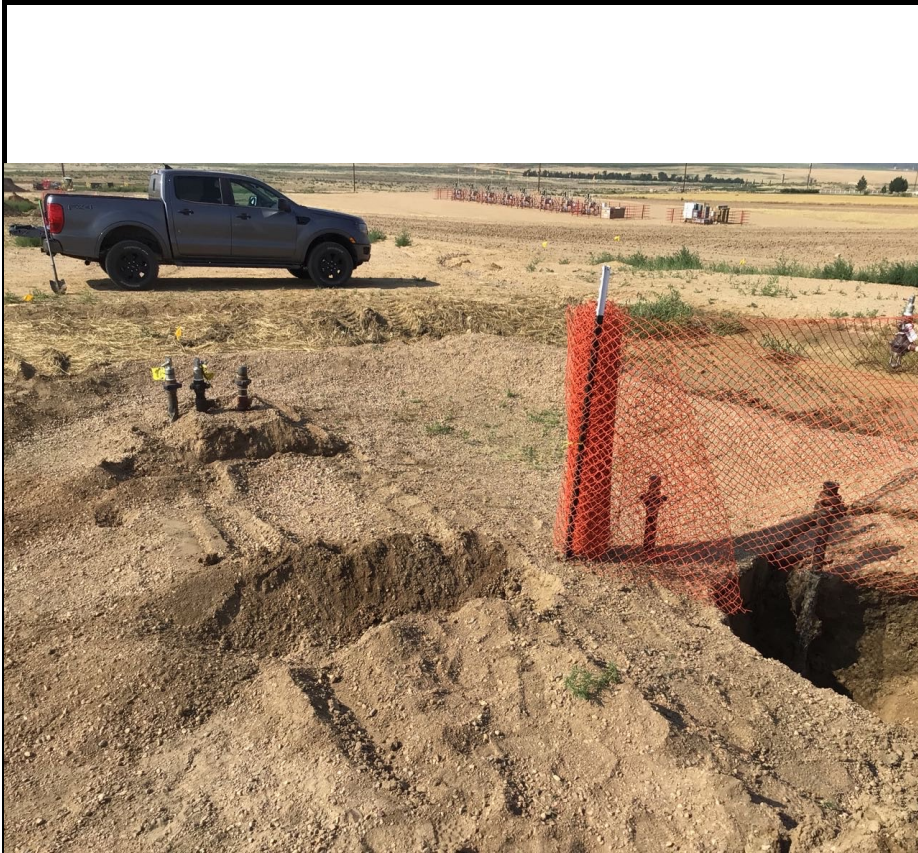
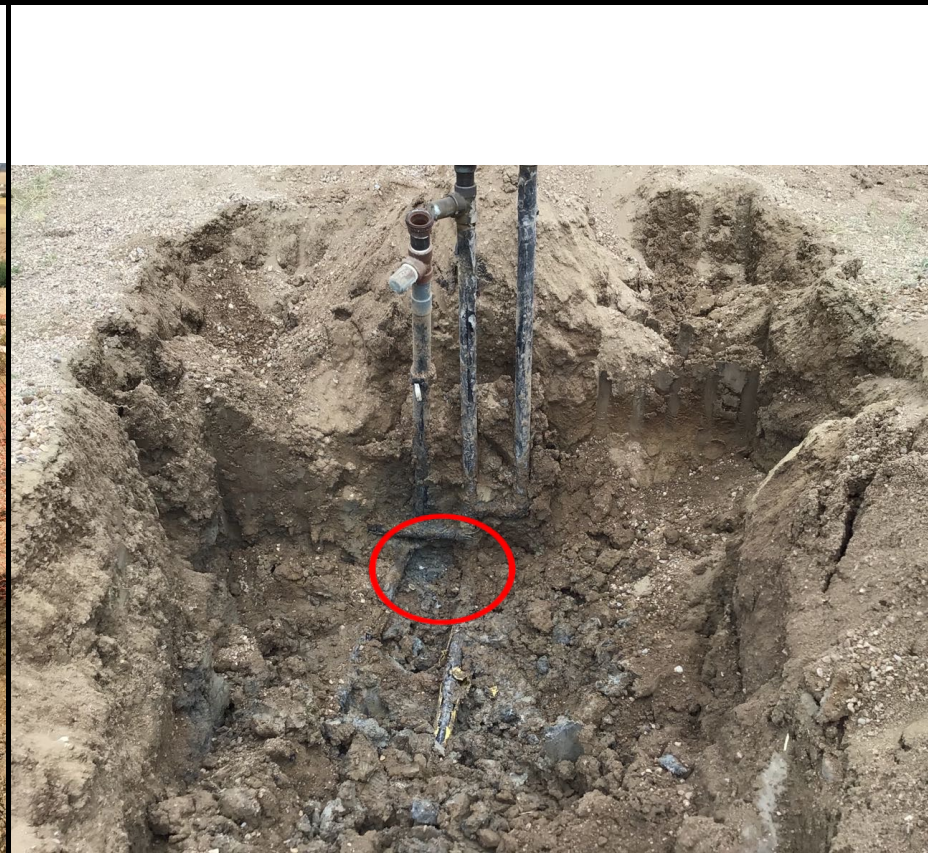
Equipment ID: Separator footprint		Equipment Type:	
Material:	Volume:	Contents:	
Notes/Conditions:

Equipment ID: SEP-DL		Equipment Type:	
Material:	Volume:	Contents:	
Notes/Conditions: Dark organic material observed beneath dump line riser at separator - no odor

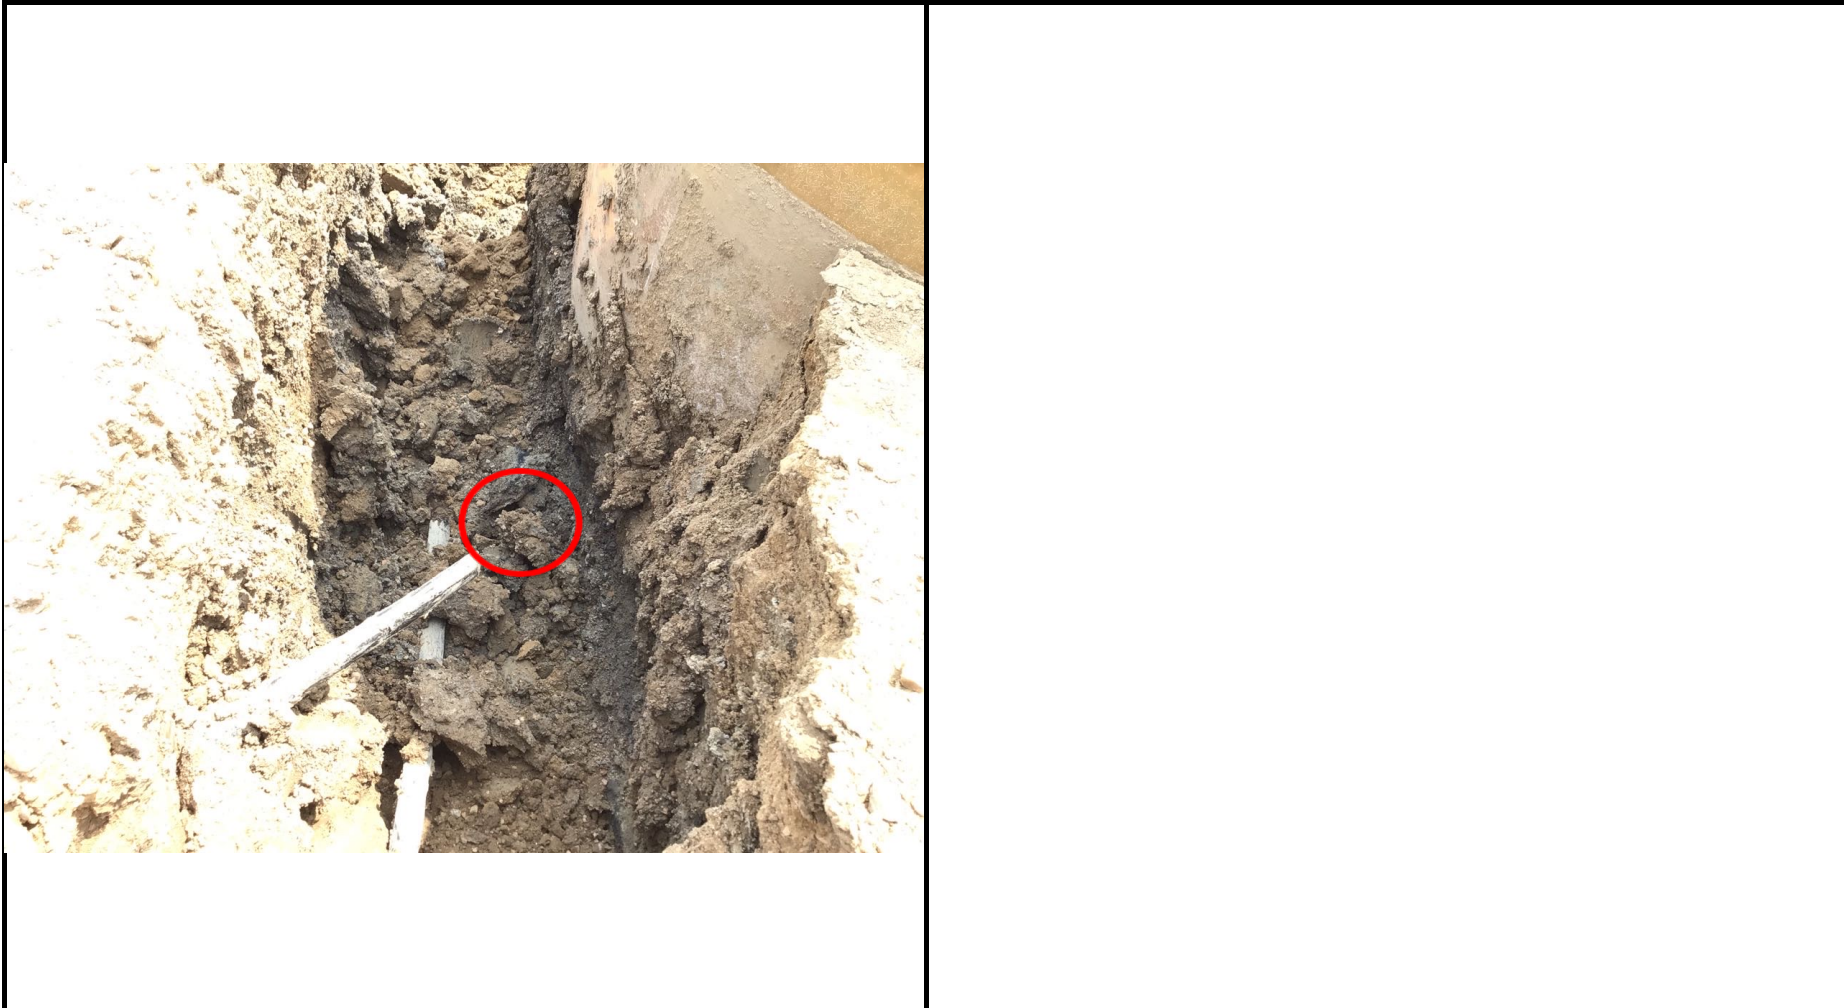
Equipment ID: Ss01		Equipment Type:		Equipment ID:		Equipment Type:	
Material:		Volume:		Material:		Volume:	
Contents:				Contents:			
Notes/Conditions: Collected adjacent to the PWV WDL connection				Notes/Conditions:

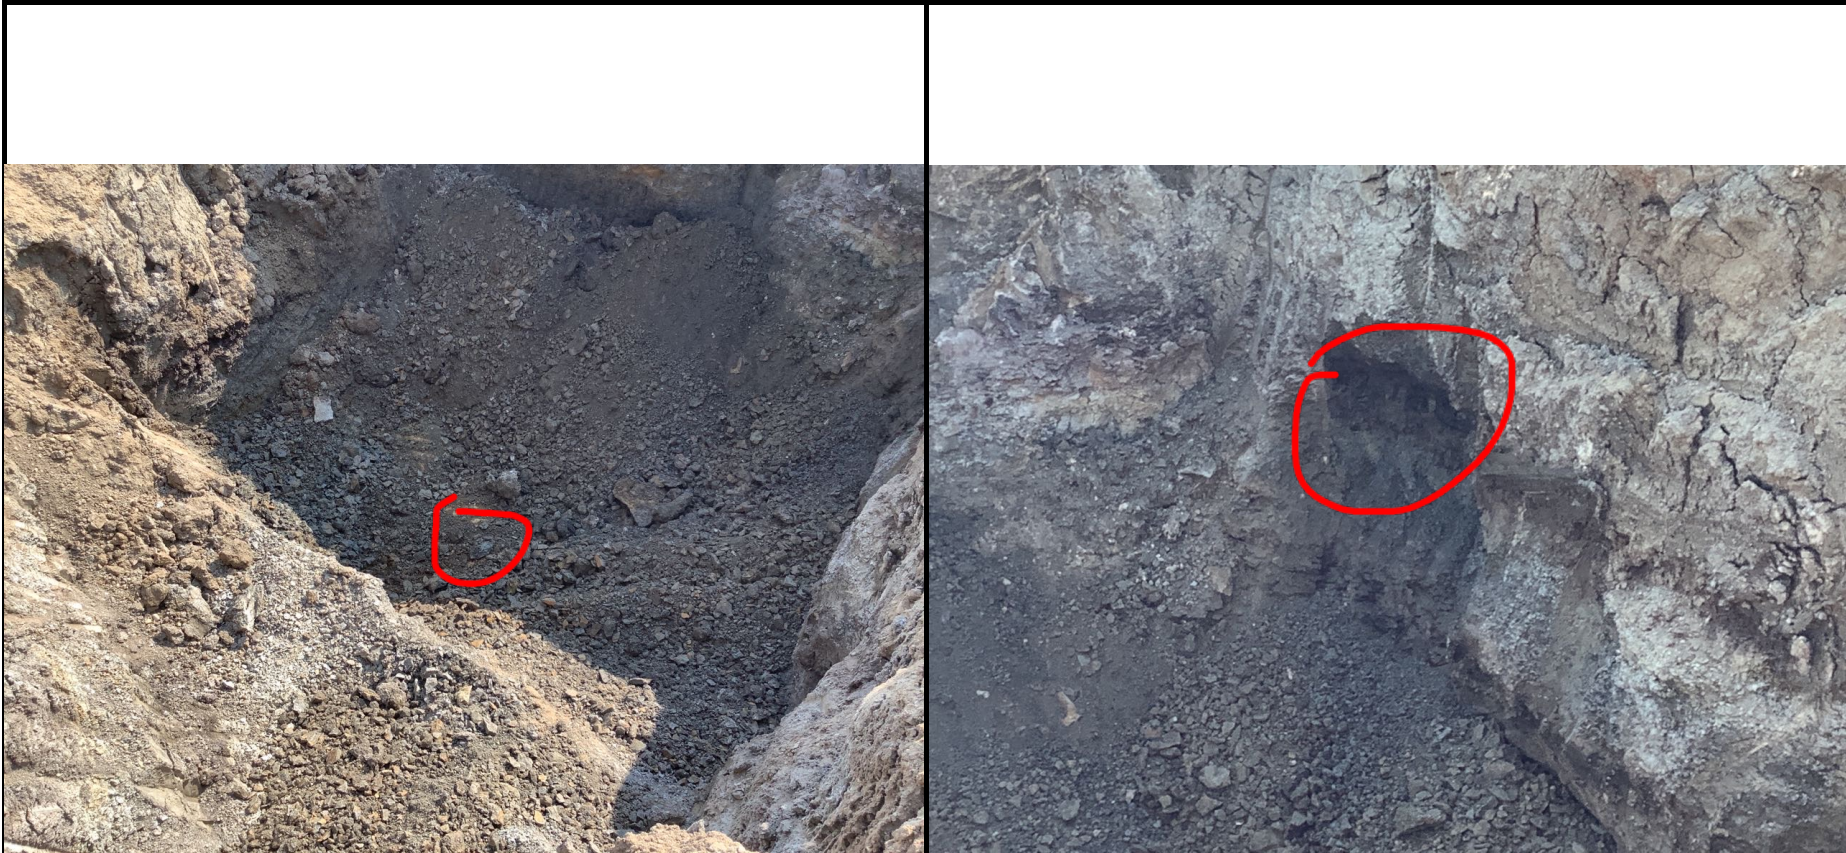
Equipment ID:			Equipment Type:			Equipment ID:			Equipment Type:		
Material:		Volume:	Contents:			Material:		Volume:	Contents:		
Notes/Conditions: B@9.5', (on top of confining siltstone layer)						Notes/Conditions: S, GS03@5'

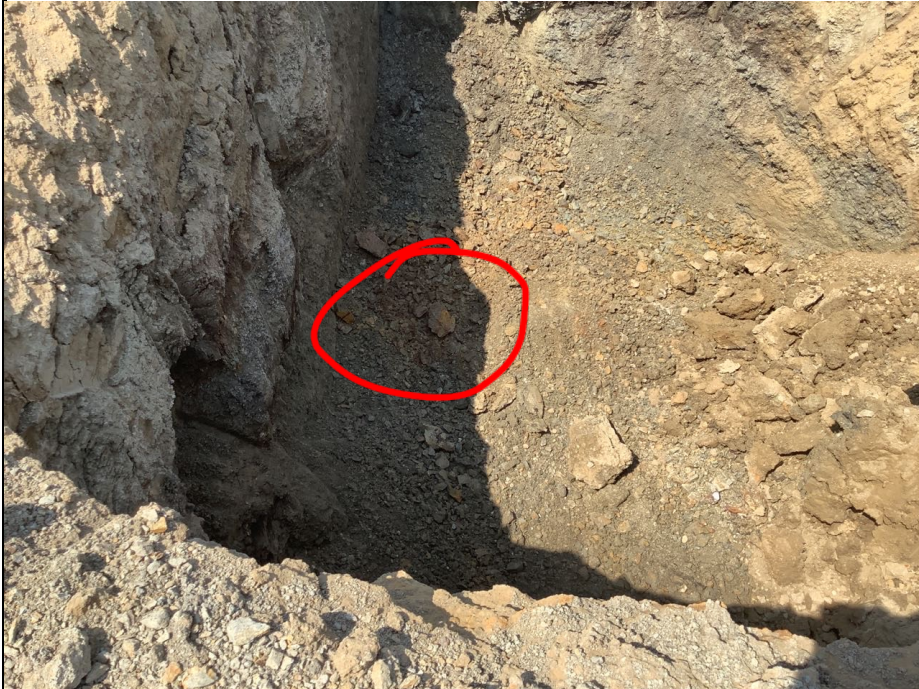
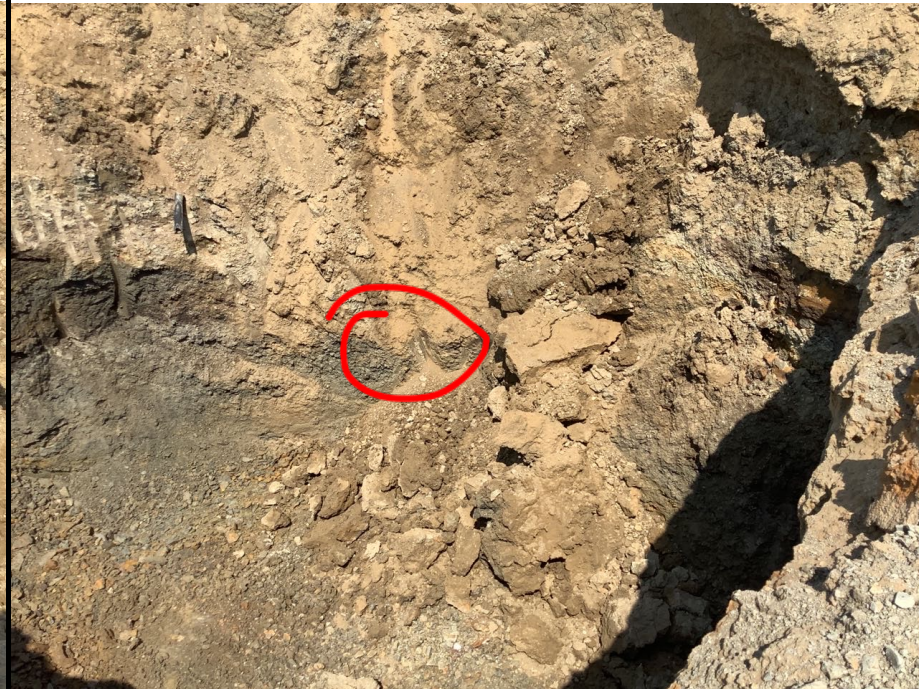
Material:	Volume:	Contents:	Material:	Volume:	Contents:
Notes/Conditions: B, SS02@10'			Notes/Conditions: N, GS01@7'

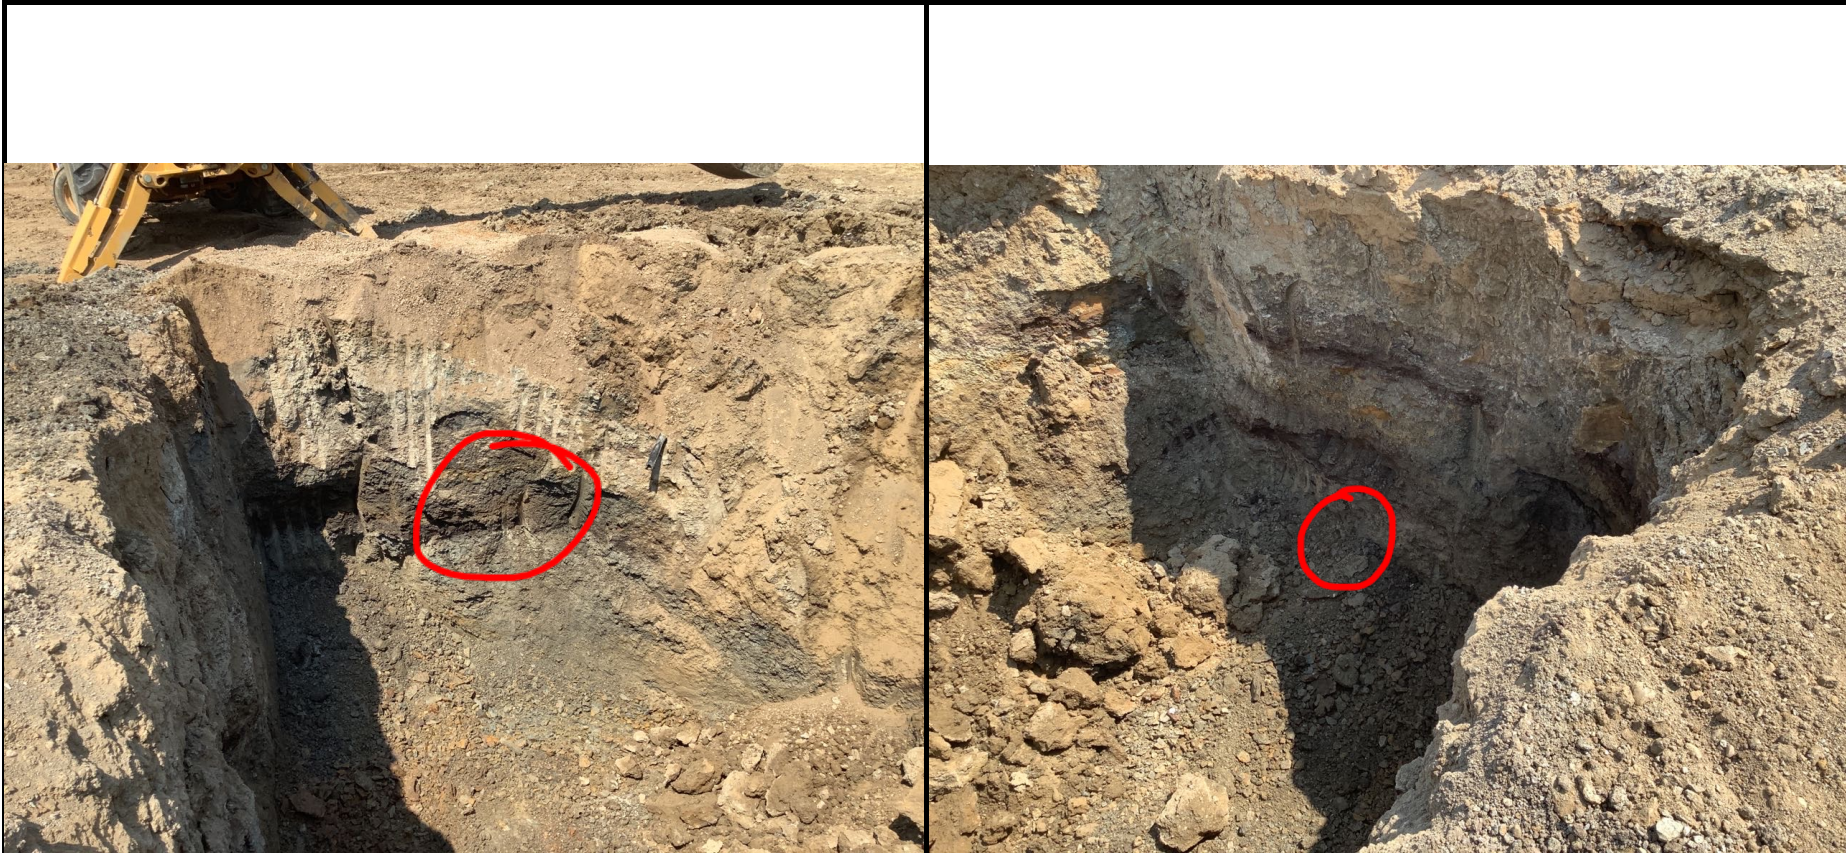
Equipment ID:		Equipment Type:		Equipment ID:		Equipment Type:	
Material:	Volume:	Contents:		Material:	Volume:	Contents:	
Notes/Conditions: W, GS02@5'				Notes/Conditions: E, GS04@7'

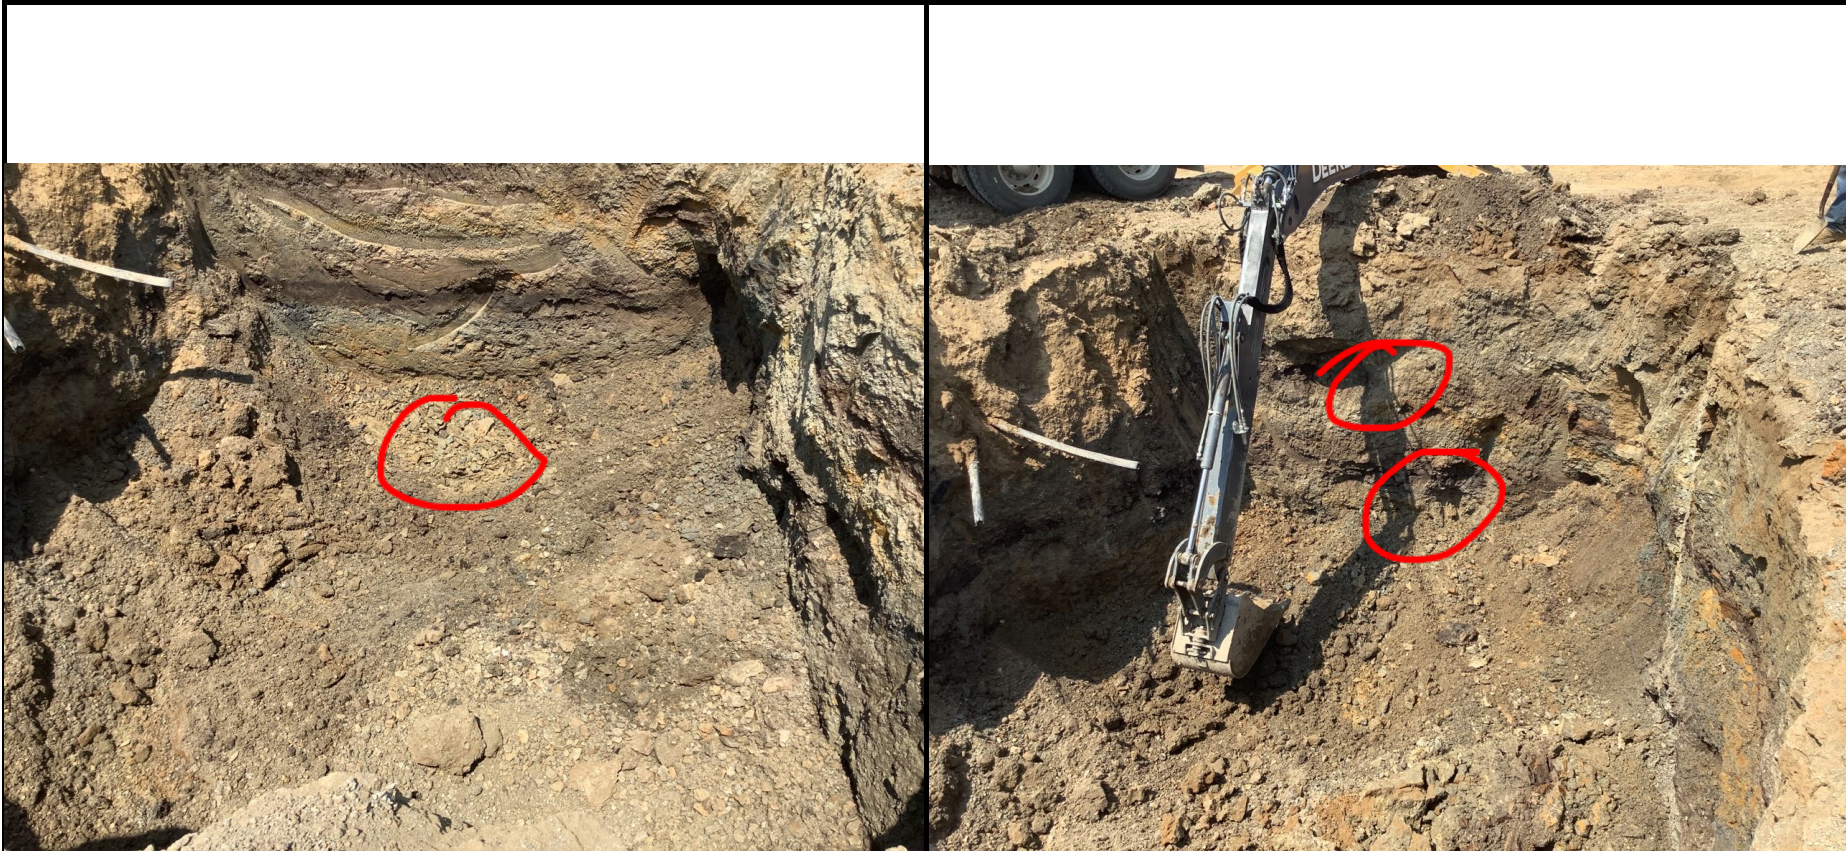
Equipment ID:		Equipment Type:		Equipment ID:		Equipment Type:	
Material:	Volume:	Contents:		Material:	Volume:	Contents:	
Notes/Conditions: B, SS03@10'				Notes/Conditions: SS04@5', SS05@8', N wall

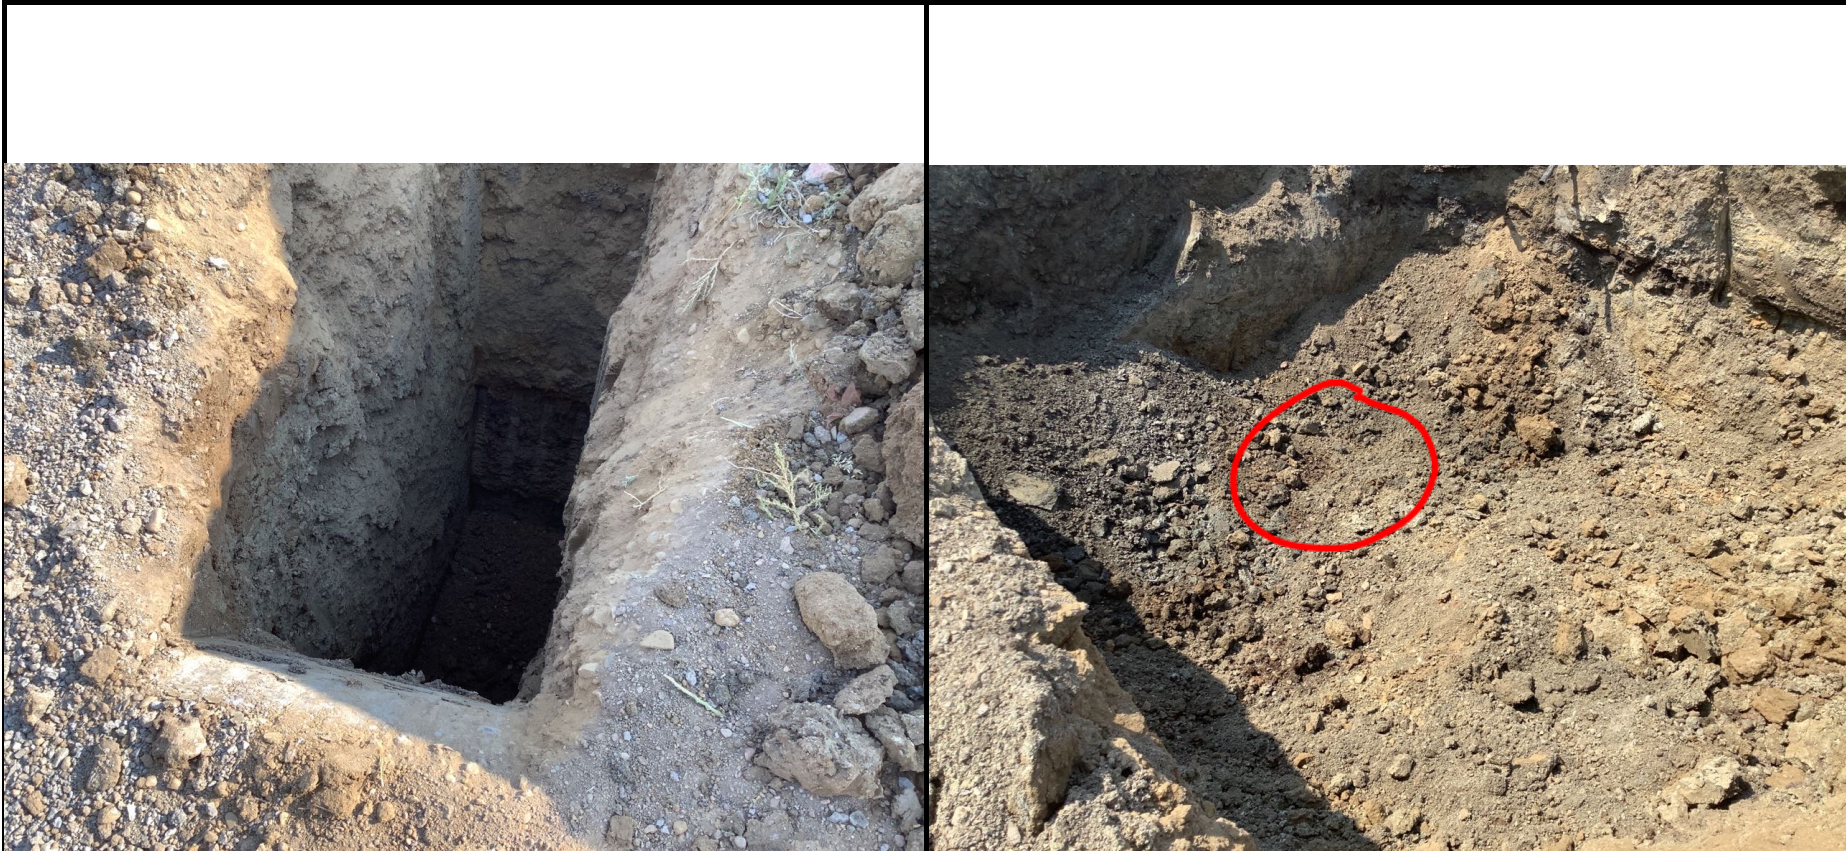
Equipment ID:		Equipment Type:		Equipment ID:		Equipment Type:	
Material:	Volume:	Contents:		Material:	Volume:	Contents:	
Notes/Conditions: TP06				Notes/Conditions: SS06@10', B

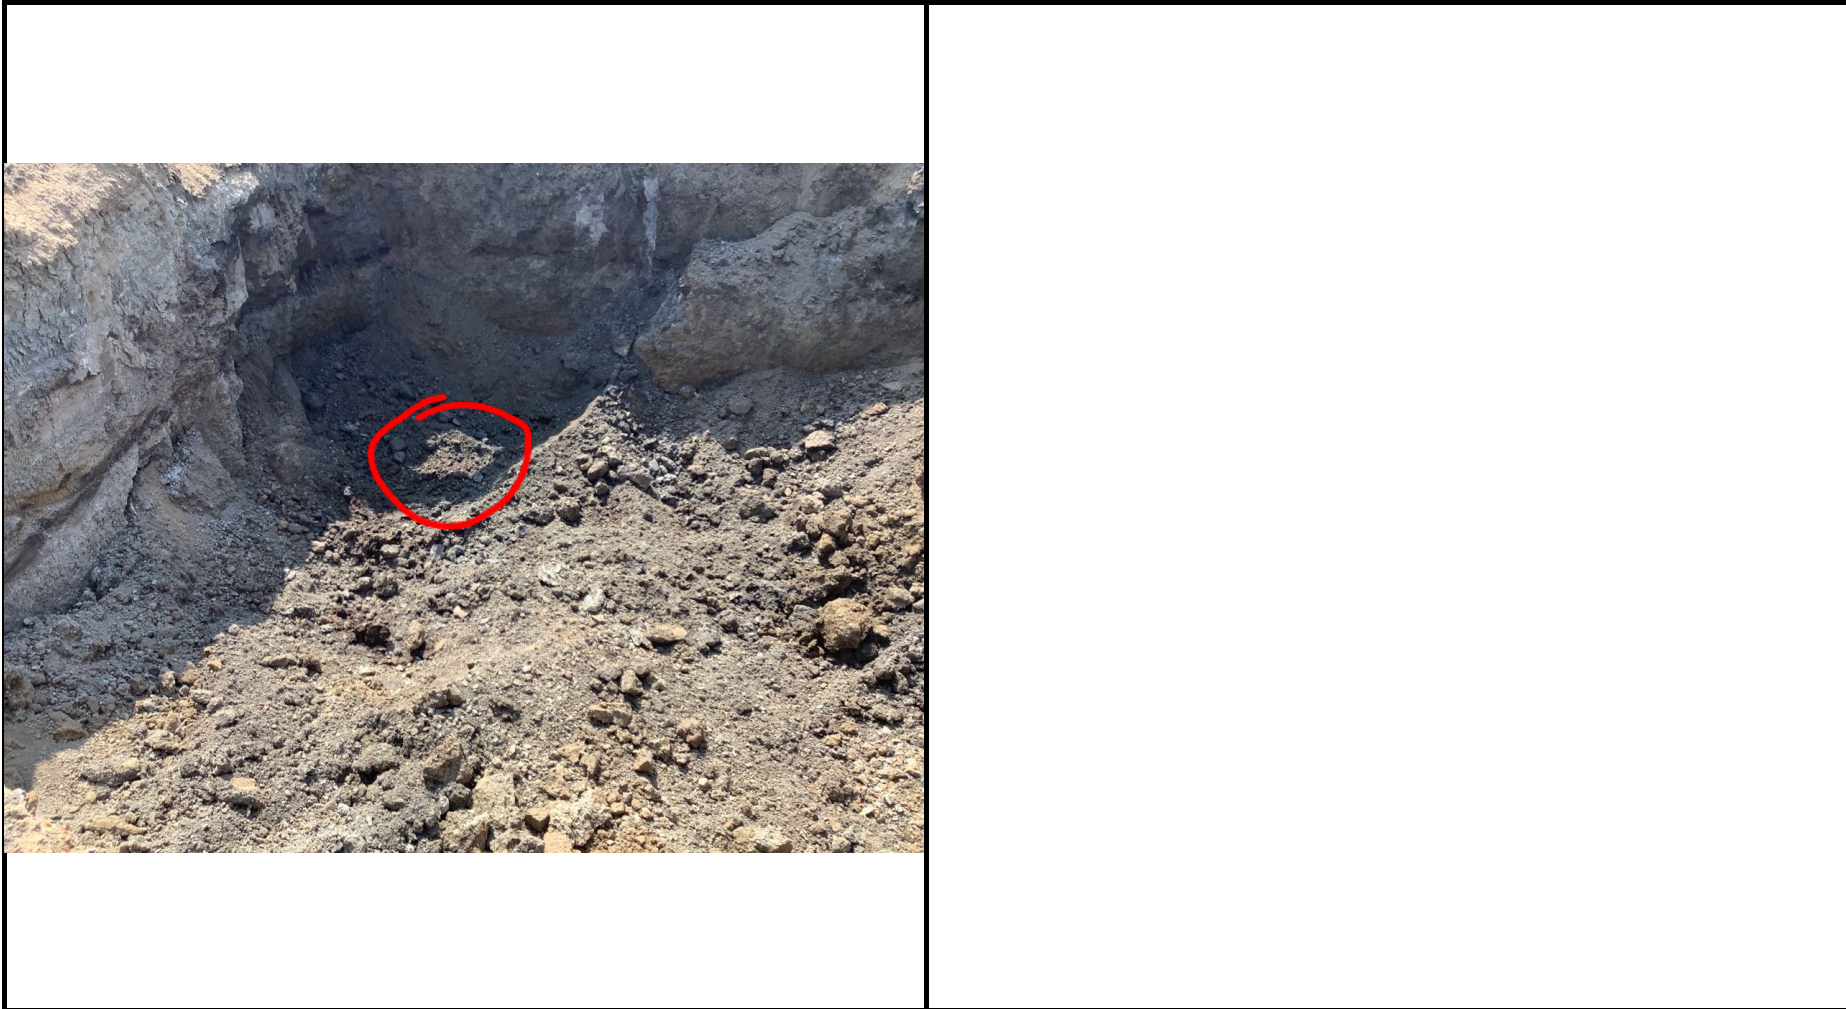
Equipment ID:		Equipment Type:		Equipment ID:		Equipment Type:	
Material:	Volume:	Contents:		Material:	Volume:	Contents:	
Notes/Conditions: B, SS07 @ 10'				Notes/Conditions:

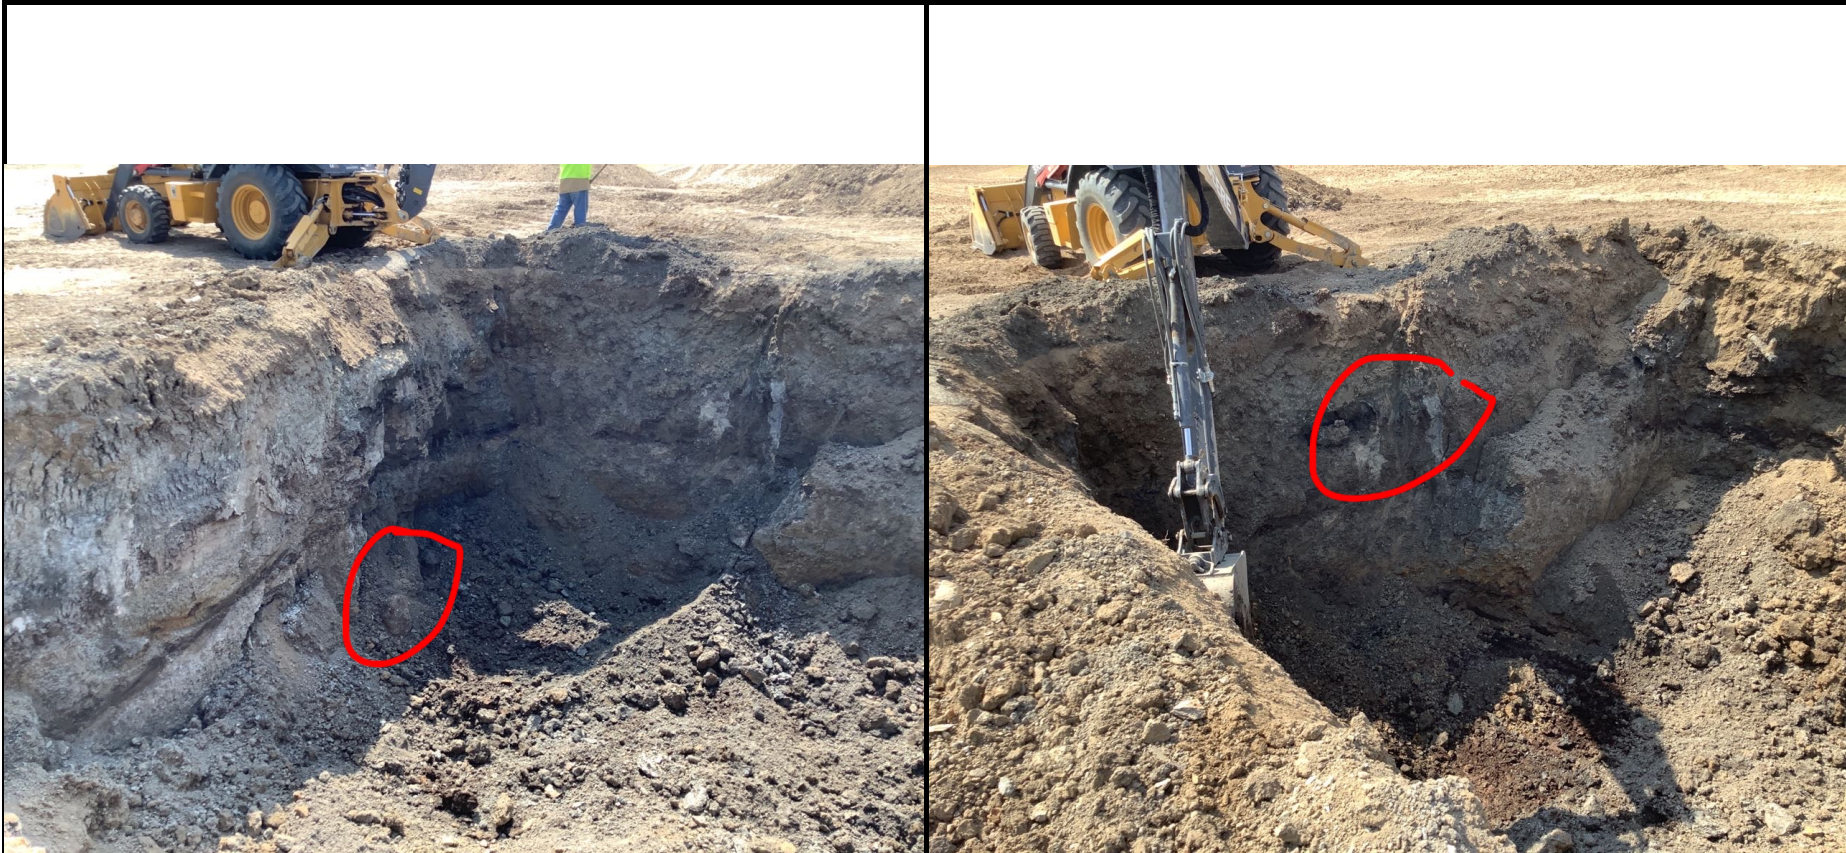
Notes/Conditions: S, GS04@8'

Notes/Conditions: W, GS05@5'

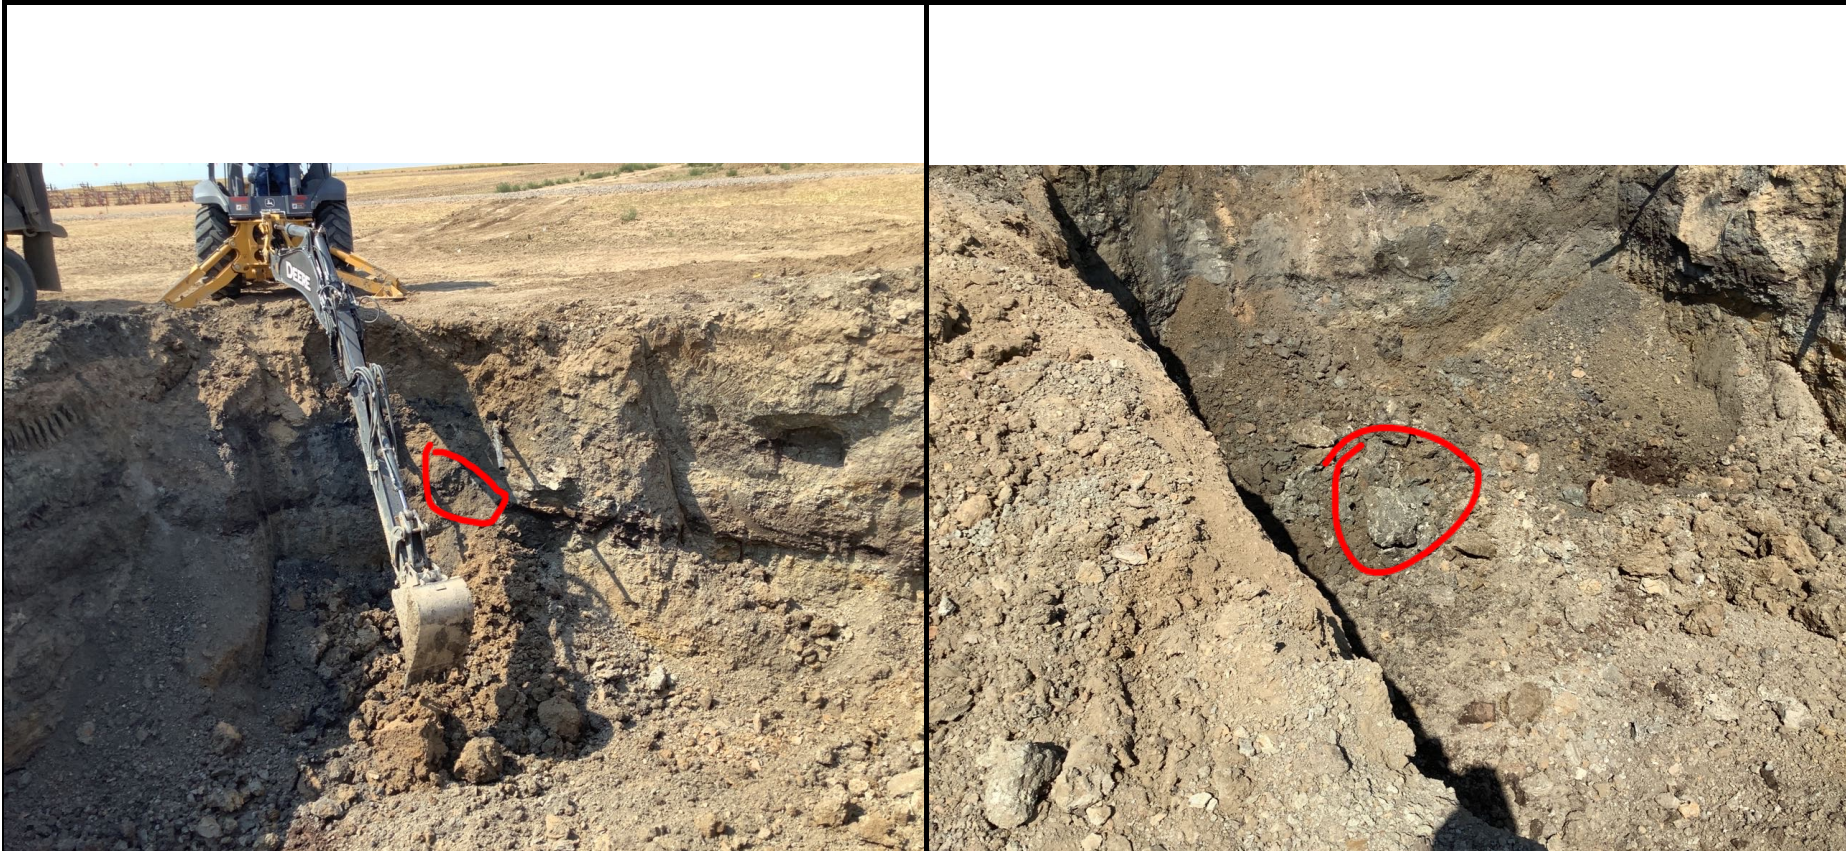
Notes/Conditions: GS06 @ 5', N wall

Notes/Conditions: SS08 @ 10' after cave in, B
