Attachment B

TANK BATTERY DECOMMISSIONING FORM

SITE NAME: Miller 5 Excavation							DATE: 8/11/2021	REM. PROJECT #: 18732	WEATHER: 70's Sunny	
SITE DIRECTIONS: CR30/HWY 85, 1.5 mi E, N into							CLIENT: PDC - Paul Ruiz			
LEGALS AND LAT/LONG: 40.203401, -104.793862							TASMAN PERSONNEL: Jesse Marcus			
SOIL TYPES: Lean Clay - CL							SURFACE GRADIENT: West			
SOIL SAMPLING							FACILITY INFRASTRUCTURE			
Date/Time	Soil Sample ID	PID (ppm)	Visual	Olfactory	Photo?	Grab or Lab Sample?	EQUIPMENT		Quantity	
							Above Ground Storage Tank (AST)			
8/11/2021 09:51	B@9.5	54.6	HC Staining	Slight HC Odor	Yes	Grab	Buried or Partially Buried Vessel			
8/11/2021 11:28	N@7'	451.5	HC Staining	Strong HC Odor	Yes	Grab	Separator			
8/11/2021 11:27	W@5', GS01@5'	1639	HC Staining	Strong HC Odor	Yes	Grab	Emission Control Device (ECD)			
8/11/2021 10:27	S@5', GS02@5'	630.3	HC Staining	HC Odor	Yes	Grab	Dump Line			
8/11/2021 11:29	E@7', GS03@ 8'	560.9	HC Staining	HC Odor	Yes	Grab	Wellhead

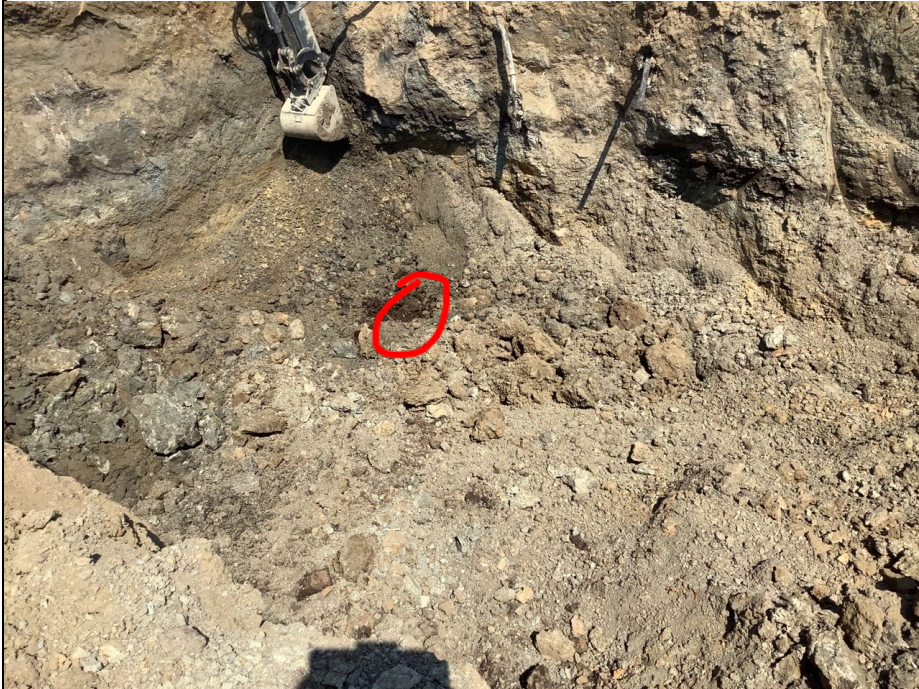
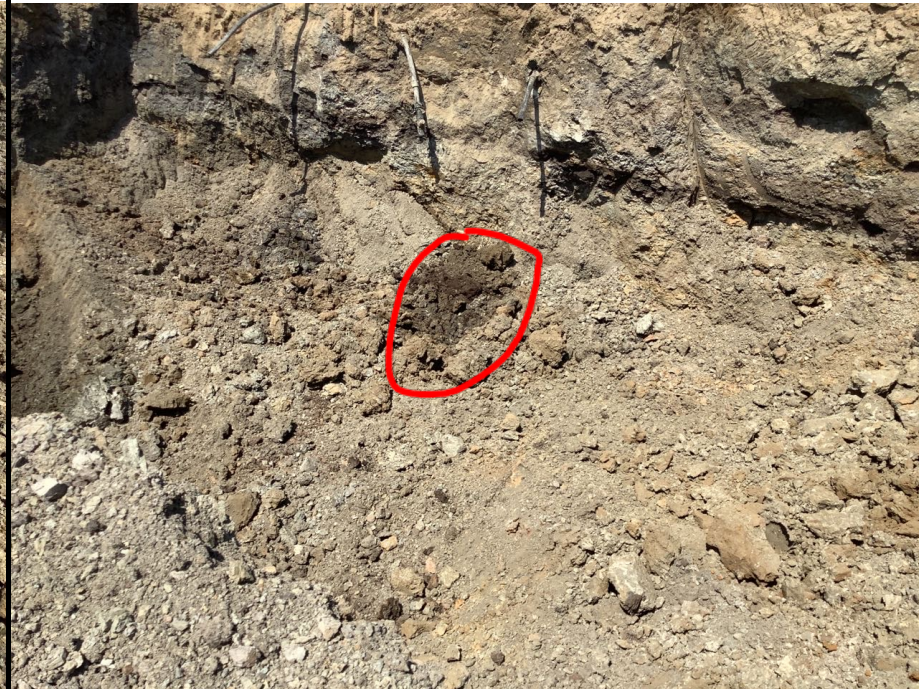
Equipment ID:		Equipment Type:	Equipment ID:		Equipment Type:
Material:	Volume:	Contents:	Material:	Volume:	Contents:
Notes/Conditions: SS09@10', B			Notes/Conditions: SS10@10.5', B

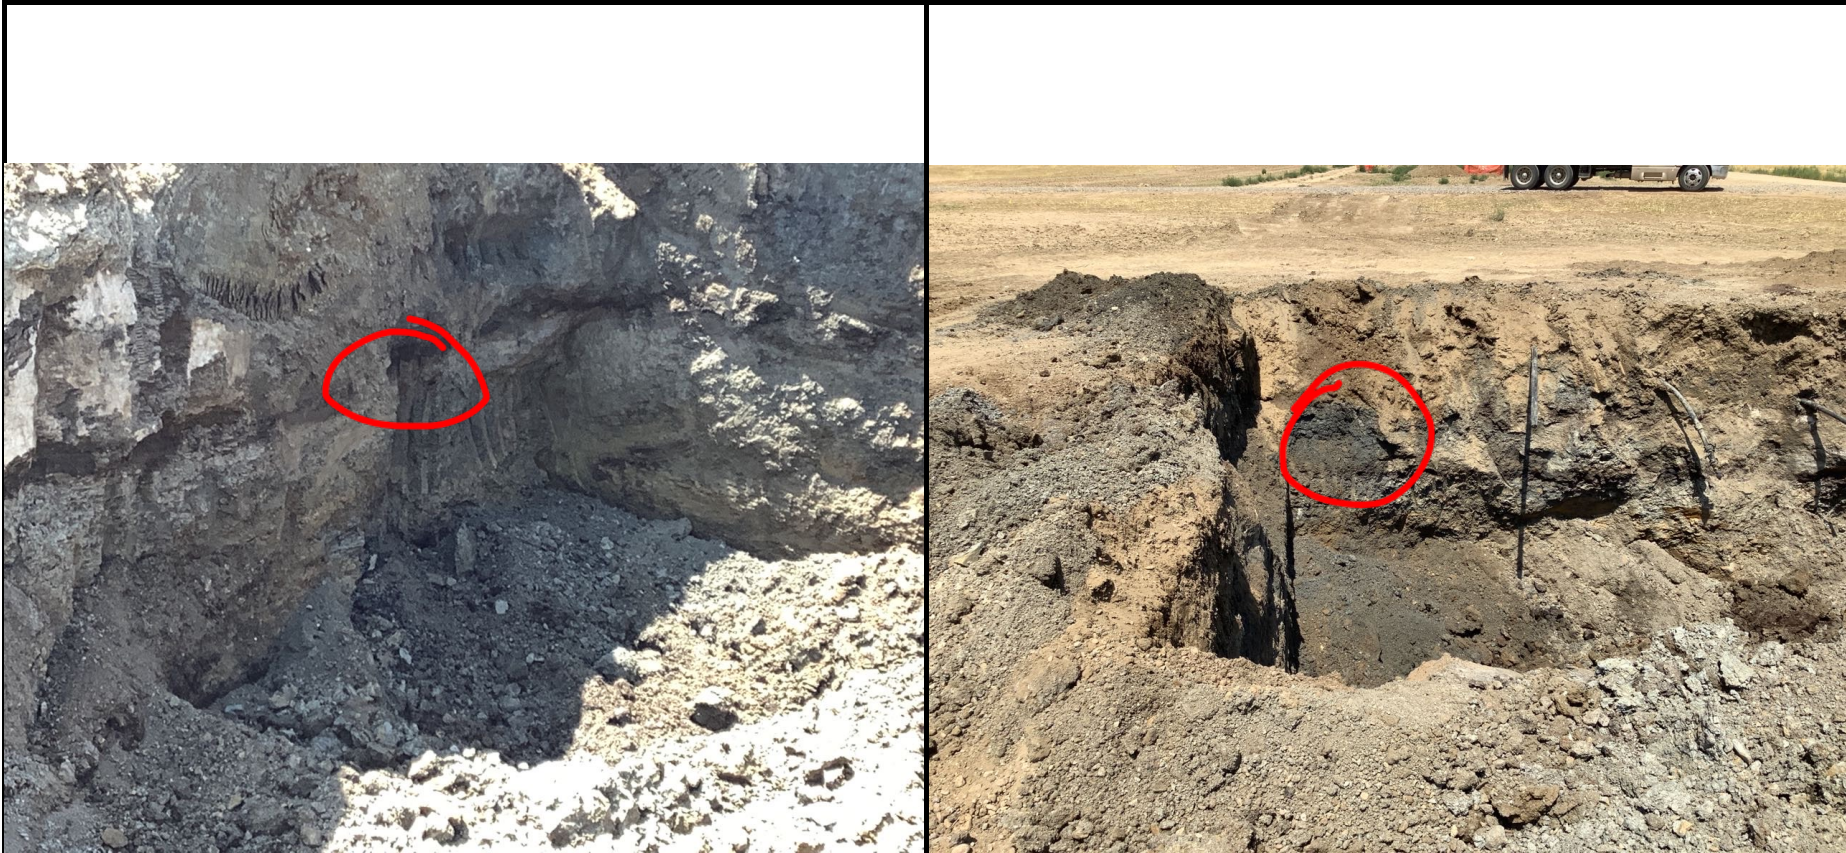
Equipment ID:		Equipment Type:		Equipment ID:		Equipment Type:	
Material:	Volume:	Contents:		Material:	Volume:	Contents:	
Notes/Conditions: S, GS07@5'				Notes/Conditions: GS08@5', N

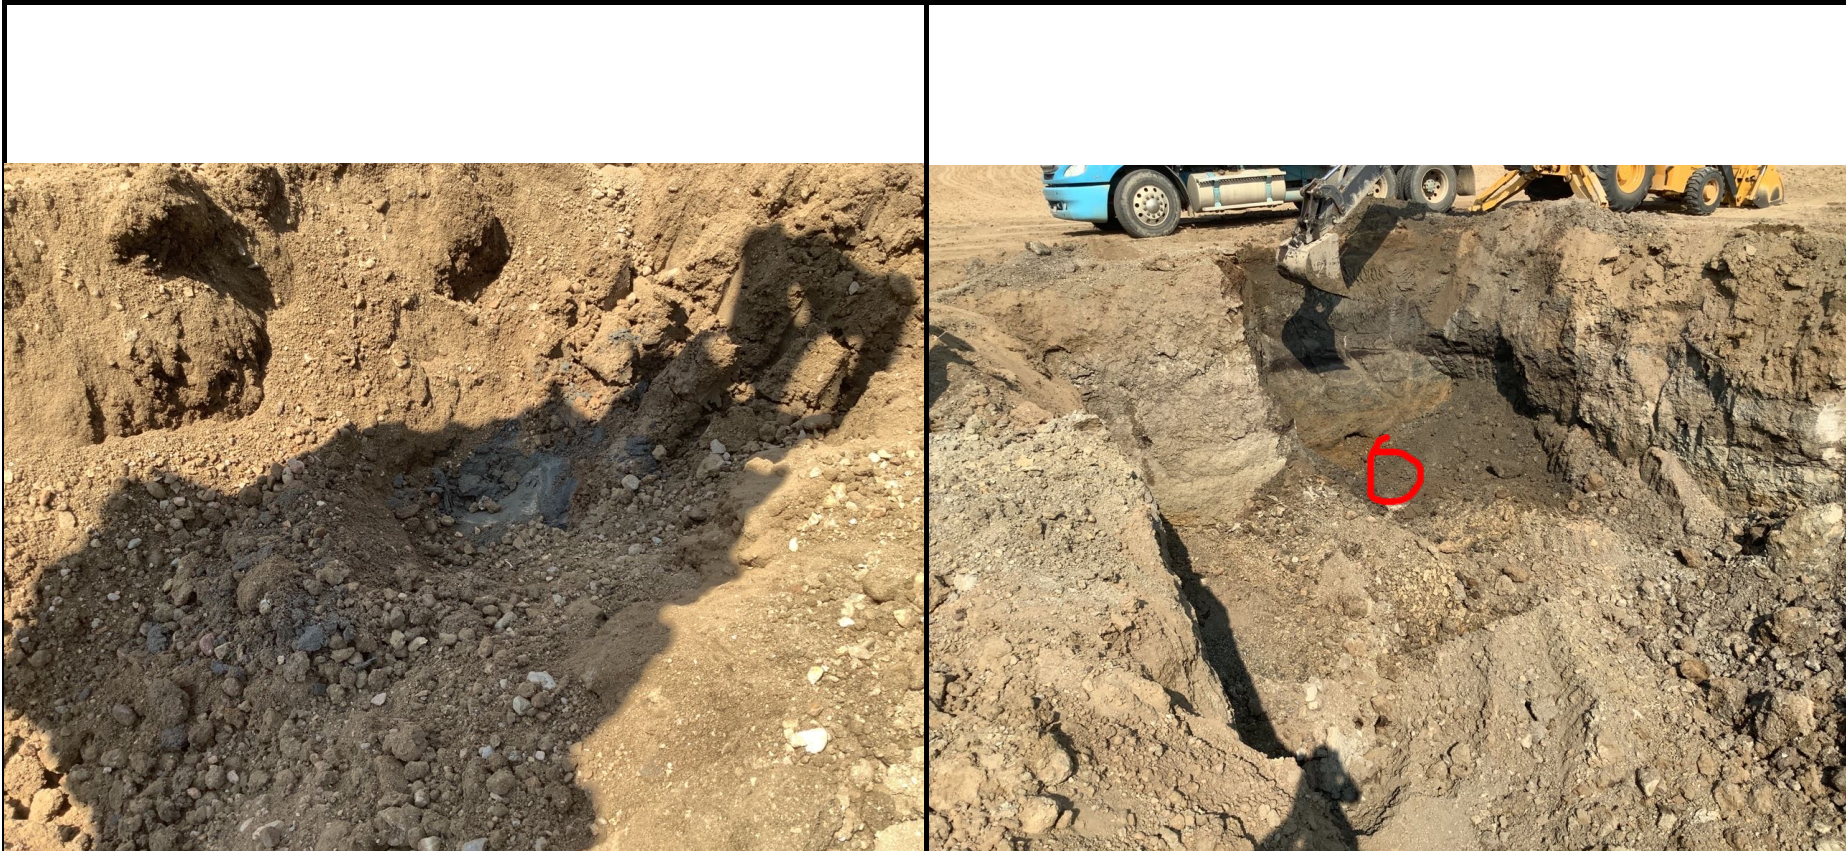
Equipment ID:		Equipment Type:		Equipment ID:		Equipment Type:	
Material:	Volume:	Contents:		Material:	Volume:	Contents:	
Notes/Conditions: TP07 @2', W side				Notes/Conditions: B, SS11 @10'

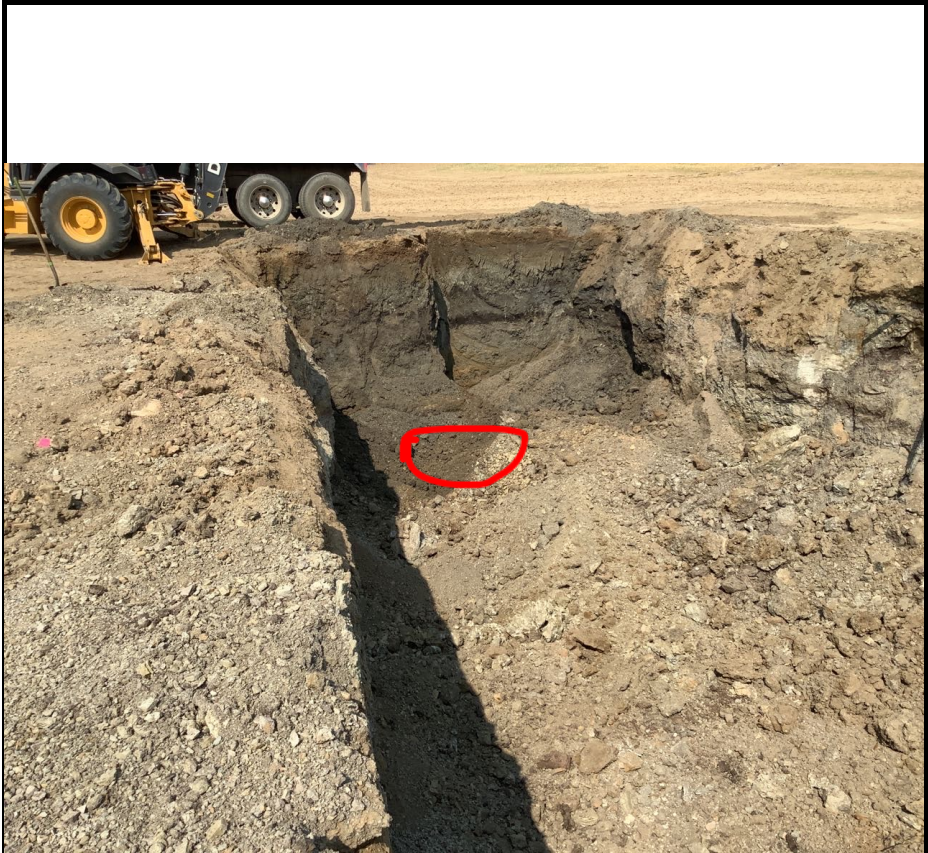
Equipment ID:		Equipment Type:	
Material:	Volume:	Contents:	
Notes/Conditions: SS12@10', B
