Inspection Photos
Operator: Simcoe
API: 067-08253
Date: 8/10/2021

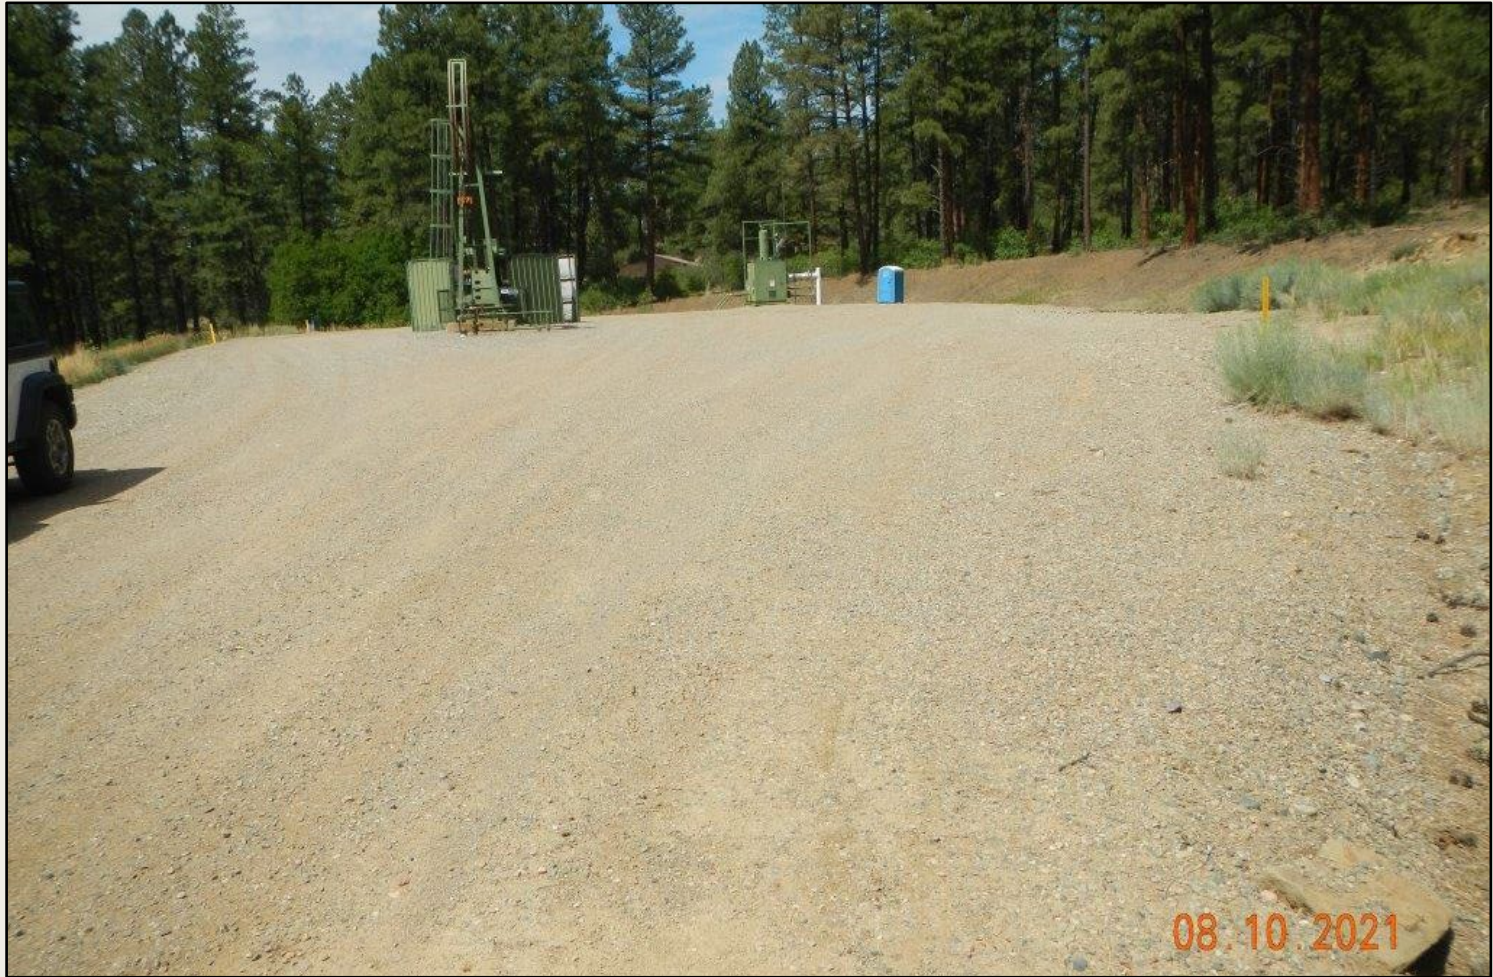
Photo 1. View of the project area from the well pad entrance facing center.

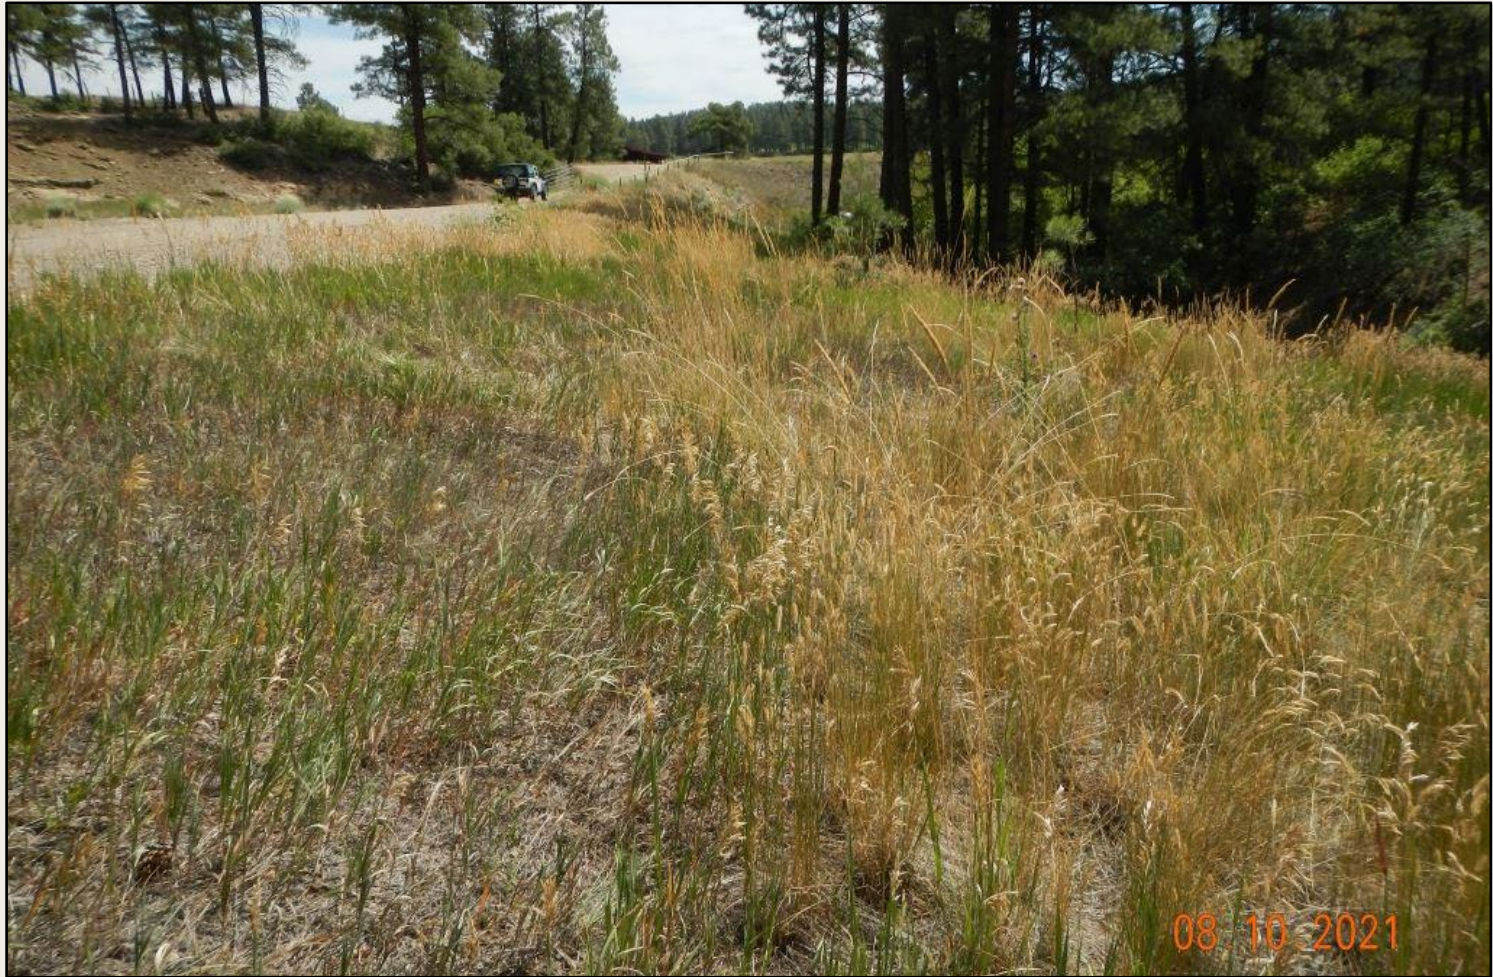
Photo 2. View of the southern project area from the southwestern corner facing eastward. Revegetation is progressing, largely with crested wheatgrass, smooth brome, and sand dropseed.

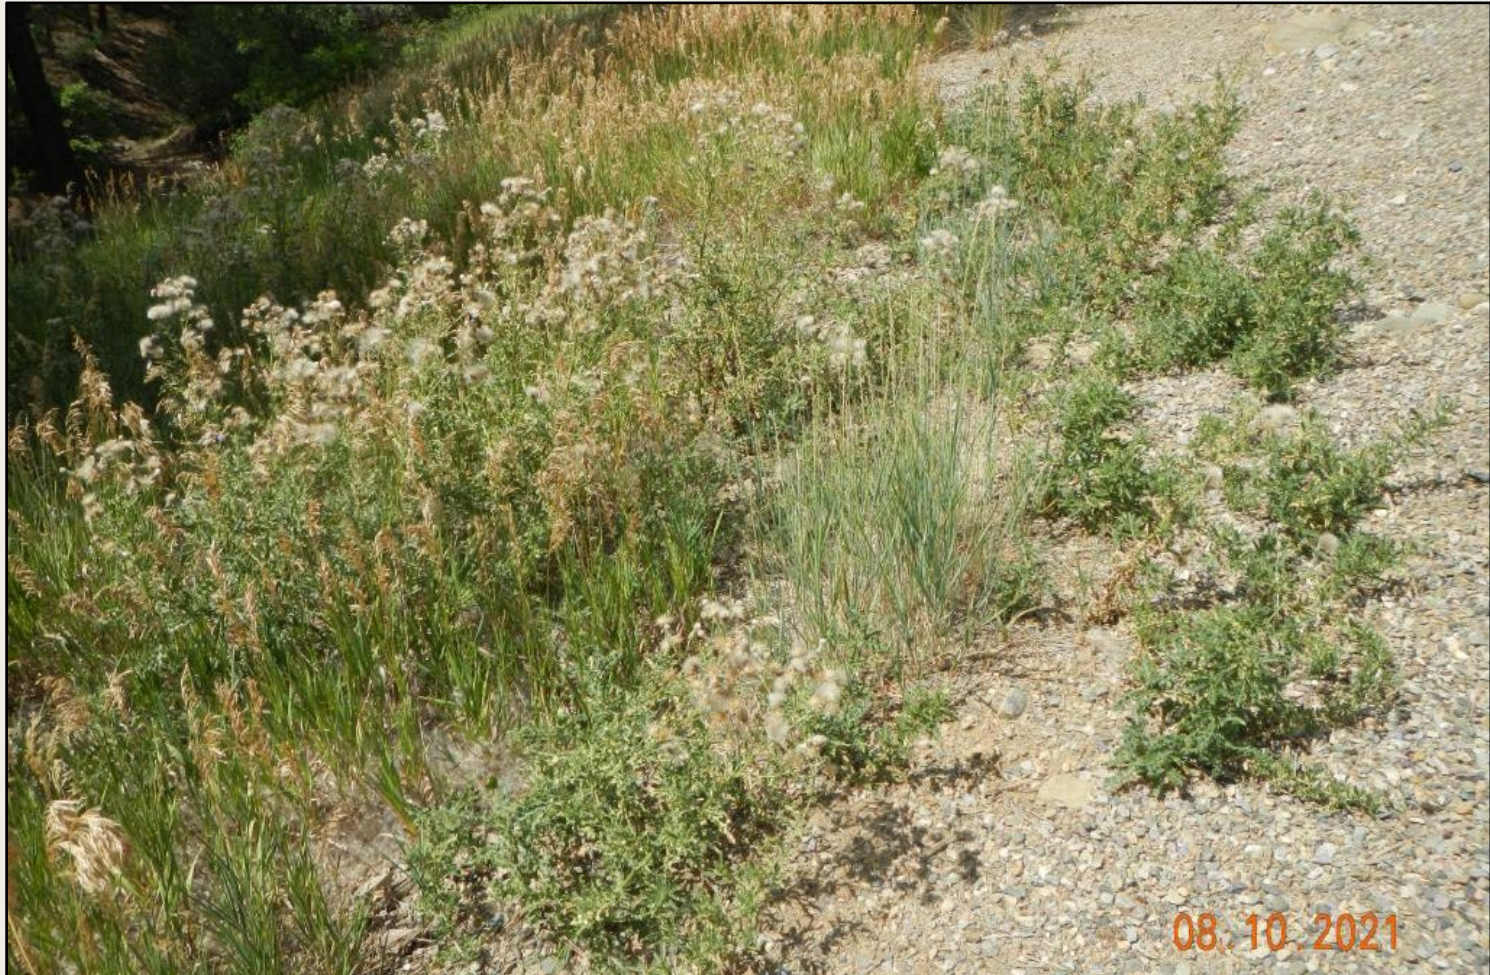
Photo 3. View of Canada thistles (approx. 200) observed within the southern project area.

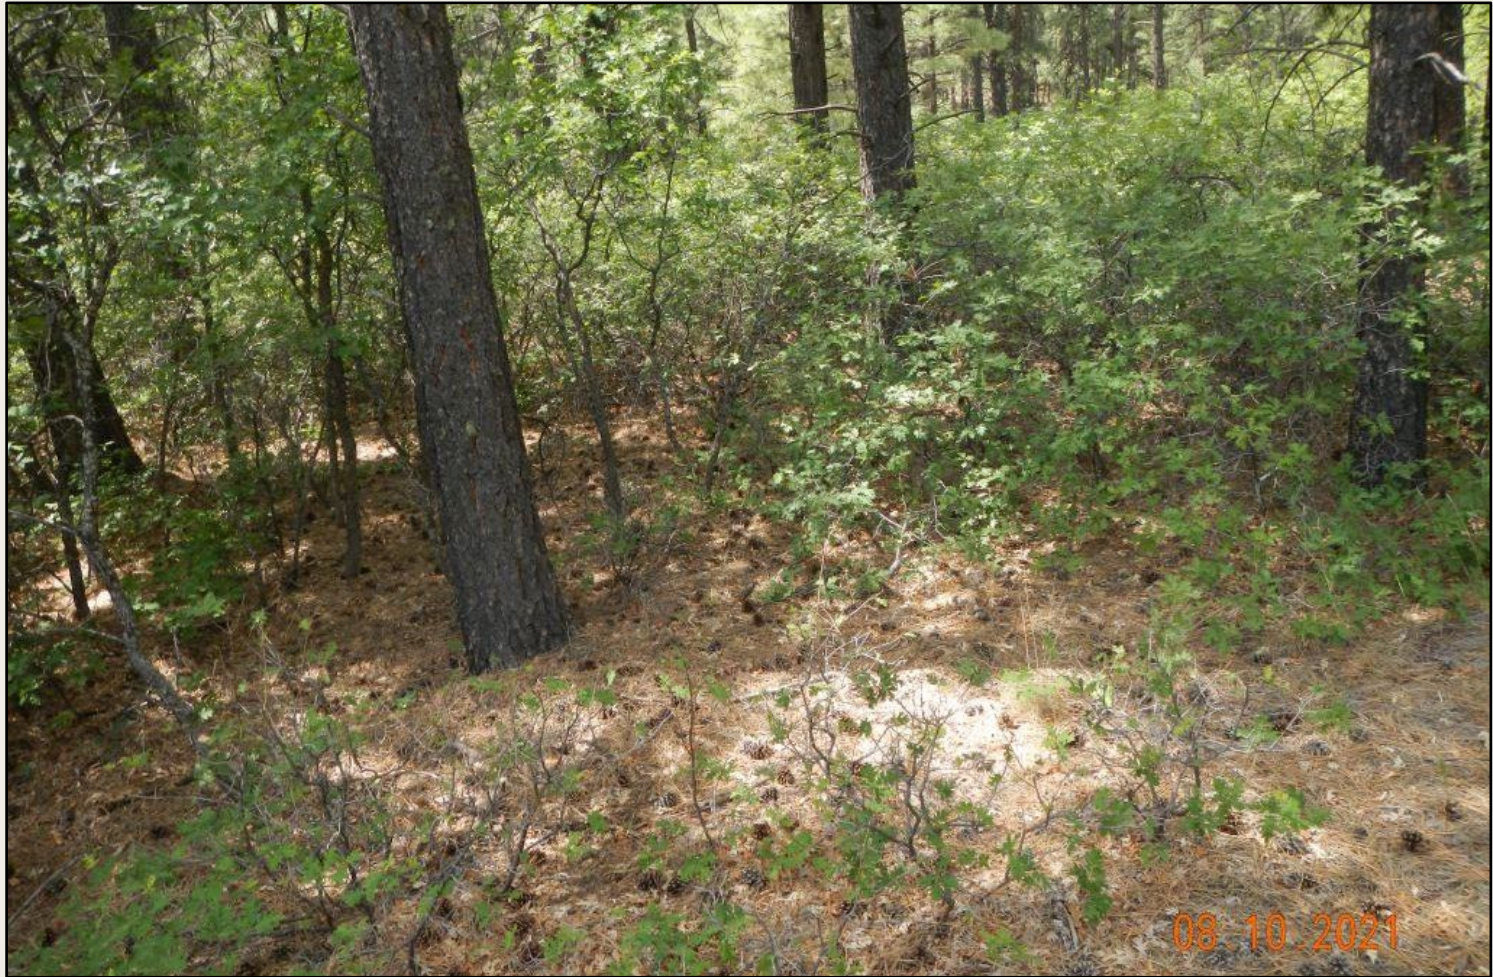
Photo 4. View of the reference area comprised of ponderosa pine forest with understory of gambel oak, Oregon grape, Junegrass, and squirreltail.
