Inspection Photos

API: 073-06774

Operator: KODA EXPLORATION LLC

Inspection Date: 8/23/2021

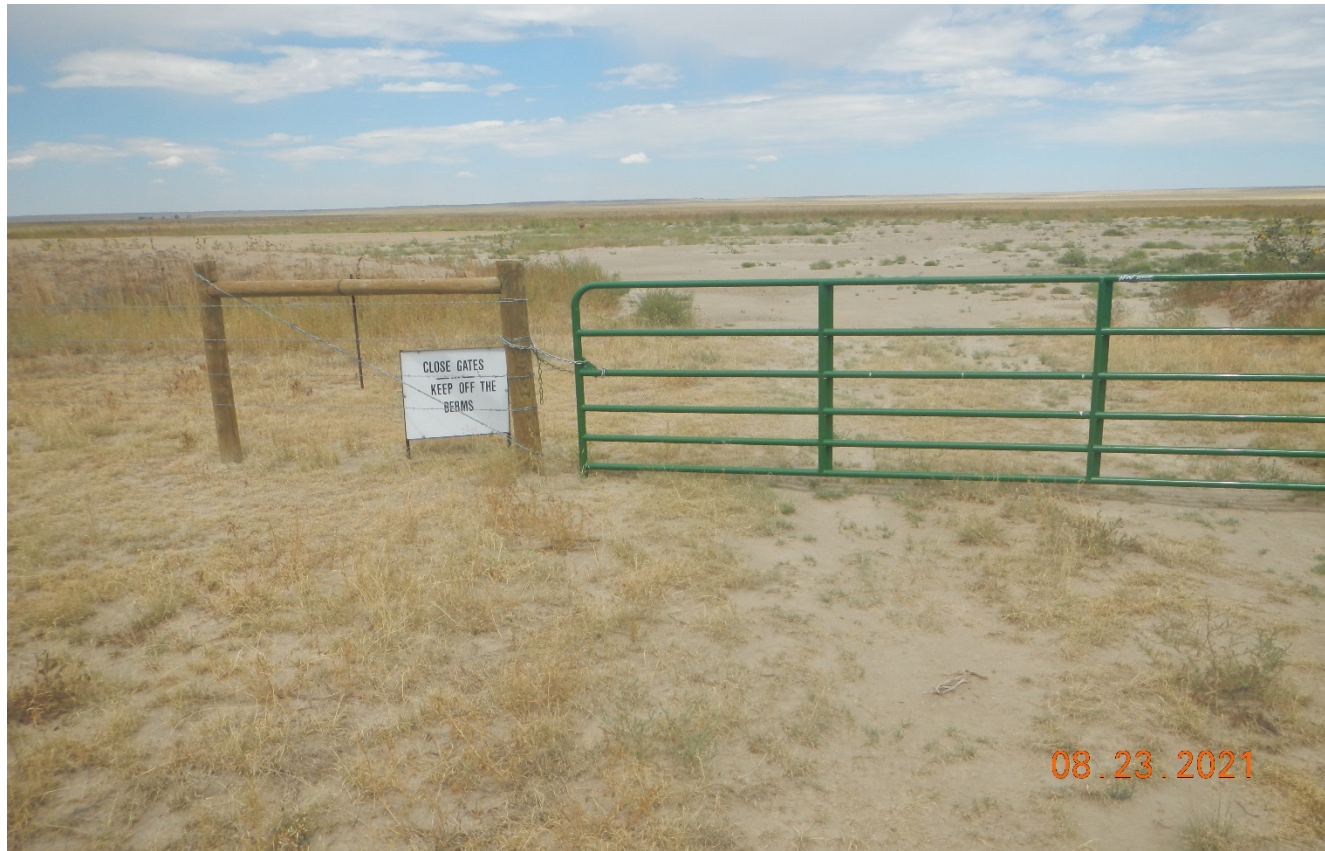
Photo 1. Facing north toward the location which is fenced. The location sign is installed by the gate.

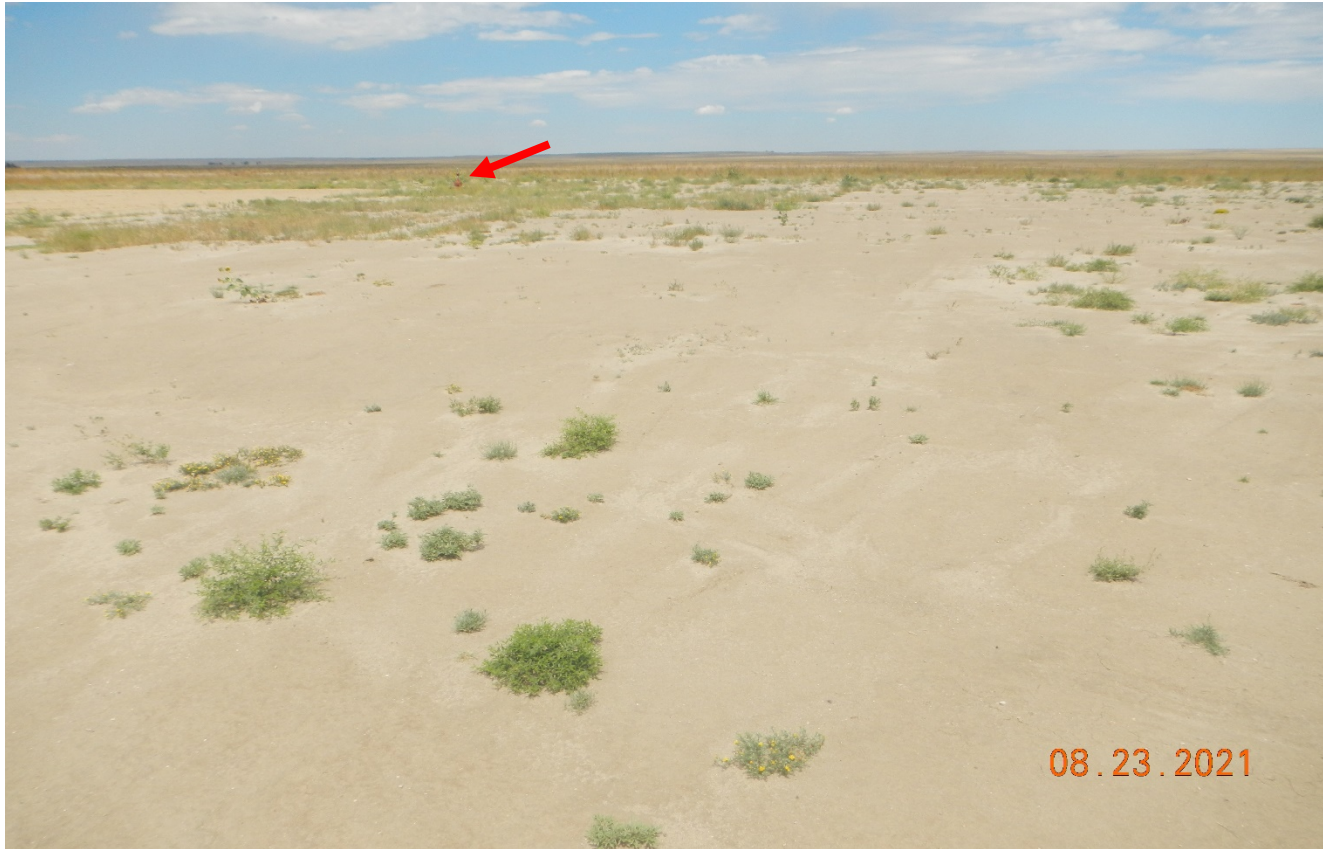
Photo 2. Facing north toward the location. Interim reclamation has not been performed. Unused areas of the location need to be reclaimed.
Arrow points to the TA well.

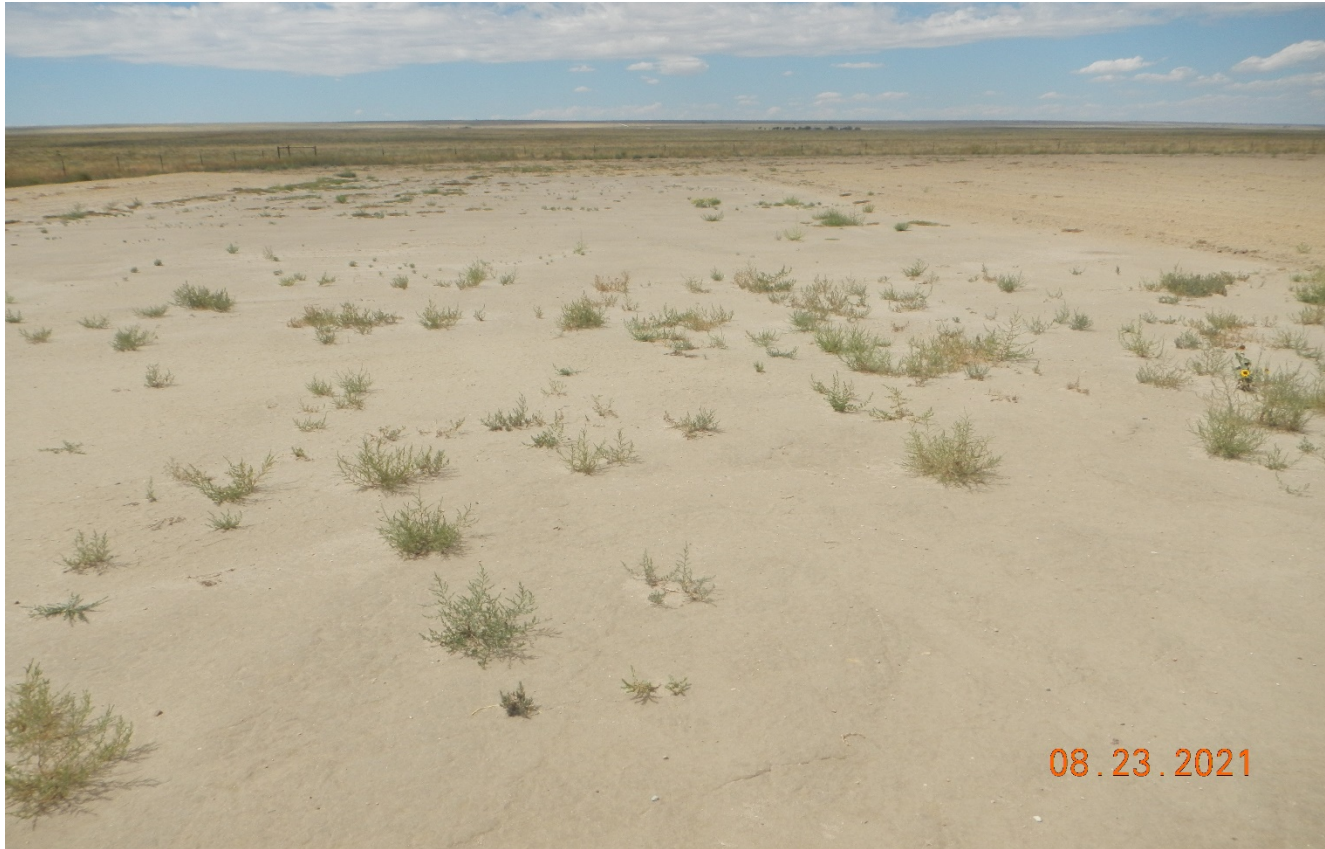
Photo 3. Facing west at the location. Interim reclamation has not been performed.

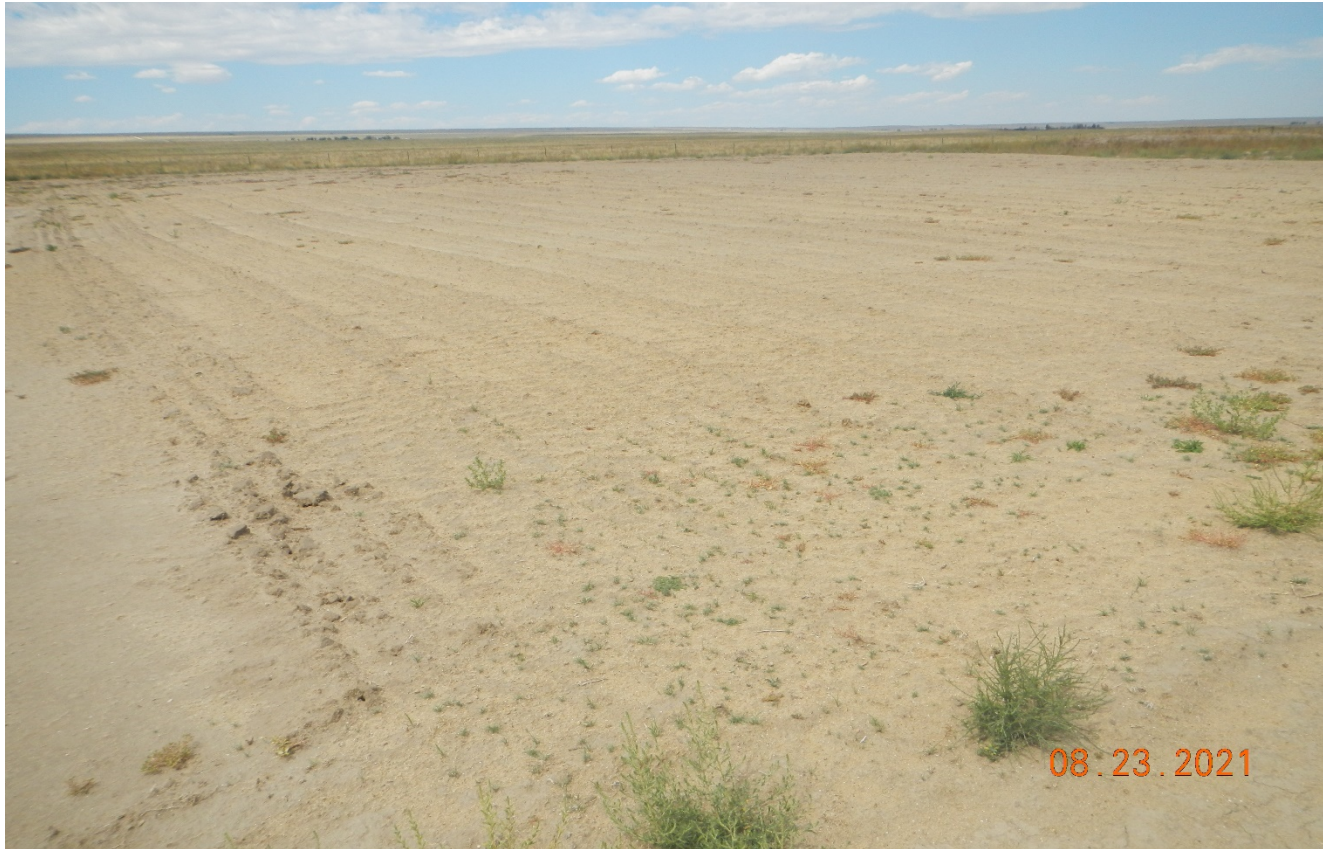
Photo 4. The pit has been backfilled and reclaimed. This is the only area of the location which was reclaimed

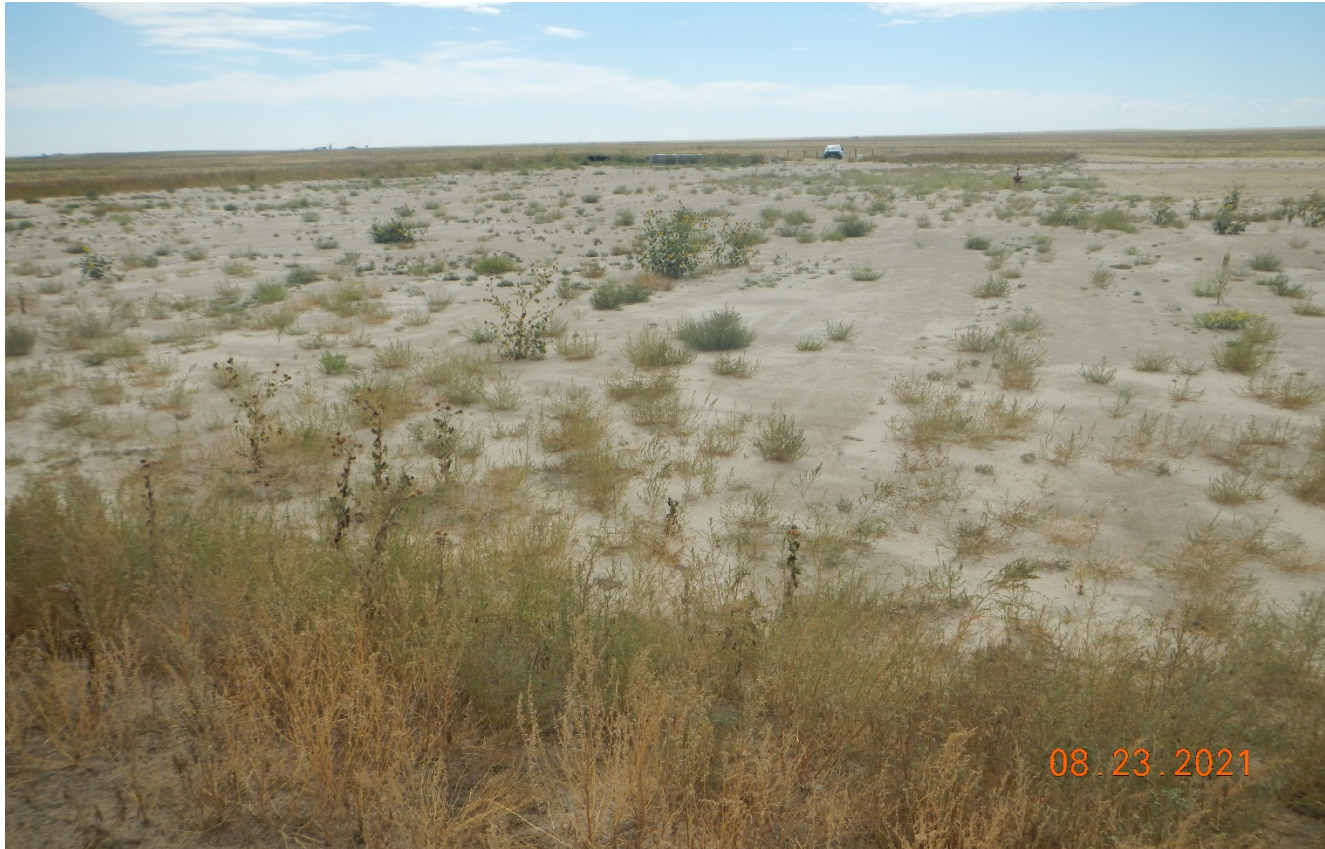
Photo 5. Facing southeast at the location. Unused areas of the location are not stabilized and undesirable weeds are establishing.

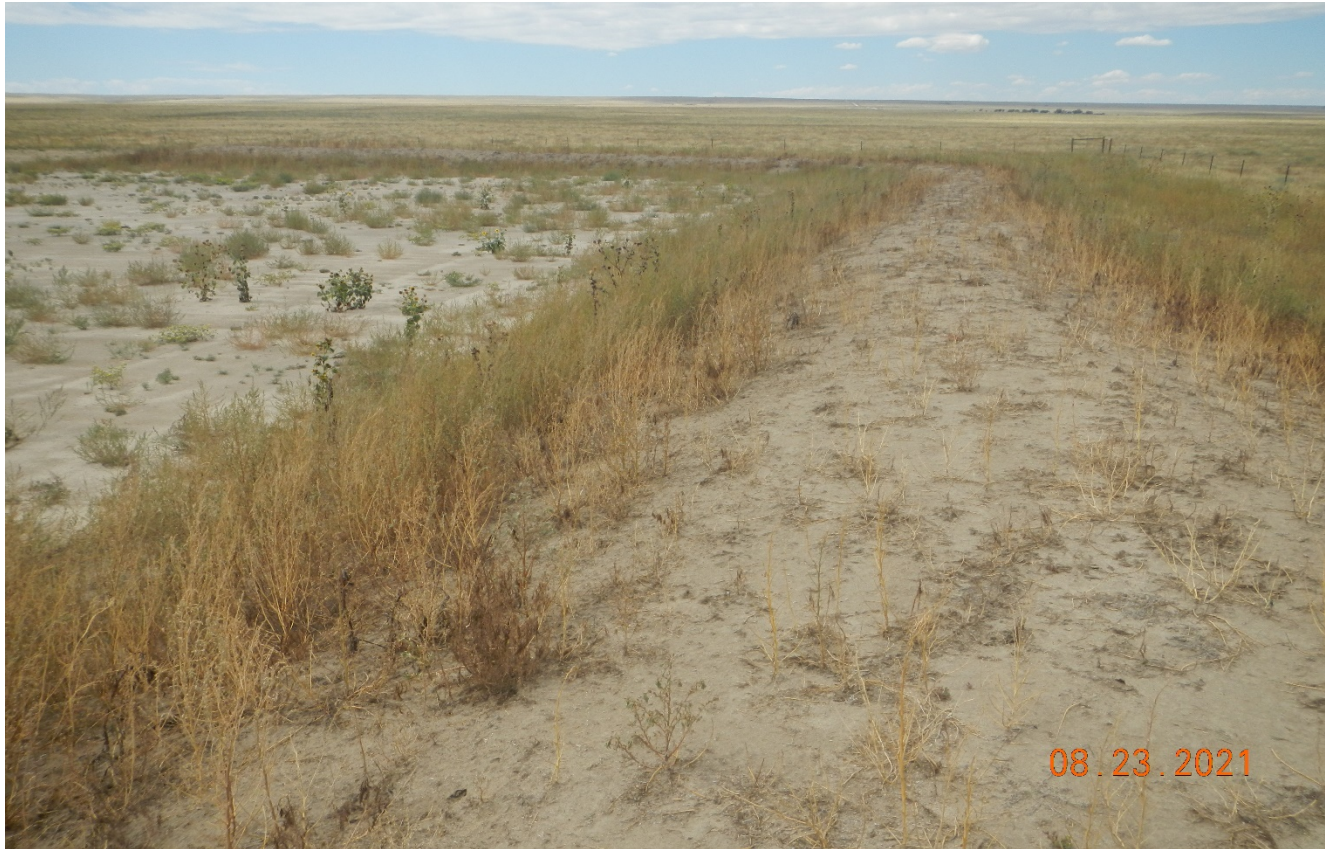
Photo 6. Facing west at the north side of the location. The topsoil pile has not been replaced back to the original position and contour. The topsoil pile is not maintained or stabilized and there are undesirable weeds growing on the segregated soils.

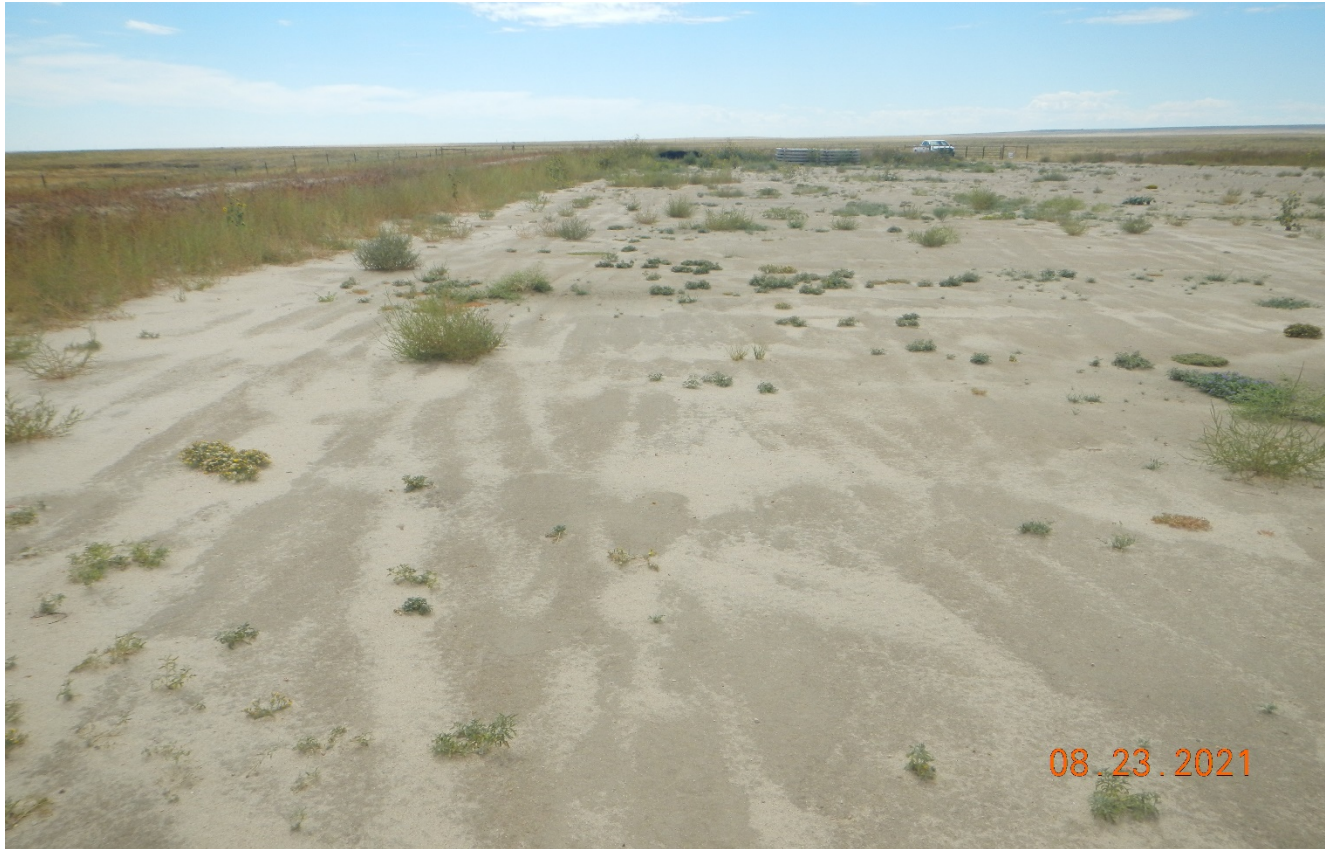
Photo 7. Facing south on the pad surface which has not been recontoured. There are signs of wind erosion on the surface.

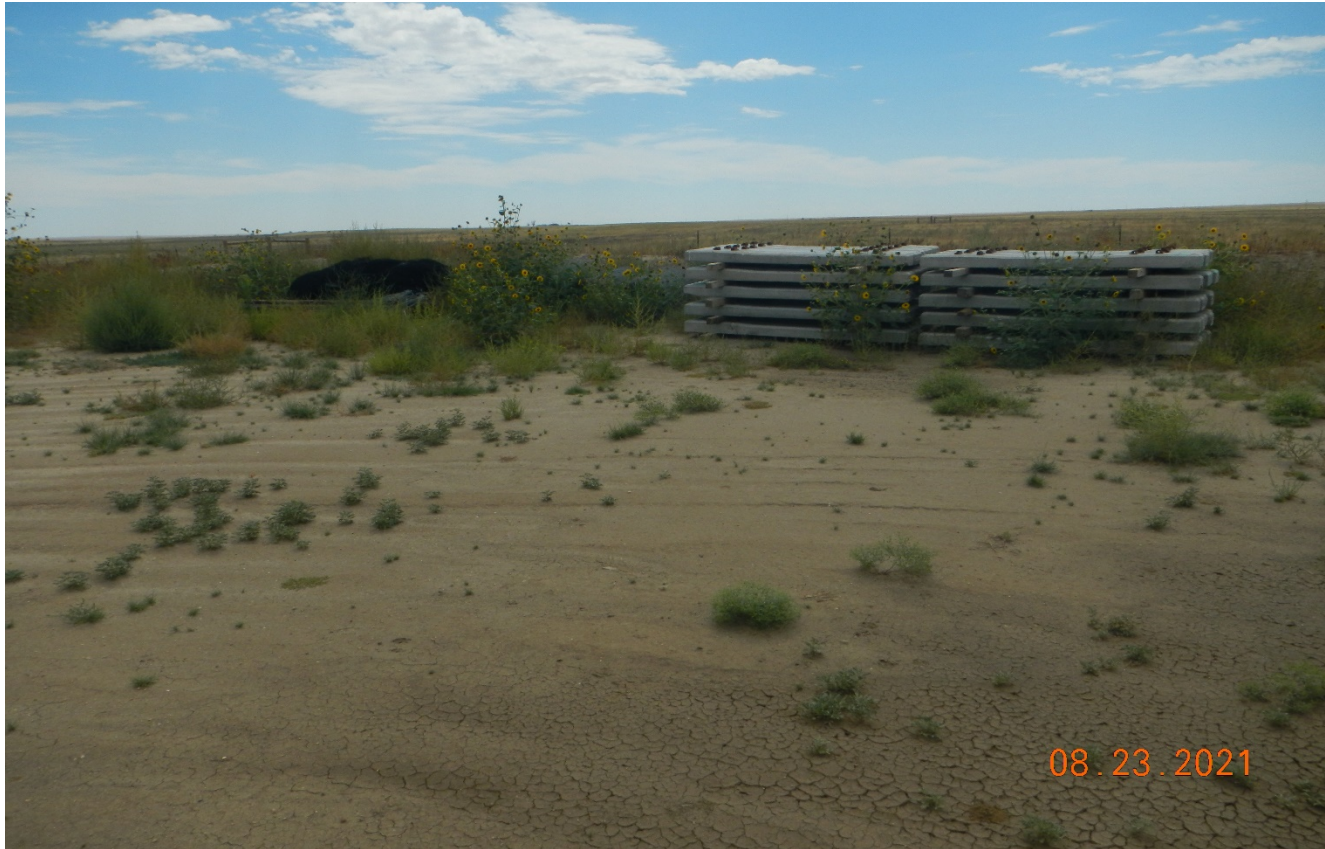
Photo 8. There is unused supplies stored on location which needs to be removed.
