Interim Reclamation and Stormwater Inspection

Operator: GREAT WESTERN OPERATING COMPANY LLC- #10110

Location ID: 434399

Location Name: Willow Bend LD Pad /18-36HN-2

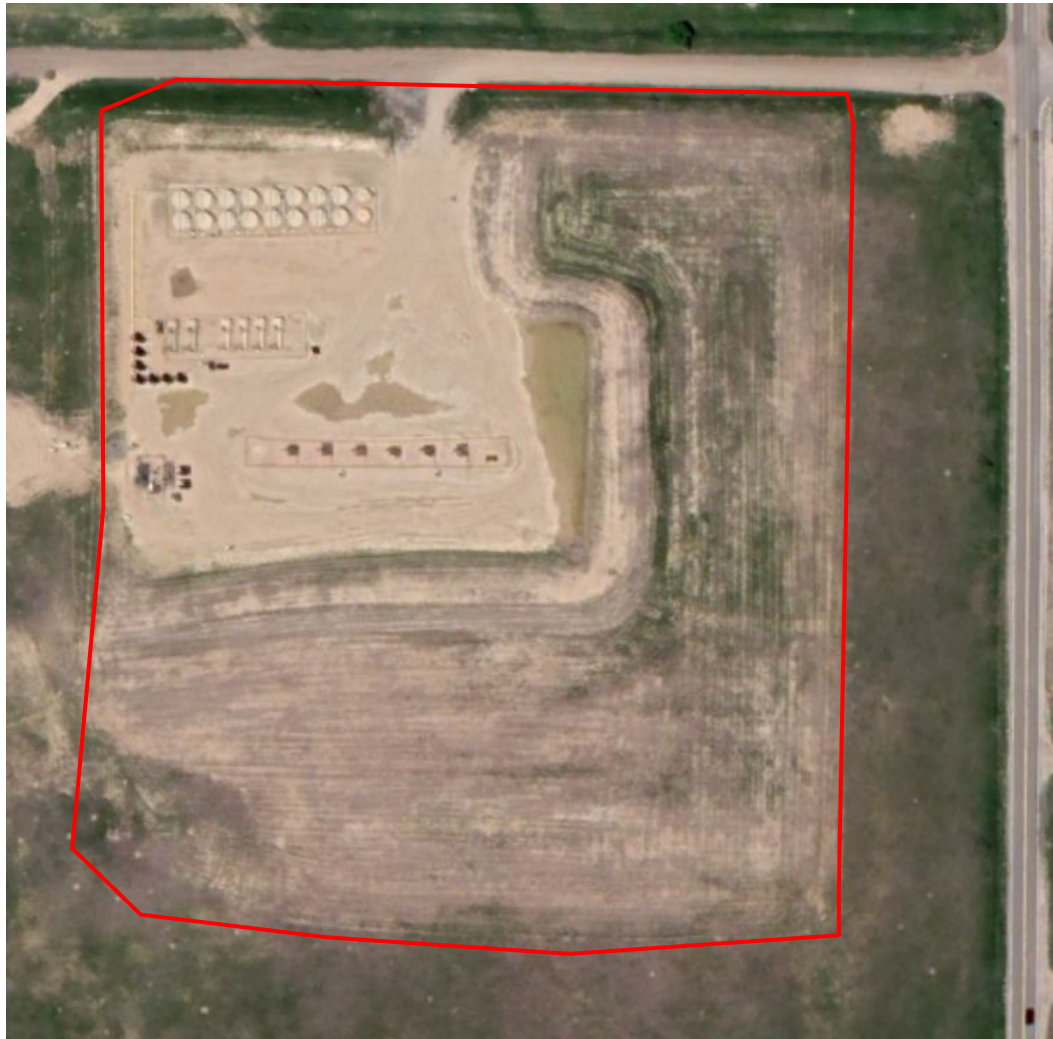
Photo 1. Google Earth aerial imagery taken 5/26/2021. Photo illustrates Operator performed interim reclamation activities in response to a previous corrective action.

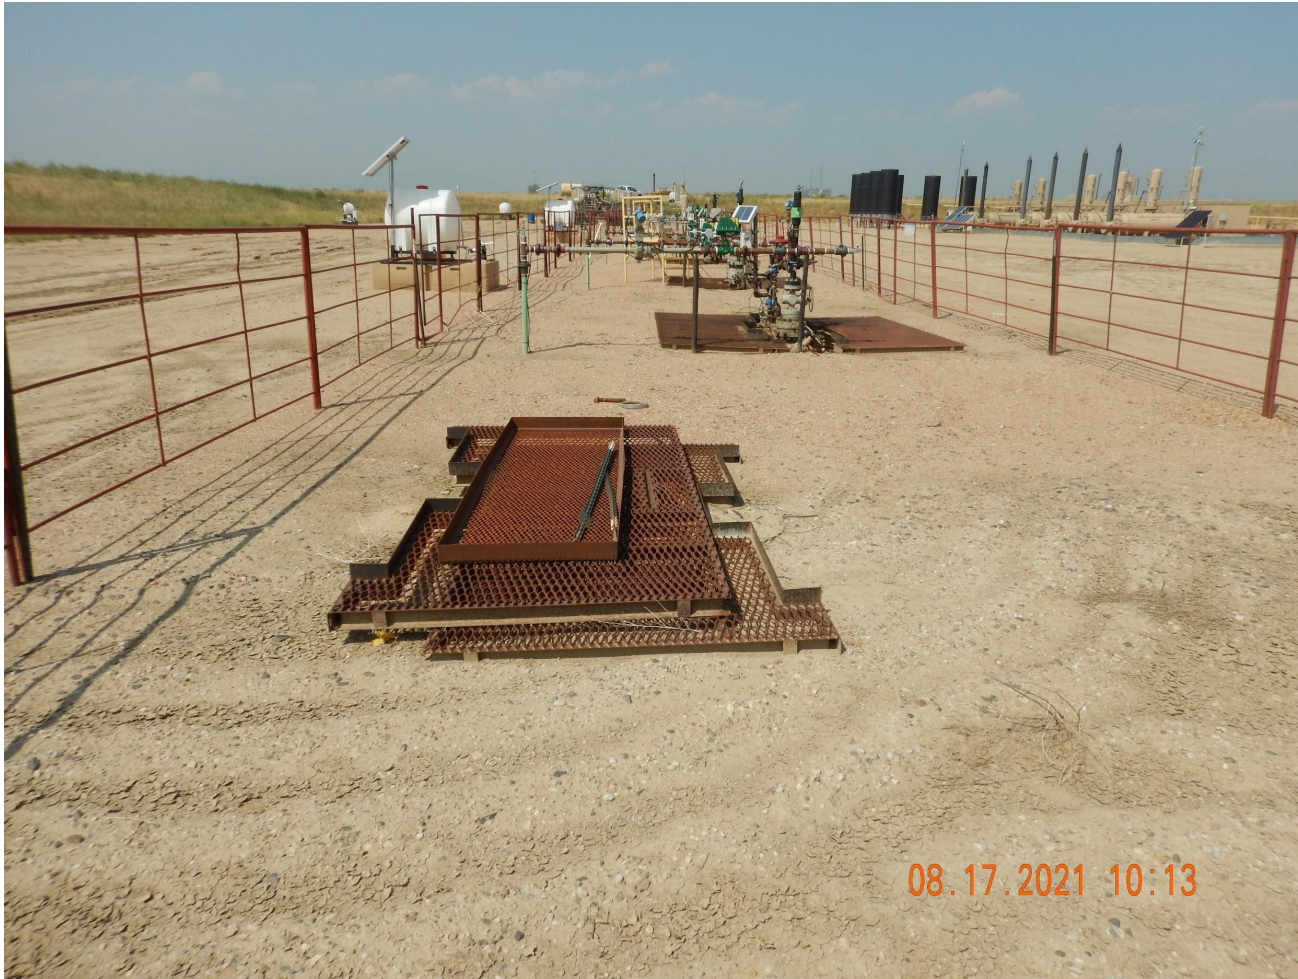
Photo 2. Photo taken from the eastern location, facing West. Photo illustrates unused equipment.

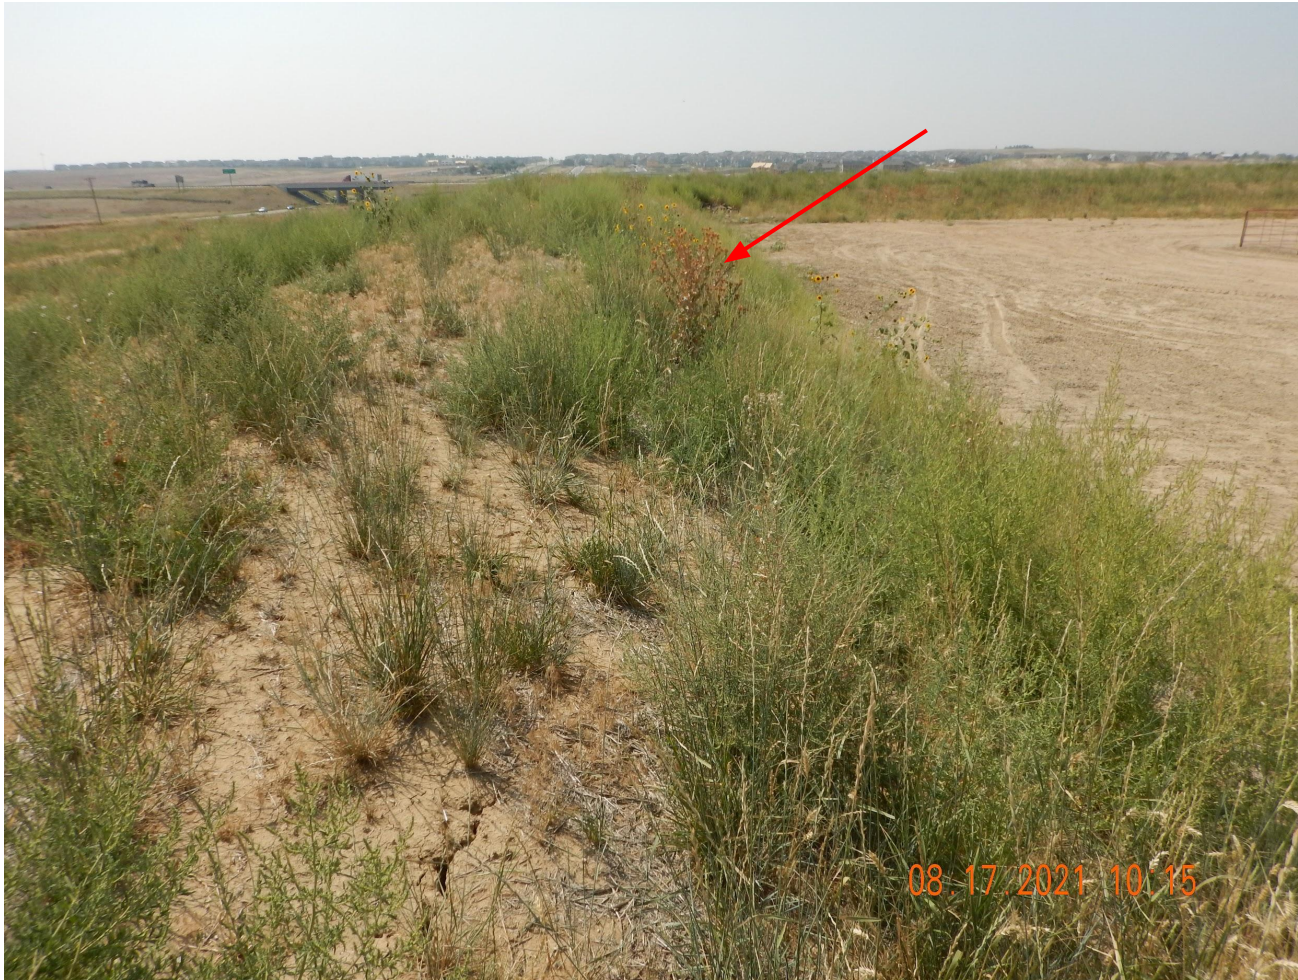
Photo 3. Photo taken from the eastern location, facing South. Photo illustrates an unmanaged List B Colorado noxious weed, Scotch thistle. Photo illustrates Operator has failed to properly manage the noxious weed to prevent the weed from setting seed and has failed to manage other undesirable plant species.

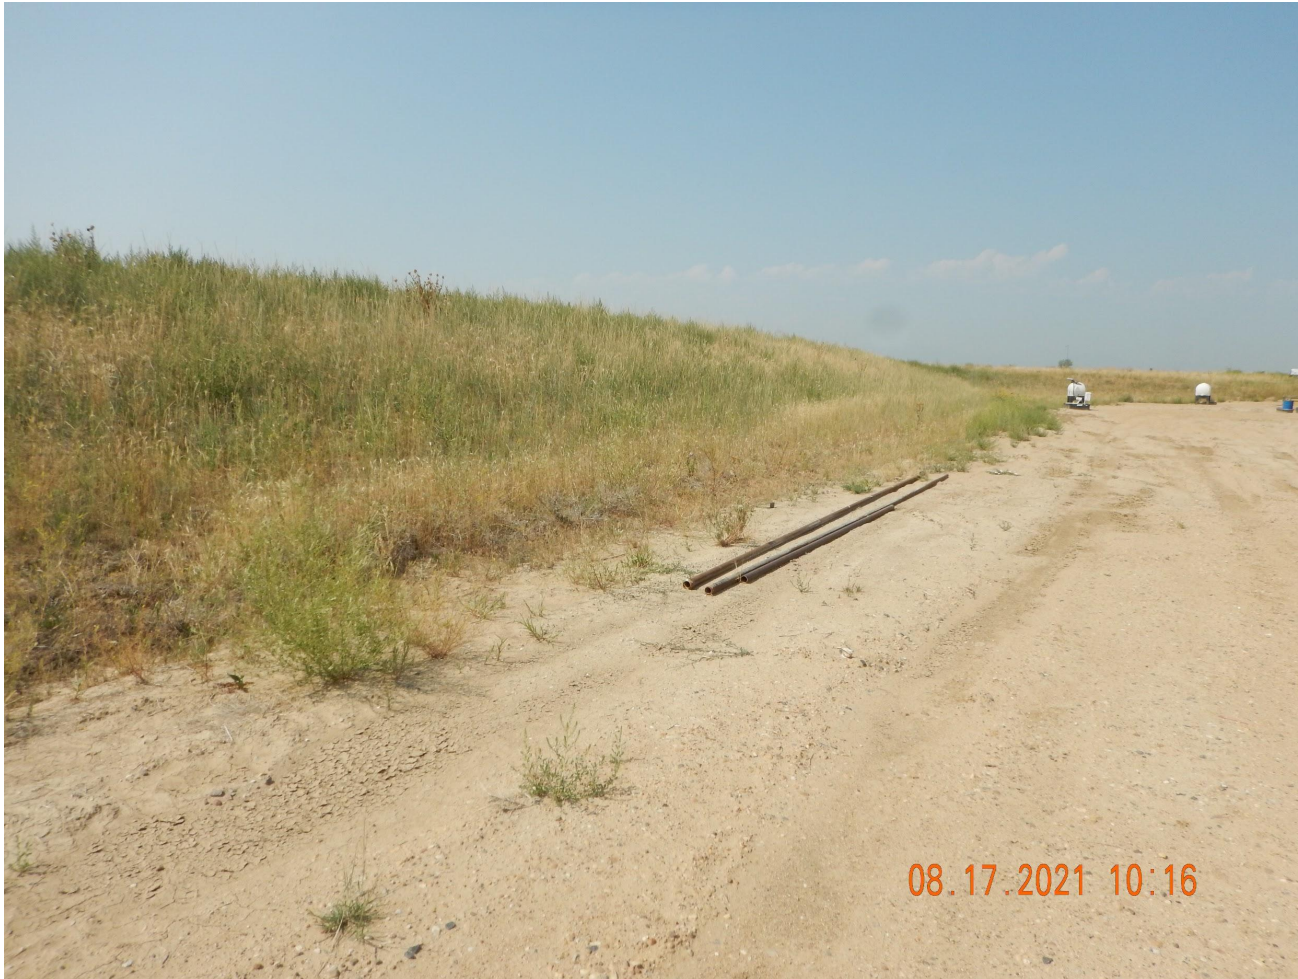
Photo 4. Photo taken from the southern location, facing West. Photo illustrates unused equipment.

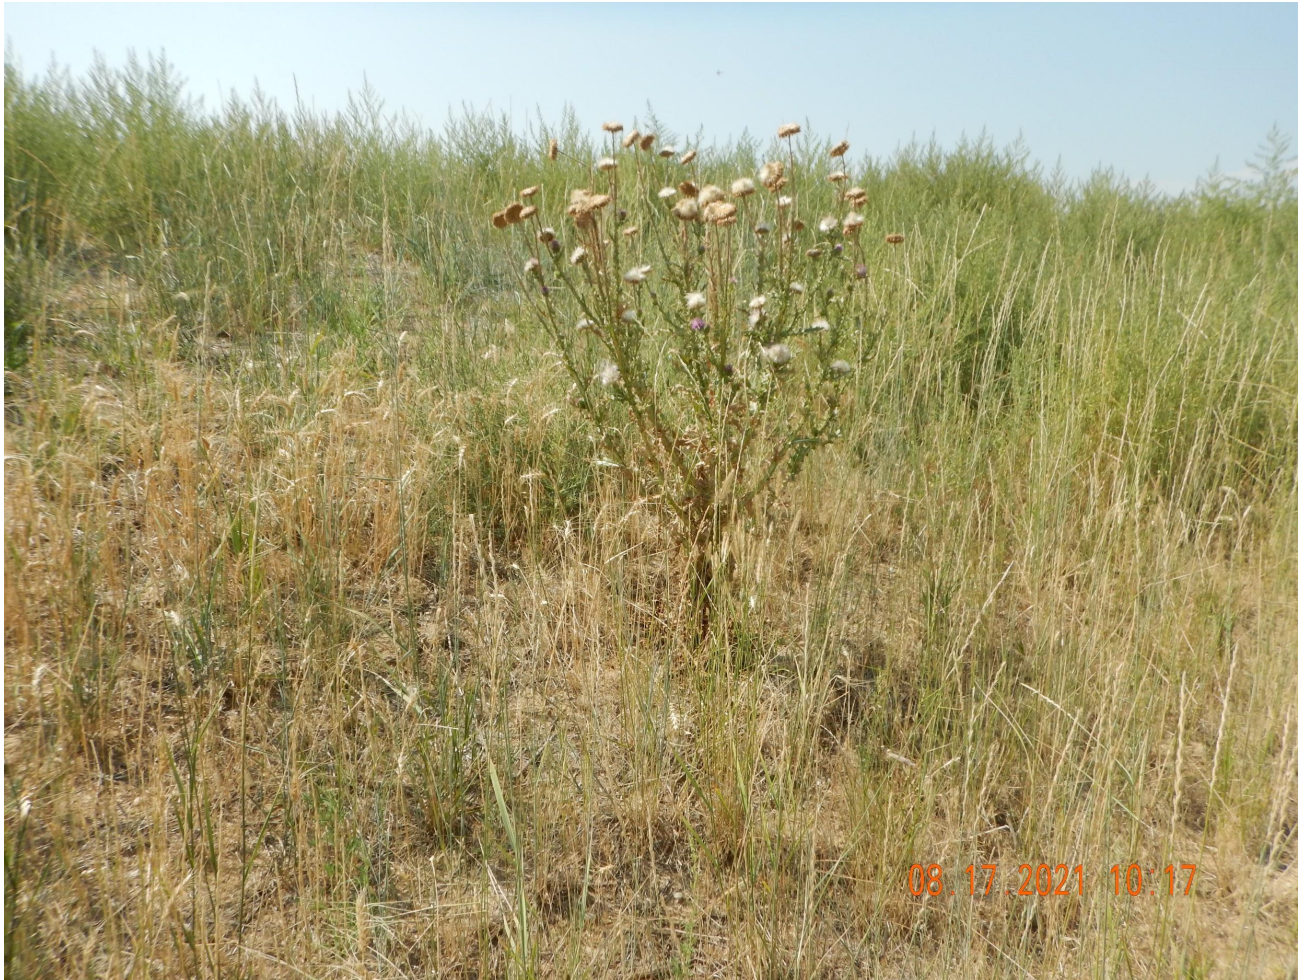
Photo 5. Photo taken from the southwestern location, facing West. Photo illustrates an unmanaged List B Colorado noxious weed, Musk thistle. Photo illustrates Operator has failed to properly manage the noxious weed to prevent the weed from setting seed and has failed to manage other undesirable plant species.

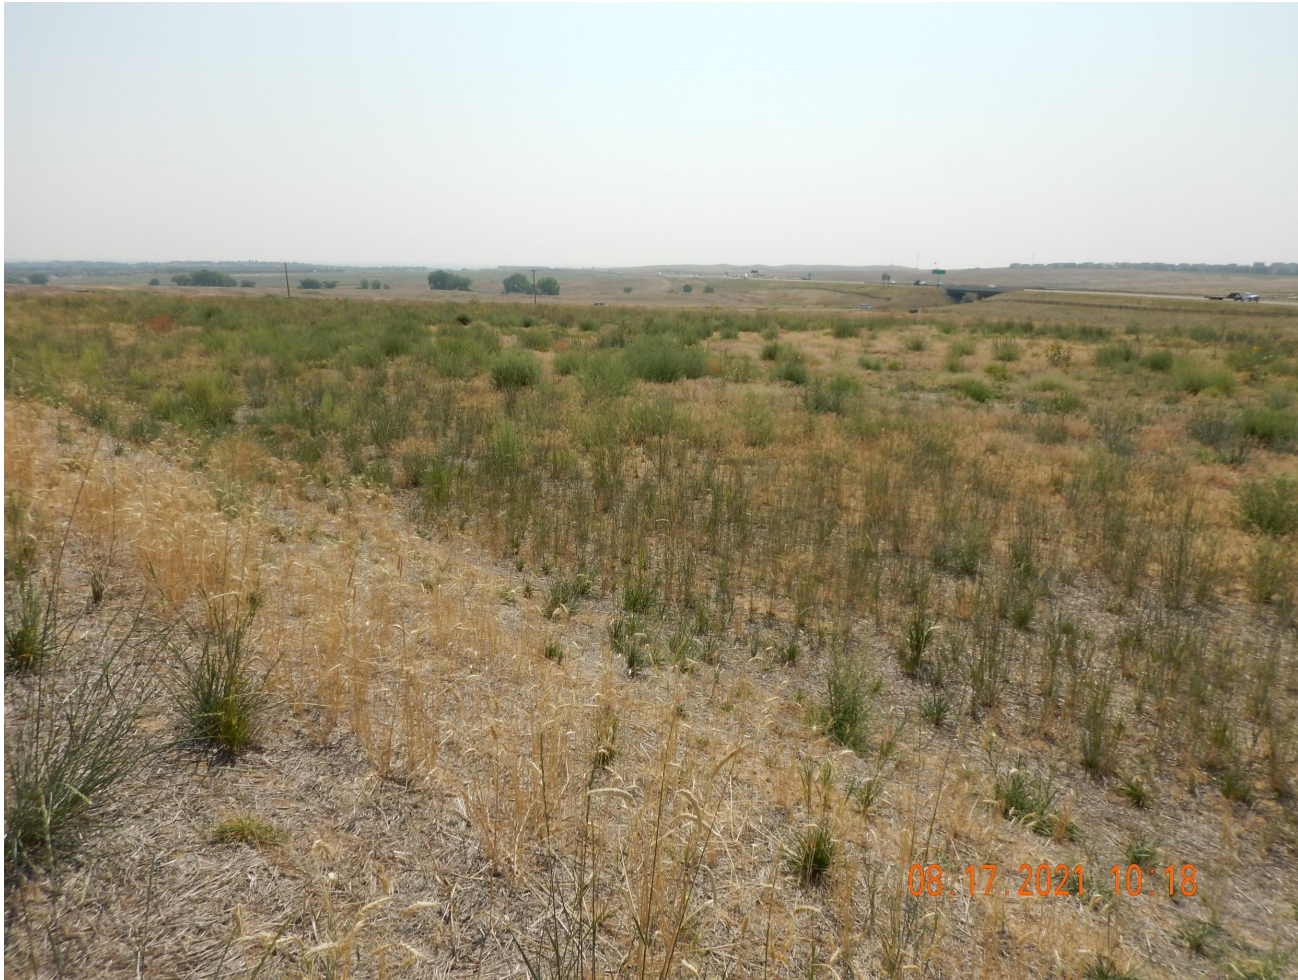
Photo 6. Photo taken from the southwestern location, facing South. Photo illustrates unmanaged List B Colorado noxious weeds, Scotch and Musk thistle, throughout the interim reclamation areas. Photo illustrates Operator has failed to properly manage the noxious weed to prevent the weed from setting seed and has failed to manage other undesirable plant species.
