# Final Reclamation Inspection

Operator: GREAT WESTERN OPERATING COMPANY LLC- #10110

Location ID: 320352

Inspection Photos  
Location Name: WIERMAN #43-7 (1)  
Location ID: 320352

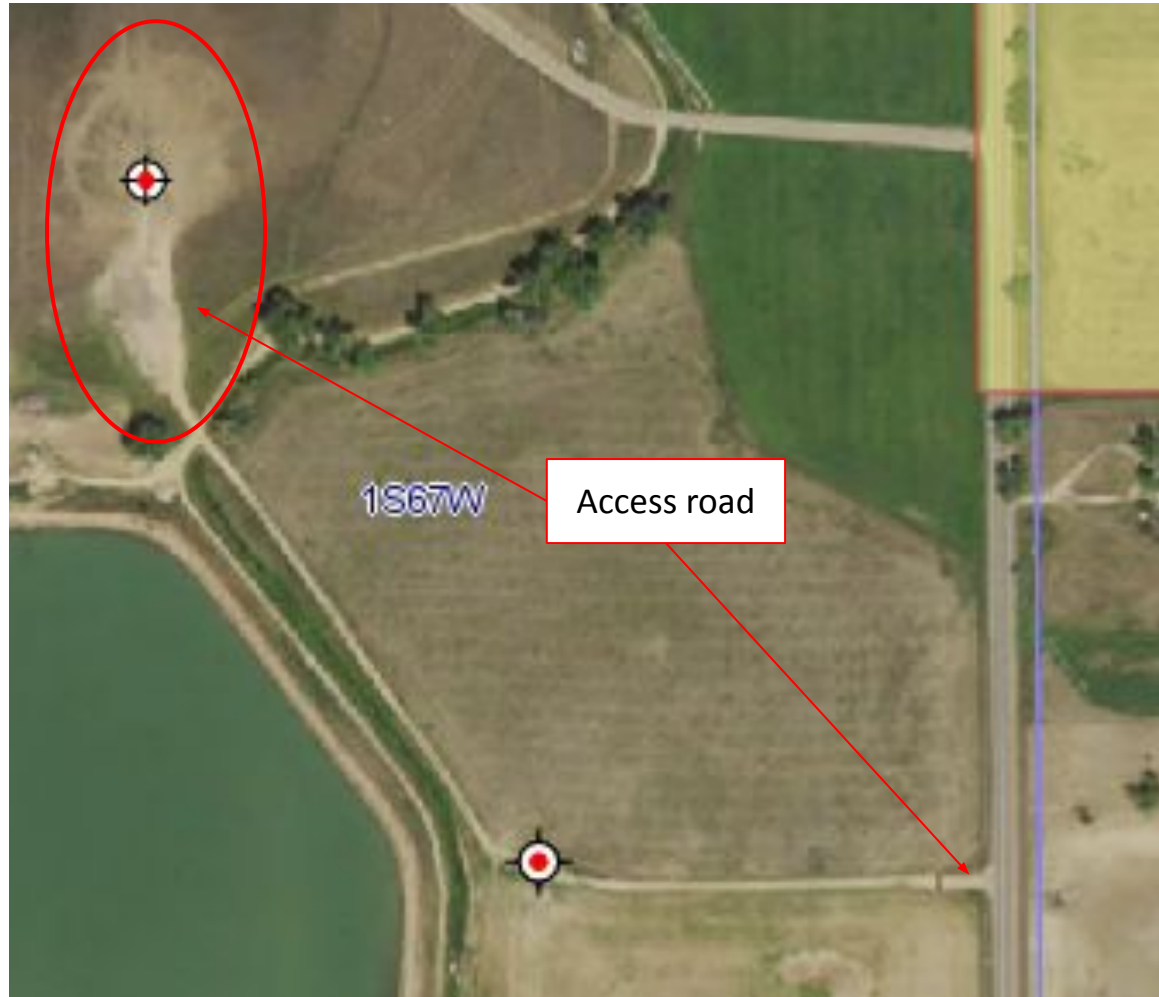
**Photo 1.** Aerial imagery from 2019 illustrates the well location and tank battery (red circle) and the associated access road.

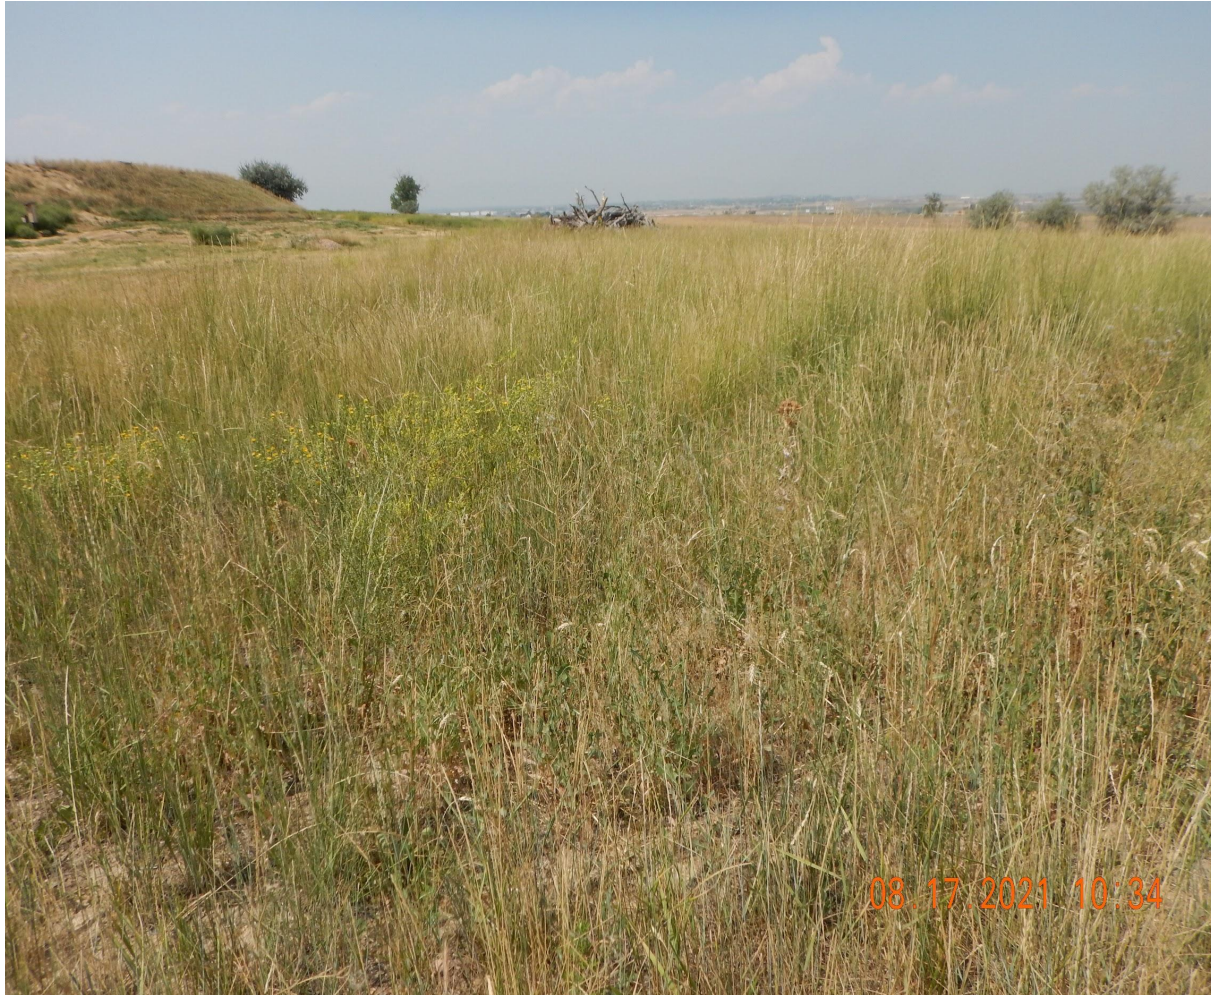
**Photo 2.** Photo taken from the associated tank battery, facing West. Photo illustrates all equipment has been removed and final reclamation has been performed. Final reclamation will remain in-process since the well location and access road do not yet meet Rule 1004 standards.

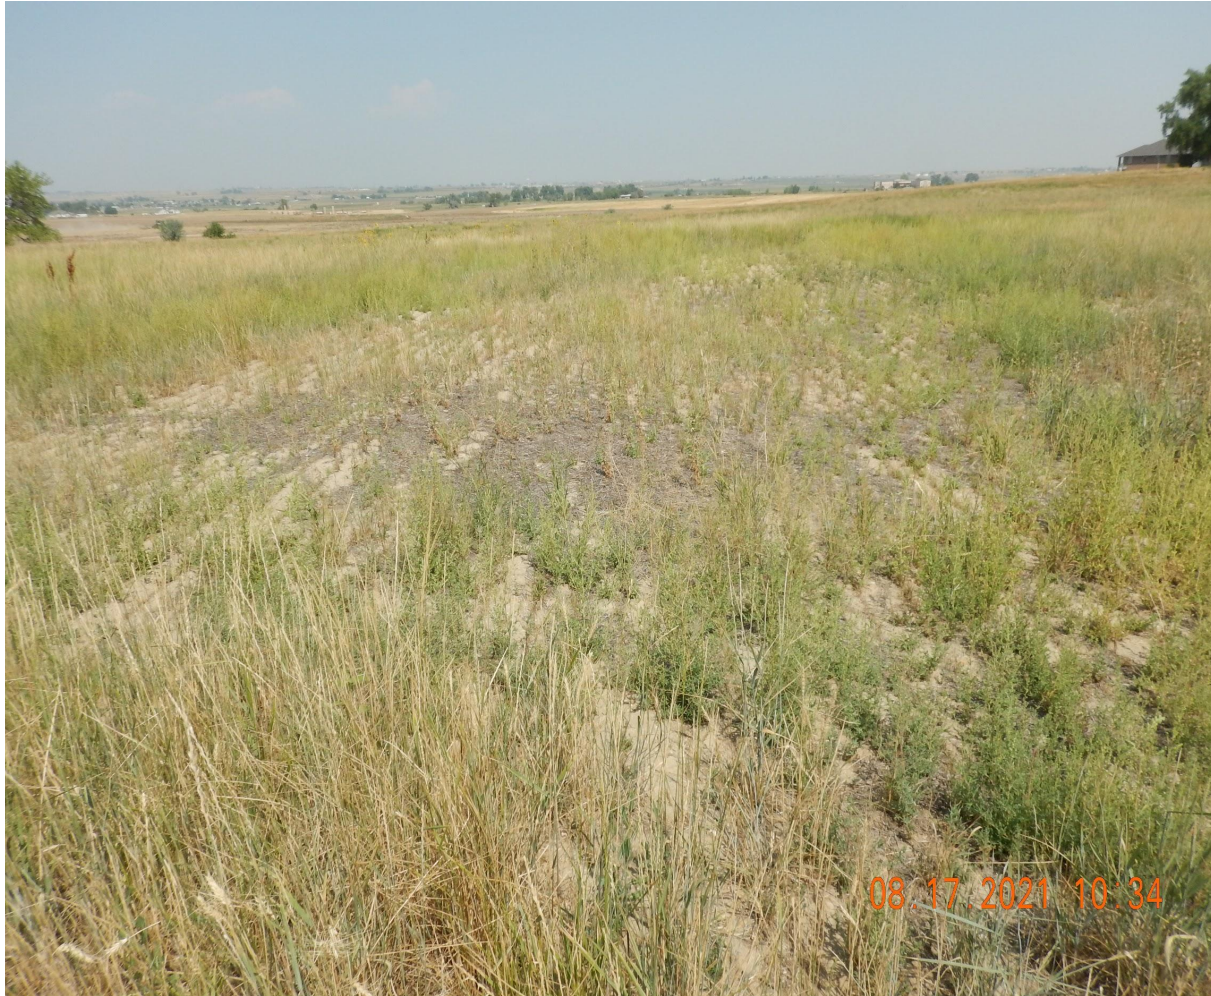
**Photo 3.** Photo taken from the well location, facing North. See comments under Photo 2.

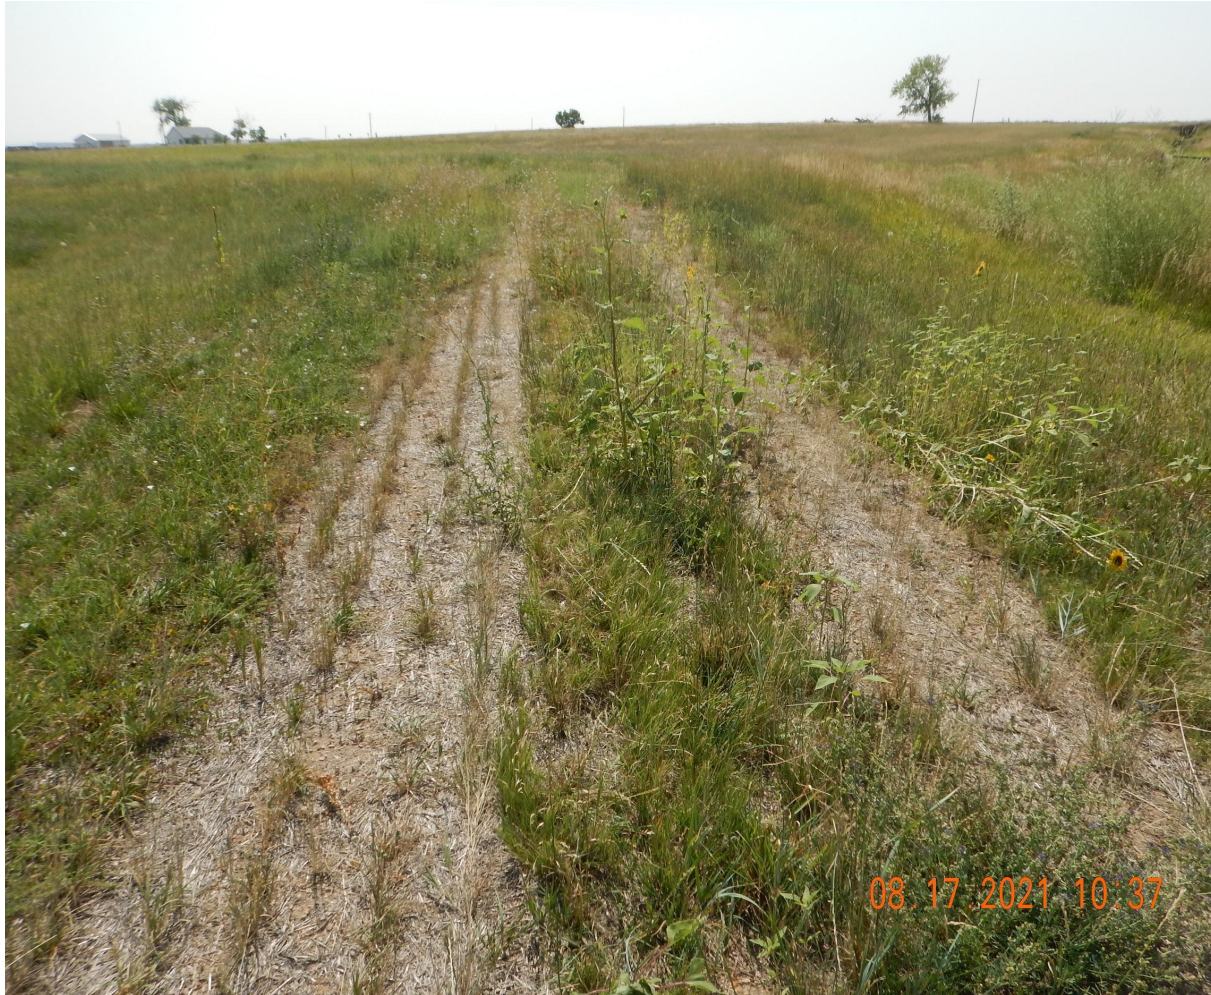
**Photo 4.** Photo taken from the northern portion of the access road, facing South. Photo illustrates drill rows and desirable establishment. See comments under Photo 2.

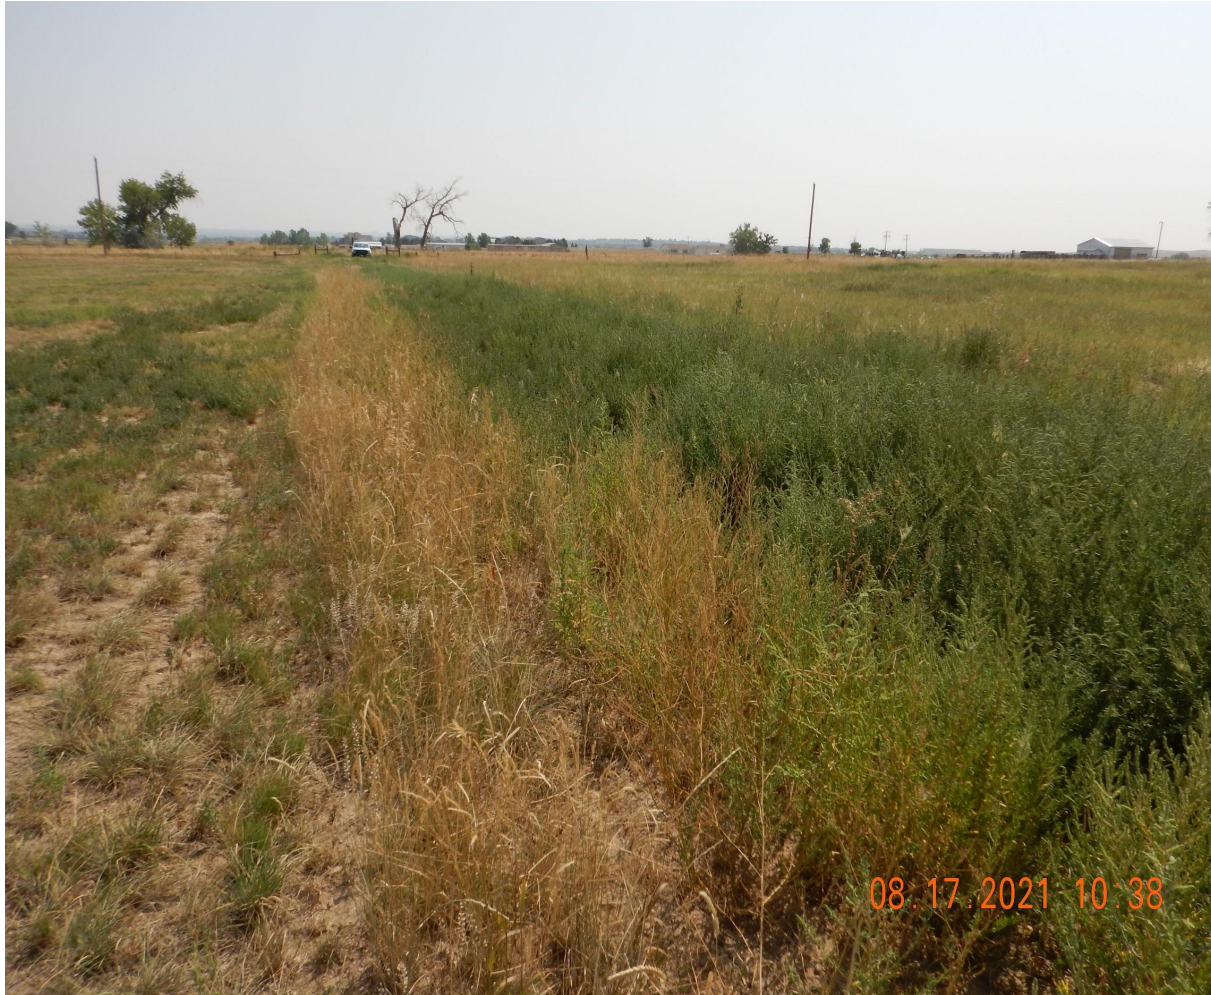
**Photo 5.** Photo taken from the eastern portion of the access road, facing East. Photo illustrates undesirable weeds, Kochia and Russian thistle, which will need to be managed in the future. It appears weed management in the form of mowing was observed.
