Inspection Photos

Operator: NONSUCH NATURAL GAS INC

Location ID: 324169

Garfield County, CO

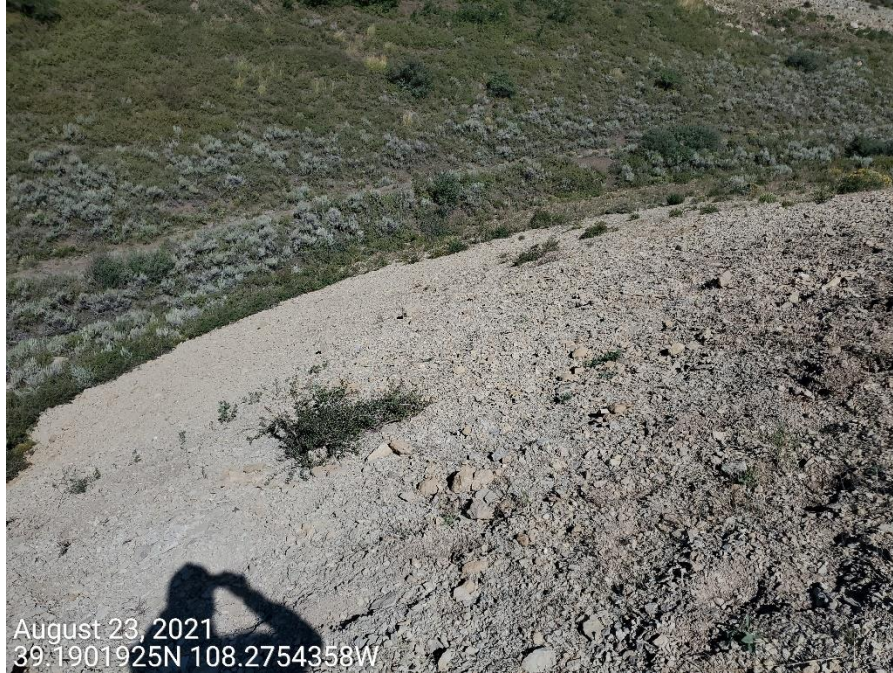
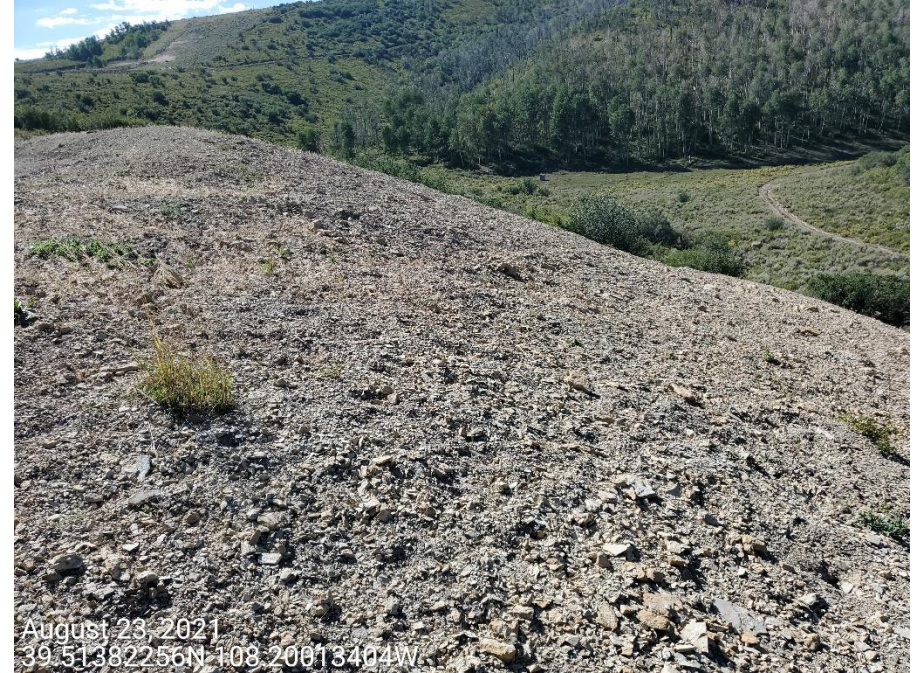
Photo 1: Photo taken from the interim areas, on the west end of the Location. Unable to find evidence that additional reclamation work was performed; control measures to stabilize the seeded soils not implemented. Photo also shows control measures to protect/stabilize the cut/fill slopes of the Location, and to prevent offsite sediment transport remains missing or insufficient.

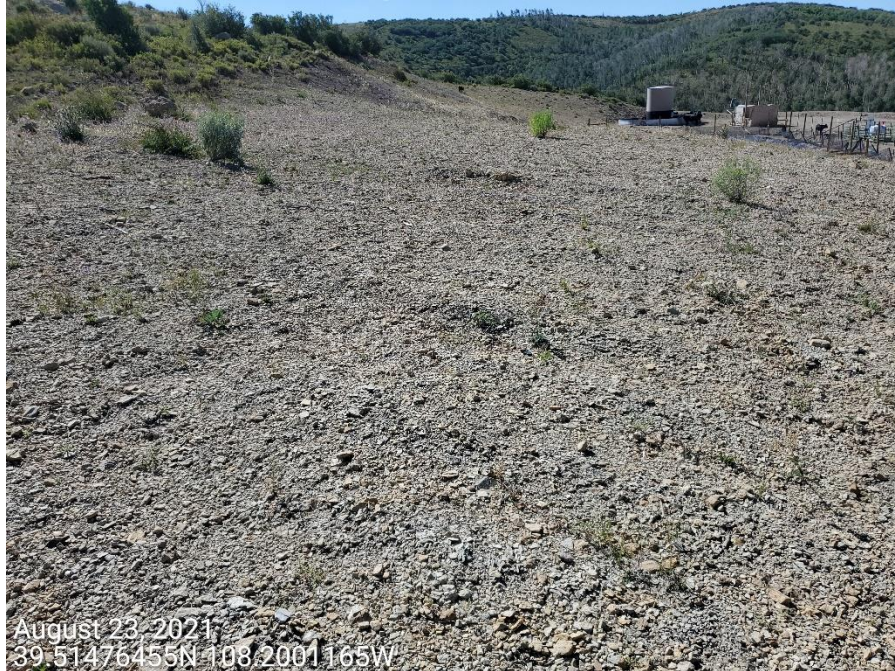
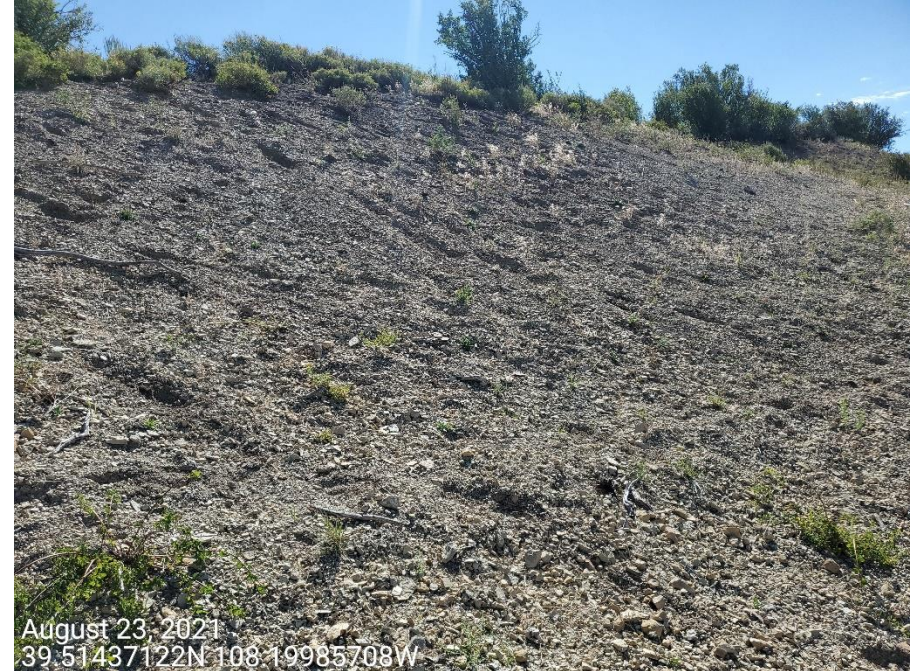
Photo 2: Photo taken from the interim areas, on the north and east end of the Location. Unable to find evidence that additional reclamation work was performed; control measures to stabilize the seeded soils not implemented. Photo also shows control measures to protect/stabilize the cut/fill slopes of the Location, and to prevent offsite sediment transport remains missing or insufficient.

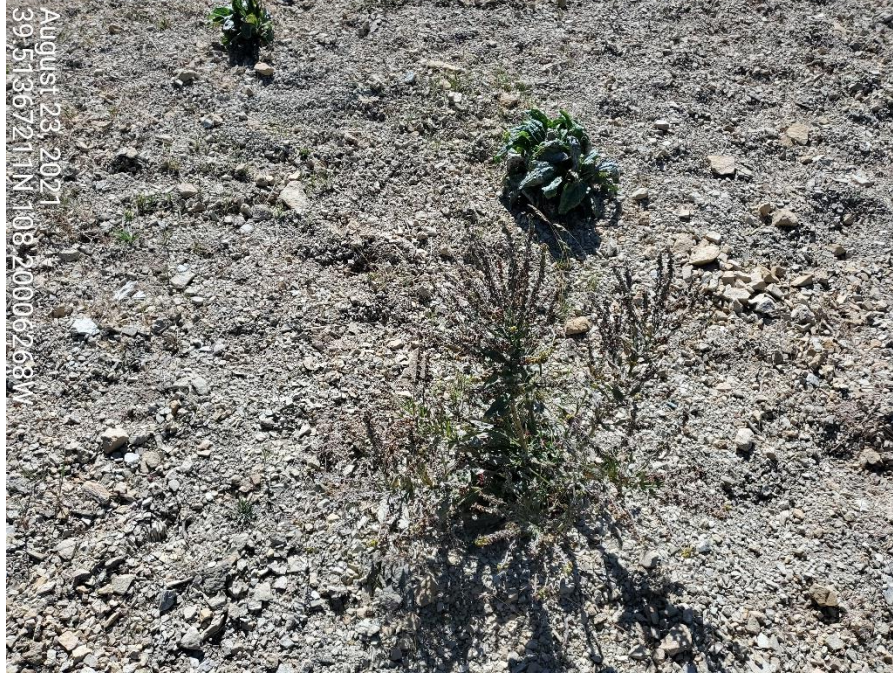
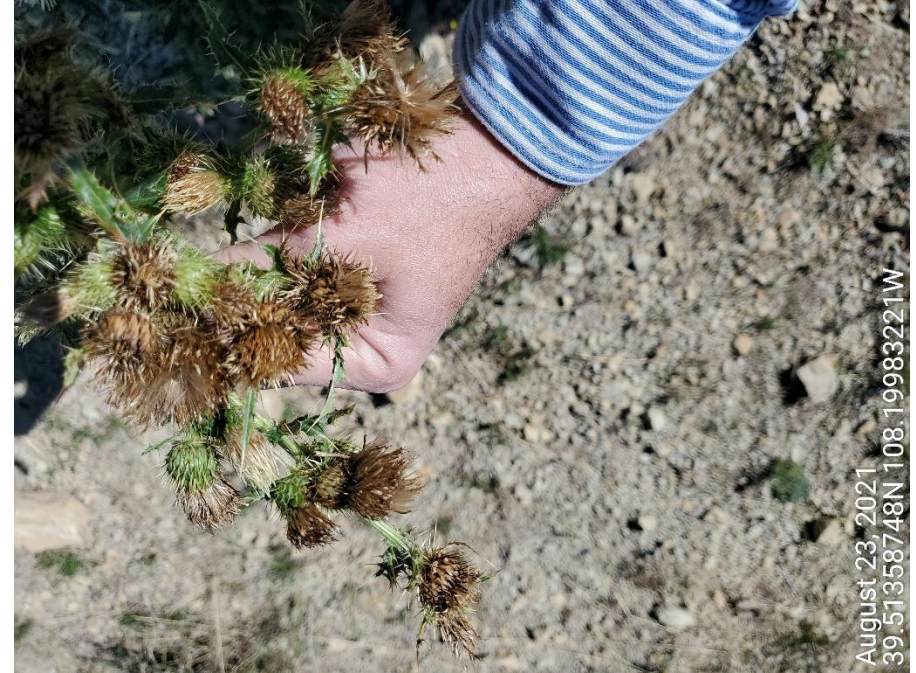
Photo 3: Photo provides example of noxious weeds on the Location that have matured with viable seed heads.

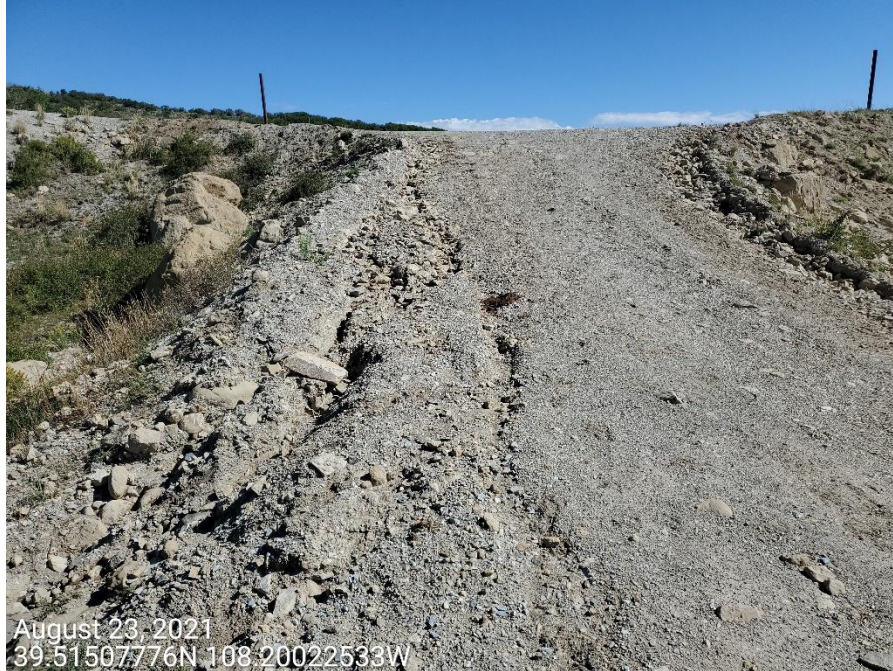
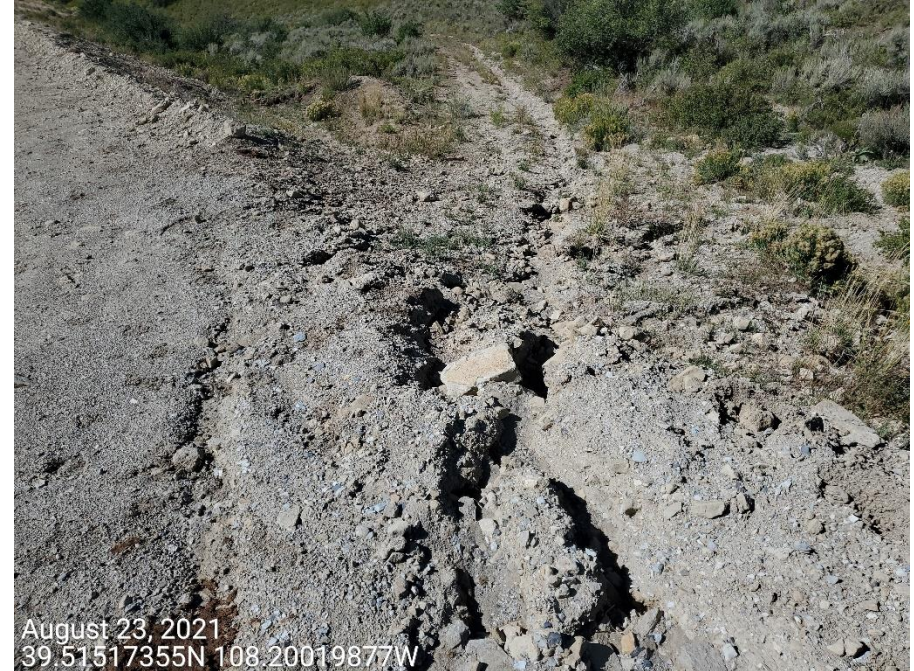
Photo 4: Photo shows erosion degradation along access road; BMPs to stabilize, manage runoff, and minimize erosion are missing or insufficient at the access road; erosion degradation and offsite sediment transport observed on road.

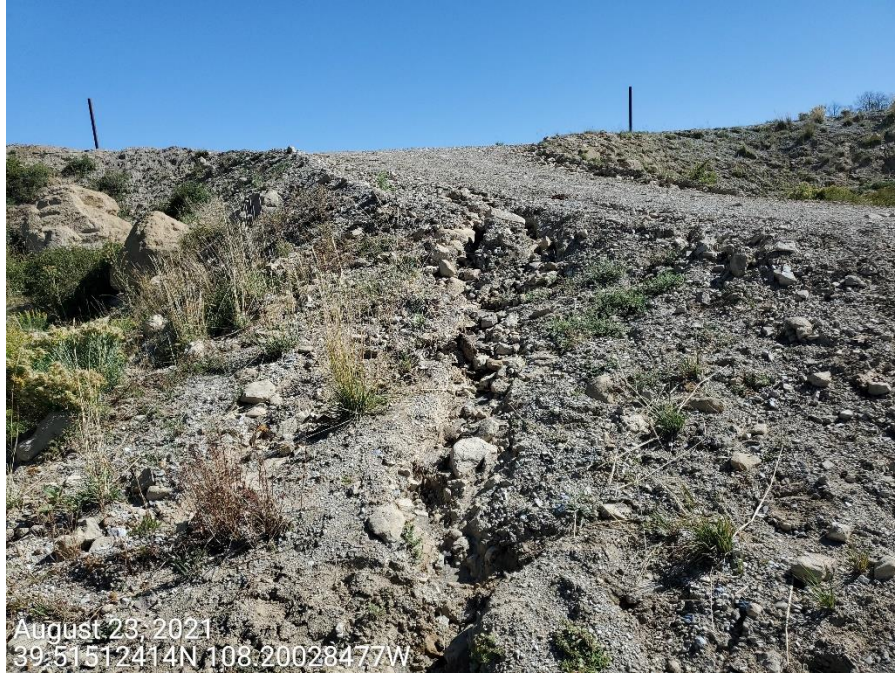
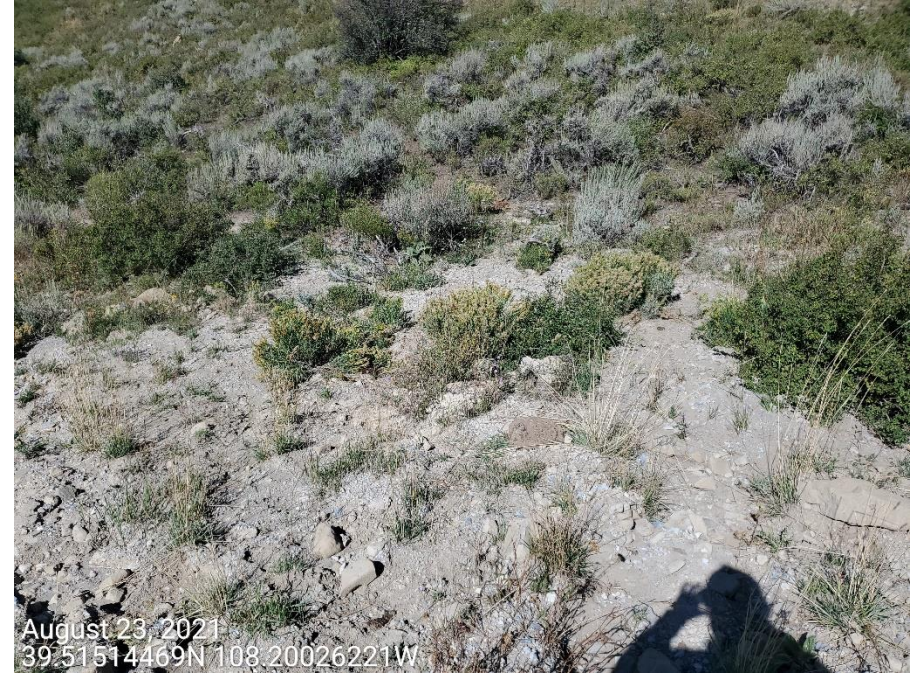
Photo 5: Photo shows erosion degradation, and offsite sediment transport along access road; BMPs to stabilize, manage runoff, and minimize erosion are missing or insufficient at the access road; erosion degradation and offsite sediment transport observed on road.

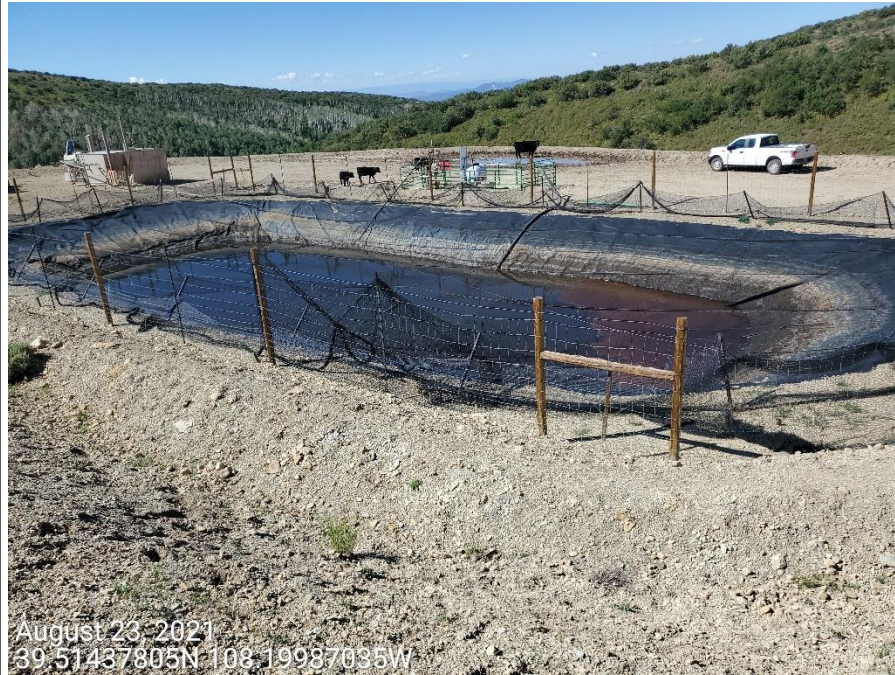
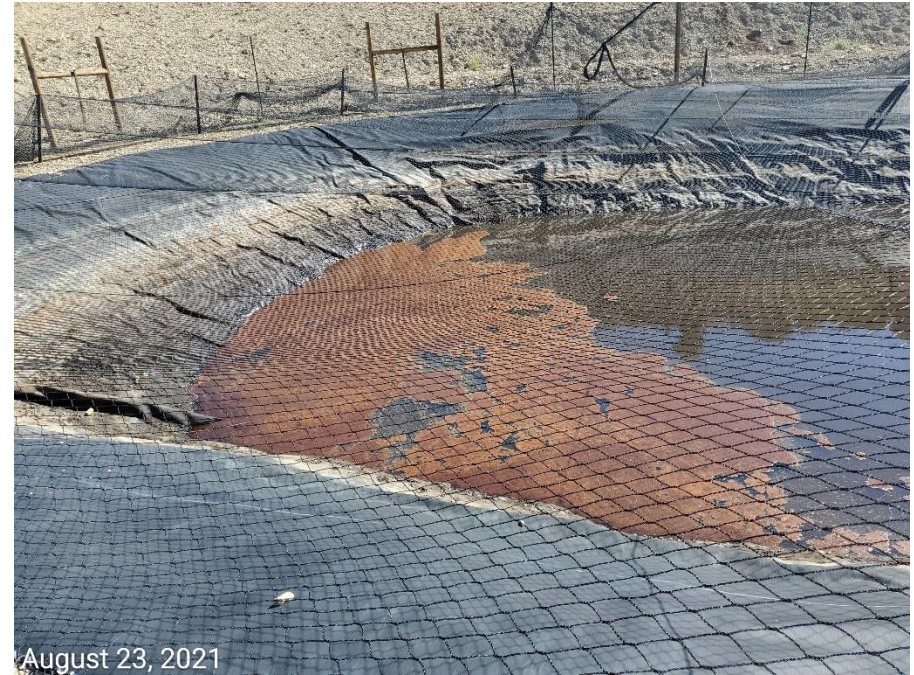
Photo 6: Photos show hydrocarbon accumulation within the pit on the Location.
