# Inspection Photos

Operator: LARAMIE ENERGY LLC #10433

Location ID: 452807

Garfield County, CO

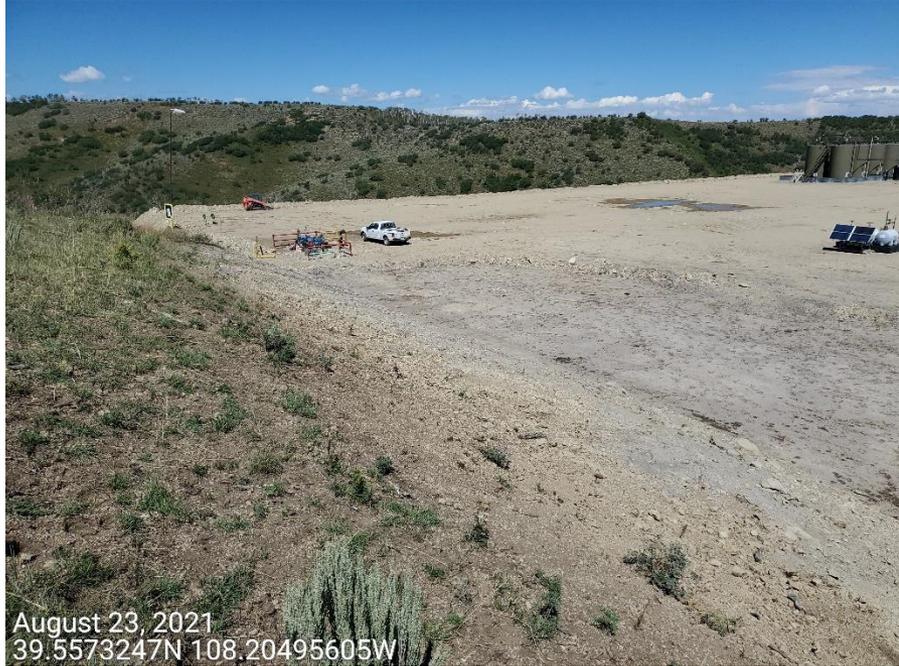
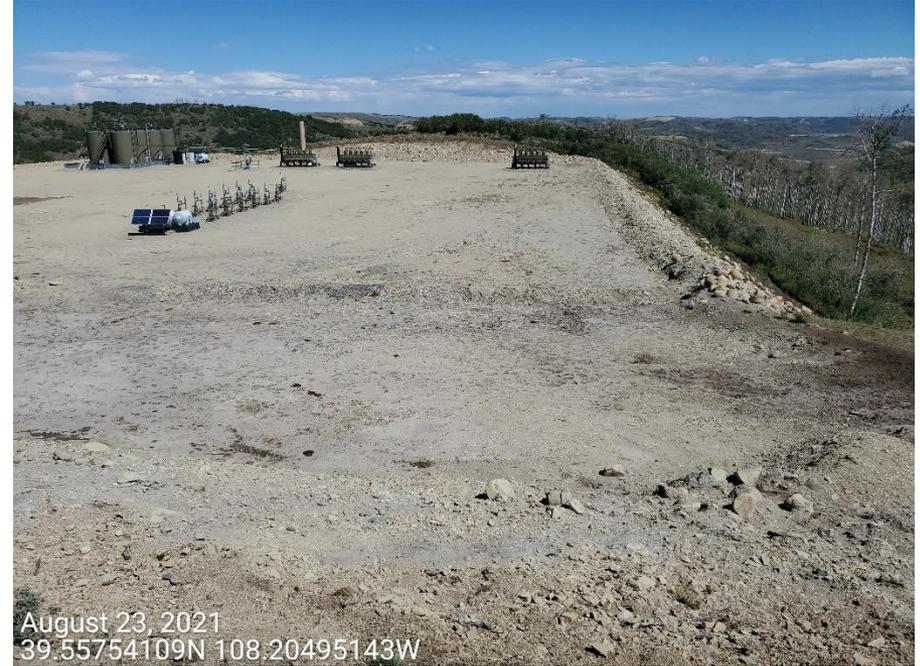
**Photo 1:** Photos taken from the southeast end of the Location. Photos provide overview of the Location. Photos show interim reclamation of the Location has not been conducted in accordance with 1003 Rules.

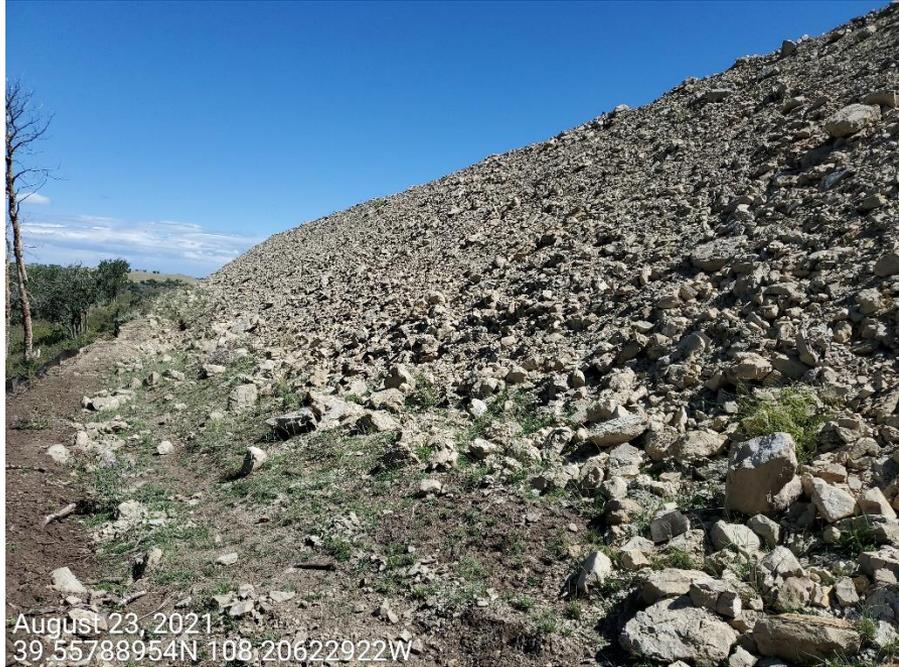
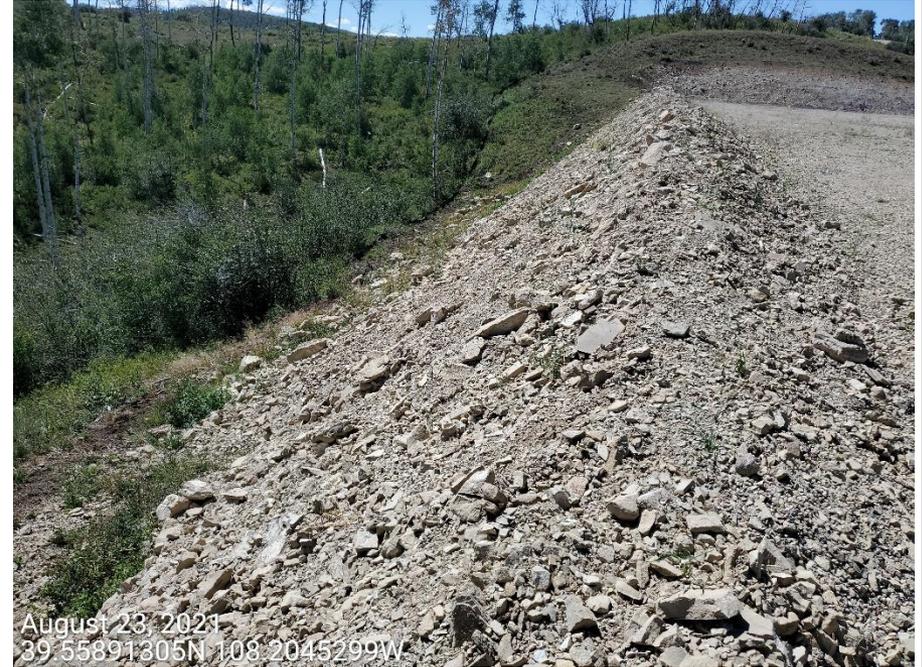
**Photo 2:** Photos taken from the slopes on the east and west end of the Location. Photo shows control measures to protect and stabilize the slopes of the Location remain missing or insufficient.

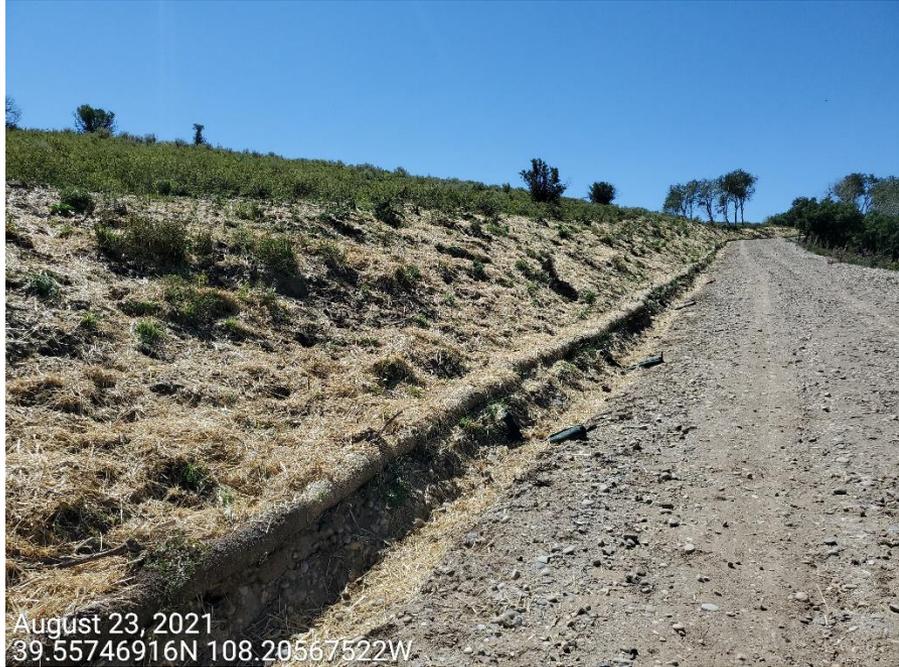
**Photo 3:** Photo taken from the access road. Photo shows additional control measures to stabilize and protect slopes along the access road have been installed.
