Inspection Photos

8/23/2021

Operator: LARAMIE ENERGY LLC #10433

Location ID: 335647

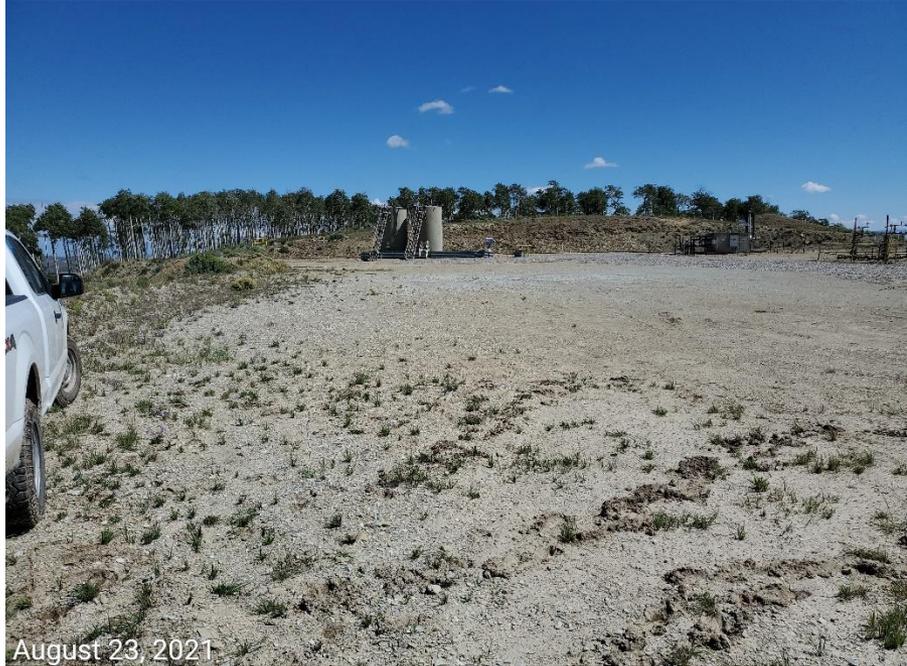
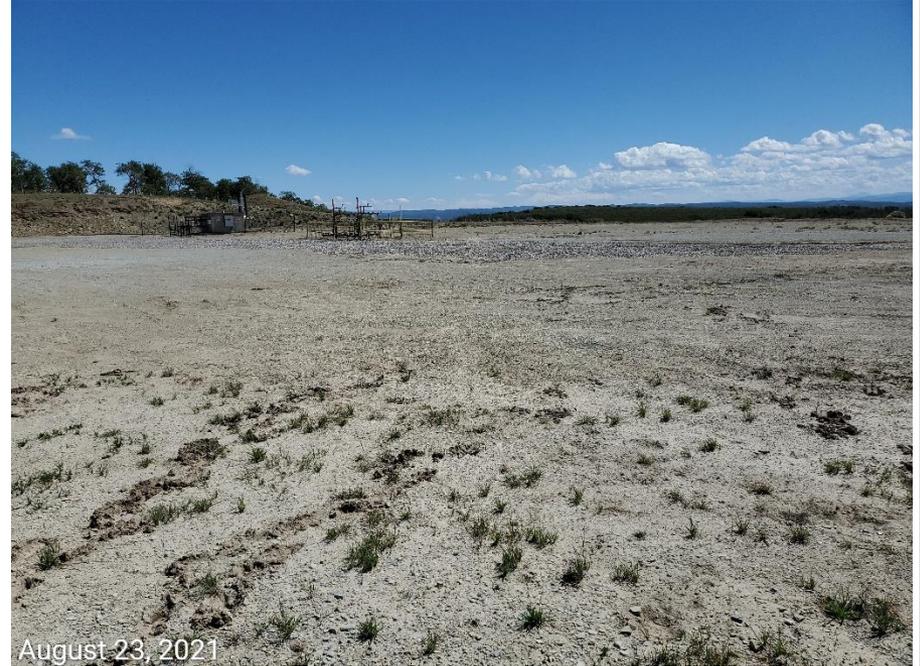
Photo 1: Photo taken from the southwest end of the Location, facing north/northeast. Photos show interim reclamation of areas not needed for production has not been conducted in accordance with 1003 Rules.

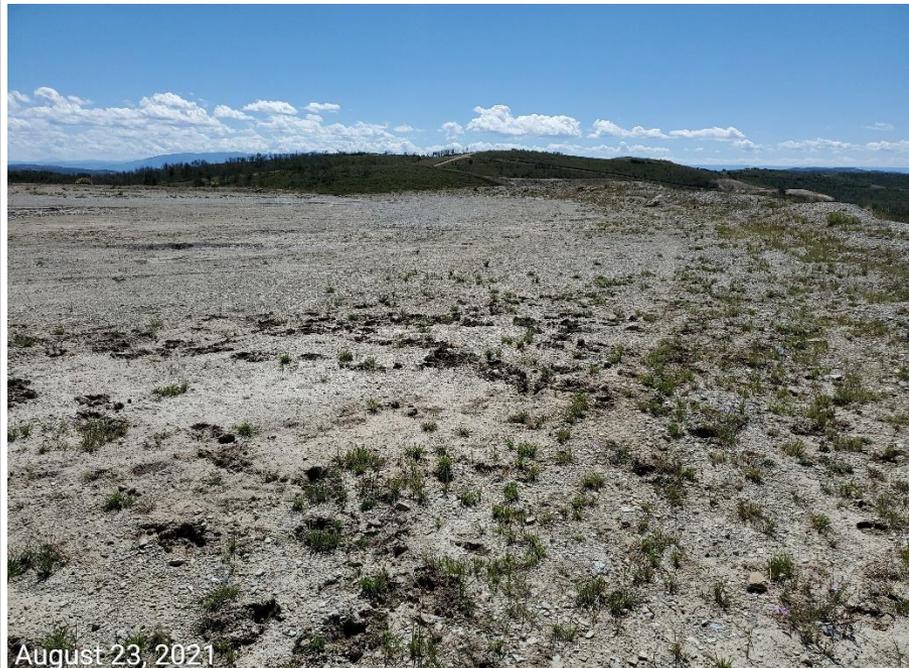
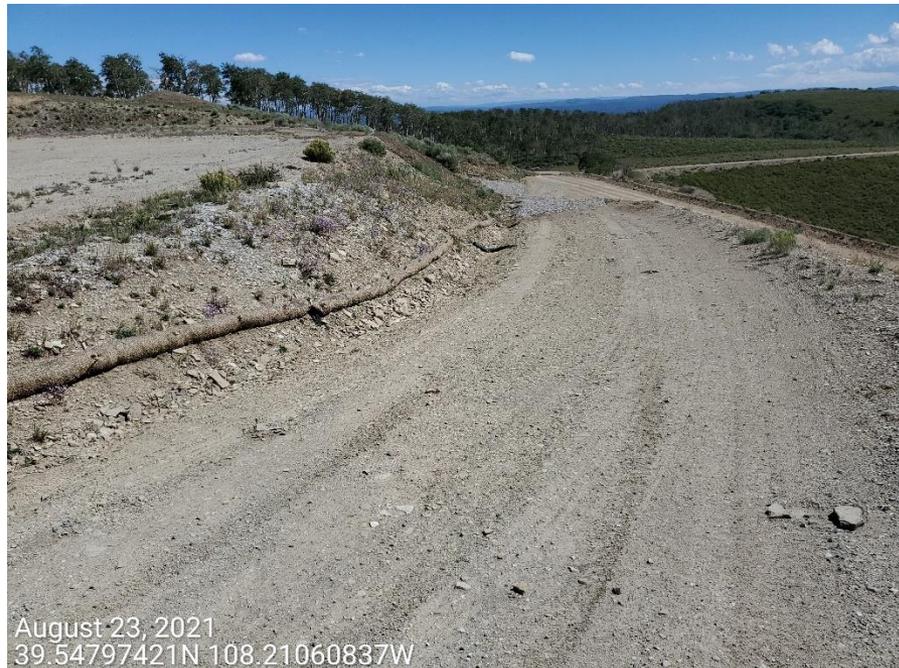
Photo 2: Photo left taken from the southwest end of the Location, facing east. Photo right taken from the south end of the Location, facing east. Photos show interim reclamation of areas not needed for production, including a second access road, has not been conducted in accordance with 1003 Rules.

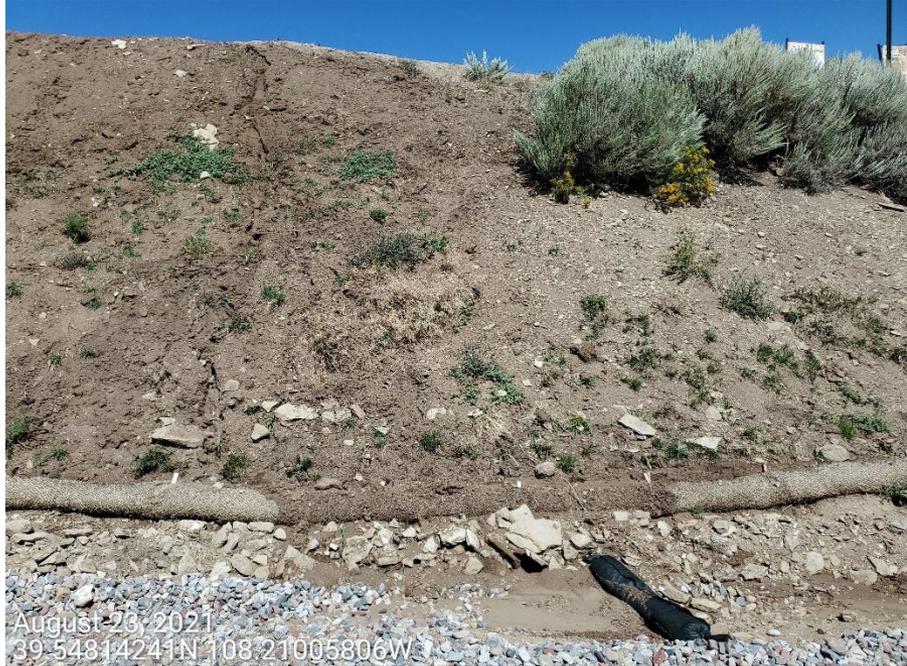
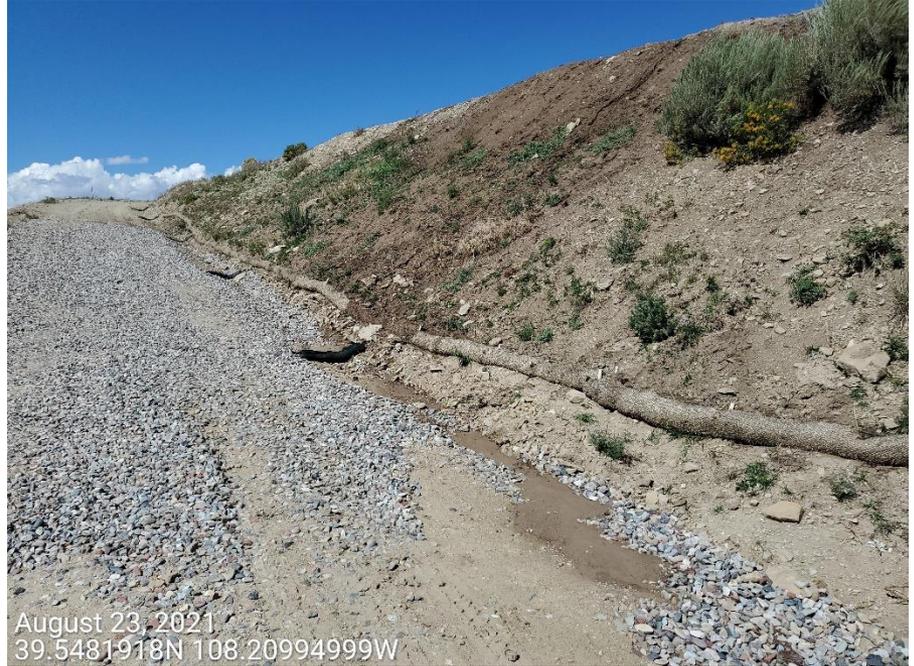
Photo 3: Photo taken south end of the Location. Photo shows BMPs to protect and stabilize slopes of the Location, and to allow for sediment laden-free stormwater discharge, remains missing or insufficient.

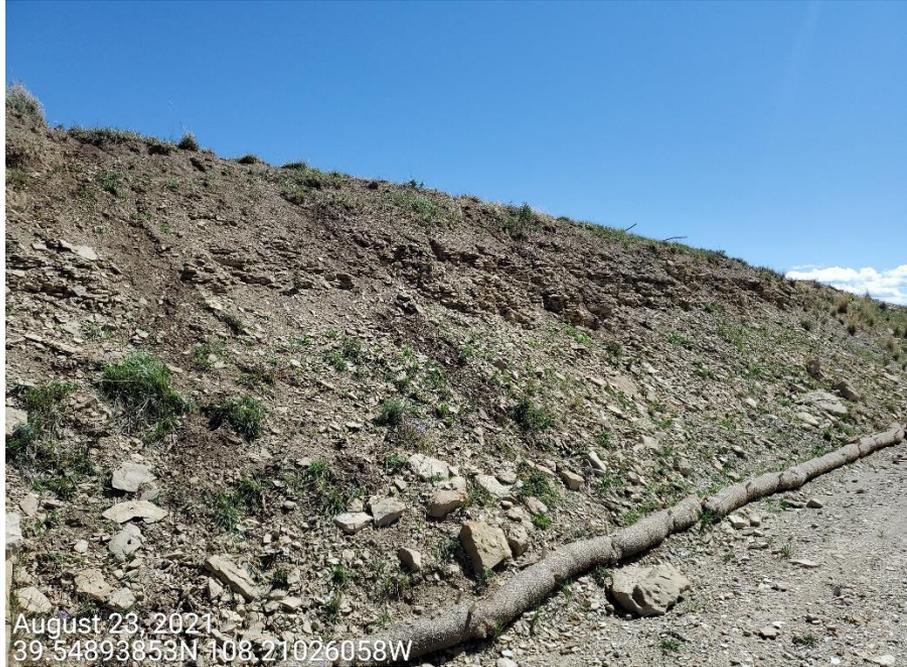
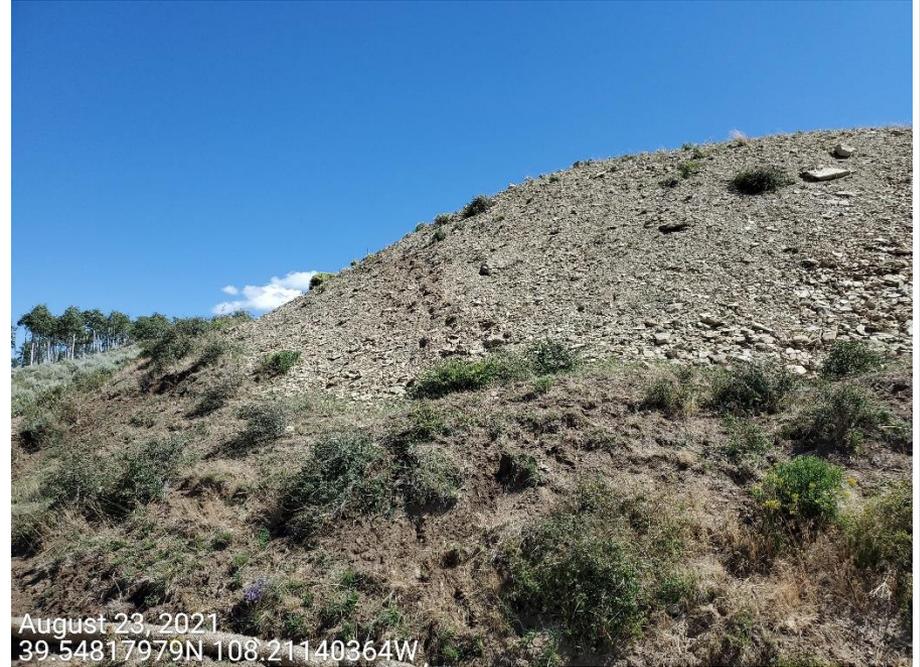
Photo 4: Photos show examples of the cut/fill slopes on the Location, where BMPs to protect and stabilize the slopes are missing or insufficient.

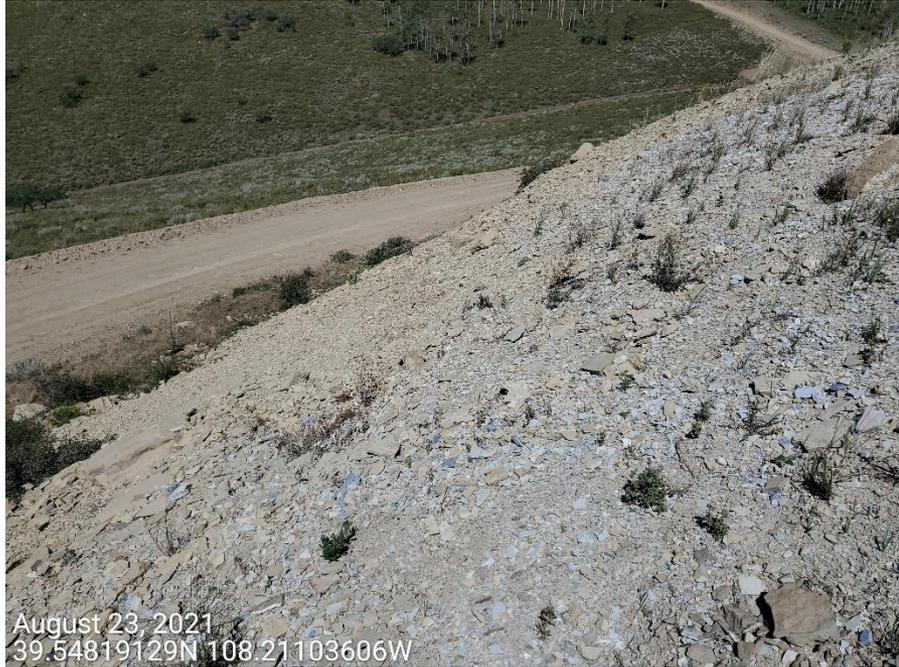
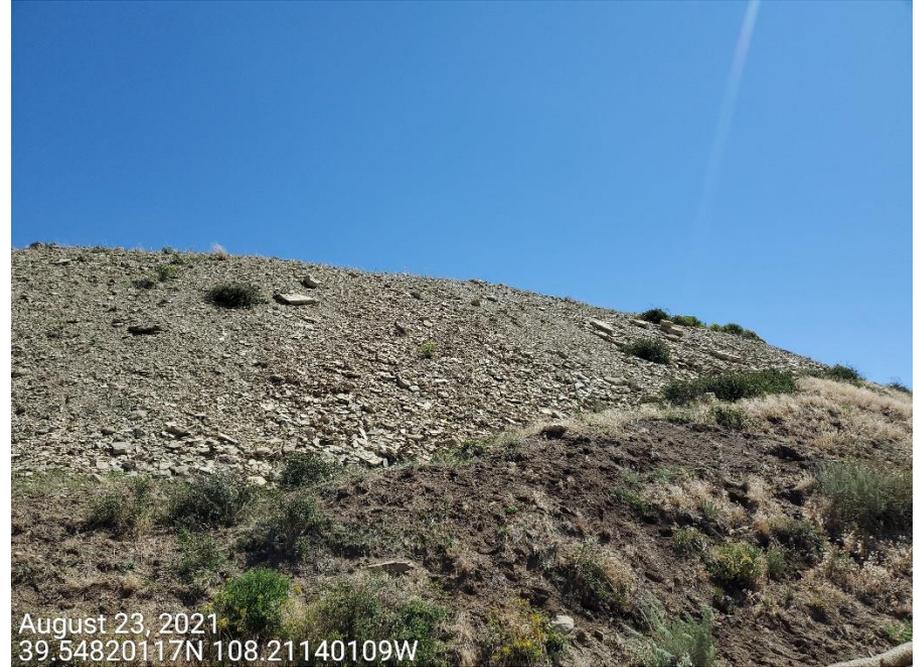
Photo 5: Photos show examples of the cut/fill slopes on the Location, where BMPs to protect and stabilize the slopes are missing or insufficient
