# Inspection Photos

Operator: LARAMIE ENERGY LLC #10433

Location ID: 383337

Garfield County, CO

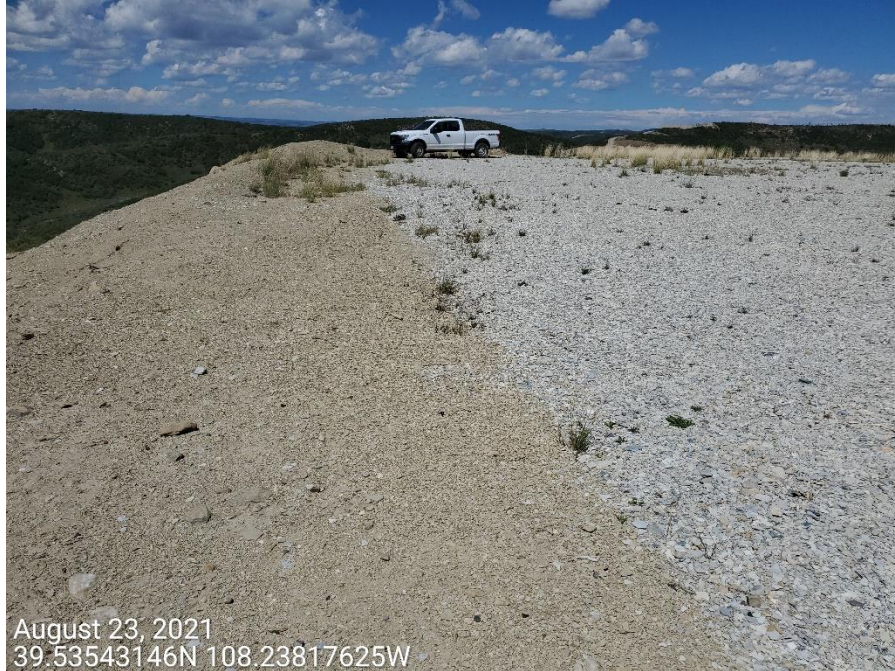
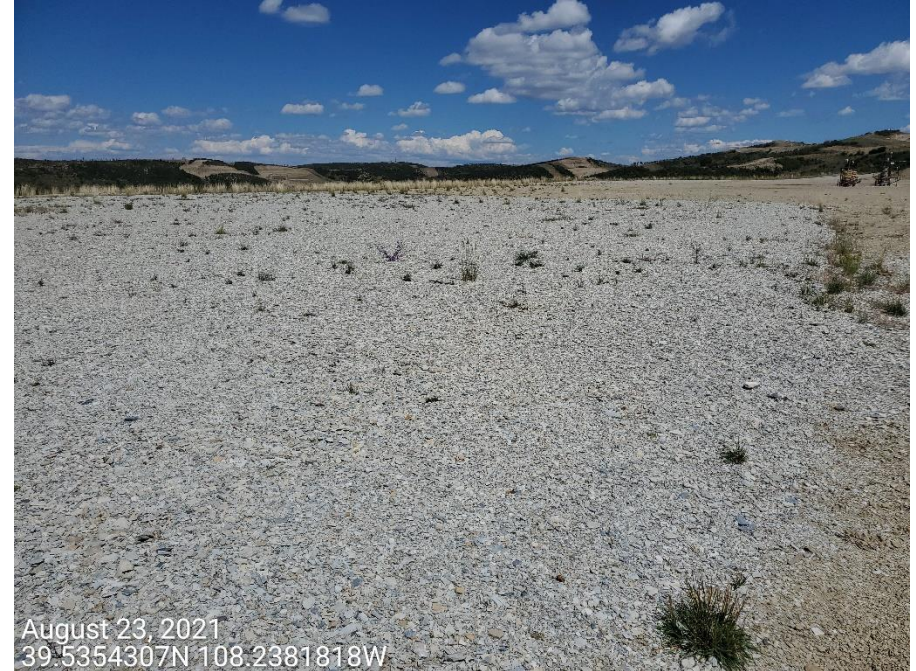
**Photo 1:** Photos 1-2 taken from the south end o the Location. Photos provide an overview of the Location from west, northwest, northeast to east. Photos show interim reclamation of the Location has not been conducted in accordance with 1003 Rules.

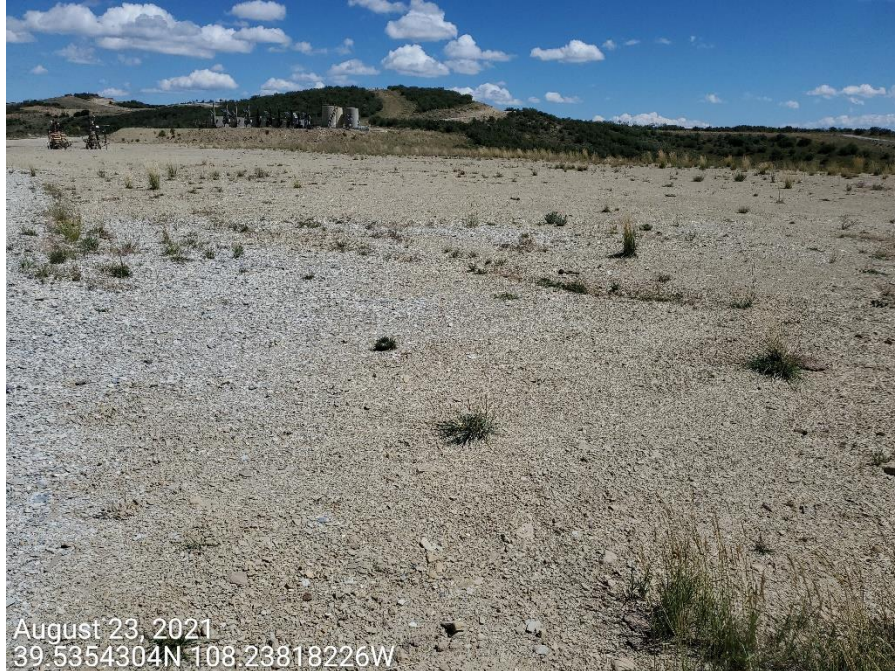
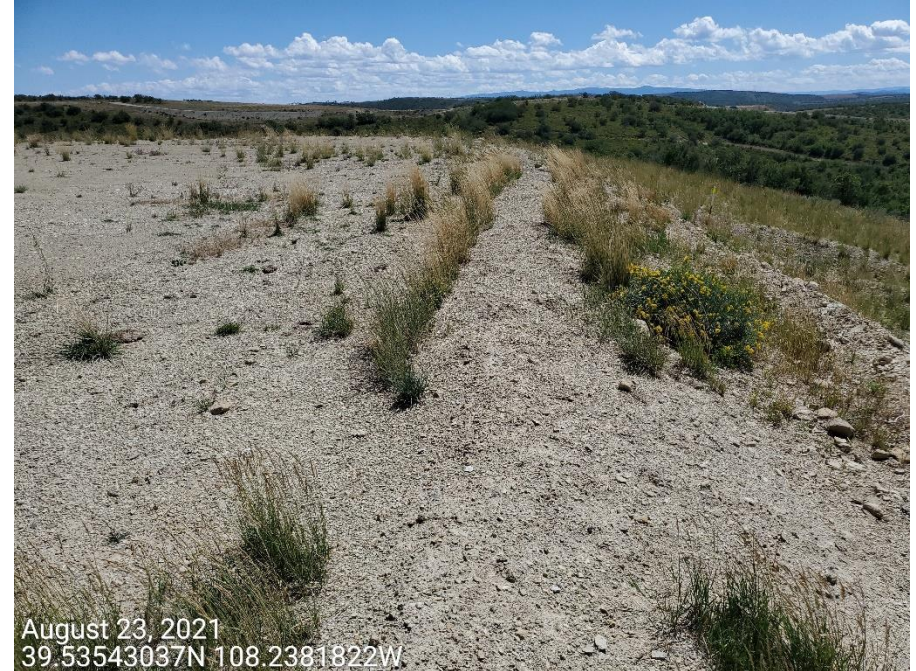
**Photo 2:** Photos 1-2 taken from the south end o the Location. Photos provide an overview of the Location from west, northwest, northeast to east. Photos show interim reclamation of the Location has not been conducted in accordance with 1003 Rules.

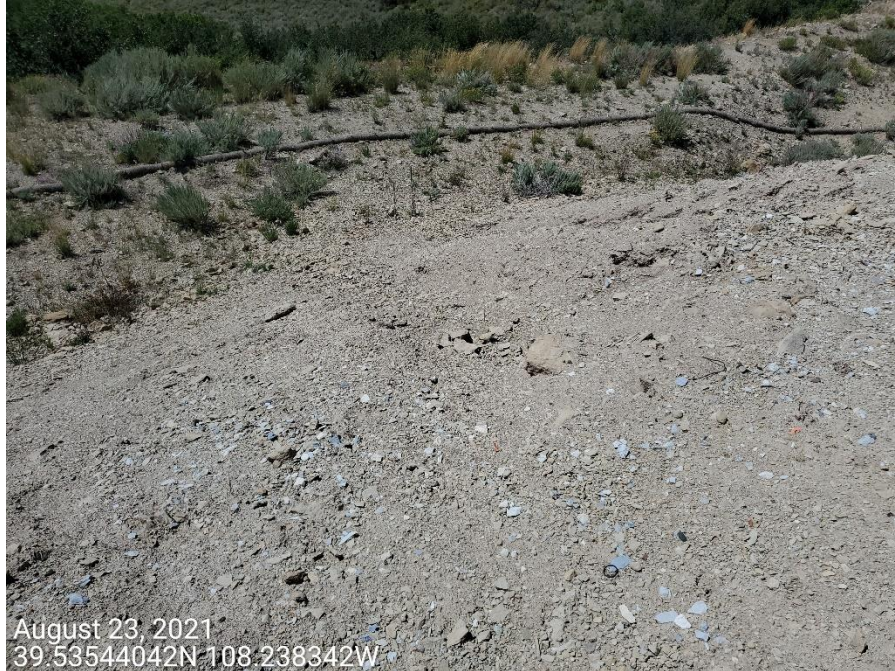
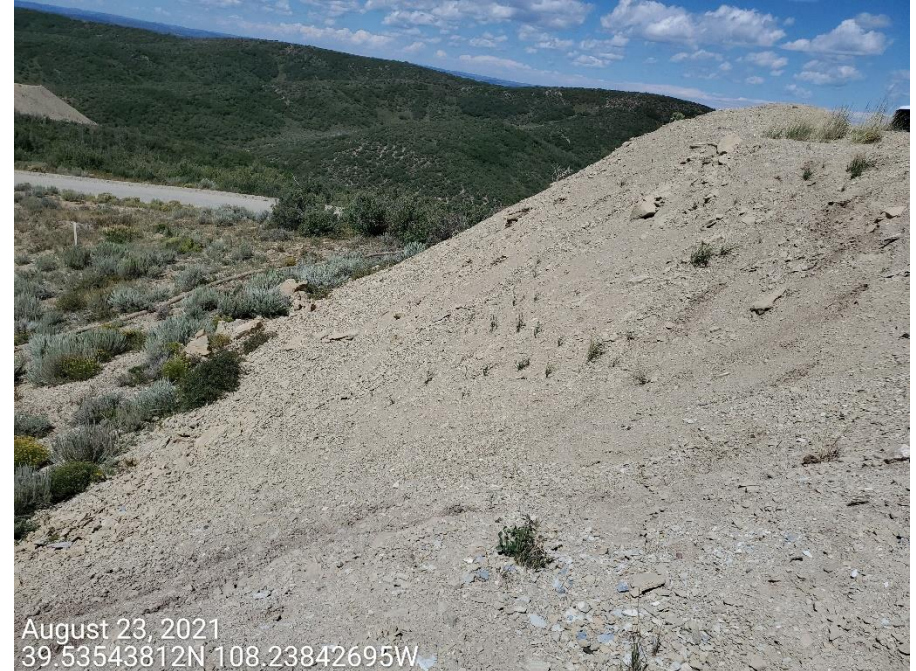
**Photo 3:** Photos show example of areas where BMPs to protect and stabilize the slopes of the Location are missing or insufficient/inadequate.

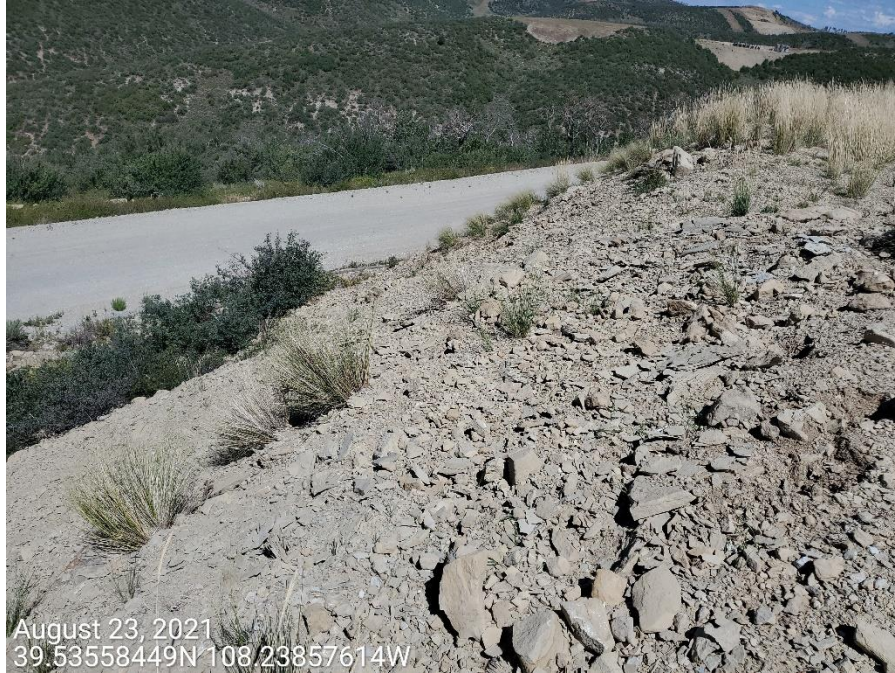
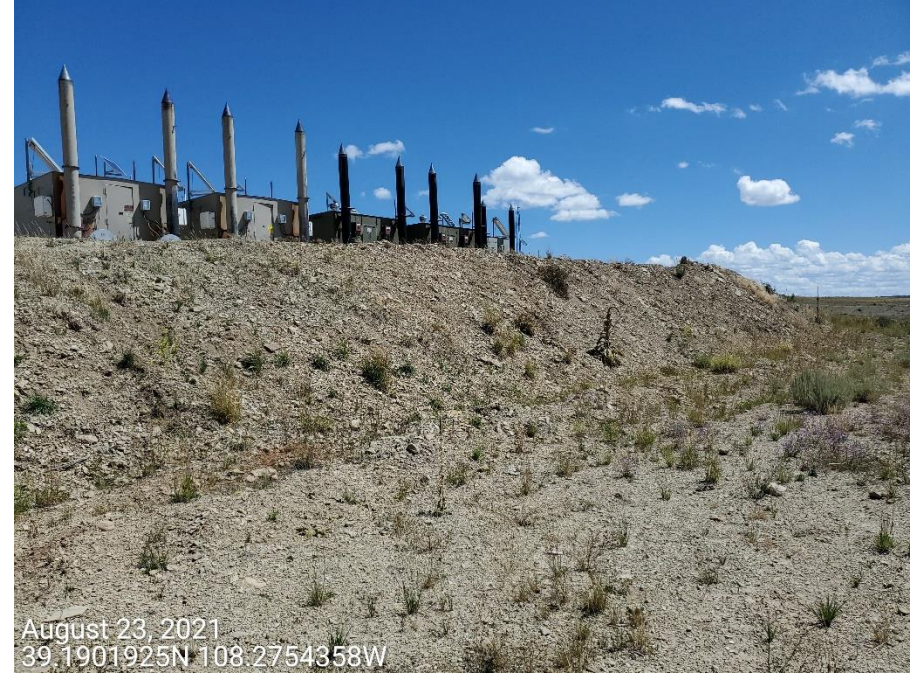
**Photo 4:** Photos show example of areas where BMPs to protect and stabilize the slopes of the Location are missing or insufficient/inadequate.
